Remediation Summary & Deferral Request

Mewbourne Oil Company

Layla 27 SWD #001

NMOCD Reference No. nAPP2428849677

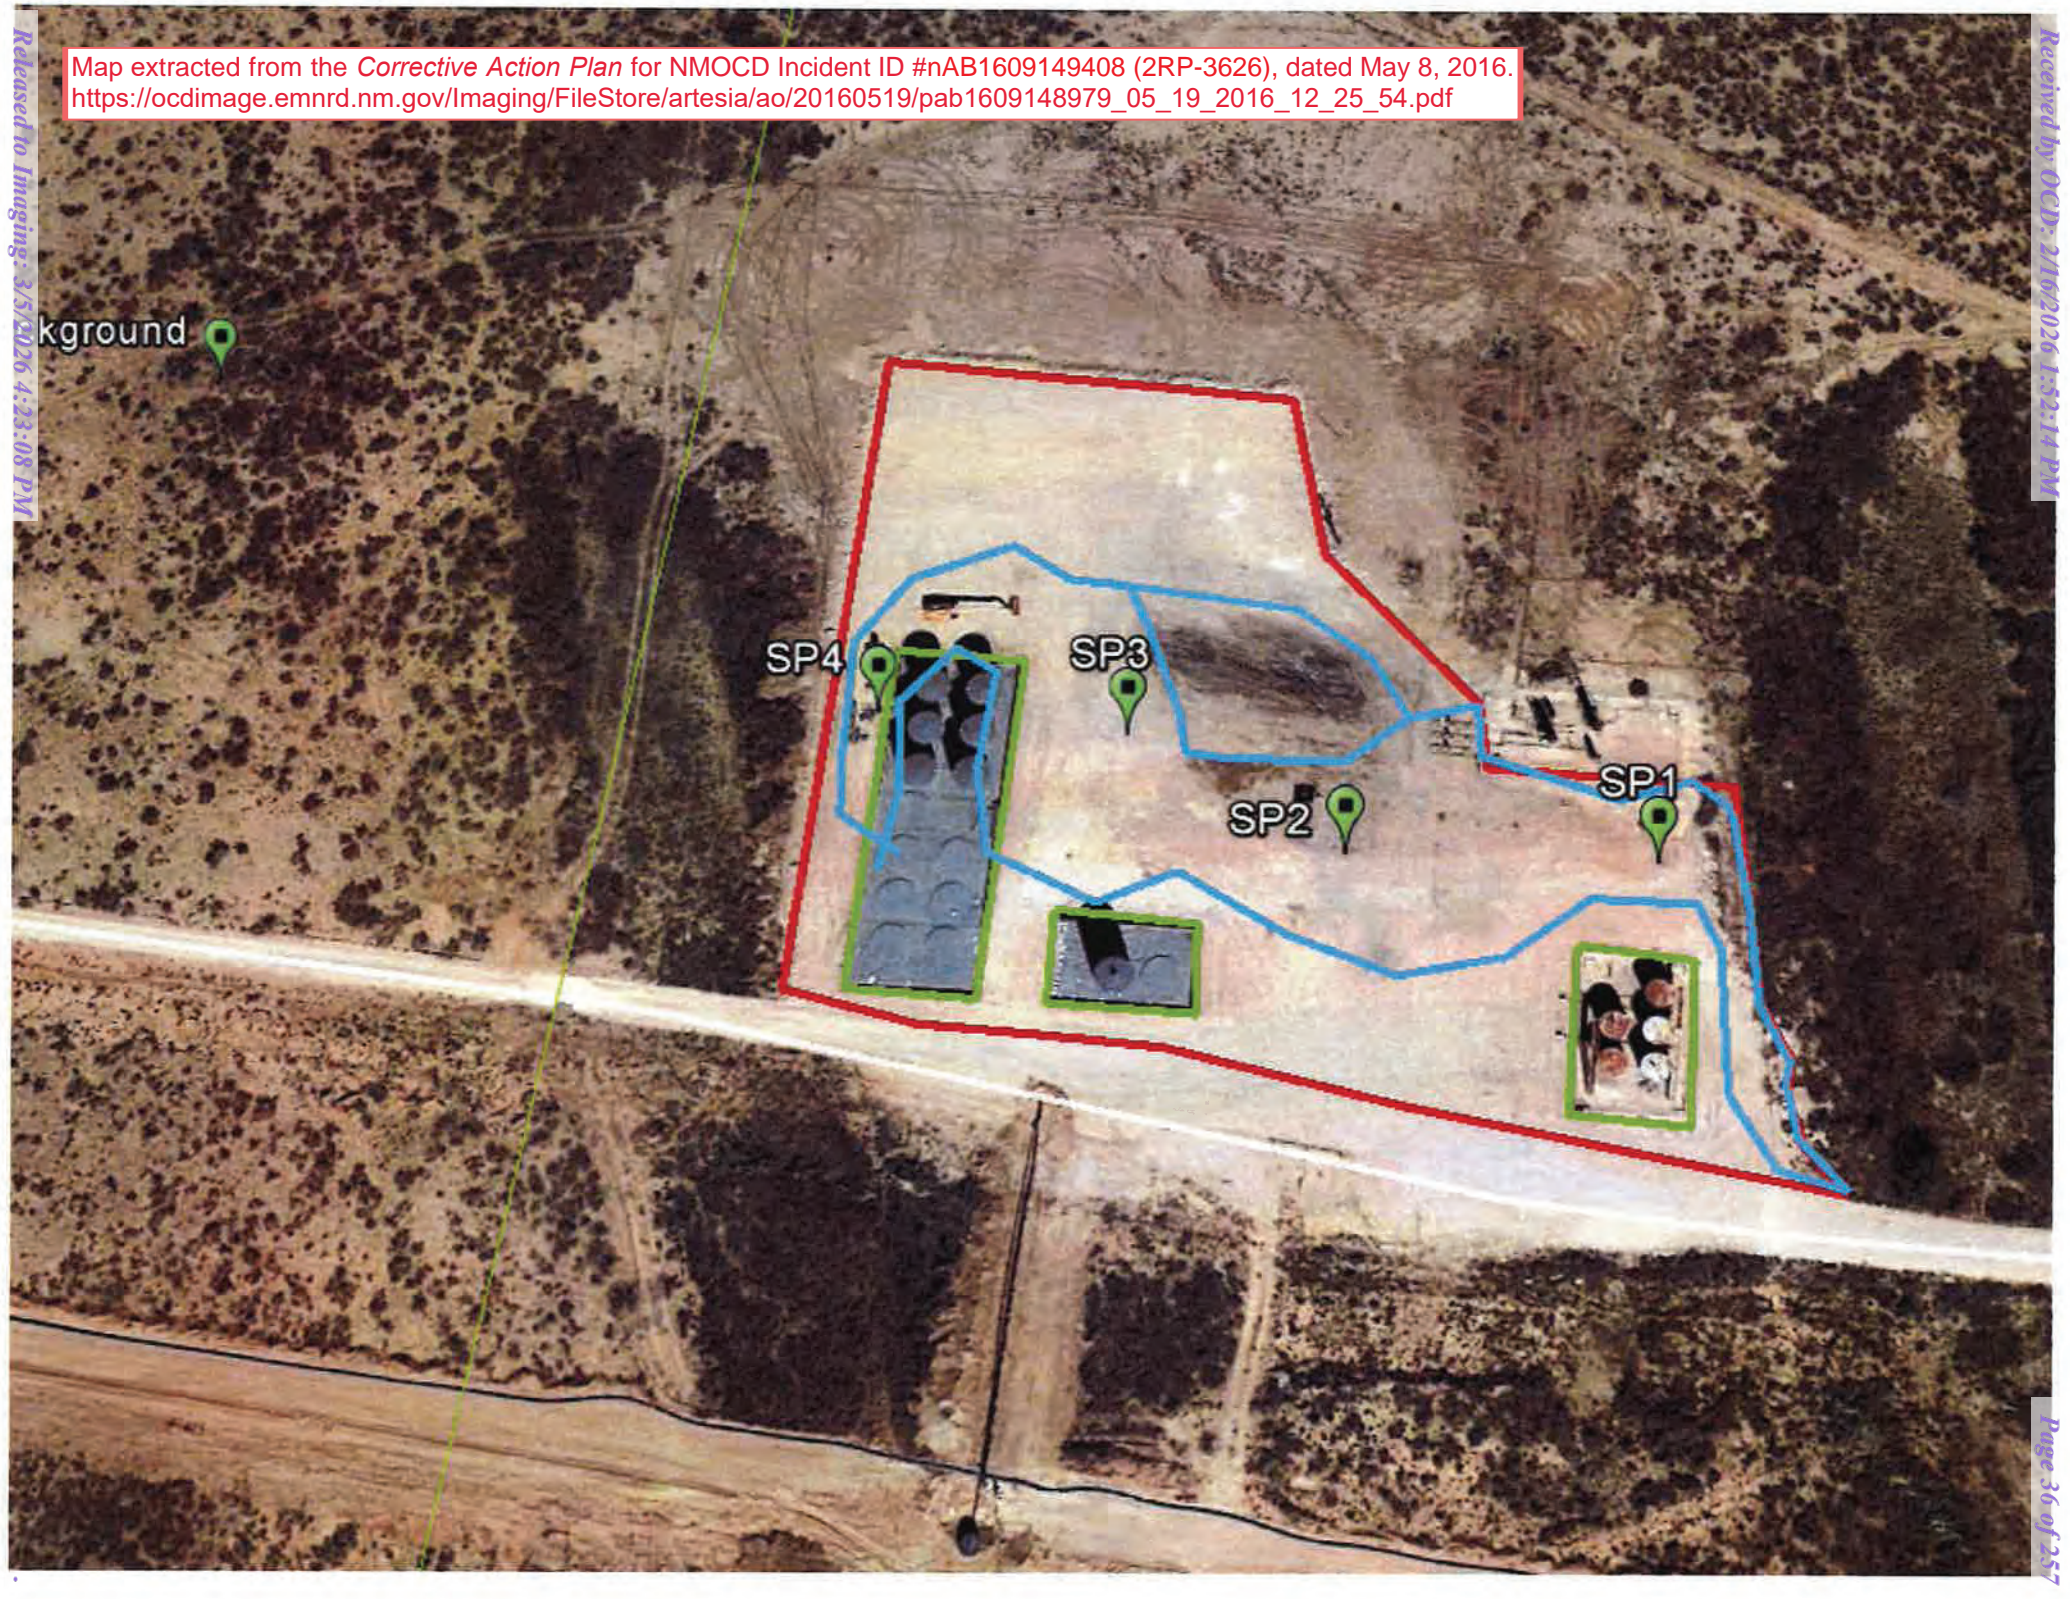
Pad Liner Installation (2016)

Map extracted from the *Corrective Action Plan* for NMOCD Incident ID #nAB1609149408 (2RP-3626), dated May 8, 2016.
https://ocdimage.emnrd.nm.gov/Imaging/FileStore/artesia/ao/20160519/pab1609148979_05_19_2016_12_25_54.pdf

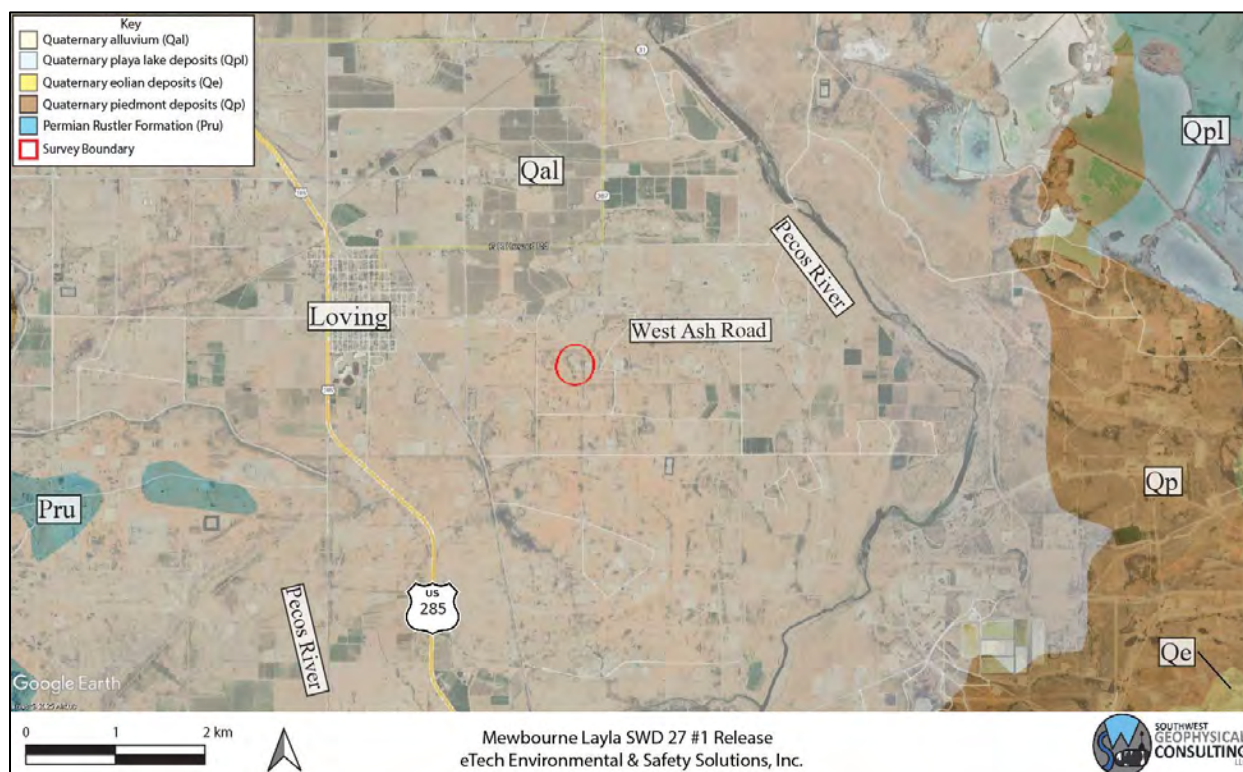
Figure 3: Geology overview. Geology map credit: The Digital Geologic Map of New Mexico in ARC/INFO Format. Background image credit: Google Earth. Image date: July 13, 2024. Image datum: WGS-84.

The site for the LS271 survey is located at an elevation of 926 meters (3,038 feet), ± 3 meters (9.8 feet), and is located within a region underlain by the Permian Rustler Formation (Pru). The area is mantled by thin gypsiferous soils (gypsite), Quaternary alluvium (Qal), and piedmont gravels (Qp)^[11] up to 5 meters in depth (**Figure 3**).

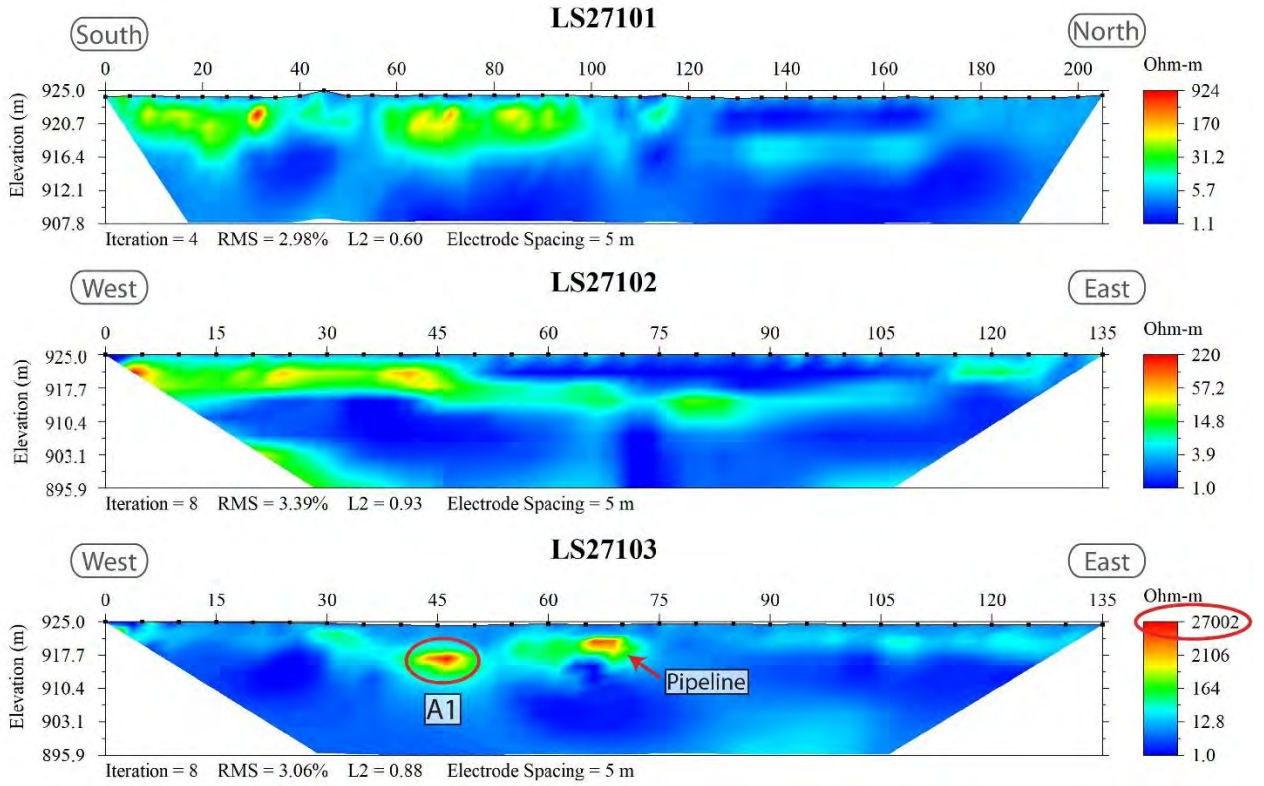
Figure 7: 2D inverted resistivity sections. Red ellipse highlights high-resistivity anomaly. Reds and oranges indicate higher resistivity values. Yellows and greens are medium-resistivity values. Blues are low-resistivity values. Please note that the color scale is relative.

One high-resistivity anomaly (A1) consistent with an air-filled subsurface void is located just outside of the 61-meter (200-foot) survey boundary. This anomaly could also represent a sandstone or dolomite lens, or a gravel layer. The anomaly may represent a small (less than 5-meter diameter) to medium (less than 10-meter) isolated air-filled void in caliche or near-surface solution-enlarged fracture within gypsite or an evaporite layer in the Rustler Formation. Such a feature could be associated with groundwater recharge and may also represent a collapse hazard.

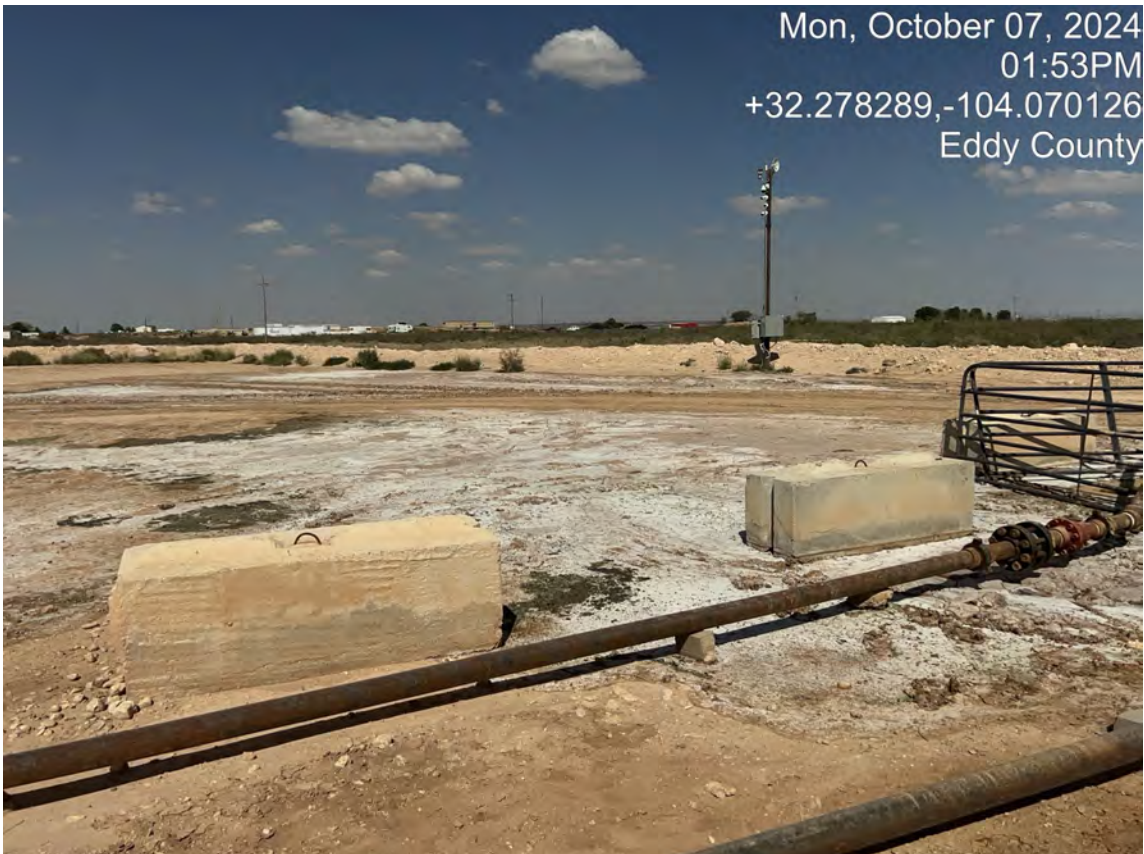
Photo Number: 6

<p>Mon, October 07, 2024 01:53PM +32.278289,-104.070126 Eddy County</p>
Photo Direction: Northeast	
Photo Description: View of the affected area.

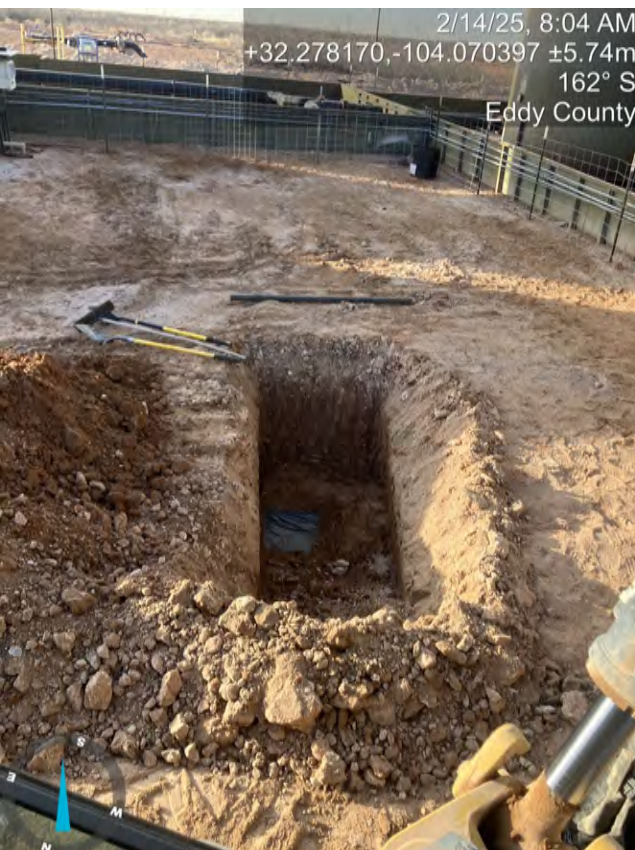
Photo Number: 10

Photo Direction: South-Southeast	
Photo Description: View of test trench TT 4 and liner.
