**Re: Closure Request
PLU BS 19-24-31
Incident Number nAPP2528732266
Eddy County, New Mexico**

Ensolum, LLC (Ensolum), on behalf of XTO Energy, Inc. (XTO), has prepared this *Closure Request* to document the findings of a liner integrity inspection and delineation activities completed at the PLU BS 19-24-31 (Site) following a release of produced water within a steel-walled lined containment housing storage tanks, transfer pumps, and process piping. Based on the liner integrity inspection and delineation activities, XTO is submitting this *Closure Request*, describing the inspection results and requesting closure for Incident Number nAPP2528732266.

XTO Energy, Inc.
Closure Request
PLU 19-24-31 USA Battery

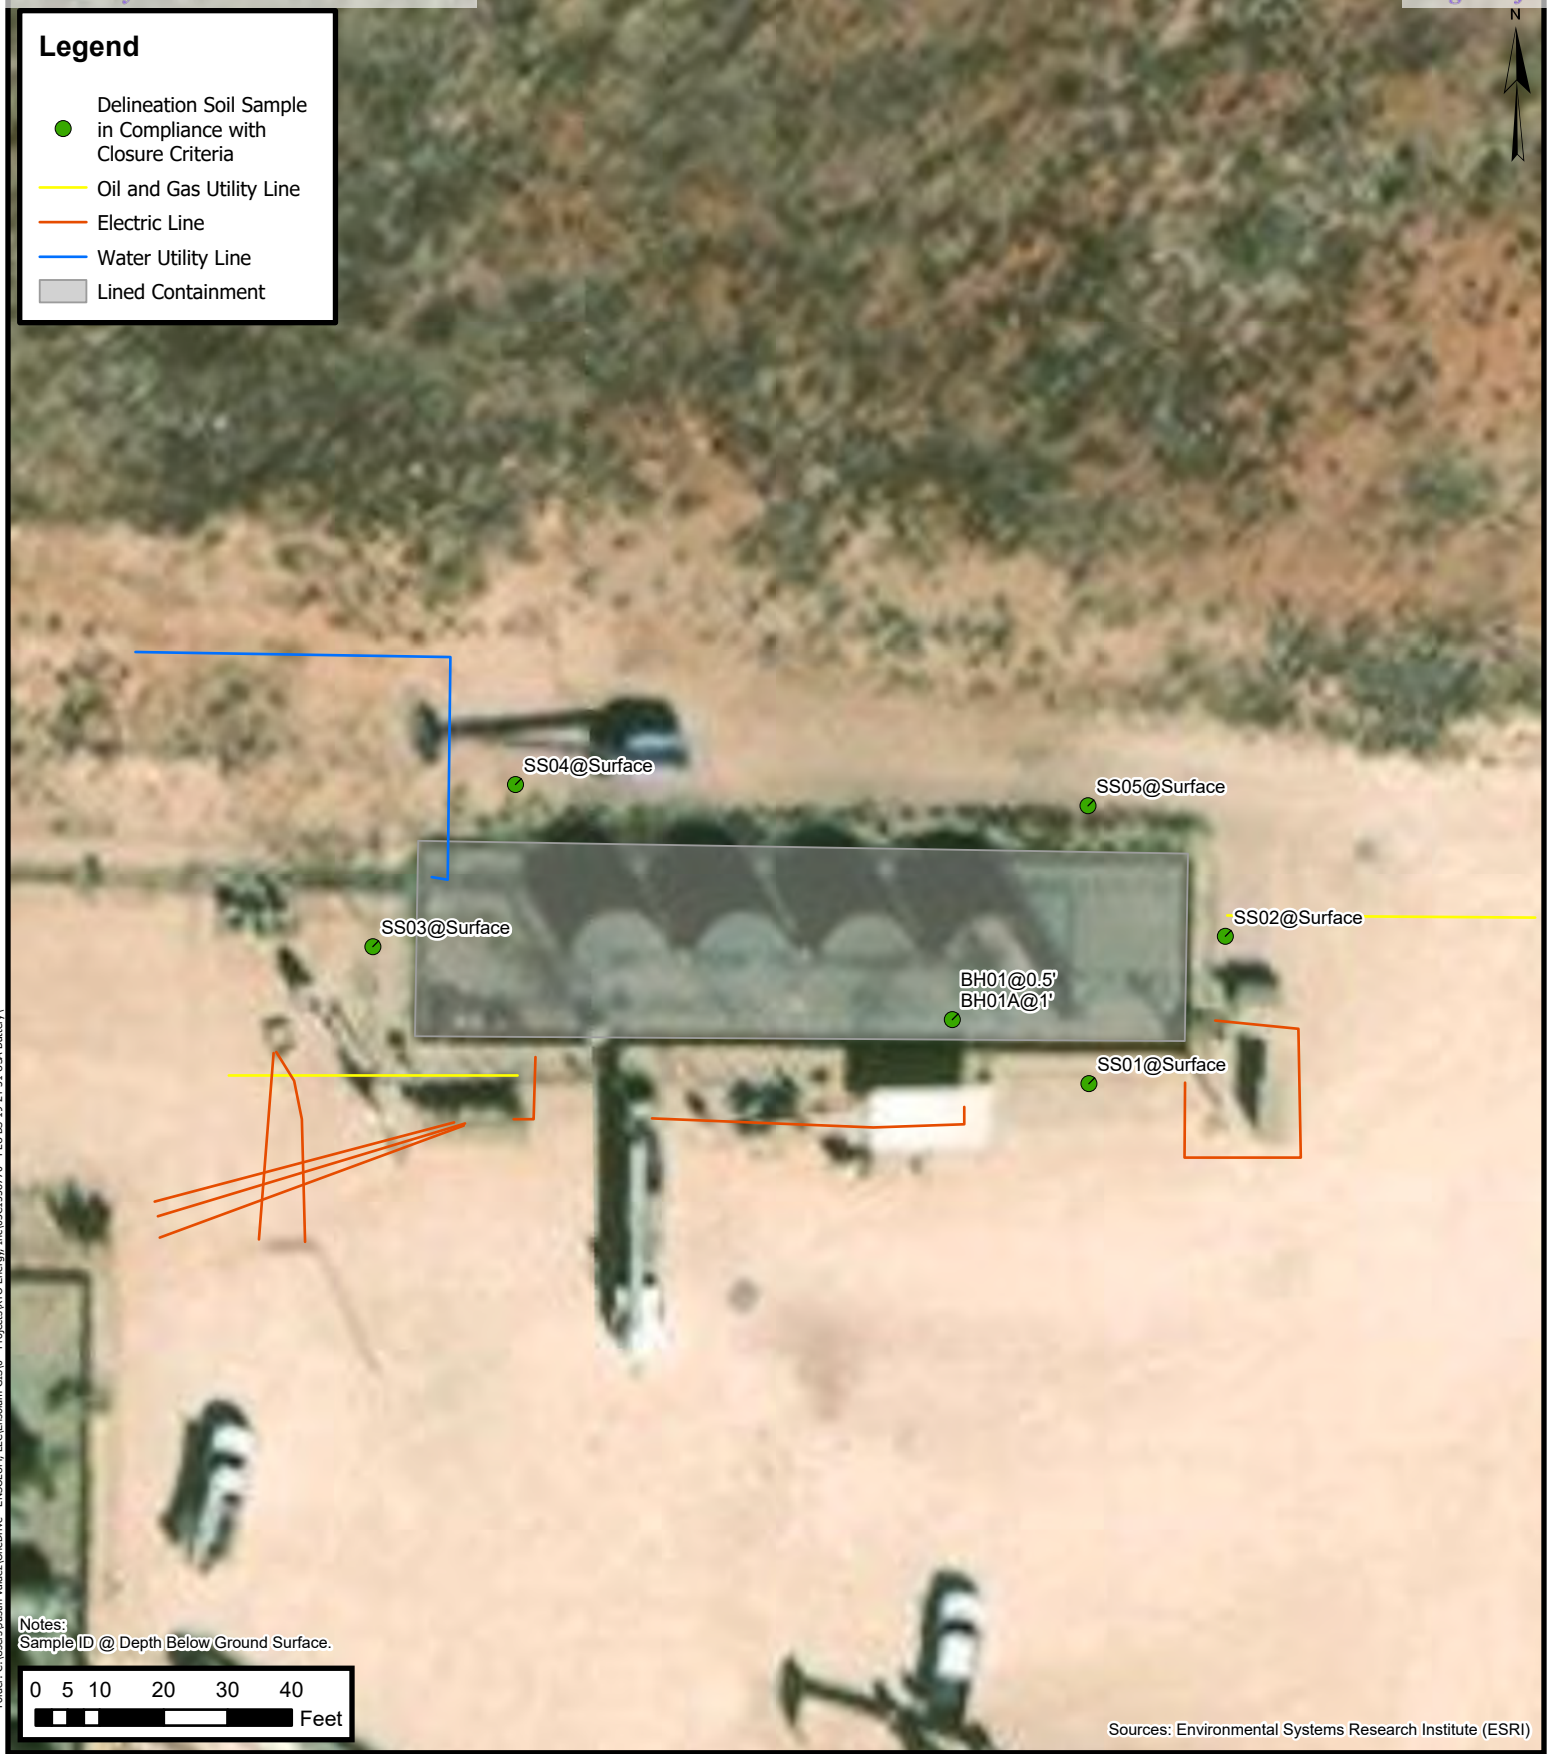
FIGURE

On January 16, 2026, Ensolum personnel were at the Site to conduct delineation activities. Four delineation soil samples (SS01 through SS04) were collected around the lined containment from ground surface to confirm the release did not breach the containment walls. One borehole (BH01) was advanced via hand auger to a terminal depth of 1-foot bgs in the location of the tear in the liner. The delineation soil samples were field screened for volatile organic compounds (VOCs) utilizing a calibrated photoionization detector (PID) and chloride utilizing Hach® chloride QuanTab® test strips. Field screening results and observations of the soil samples from the borehole were logged on a lithologic/soil sampling log, which is included in Appendix C. The delineation soil sample locations were mapped utilizing a handheld Trimble® Catalyst™ DA2 Global Positioning System (GPS) unit and are depicted on Figure 2. Photographic documentation is included in Appendix B.

Delineation Soil Sample Locations

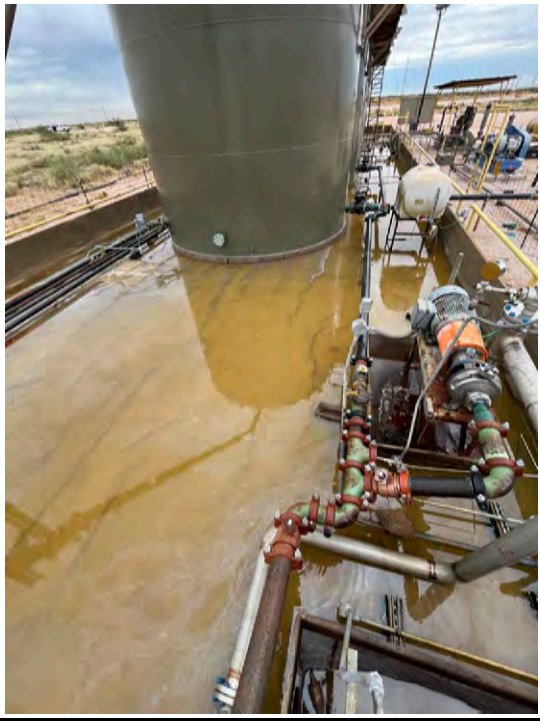
<p><u>Photograph</u> 1</p>	<p><u>Date</u> 10/13/2025</p>

On October 13, 2025, failure of a transfer pump seal resulted in the release of 18 barrels (bbls) of produced water into a steel-lined containment measuring approximately 3,362 square feet. A vacuum truck was dispatched to the Site to recover free-standing fluid, and all released fluid was recovered. The pump was repaired and returned to service. XTO reported the release to the NMOCD via a Notification of Release (NOR) on October 14, 2025, and subsequently an Initial C-141 Application (C-141) on October 30, 2025. The release was assigned Incident Number nAPP2528732266.

<p><u>Description</u> Initial release in containment</p>		
<p><u>View</u> West</p>		
<p><u>Photograph</u> 2</p>	<p><u>Date</u> 1/05/2026</p>

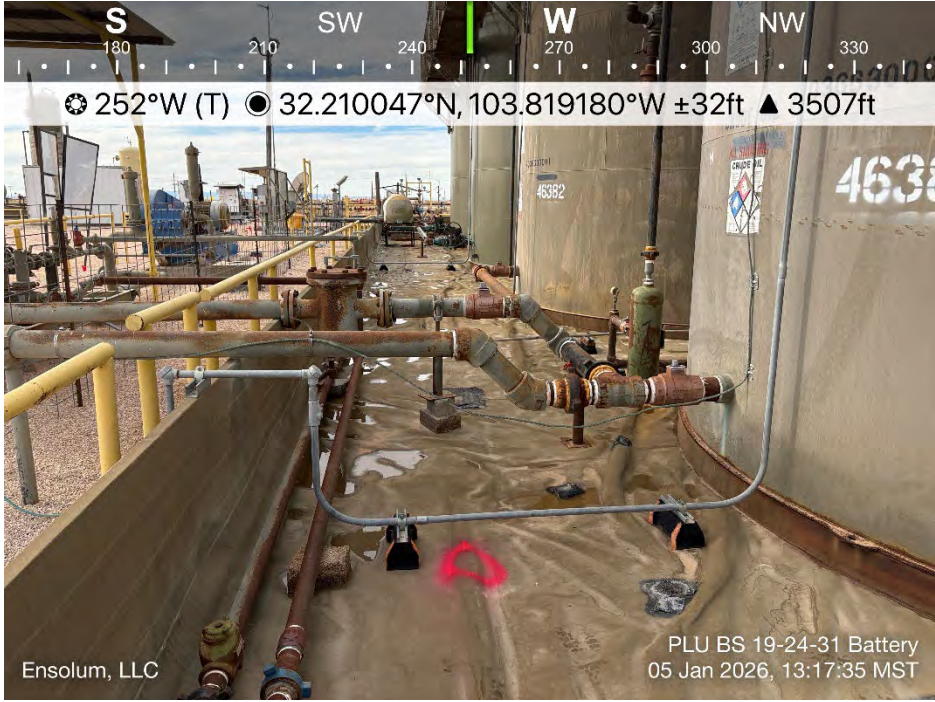
<p><u>Photograph</u> 5</p>	<p><u>Date</u> 1/05/2026</p>

The lined containment was cleaned of all debris, power washed and a 48-hour advance notice of the liner inspection was submitted to the NMOCD on January 2, 2026. On January 5, 2026, the lined containment was inspected by Ensolum personnel and was determined to contain a small tear near the southeastern edge of the containment. Delineation to determine the extent of the release was warranted. A site map of the lined containment is included in Figure 2. Photographic documentation of the inspection is included in Appendix B.

<p>252°W (T) 32.210047°N, 103.819180°W ±32ft ▲ 3507ft</p> <p>PLU BS 19-24-31 Battery 05 Jan 2026, 13:17:35 MST</p>
<p><u>Description</u> Tear found during inspection activities</p>		
<p><u>View</u> West</p>		
<p><u>Photograph</u> 6</p>	<p><u>Date</u> 1/16/2026</p>

Liner integrity inspection and delineation activities were conducted at the Site to address the October 2025 release of produced water. Laboratory analytical results for the delineation soil samples, collected below the liner tear, indicated that all COC concentrations were compliant with the Site Closure Criteria. Based on the soil sample analytical results, no impacted soil was identified, and no further remediation was required. Ensolum patched the tear in the liner following completion of delineation activities.

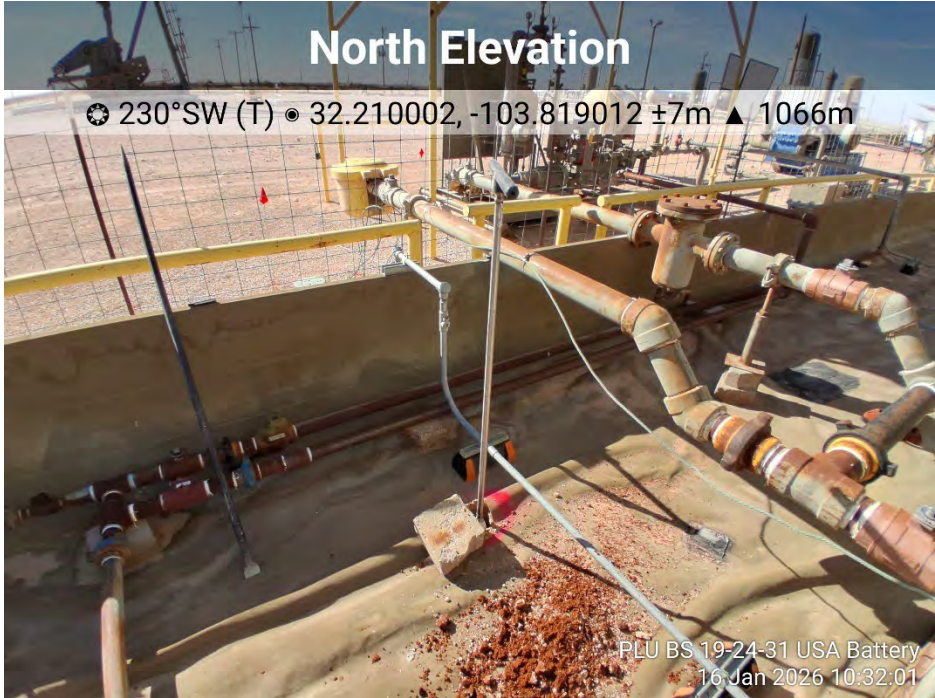
<p>North Elevation</p> <p>230°SW (T) 32.210002, -103.819012 ±7m ▲ 1066m</p> <p>PLU BS 19-24-31 USA Battery 16 Jan 2026 10:32:01</p>
<p><u>Description</u> Delineation activities; near BH01</p>		
<p><u>View</u> Southwest</p>

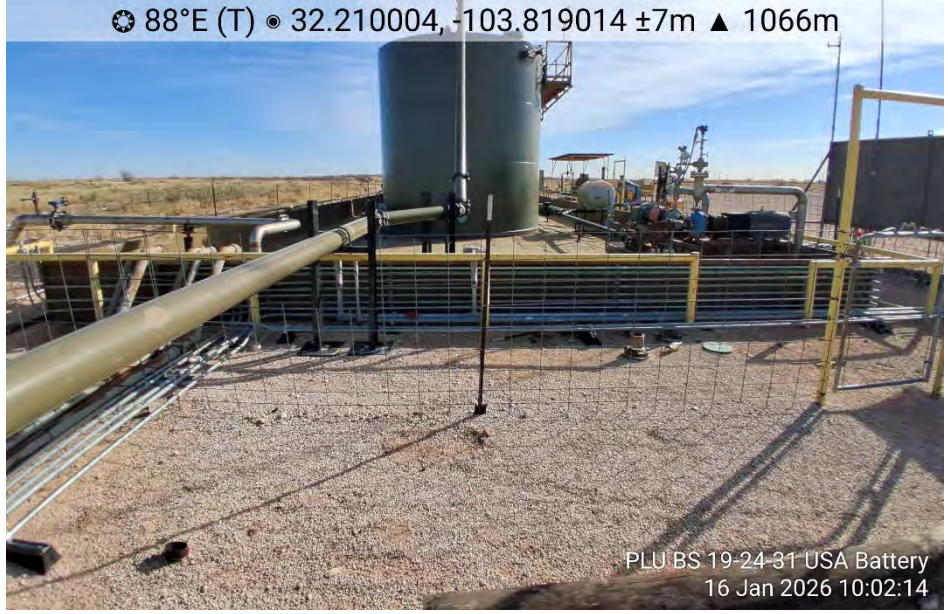
<p><u>Photograph</u> 7</p>	<p><u>Date</u> 1/16/2026</p>	<div data-bbox="535 323 1477 430"> <p>West Elevation</p> <p>☉ 88°E (T) • 32.210004, -103.819014 ±7m ▲ 1066m</p> </div>

<div data-bbox="1153 966 1461 1029"> <p>PLU BS 19-24-31 USA Battery 16 Jan 2026 10:02:14</p> </div>
<p><u>Description</u> Delineation activities; near SS03</p>		
<p><u>View</u> East</p>		
<p><u>Photograph</u> 8</p>	<p><u>Date</u> 1/16/2026</p>	<div data-bbox="535 1050 1477 1165"> <p>South Elevation</p> <p>☉ 56°NE (T) • 32.210004, -103.819013 ±7m ▲ 1067m</p> </div>

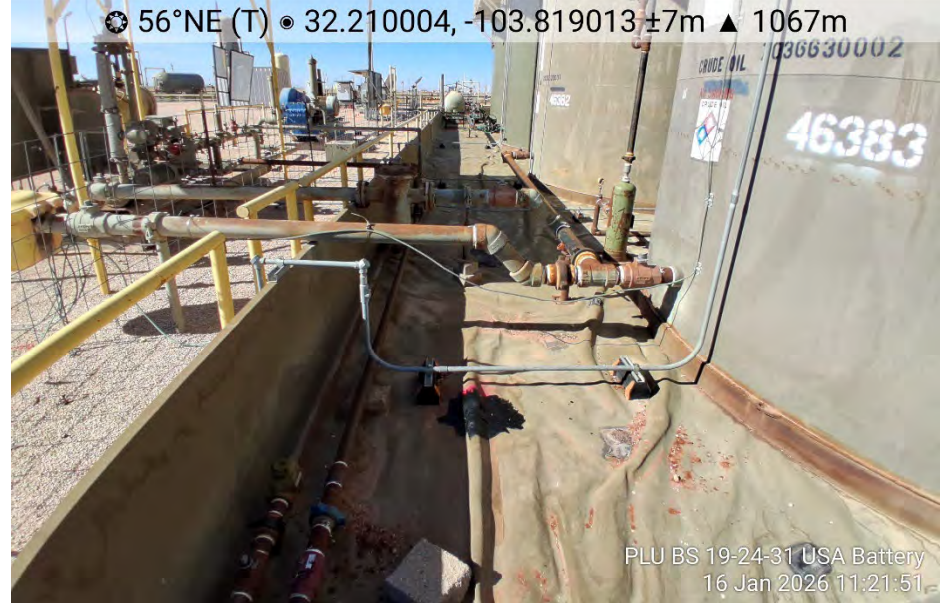
<div data-bbox="1153 1701 1461 1764"> <p>PLU BS 19-24-31 USA Battery 16 Jan 2026 11:21:51</p> </div>
<p><u>Description</u> BH01 patched</p>		
<p><u>View</u> Northeast</p>
