**Re: Closure Request  
Parkway Gathering Leak  
Incident Number: nAPP2510026094  
Eddy County, New Mexico**

Ensolum, LLC (Ensolum), on behalf of Devon Energy Production Company, LP (Devon), has prepared this *Closure Request* to document excavation and soil sampling activities performed to address the produced water release at the Parkway Gathering Leak (Right-of-way (ROW); Site). Based on the excavation activities and analytical results from the soil sampling events, Devon is submitting this *Closure Request*, describing remediation that has occurred and requesting closure for Incident Number nAPP2510026094.

On April 08, 2025, a valve on a gathering line failed, which resulted in the release of approximately 22 barrels (bbls) of produced water onto an off-pad pasture and ROW area. Devon reported the release to the New Mexico Oil Conservation Division (NMOCD) via Notification of Release (NOR) on April 10, 2025, and submitted an Initial Release Notification Form C-141 (Form C-141) on April 15, 2025. The release was assigned Incident Number nAPP2510026094. The Form C-141 can be referenced on the NMOCD Portal.

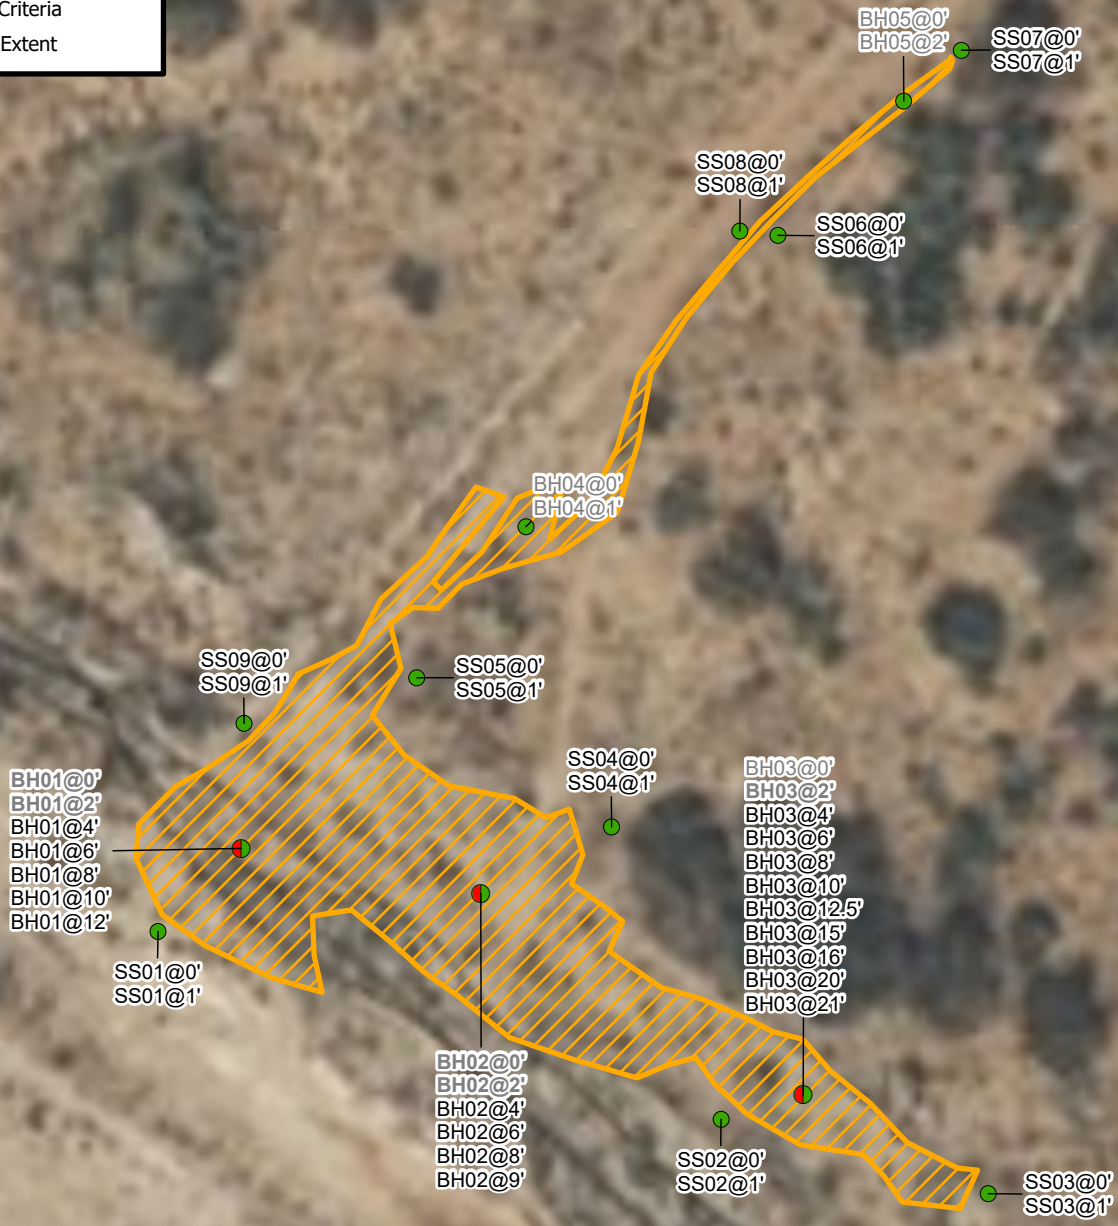
- Delineation Soil Sample in Compliance with Closure Criteria
- Delineation Soil Sample with Concentrations Previously Exceeding Closure Criteria
- Release Extent

Notes:  
 Sample ID @ Depth Below Ground Surface.  
 Concentrations in **bold** exceed the NMOCD Table I Closure Criteria reclamation standard where applicable.  
 Grey text indicate soil sample that have been excavated.  
 Red text represents samples that exceed Closure Criteria.

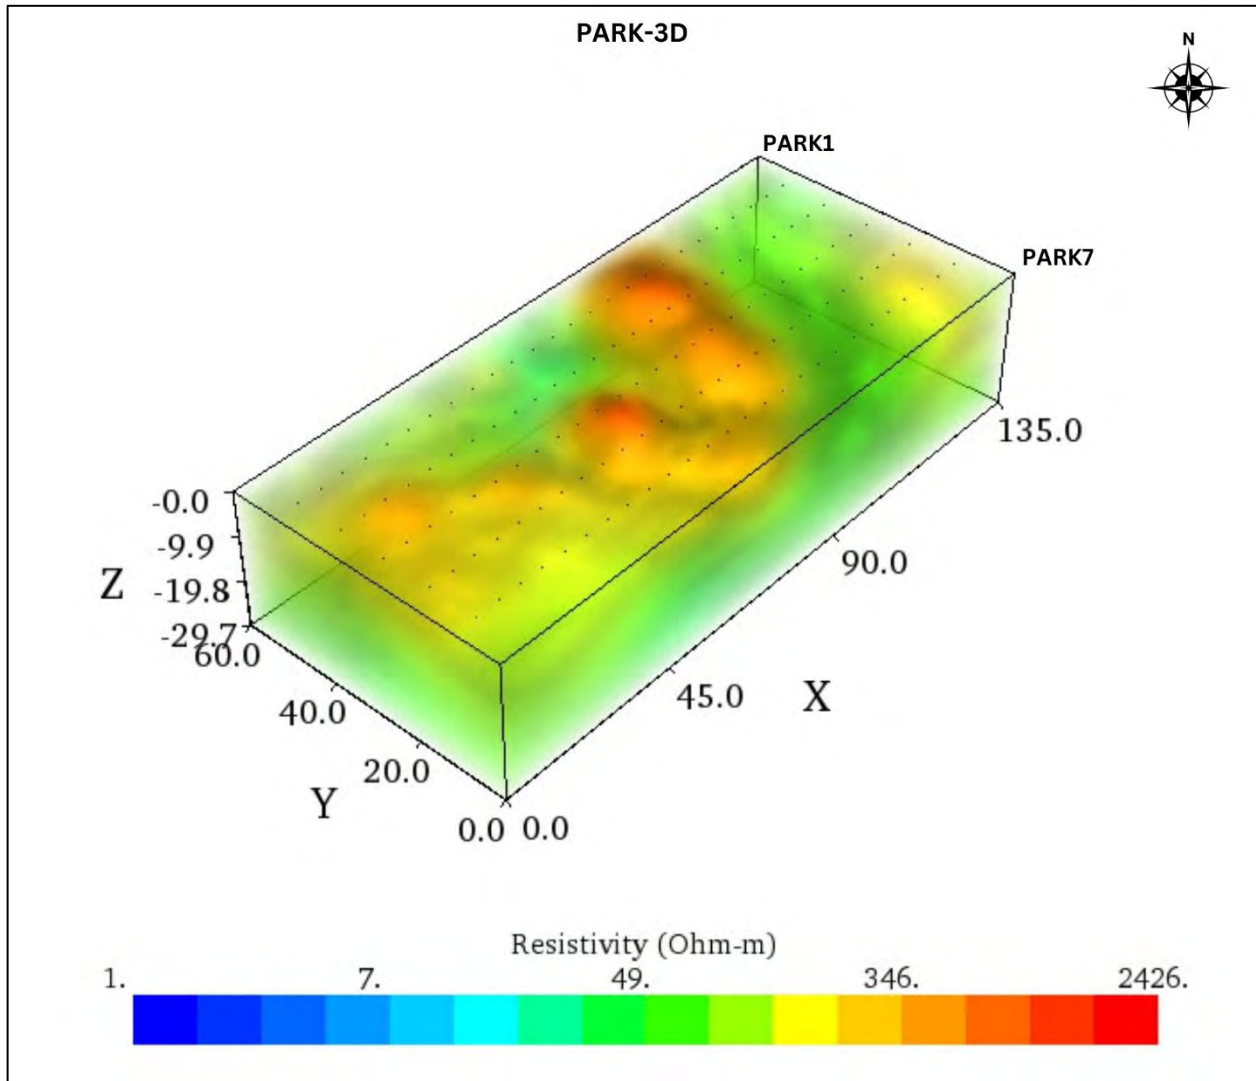
**Figure 6.** 3-D image of the subsurface surrounding the release near the Parkway Gathering site. This model was created by combining the 2-D resistivity lines PARK1 through PARK7.

The geophysical survey did not identify any subsurface anomalies that could be characterized as air-filled voids or areas of increased porosity. However, due to the resolution limitations, smaller fractures and voids/conduits may be present but went undetected.

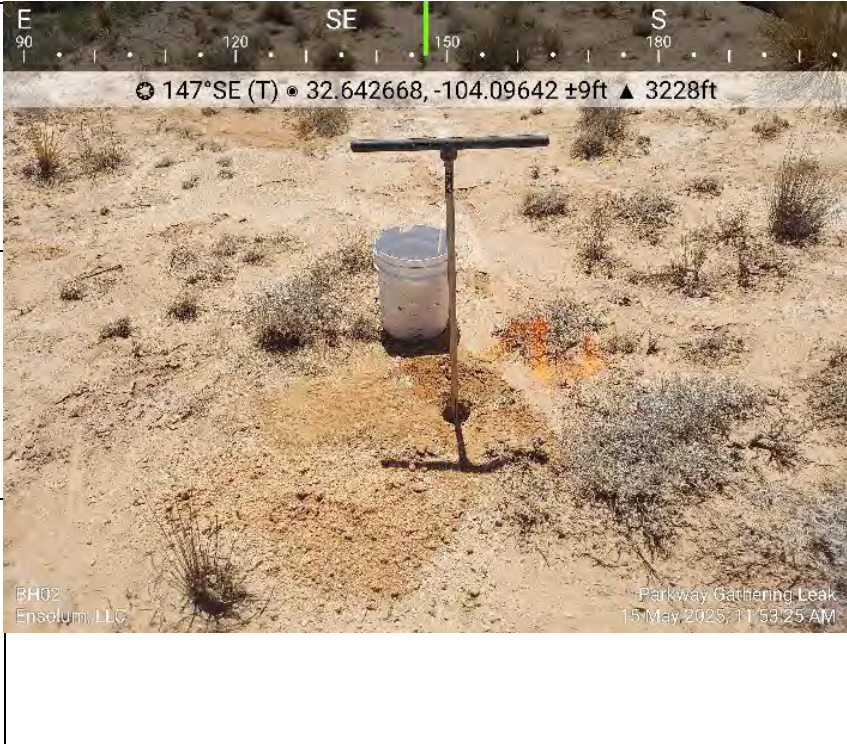
<p><u>Photograph</u> 7</p>	<p><u>Date</u> 5/15/2025</p>

<p><u>Description</u> Delineation (BH02)</p>		
<p><u>View</u> Southeast</p>		
<p><u>Photograph</u> 8</p>	<p><u>Date</u> 5/15/2025</p>

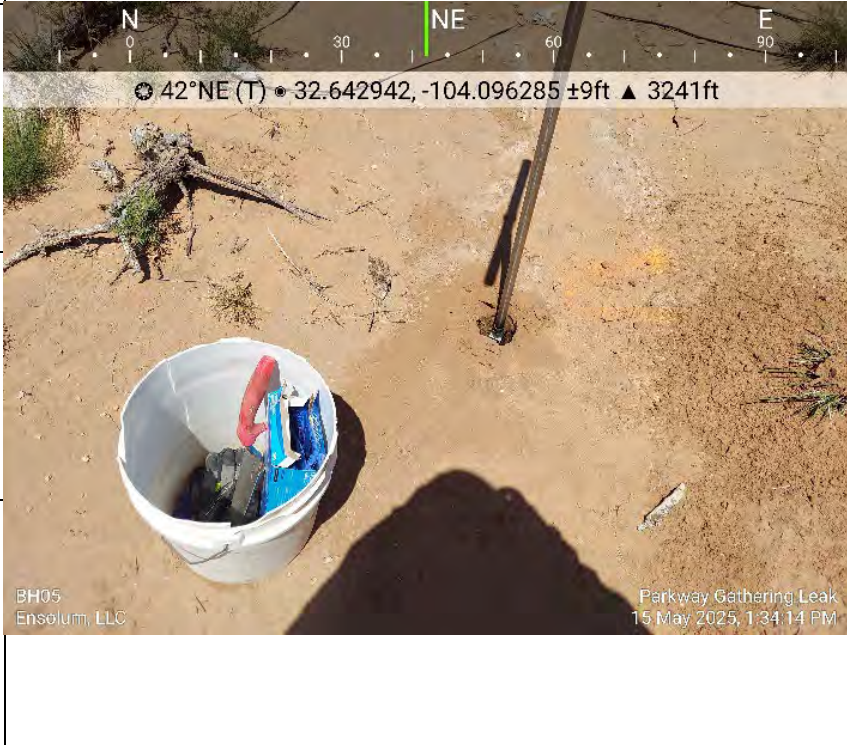
<p><u>Description</u> Delineation (BH05)</p>		
<p><u>View</u> Northeast</p>

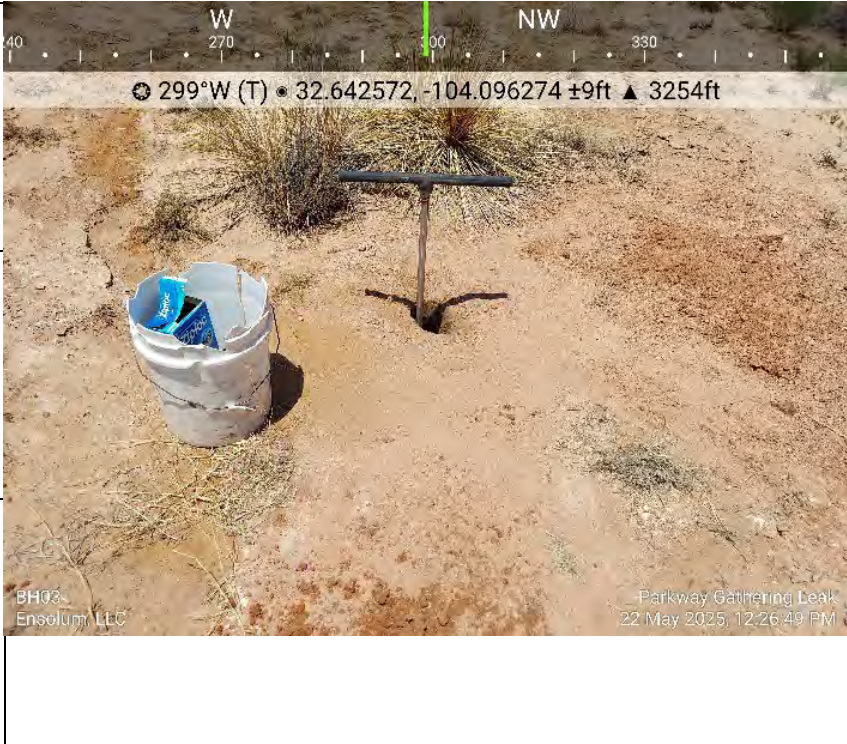
<p><u>Photograph</u> 11</p>	<p><u>Date</u> 5/15/2025</p>

<p>BH03 Ensolum, LLC</p> <p>Parkway Gathering Leak 22 May 2025, 12:26:49 PM</p>
<p><u>Description</u> Delineation (BH03)</p>		
<p><u>View</u> Northwest</p>		
<p><u>Photograph</u> 12</p>	<p><u>Date</u> 8/29/2025</p>

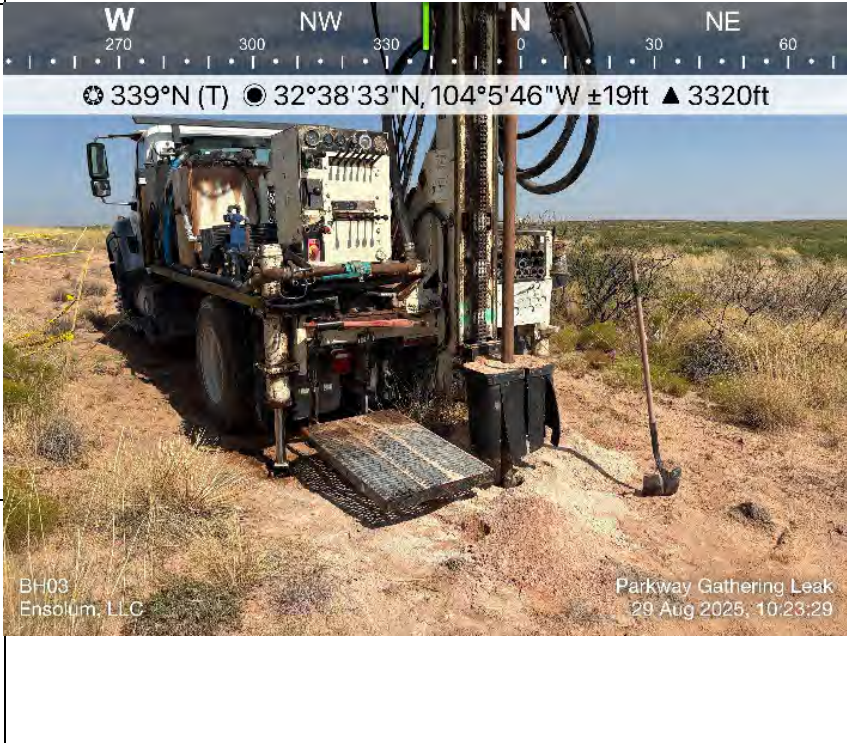
<p>BH03 Ensolum, LLC</p> <p>Parkway Gathering Leak 29 Aug 2025, 10:23:29</p>
<p><u>Description</u> Delineation (BH03)</p>		
<p><u>View</u> Northwest</p>

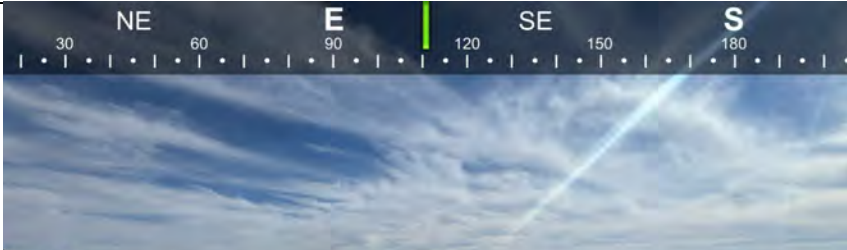
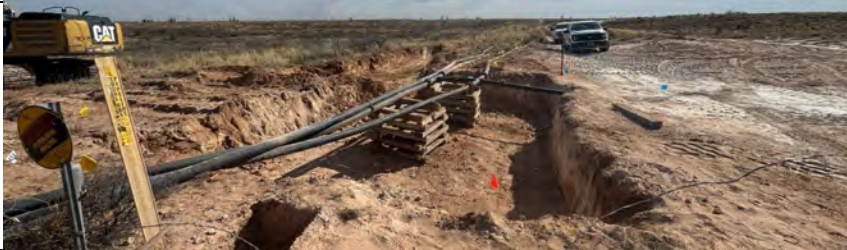
<p><u>Photograph</u> 17</p>	<p><u>Date</u> 1/12/2026</p>

<p><u>Description</u> Excavation</p>

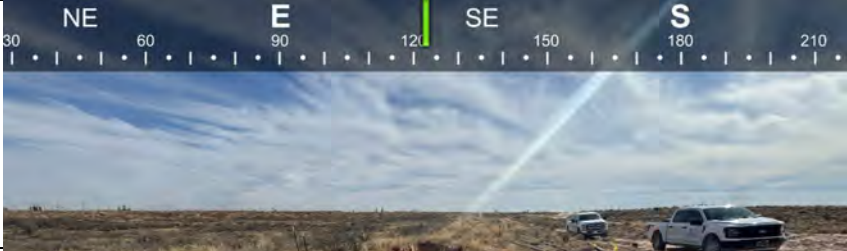
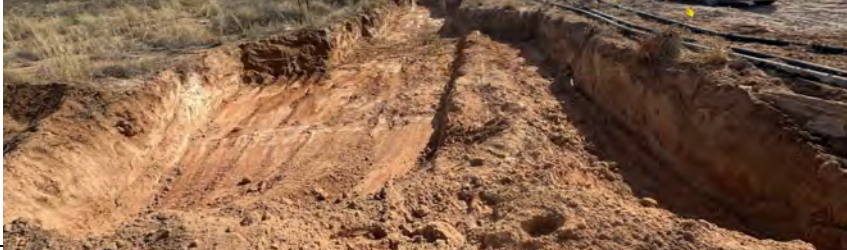
<p><u>View</u> East</p>		<p>Excavation Ensolum, LLC</p> <p>Parkway gathering Leak 12 Jan 2026, 11:25:29</p>
<p><u>Photograph</u> 18</p>	<p><u>Date</u> 1/12/2026</p>

<p><u>Description</u> Excavation</p>

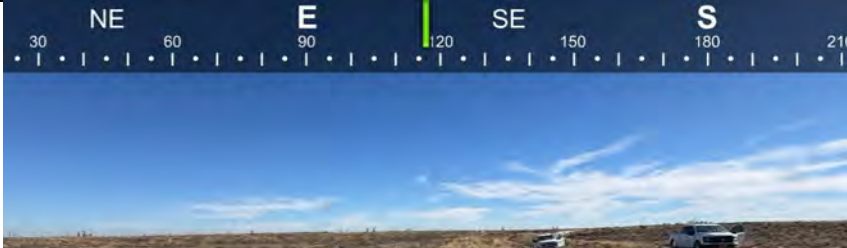
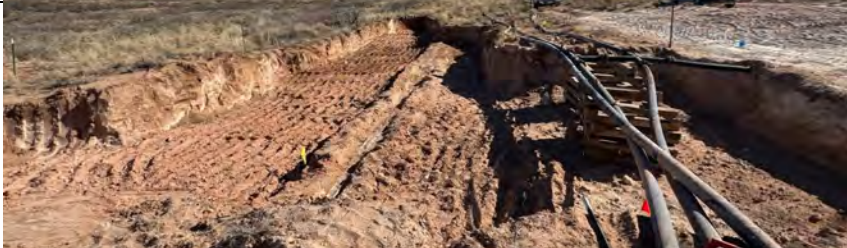
<p><u>Photograph</u> 21</p>	<p><u>Date</u> 1/12/2026</p>

<p><u>Description</u> Excavation</p>

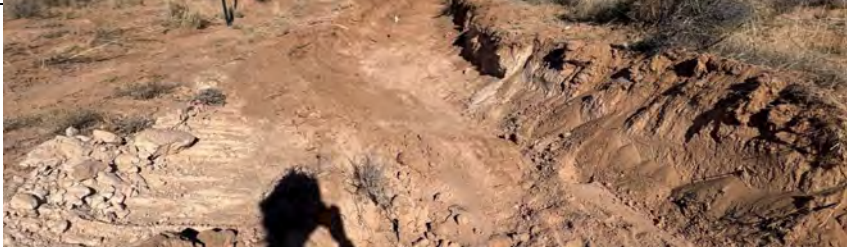
<p><u>Description</u> Excavation</p>

<p><u>View</u> North</p>		<p>Excavation Ensolum, LLC</p> <p>Parkway gathering Leak 13 Jan 2026, 13:10:53</p>

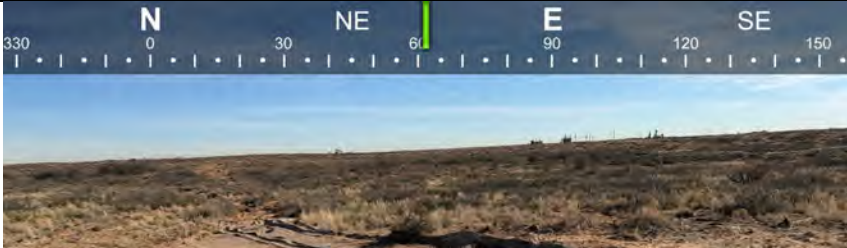
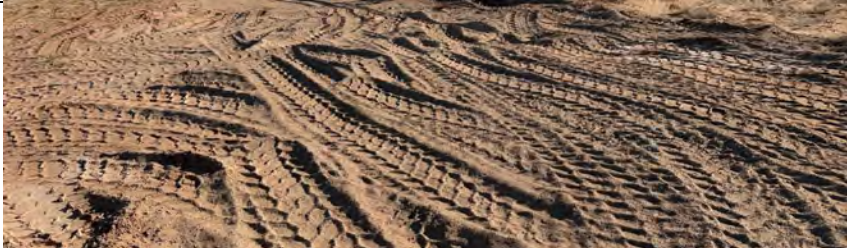
<p><u>Photograph</u> 23</p>	<p><u>Date</u> 2/16/2026</p>

<p><u>Description</u> Backfill</p>

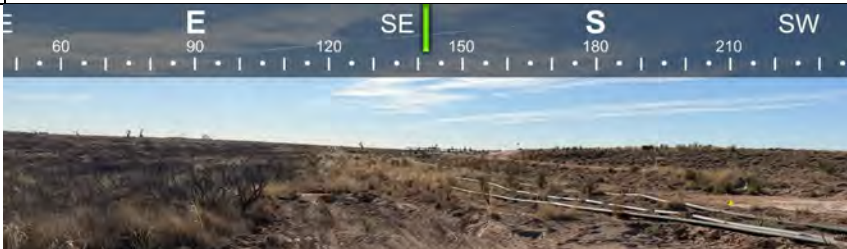
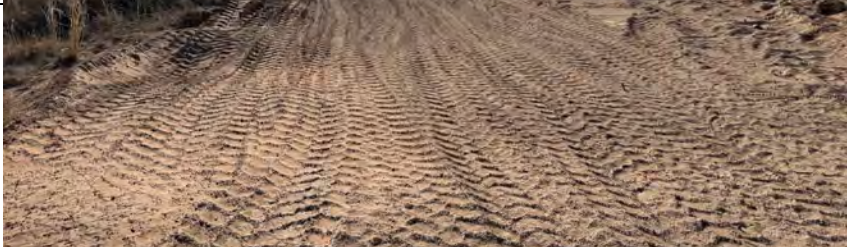
<p><u>View</u> Northeast</p>		<p>Backfill Ensolum, LLC</p> <p>Parkway Gathering Leak 16 Feb 2026, 08:46:51</p>
<p><u>Photograph</u> 24</p>	<p><u>Date</u> 2/16/2026</p>

<p><u>Description</u> Backfill</p>
