**Re: Closure Request  
Peaches 19 Fed No. 1 Battery  
Incident Number: nAPP2515629079  
Eddy County, New Mexico**

Ensolum, LLC (Ensolum), on behalf of Chevron USA Inc. (Chevron), has prepared this *Closure Request* to document assessment, excavation, and soil sampling activities at the Peaches 19 Fed No. 1 Battery (Site). The purpose of the Site assessment and remediation activities was to address impacts to soil following a release of produced water and crude oil at the Site according to a *Remediation Workplan* approved by the New Mexico Oil Conservation Division (OCD) on December 9, 2025. Based on laboratory analytical results from confirmation soil sampling activities, Chevron is submitting this *Closure Request*, proposing no further action for Incident Number nAPP2515629079.

**Site Receptor Map**  
 Chevron USA Inc.  
 Peaches 19 Fed No. 1 Battery  
 Incident Number: nAPP2515629079  
 Unit B, Section 19, T 25S, R 27E  
 Eddy County, New Mexico

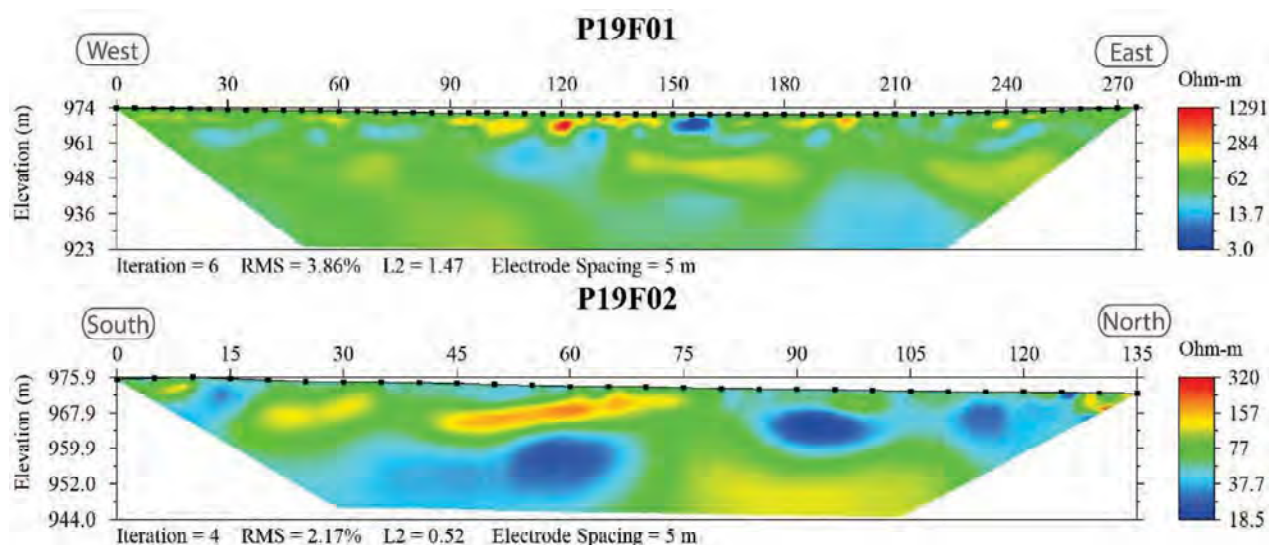
**Figure 7: 2D inverted resistivity sections P19F01 and P19F02. Reds and oranges indicate higher resistivity values. Yellows and greens are medium-resistivity values. Blues are low-resistivity values. Please note that the color scale is relative.**

The results of this study indicate a moderately well-layered geologic system with low resistivities between 3 and 1291 Ohm-m (**Figure 7**). Please keep in mind when viewing the 2D inverted resistivity sections that color maps can be widely different for each view. Always check the color map located on the right side of the image when viewing the 2D images to ensure you understand the range of resistivities presented. Distances along the top and depths along the left side are in meters. The color map along the right side is in Ohm-m. Due to the nature of the survey, shallower zones have higher resolution between electrodes than deeper zones; therefore, small features at depth will not be visible.

No anomalies consistent with air-filled subsurface voids are found within the P19F survey area. Small solutionally enlarged voids or fractures at or near the resolution limit of the survey (2.5 – 3.0 meters) may be present. Areas of high-resistivity (reds and oranges) near the surface are interpreted as dry gypsite soils and gypsum bedrock of the Salado Formation<sup>[17]</sup> (**Figure 7** and **Figure 8**). Low-resistivity areas between 15 – 20 Ohm-m may either represent fluid from the brine release, surface-to-subsurface hydrologic pathways, or a layer of either clays and halite lenses or moist or saturated layers within the Rustler Formation (**Figure 7**).

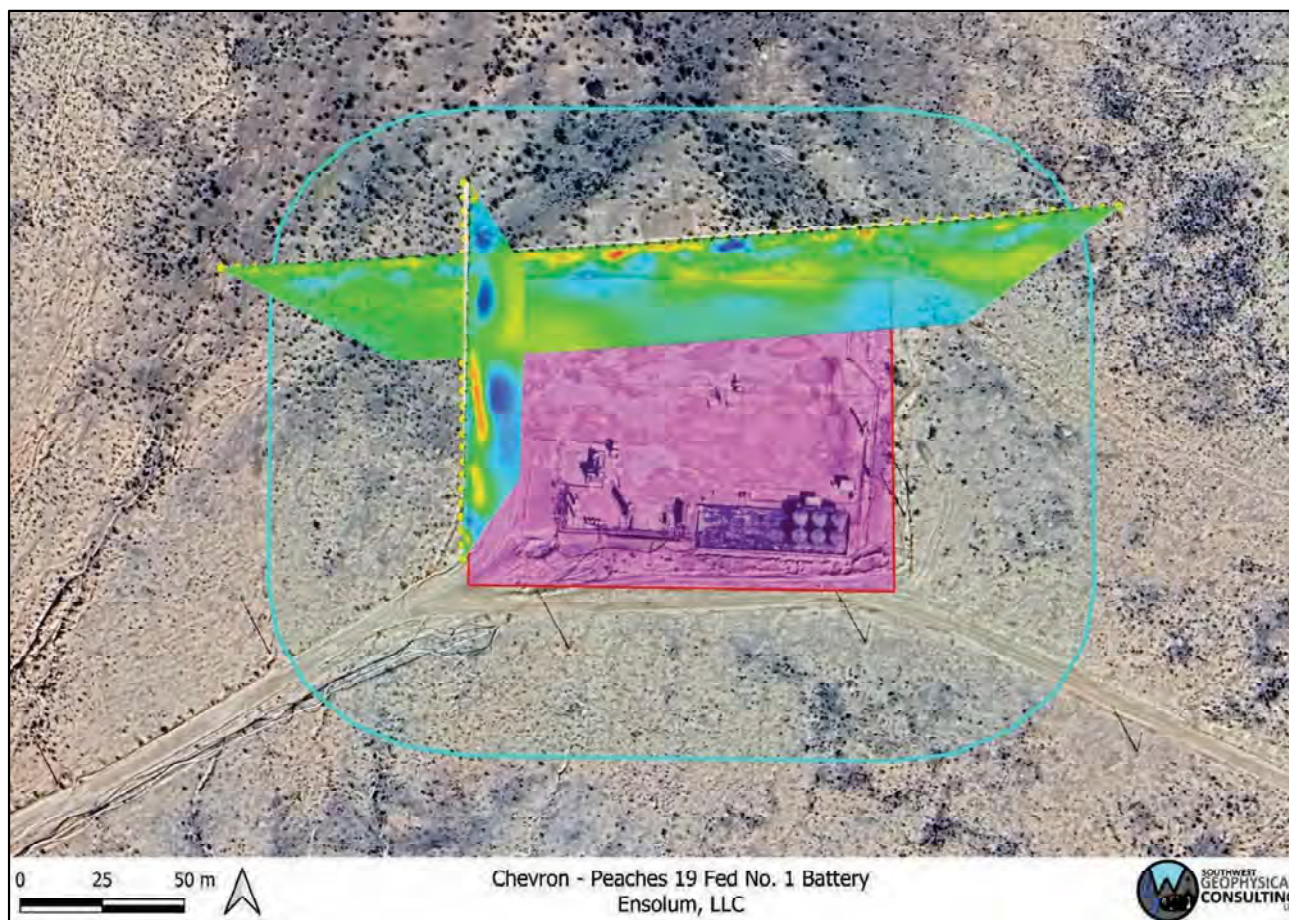
Figure 8: Data overlay. Colored trapezoids are the 2D inverted resistivity lines. Background image credit: Google Earth. Image date: March 20, 2023.

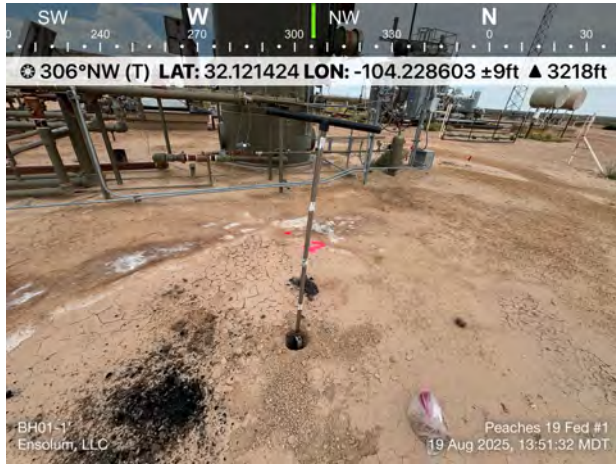
Photograph 5 Date: 08/19/2025 Description: BH01-1' View: Northwest

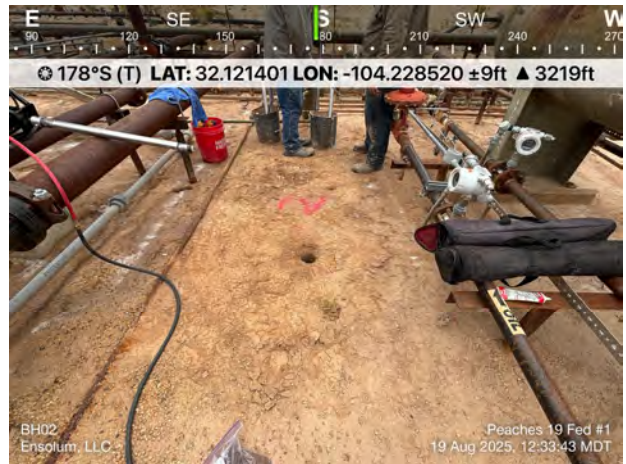
Photograph 6 Date: 08/19/2025 Description: BH02 View: Direct

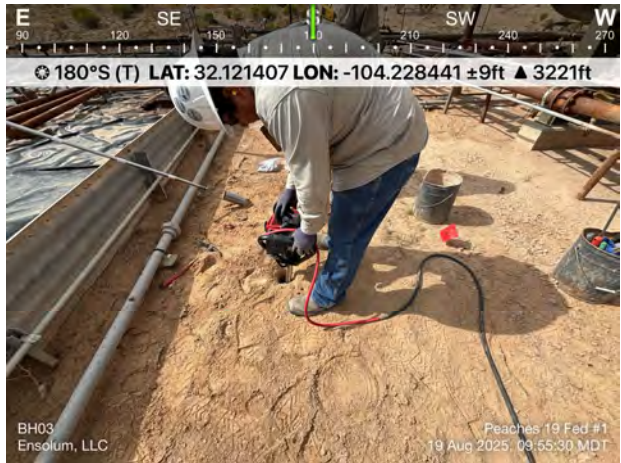
Photograph 7 Date: 08/19/2025 Description: BH03 View: Direct

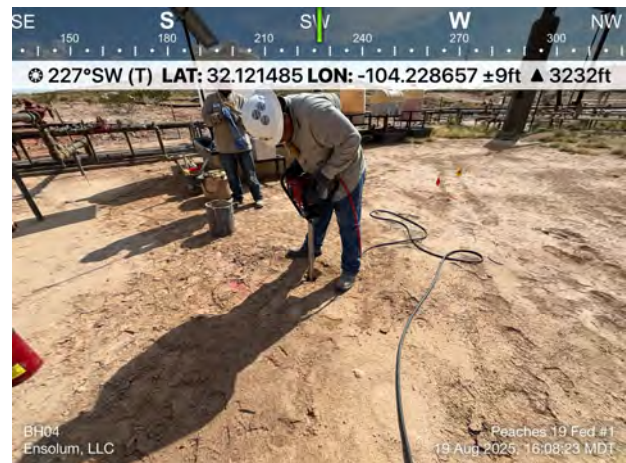
Photograph 8 Date: 08/19/2025 Description: BH04 View: Direct

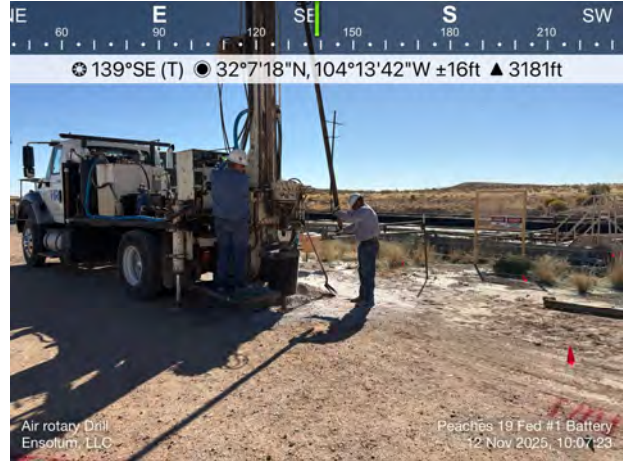
Photograph 10 Date: 11/12/2025  
Description: Depth to Water Boring  
View: Southeast

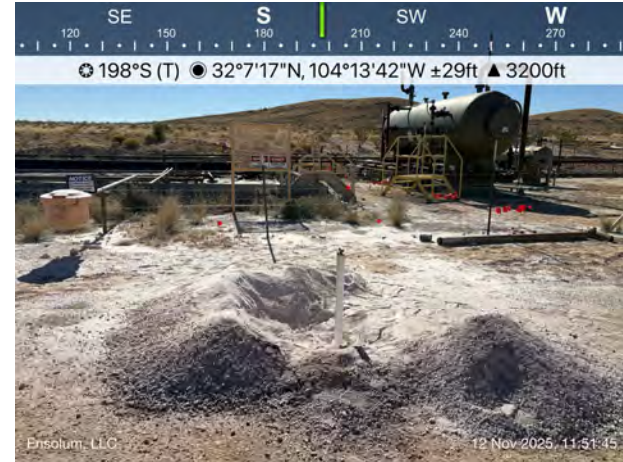
Photograph 12 Date: 11/12/2025  
Description: Completed Temporary Monitoring Well  
View: South

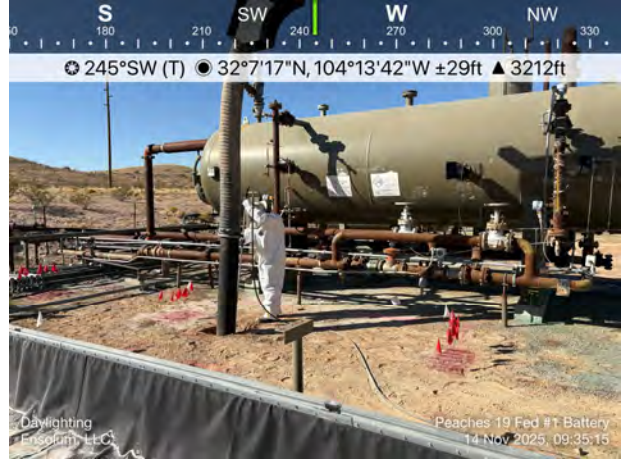
Photograph 14 Date: 11/14/2025 Description: Hydrovac Activities View: Southwest

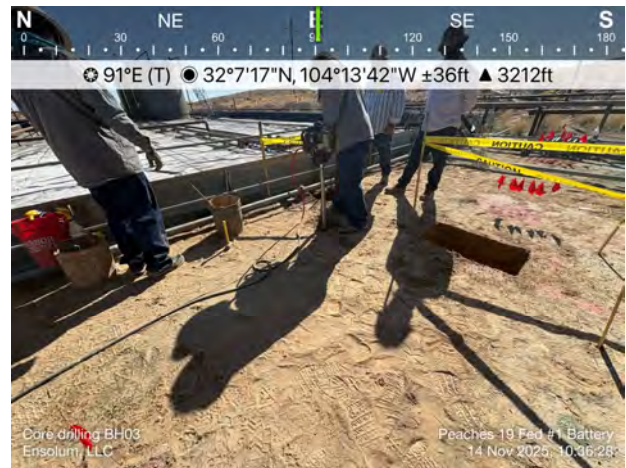
Photograph 16 Date: 11/14/2025 Description: Core Drilling BH03 View: Direct

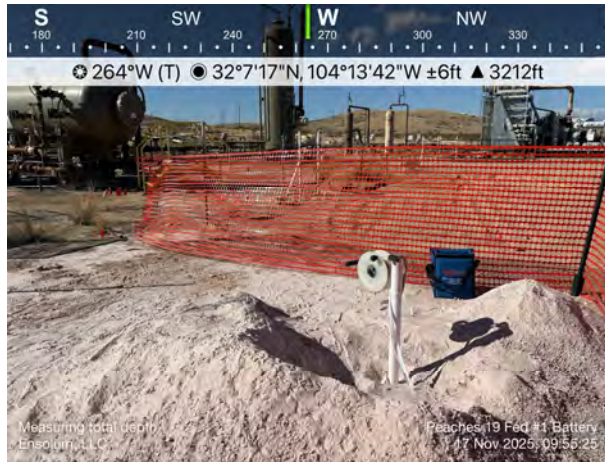
Photograph 17 Date: 11/17/2025 Description: Depth to Groundwater Measurement View: West

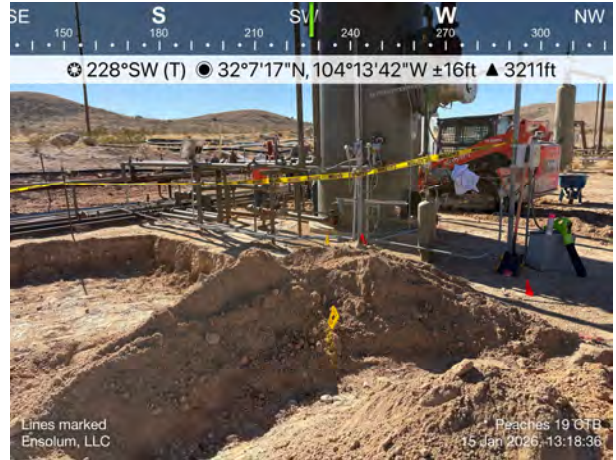
Photograph 18 Date: 01/15/2026 Description: Excavation Activities View: Southwest

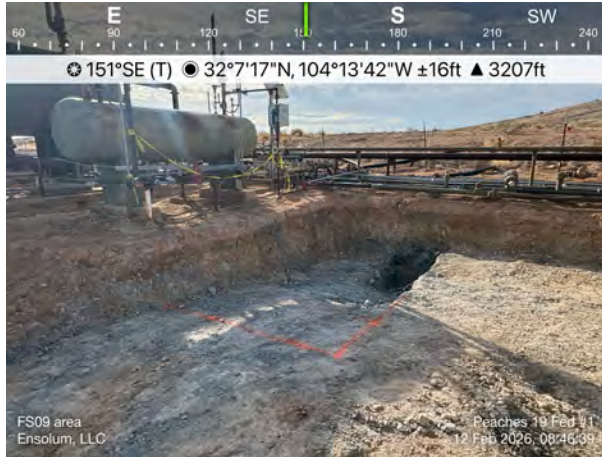
Photograph 29 Date: 02/12/2026  
Description: Excavation Activities (FS09)  
View: Southeast

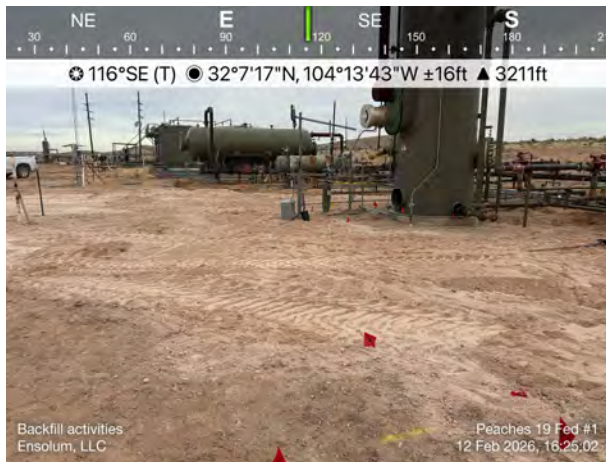
Photograph 31 Date: 02/15/2026  
Description: Backfill Activities  
View: Southeast
