**Re: Remediation Work Plan
Tiger 14 CDP TB
Incident Number: nAPP2505726681
Eddy County, New Mexico**

Ensolum, LLC (Ensolum), on behalf of Matador Production Company (Matador), has prepared this *Remediation Work Plan (RWP)* to document assessment and soil sampling activities performed at the Tiger 14 CDP TB (Site). The purpose of the Site assessment and soil sampling activities was to address impacted and waste-containing soil resulting from a crude oil release. Matador is submitting this *RWP*, describing analytical results from soil sampling and karst survey activities associated with Incident Number nAPP2505726681 and proposing to address the current sensitive Site receptor (high karst potential) of the subject matter release prior to beginning excavation activities and prior to submitting a *Closure or Deferral Request*.

**Environmental Karst Study Report
Tiger 14 CDP
Eddy County, New Mexico**

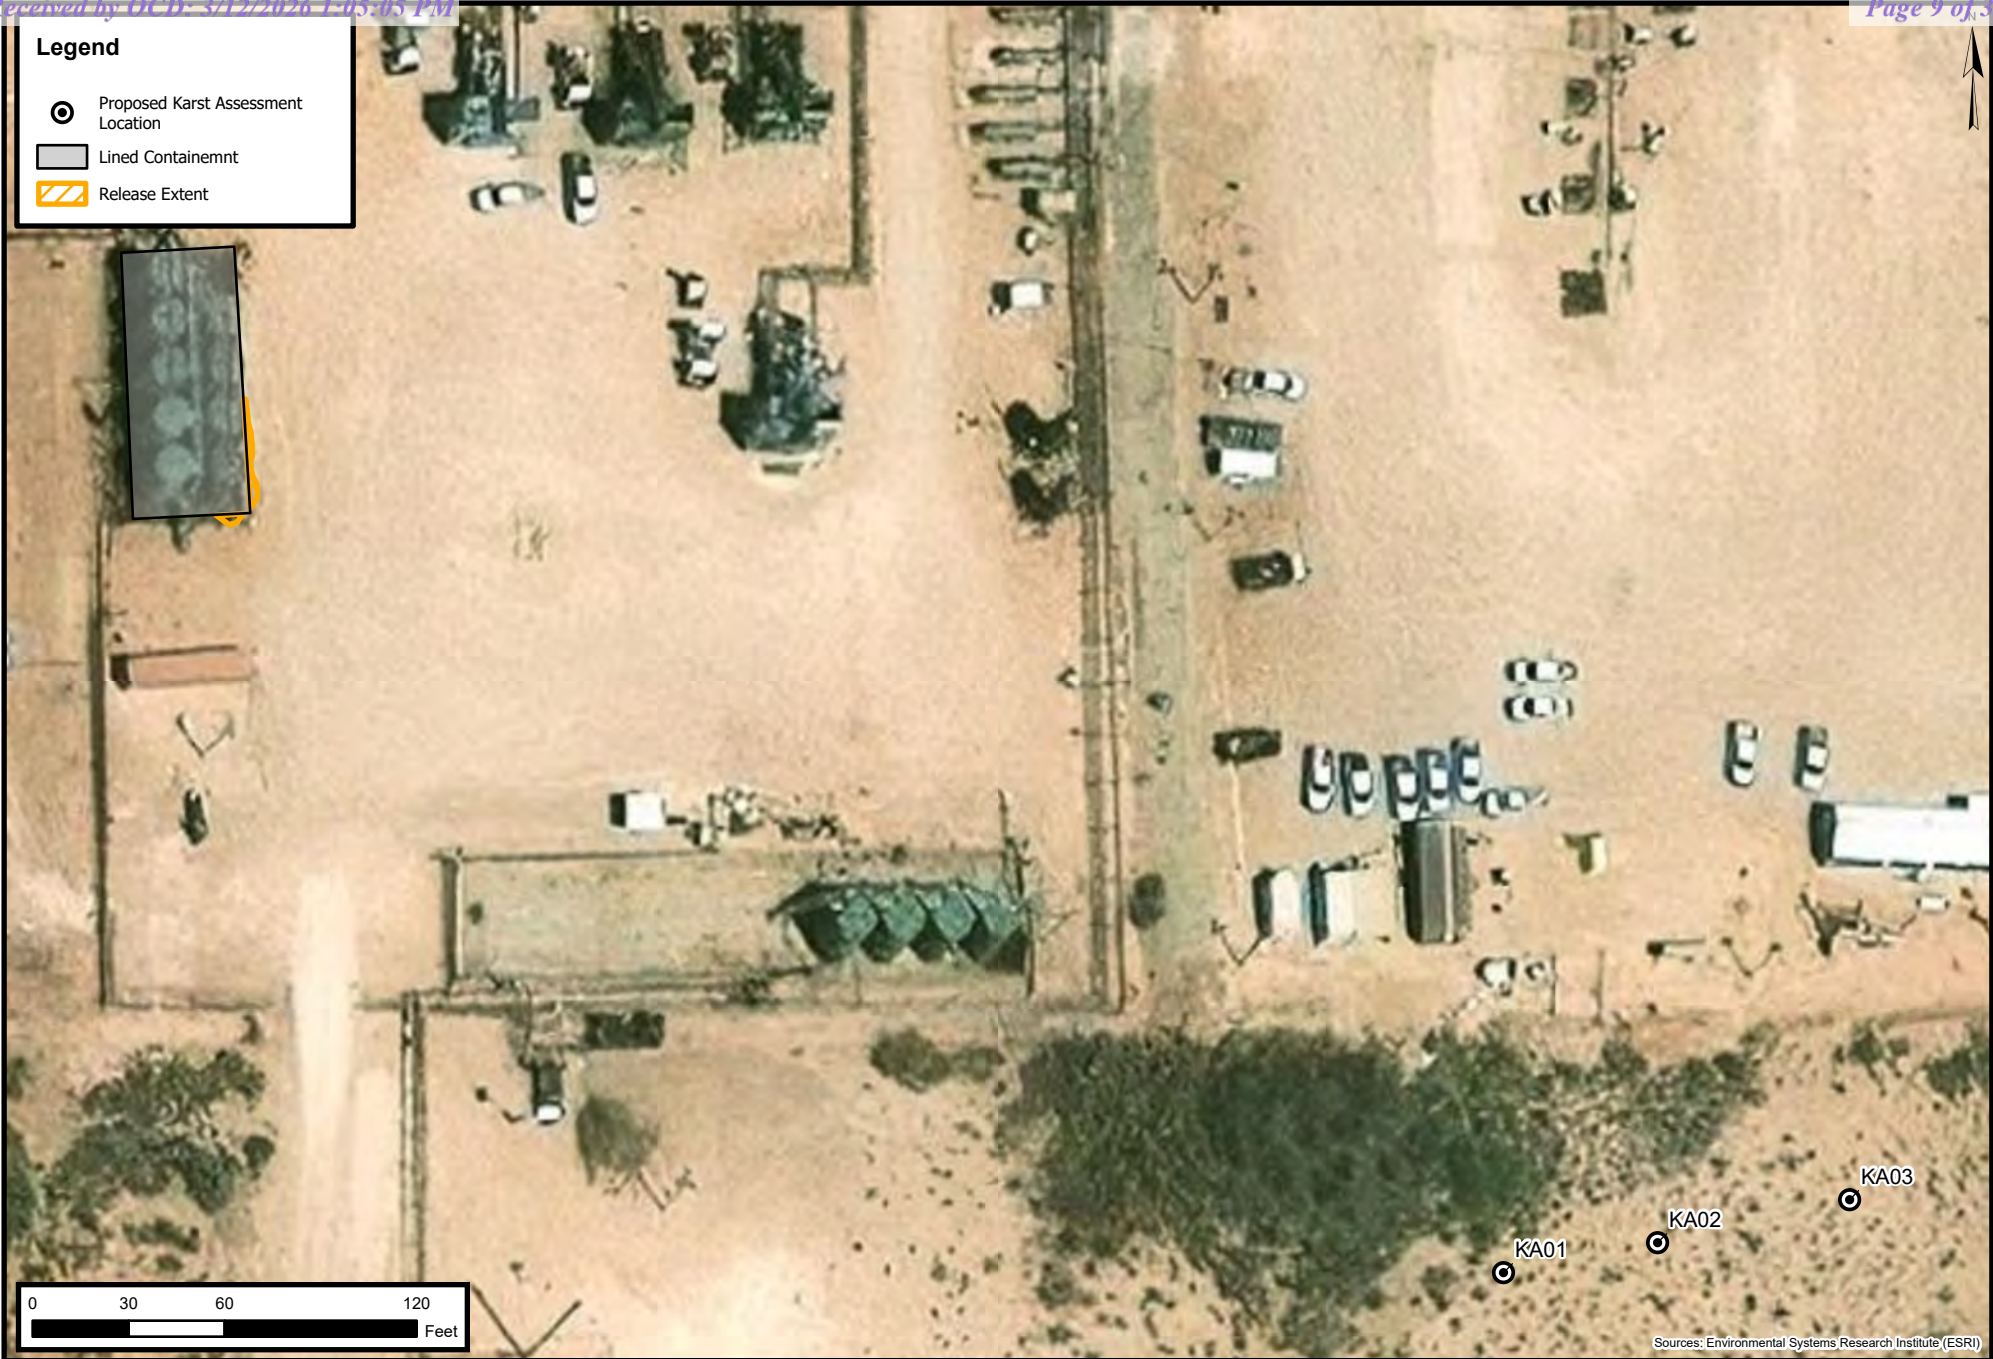
- Delineation Soil Sample in Compliance with Closure Criteria
- Delineation Soil Sample with Concentrations Previously Exceeding Closure Criteria
- Lined Containment
- Release Extent

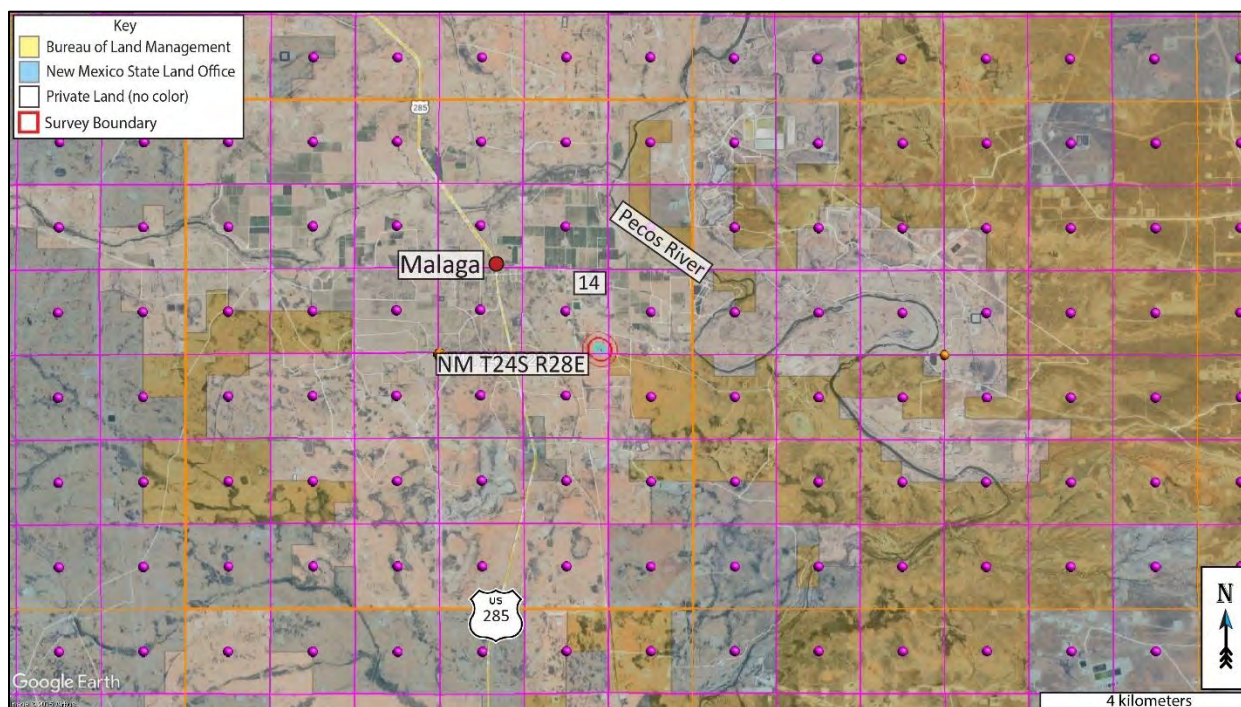
The site is located 2.5 kilometers (1.6 miles) southeast of Malaga, New Mexico, east of U.S. Highway 285 and west of the Pecos River. The release area is located within the SE ¼ section of section 14, NM T24S R28E^[6] (**Figure 1** and **Figure 2**). The region has flat terrain with karstification occurring in the gypsite soils and underlying gypsum and dolomite bedrock^[7] (see section **2.2 Local Geology Summary** for further information). The climate in this area of southeast New Mexico is semi-arid with an average annual precipitation of approximately 13 inches, of which about two-thirds falls as rain during summer thunderstorms from June to October. Summers are hot and sunny while winters are generally mild, with an average maximum temperature of 96°F in July and an average minimum temperature of 28°F in January^[8]. This area is within the Chihuahuan Desert Thornscrub as defined by the Southwestern Regional ReGAP Vegetation map^[9] and the vegetation consists mostly of areas of blue grama, nine-awned pappus grass, burro grass and low scrub including yucca. The spill delineation boundary is located within an HKOZ^[5] (**Figure 1**) and within privately managed land^[10] (**Figure 2**).

Figure 2: Land ownership and PLSS overview. Background image credit: Google Earth. Image date: July 13, 2024. Image datum: WGS-84.

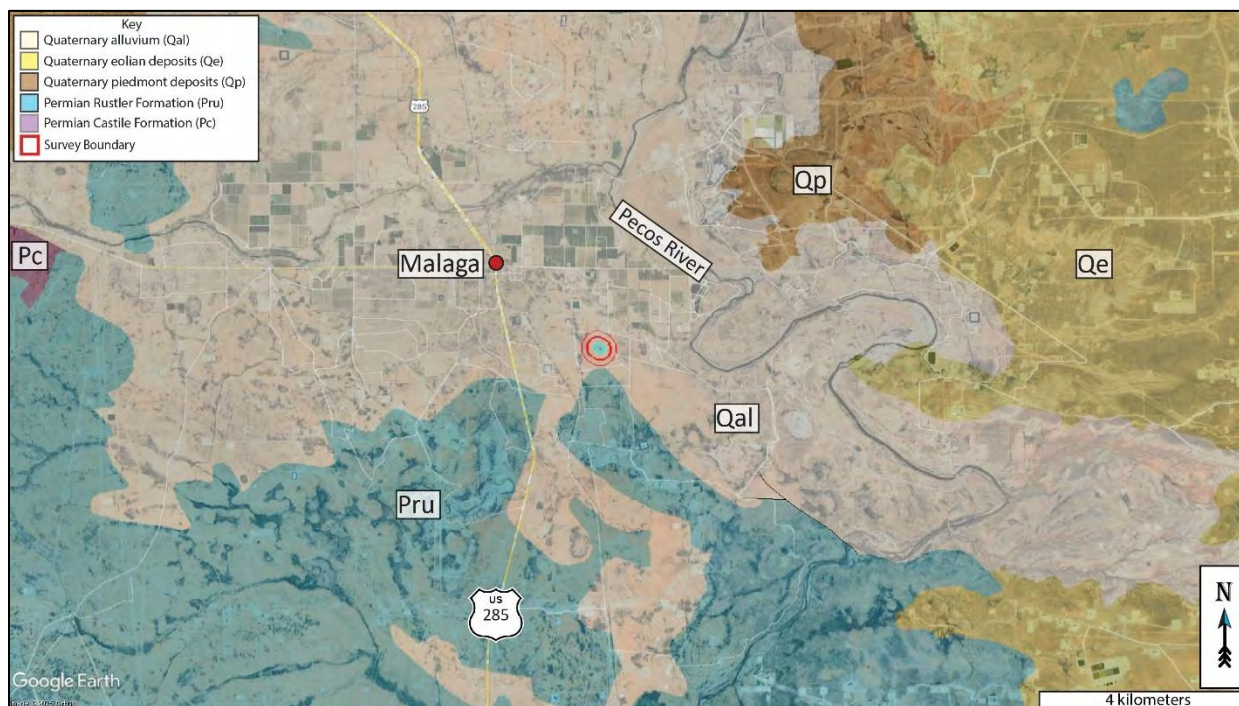
The site for the TG14 survey is located at an elevation of 904 meters (2,965 feet), \pm 3 meters (9.8 feet). This region is entirely underlain by the Permian Rustler Formation (Pru). The area is mantled by thin gypsiferous soils (gypsite), Quaternary alluvial piedmont (Qp), eolian deposits (Qe), and alluvium (Qal)^[11] up to 5 meters in depth (**Figure 3**).

Figure 3: Geology overview. Geology map credit: The Digital Geologic Map of New Mexico in ARC/INFO Format. Background image credit: Google Earth. Image date: July 13, 2024. Image datum: WGS-84.

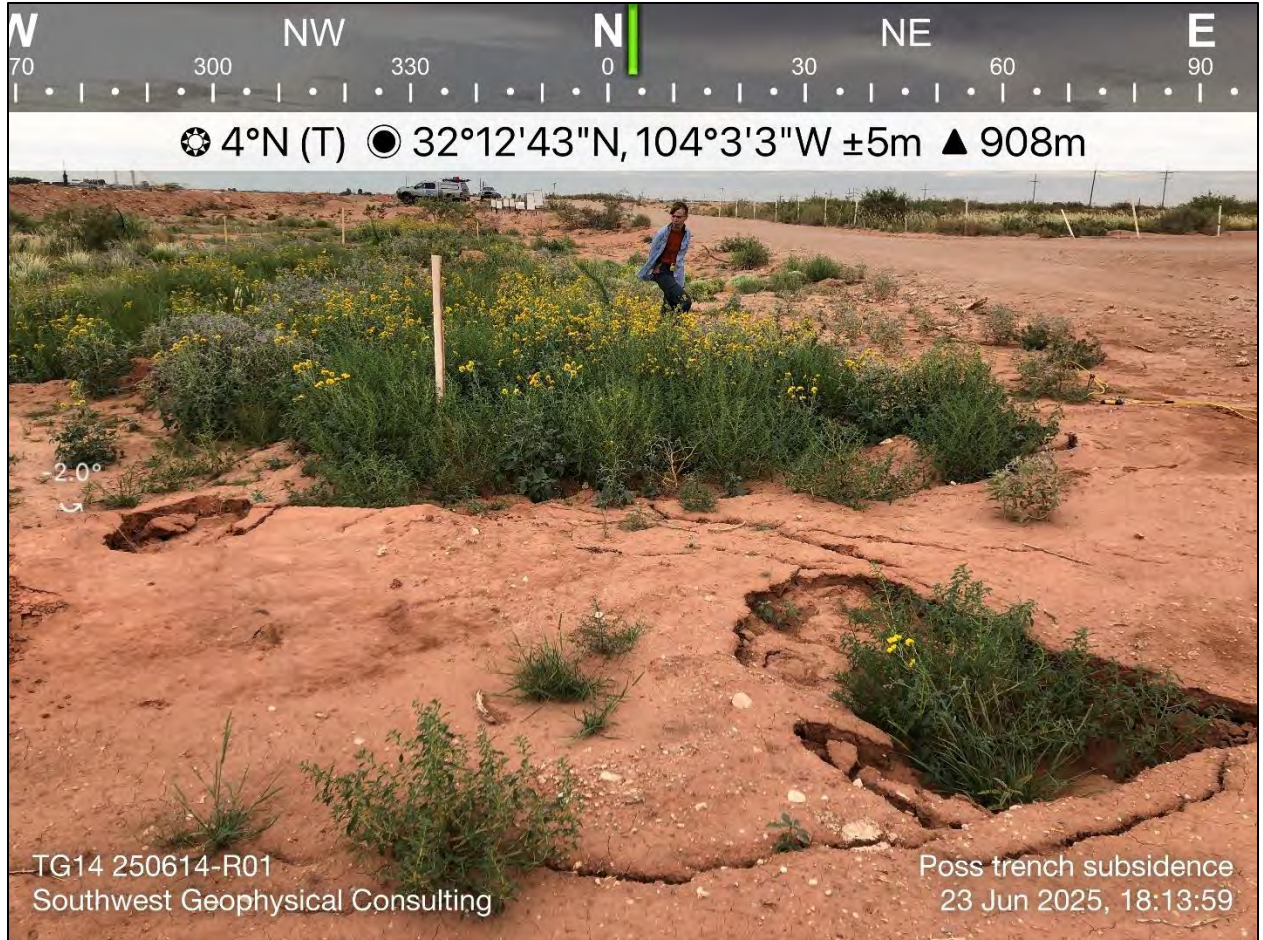
Figure 7: Feature 250614-R01. Soil subsidence within a trench.

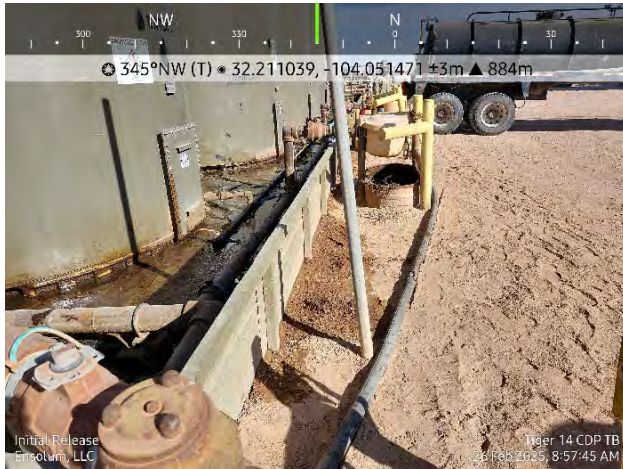
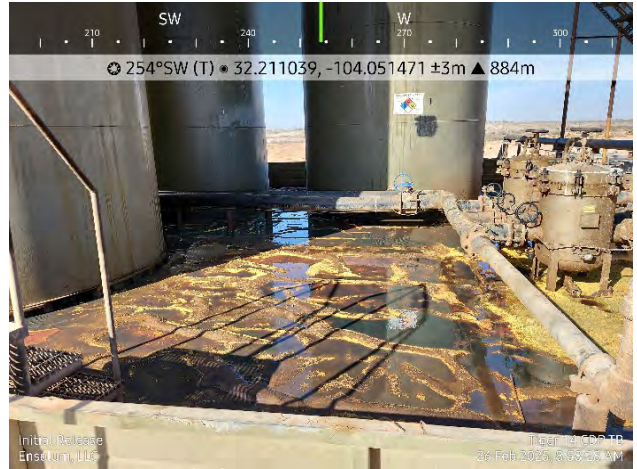
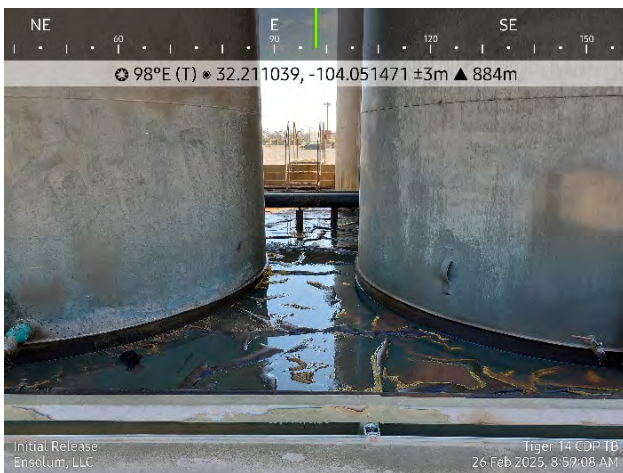
Photograph 1
Date: 2/26/2025
Description: Initial Release
View: North

Photograph 2
Date: 2/26/2025
Description: Initial Release
View: West

Photograph 3
Date: 2/26/2025
Description: Initial Release
View: East

Photograph 4
Date: 2/26/2025
Description: Initial Release
View: South

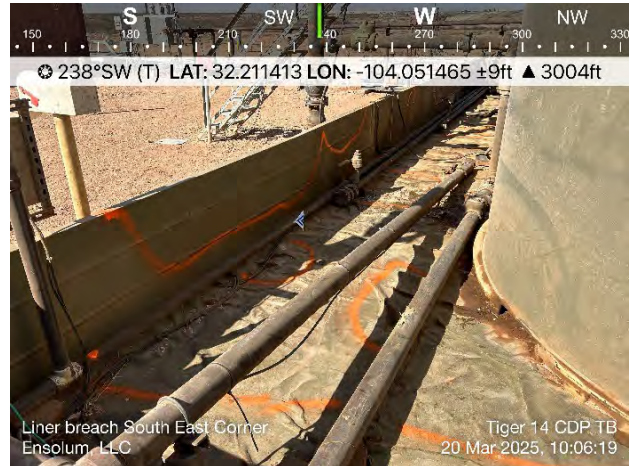
Photograph 6 Date: 3/20/2025
Description: Liner breach Southeast corner
View: Southwest

A liner integrity inspection was conducted on March 20, 2025, and the liner was found to be insufficient in containing the release. Boreholes BH01 through BH05 were advanced within the lined secondary containment area utilizing a hand auger and core drill to determine the vertical extent of impacted and waste-containing soil beneath the containment area. Borehole BH01 was advanced to a depth of 12 feet bgs, borehole BH02 was advanced to a depth of 16 feet bgs, borehole BH03 was advanced to a depth of 2 feet bgs, borehole BH04 was advanced to a depth of 3 feet bgs, and borehole BH05 was advanced to a depth of 6 feet bgs. After the delineation inside the secondary containment area was completed, all holes were patched by Ensolum personnel and Dupree Energy LLC.

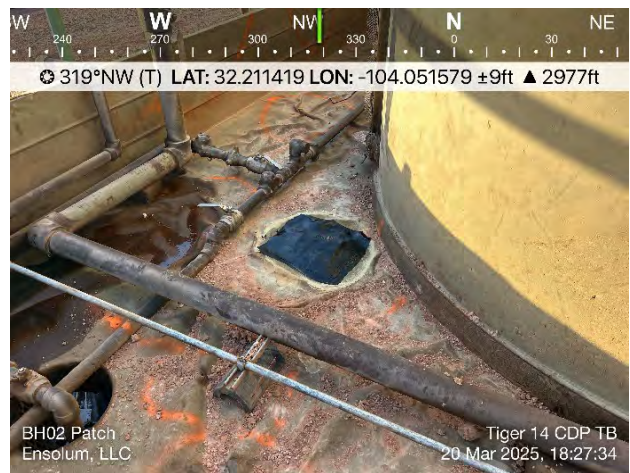
Photograph 15 Date:3/20/2025
Description: BH01 patch
View: West

Photograph 16 Date:3/20/2025
Description: BH02 Patch
View: Northwest
