**Closure Report**

**Sea Snake 35 State #004H (12.08.2025)**

**Incident ID: nAPP2534534495**

**Crude Oil and Produced Water Release**

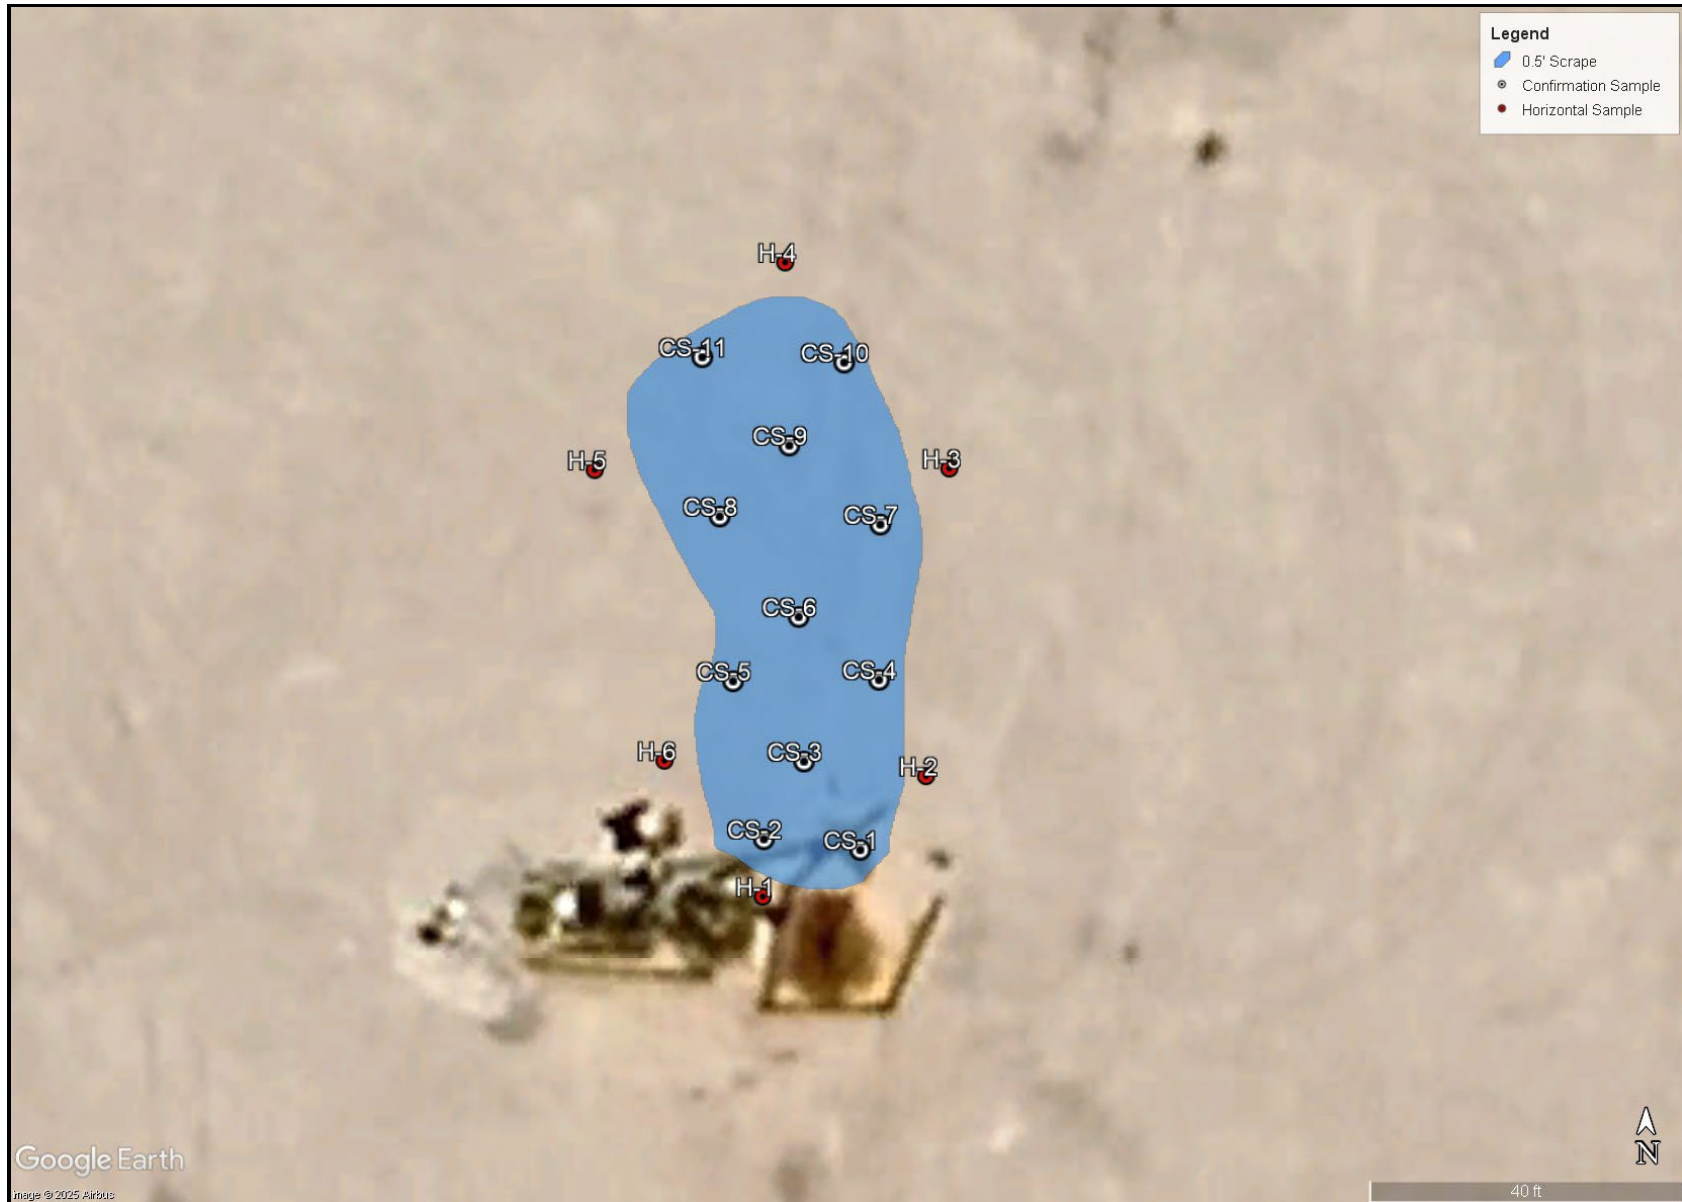
FIGURE 3

All final confirmation samples were below the regulatory requirements for TPH, BTEX, and Chlorides. Refer to Table 1. The excavation depths and confirmation sample locations are shown in Figure 3.

EXCAVATION DEPTH MAP  
DEVON ENERGY  
SEA SNAKE 35 #004H  
LEA COUNTY, NEW MEXICO  
32.25485154, -103.53725422

On January 7, 2025, Carmona Resources personnel were onsite to supervise the remediation activities, collect confirmation samples, and document backfill activities. Before collecting composite confirmation samples, the NMOCD division office was notified via NMOCD portal on December 5, 2025, per Subsection D of 19.15.29.12 NMAC, see Appendix C. The area was excavated to a depth of 0.5 ft bgs. A total of six (6) horizontal samples (H-1 through H-6) were collected for horizontal delineation, and eleven (11) confirmation floor samples (CS-1 through CS-11) were collected every 200 square feet to ensure the proper removal of contaminated soil. Composite confirmation sidewall samples were not collected due to the excavation depth not exceeding 0.5' ft bgs. For chemical analysis, the soil samples were collected and placed into laboratory-provided sample containers, stored on ice, and transported under the proper chain-of-custody protocol to Eurofins Laboratories in Midland, Texas in accordance with established chain-of-custody protocols. All collected samples were analyzed for TPH analysis by EPA method 8015 modified, BTEX by EPA method 8021B, and Chloride by EPA method 300. Copies of laboratory analysis and chain-of-custody documentation are included in Appendix E.

On January 15, once the remediation activities were completed, the excavated areas were backfilled with clean material to surface grade. A composite sample from the Halo Backfill Pit, located at 32.325776, -103.832943. Approximately 37 cubic yards of material were excavated and transported offsite for proper disposal. See Table 1 & Appendix E for laboratory analysis of the backfill sample

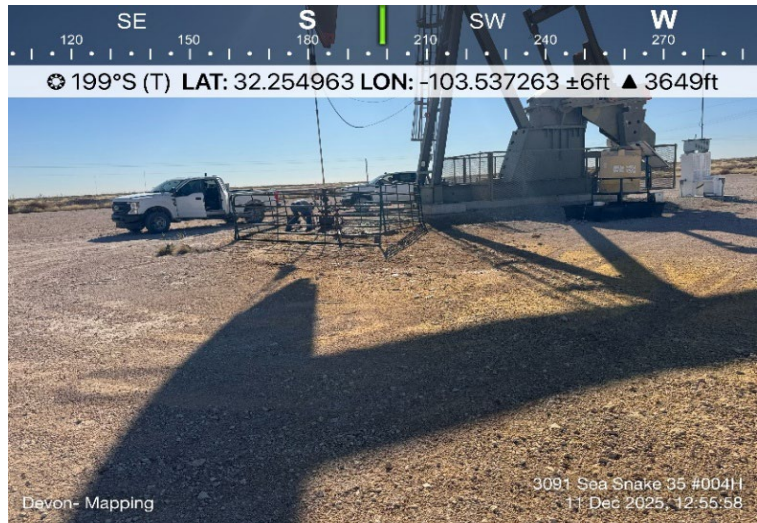
### Photograph No. 1

**Description:**  
View South, Area of concern following the release.

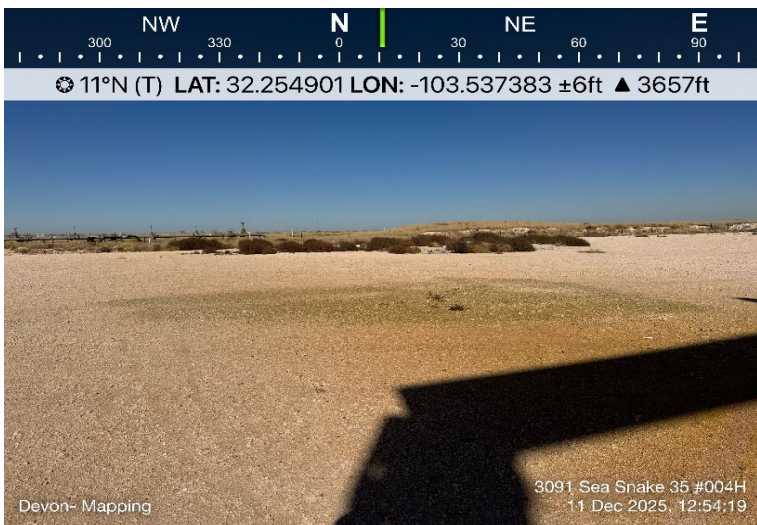
### Photograph No. 3

**Description:**  
View North, Area of concern following the release.

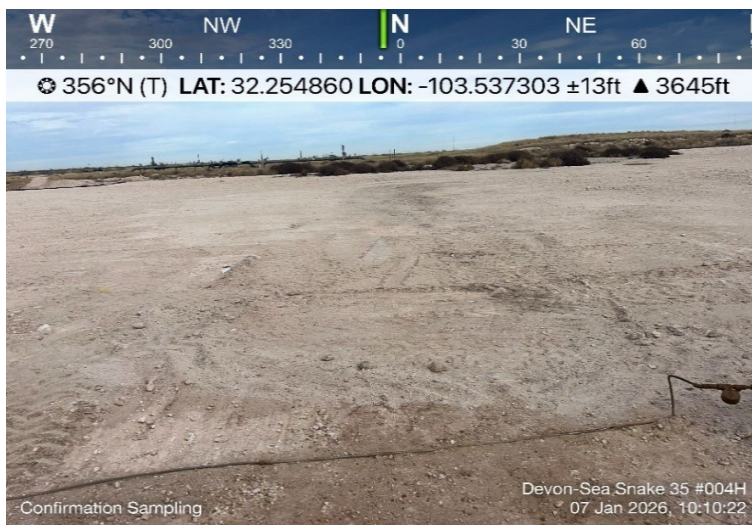
### Photograph No. 4

View North, Area of CS-1 through CS-11 following a surface scrape.

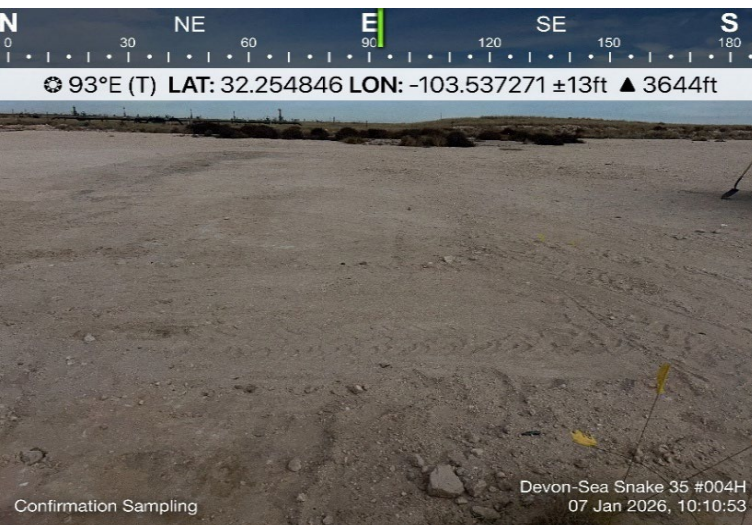
### Photograph No. 6

View East, Area of CS-1 through CS-11 following a surface scrape.
