# Amended Remediation Summary & Deferral Request

## Mewbourne Oil Company Delaware Ranch SWD #1

Eddy County, New Mexico  
Unit Letter "P", Section 11, Township 26 South, Range 28 East  
Latitude 32.05162 North, Longitude 104.05137 West  
NMOCD Reference No. nAPP2521351232

February 18, 2026

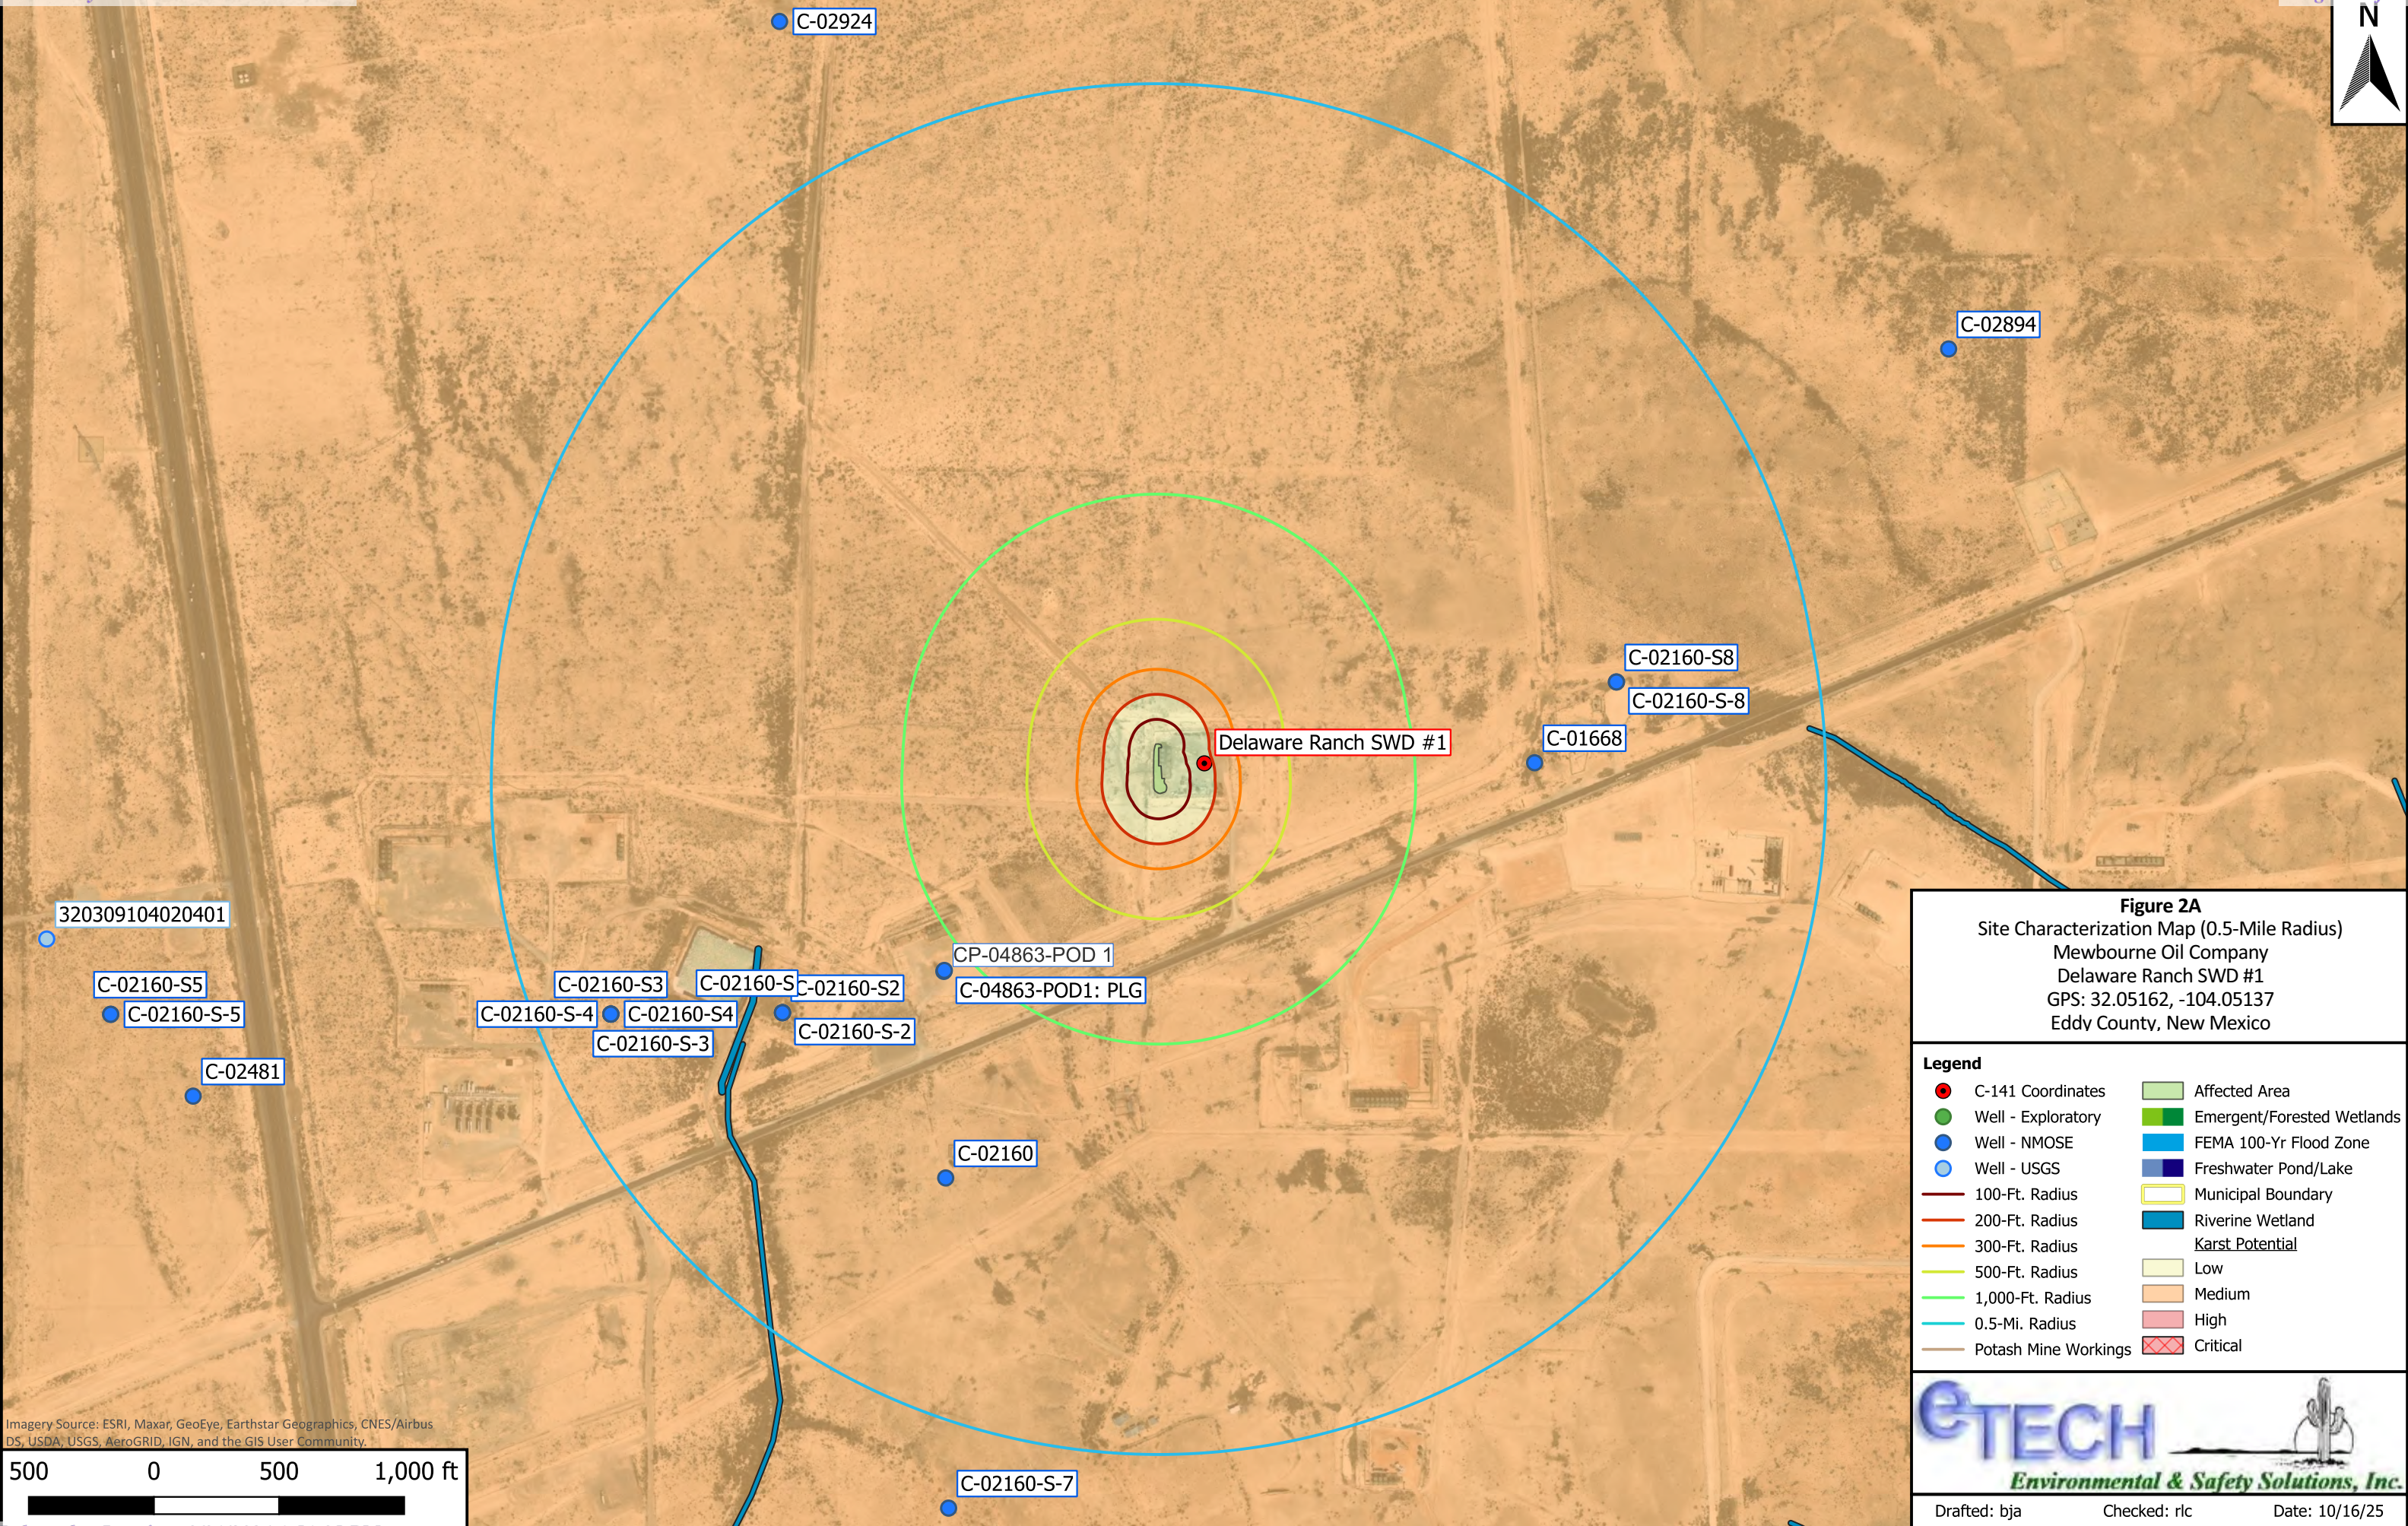
**Figure 2A**  
 Site Characterization Map (0.5-Mile Radius)  
 Mewbourne Oil Company  
 Delaware Ranch SWD #1  
 GPS: 32.05162, -104.05137  
 Eddy County, New Mexico

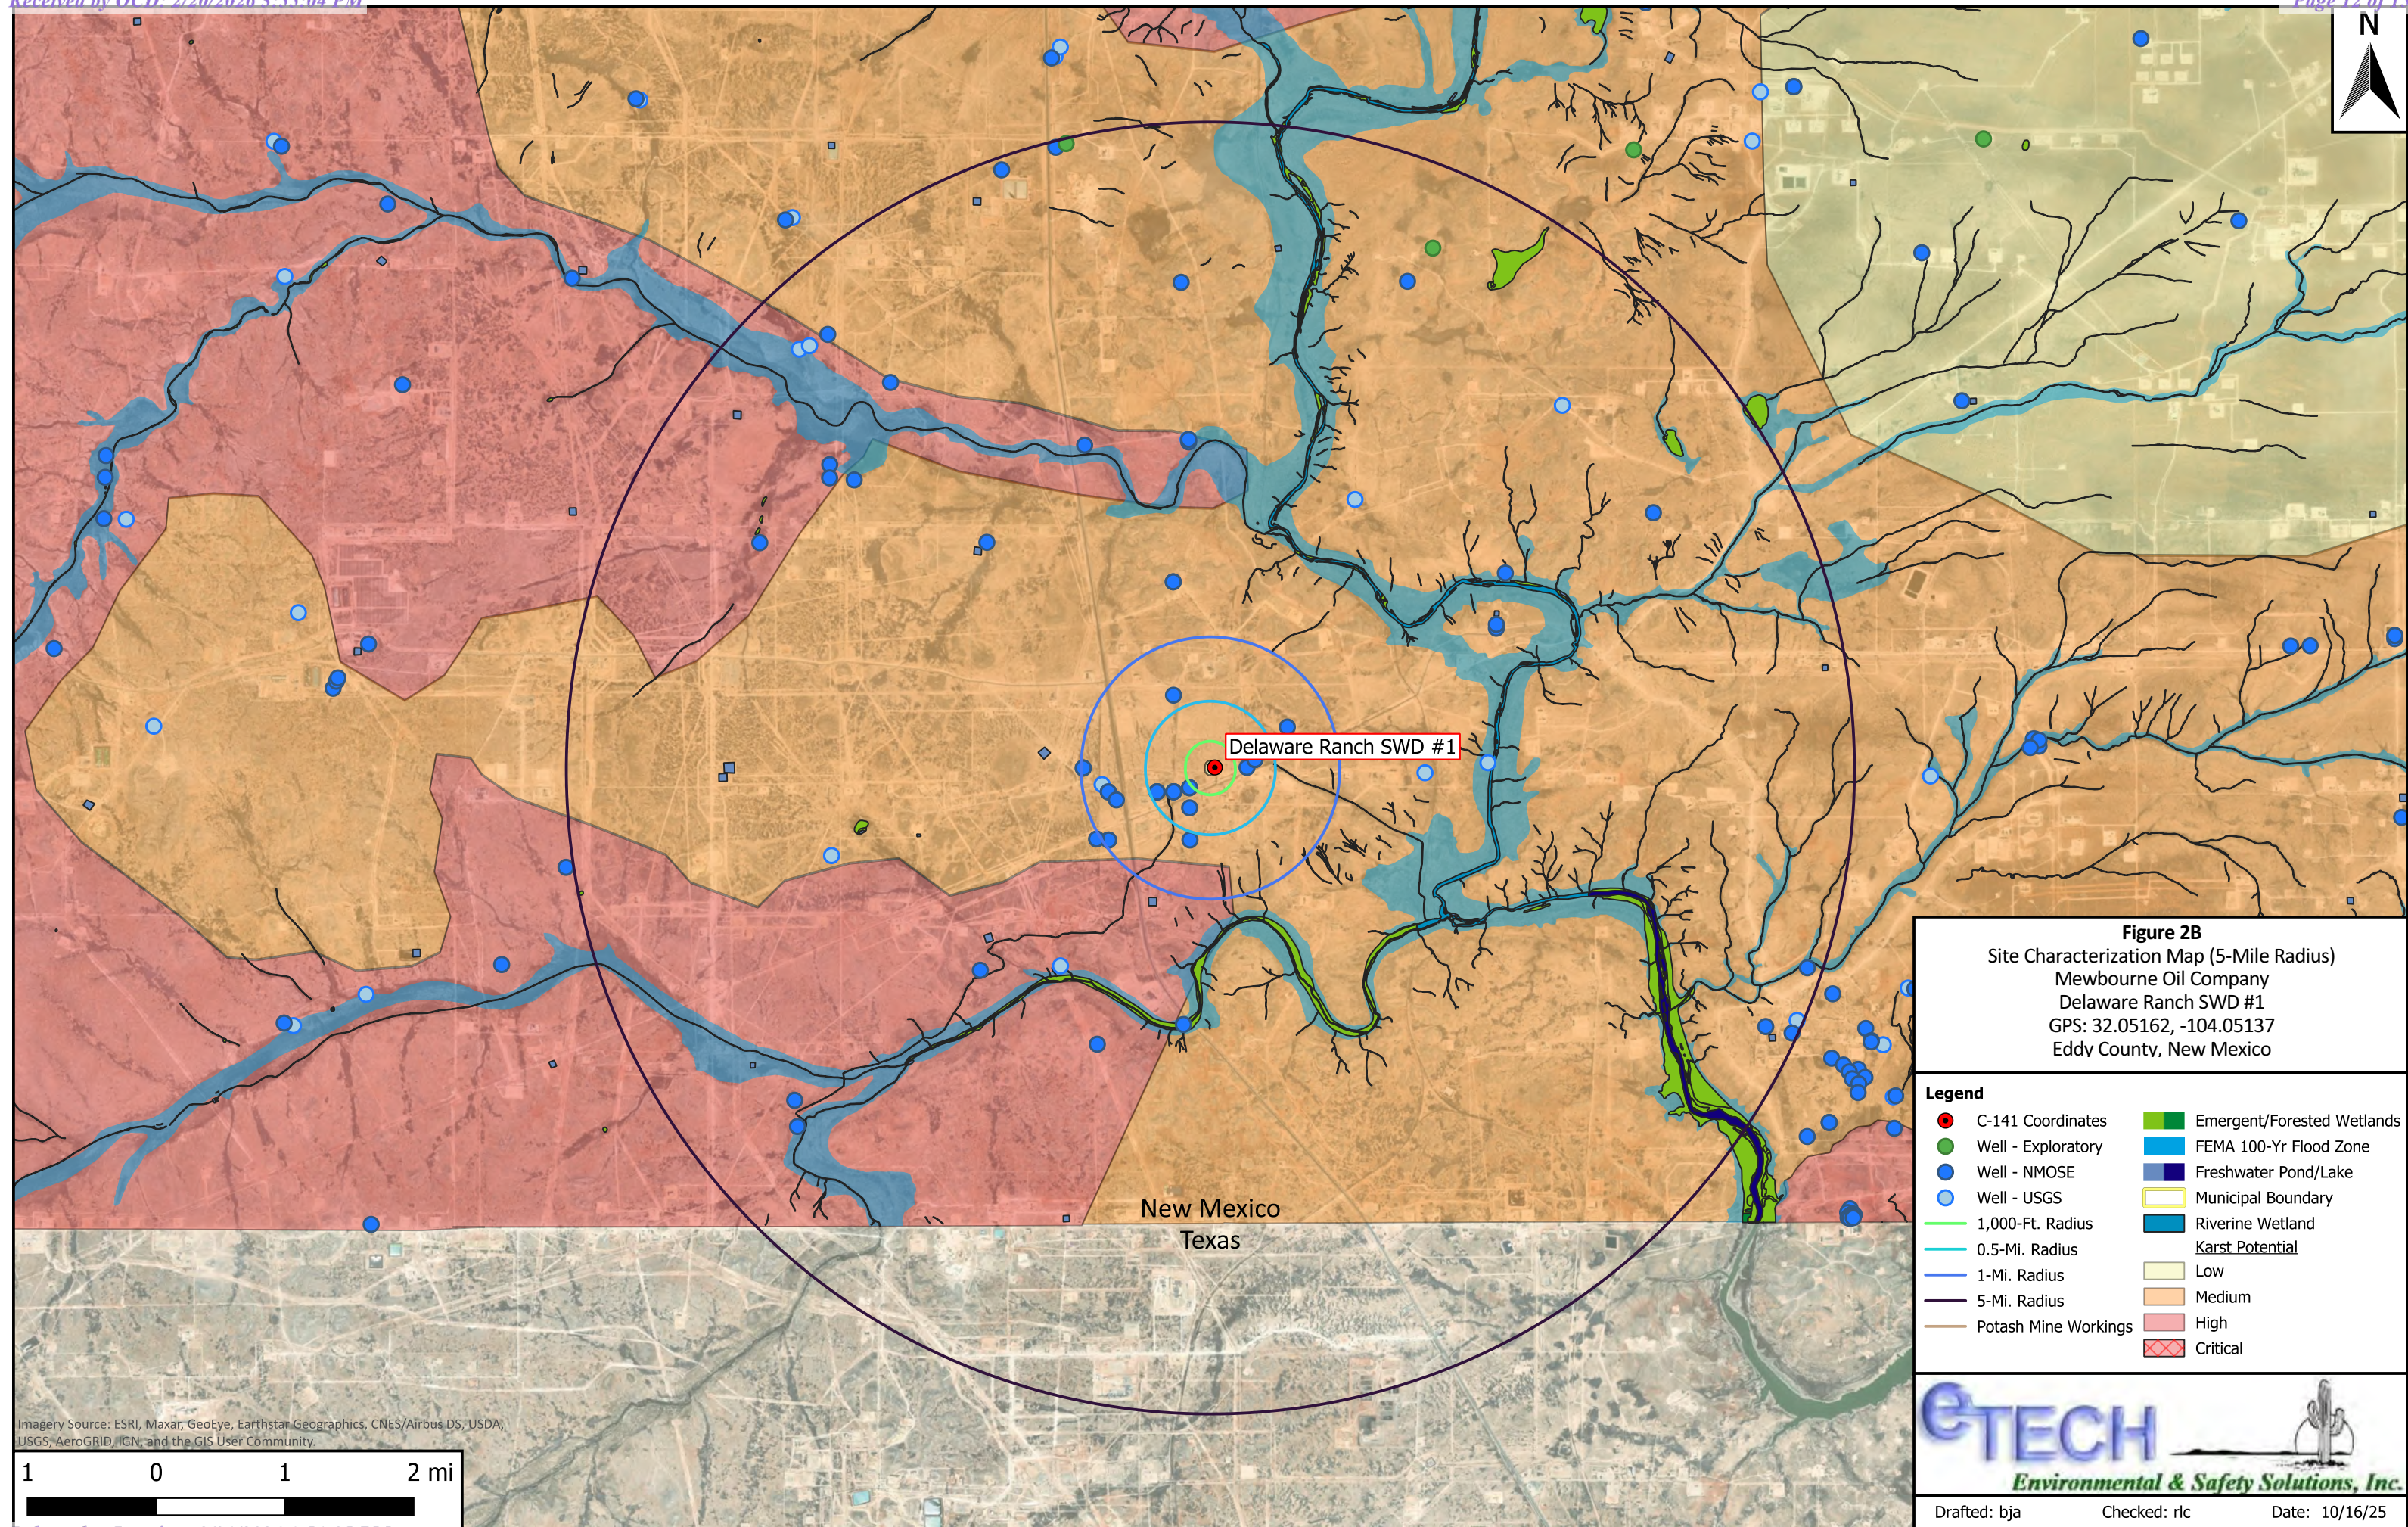
**Figure 2B**  
 Site Characterization Map (5-Mile Radius)  
 Mewbourne Oil Company  
 Delaware Ranch SWD #1  
 GPS: 32.05162, -104.05137  
 Eddy County, New Mexico

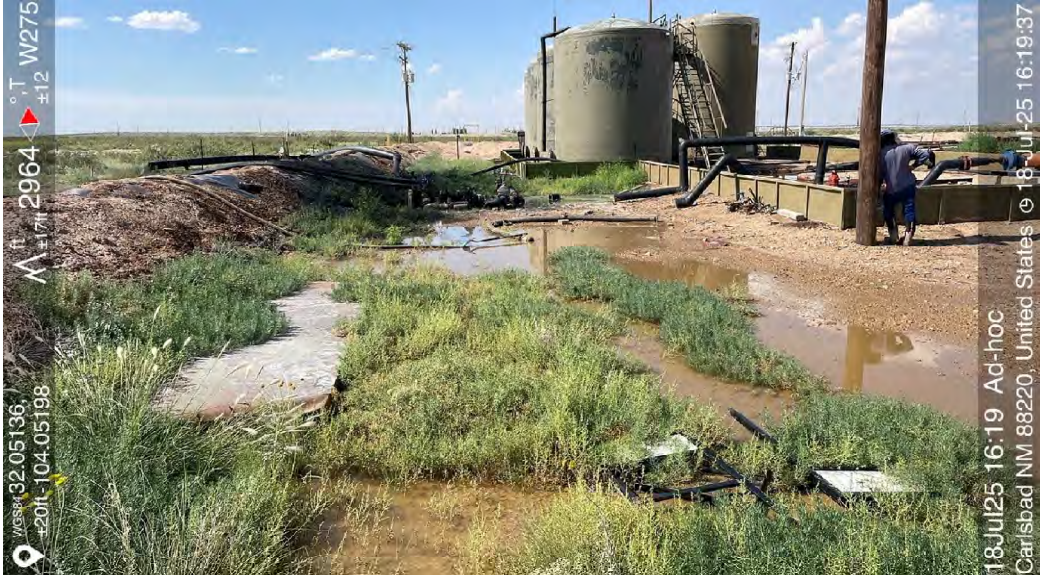
<b>Photo Number:</b> 2

<b>Photo Direction:</b> North	
<b>Photo Description:</b> View of the affected area.

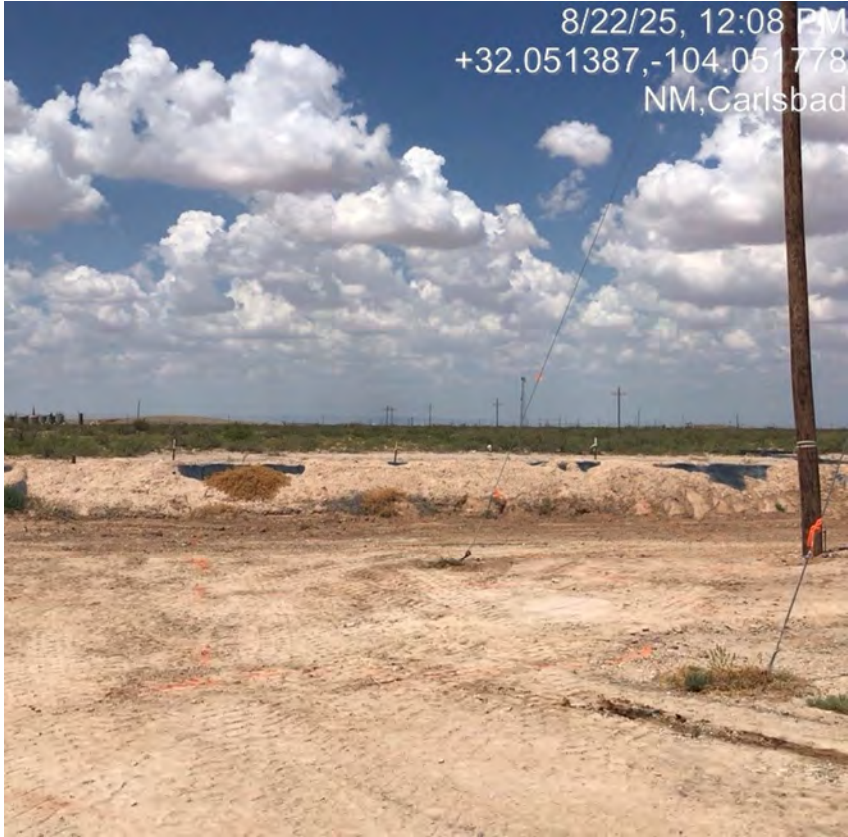
<b>Photo Number:</b> 6

<p>8/22/25, 12:08 PM +32.051387,-104.051778 NM, Carlsbad</p>
<b>Photo Direction:</b> West	
<b>Photo Description:</b>  View of the excavated area.

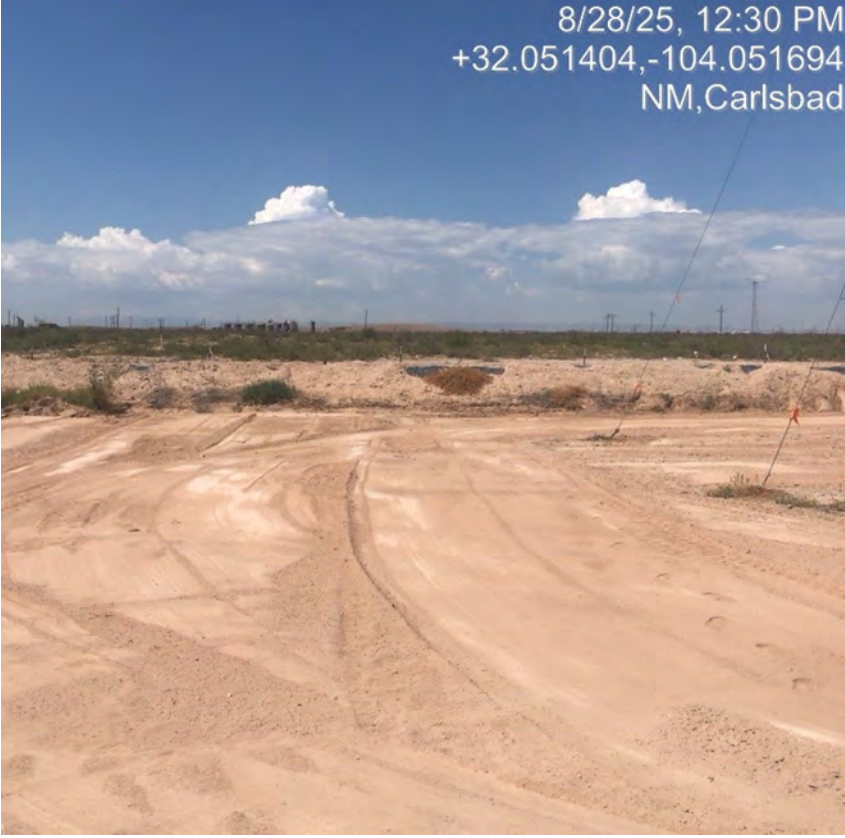
<b>Photo Number:</b> 9

<b>Photo Direction:</b> West	
<b>Photo Description:</b>  View of the remediated area following backfill and regrading.

Upon receipt of all confirmation soil sample results, areas affected by remediation and closure activities were restored to the condition that existed prior to the release, to the extent practicable. The excavation was backfilled with non-impacted, "like" material sourced from the nearby Battle Axe Ranch borrow pit and emplaced at or near original relative positions. The affected areas were compacted and contoured to achieve erosion control, stability, and preservation of surface water flow, to the extent practicable.

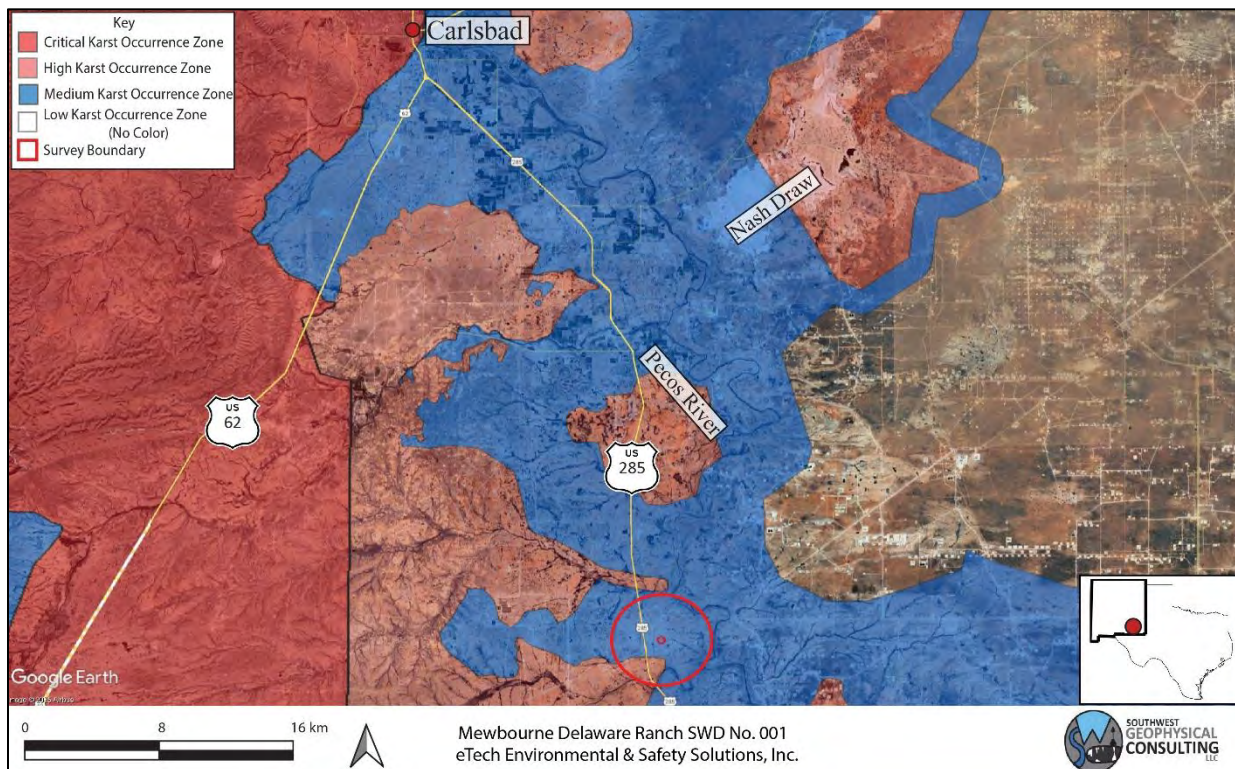
Figure 1: Karst occurrence zone overview. Background image credit: Google Earth. Image date: February 6, 2025. Image datum: WGS-84.

A medium karst occurrence zone is defined as an area in known soluble rock types that may have a shallow insoluble overburden. These areas may contain isolated karst features such as caves and sinkholes. Groundwater recharge may not be wholly dependent on karst features, but the karst features still provide the most rapid aquifer recharge in response to surface runoff<sup>[4]</sup>.

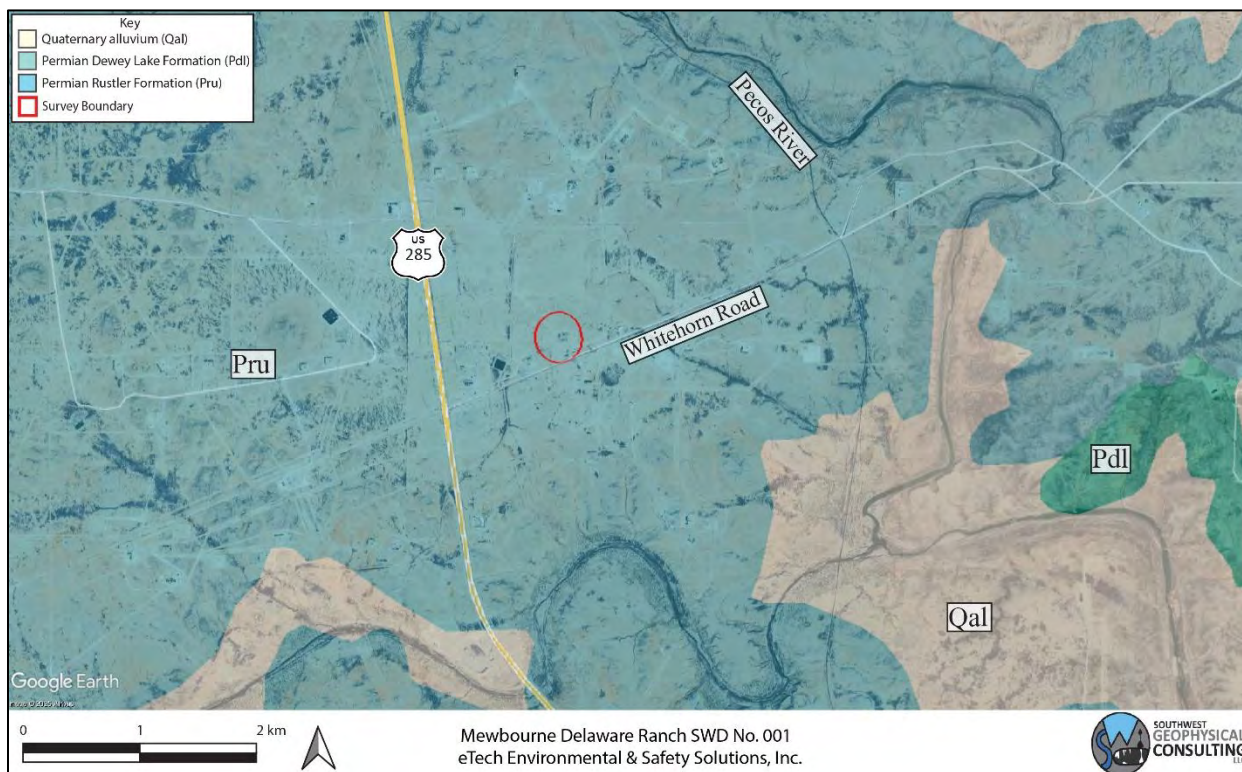
Figure 3: Geology overview. Geology map credit: The Digital Geologic Map of New Mexico in ARC/INFO Format. Background image credit: Google Earth. Image date: February 6, 2025. Image datum: WGS-84.

The Pru overlies the Permian Salado Formation (Psl – not shown in the image below), a layer of extremely soluble halite which can readily dissolve to create caves, sinkholes, and other karst features; however, due to its extremely soluble nature, only non-soluble silt and sand remain from the dissolution of this layer at the surface<sup>[12]</sup>. The Rustler Formation may be subject to collapse if a void has developed beneath it in the Salado Formation<sup>[13]</sup>.

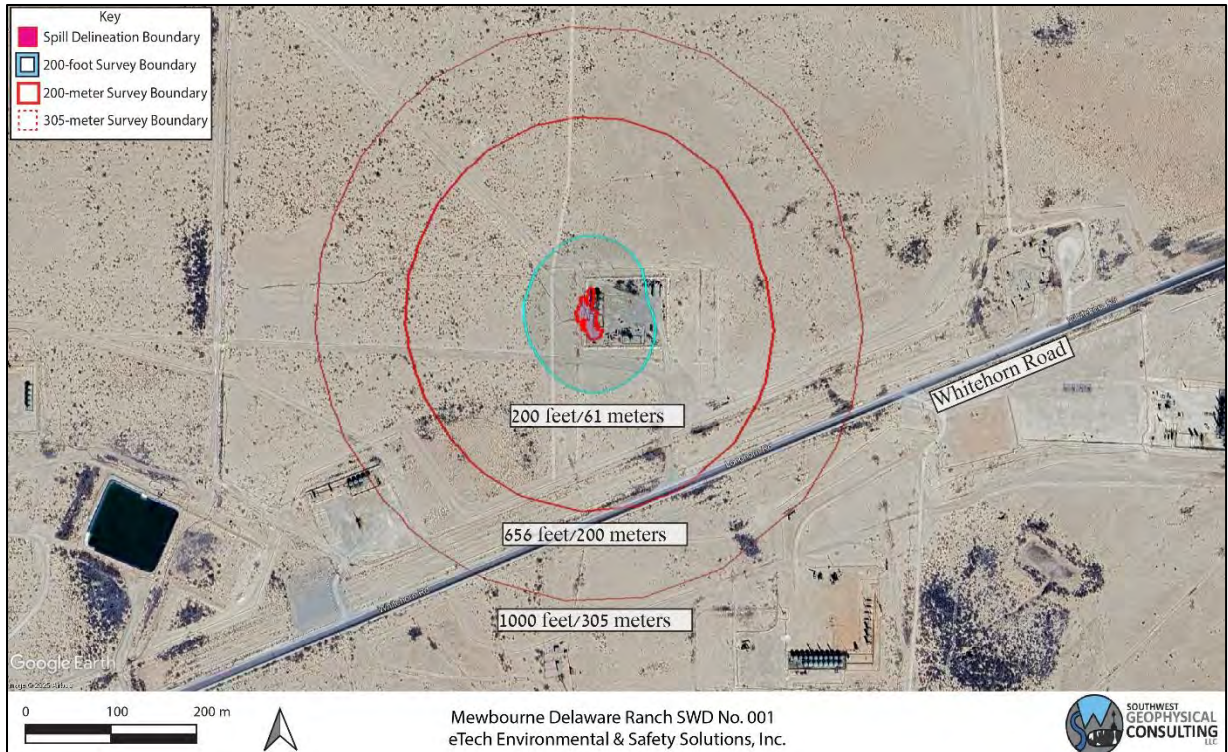
Figure 4: Surface survey overview. Background image credit: Google Earth. Image date: February 6, 2025. Datum: WGS-84.

Surface karst surveys are conducted by sUAS at low elevation within 200 meters of the spill delineation boundary<sup>[4]</sup> (**Figure 4**) following a preplanned raster pattern flightpath designed for the purpose of generating at least 75% imagery overlap. The collected high-resolution, georeferenced imagery is stitched together to develop orthomosaic imagery which is further developed into a digital elevation model (DEM); the DEM is then processed into a local relief model (LRM) (**Figure 6**). This LRM is color coded to enhance differences in elevation of as little as five centimeters. The orthoimagery, DEM, and LRM are uploaded to a server where they are analyzed by an experienced karst geologist. Finally, the data is reviewed by a senior karst geologist for quality assurance and downloaded into a table for inclusion in a written report<sup>[16]</sup>.

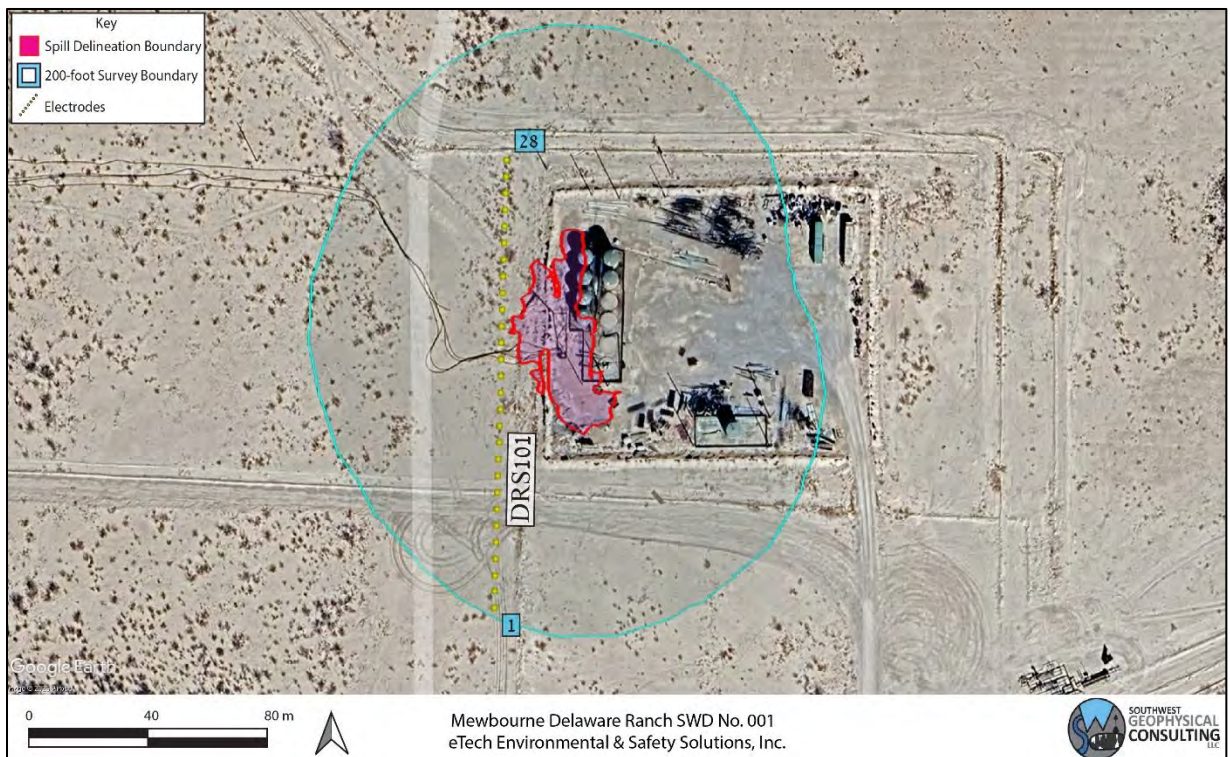
**Figure 5: Geophysical survey overview. One survey line was conducted with 28 electrodes each at 5-meter spacing (yellow dots denoted with blue numbers). Background image credit: Google Earth. Image date: February 6, 2025. Image datum: WGS-84.**

For this survey, a Guideline Geo Terrameter LS 2 and a 28-electrode array of 40-centimeter-long electrodes were used to image the subsurface. This survey consisted of one resistivity line in a dipole-dipole configuration laid out south to north. This line consisted of 28 electrodes at 5-meter spacing, resulting in a 135-meter-long array (**Figure 5, Table 1**). A preconfigured protocol file was used to run the data collection (DipoleDipole3x14). This electrode configuration provided a depth of investigation of 27 meters (89 feet) and a resolution of 2.5 to 3.0 meters (8.2 to 9.8 feet) within the first 5 to 8 meters (16 to 26 feet) from the surface. A Leica GS18 GPS was used to record electrode locations and elevations.

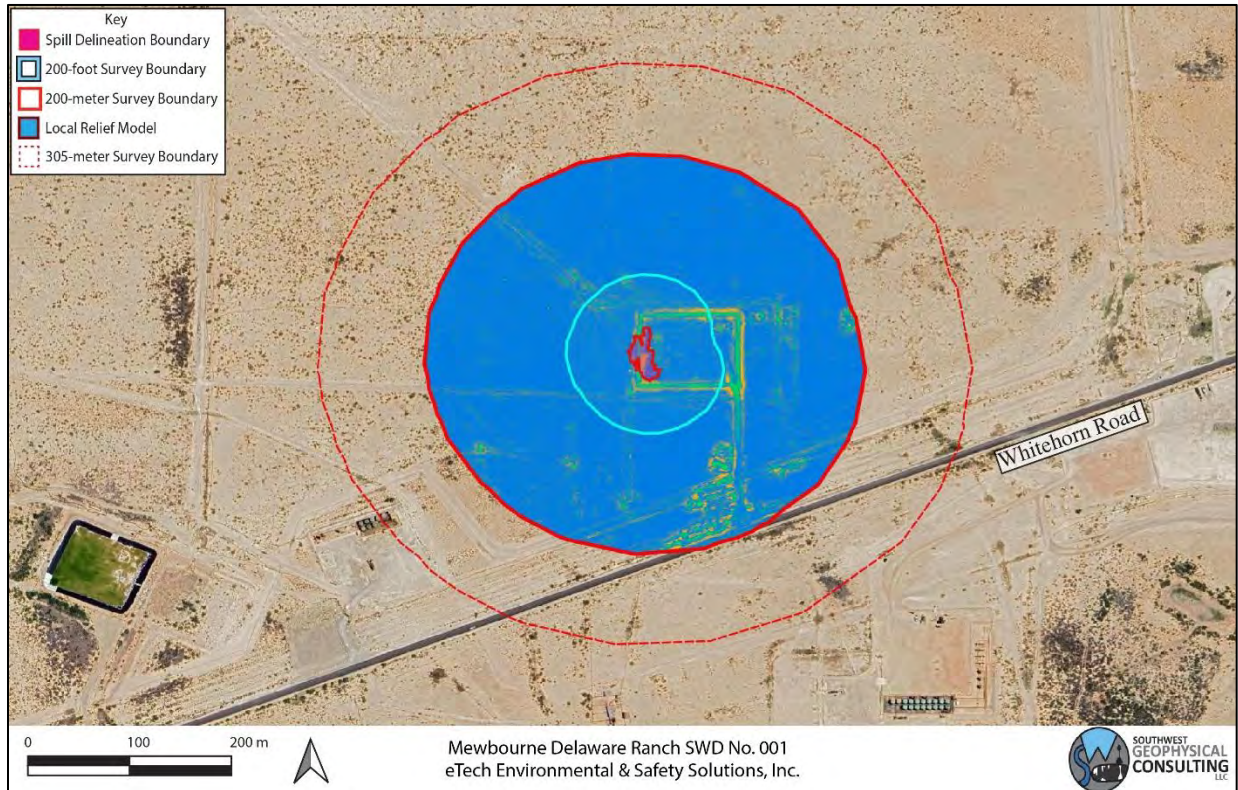
Figure 6: Surface karst survey results. Background image credit: Google Earth. Image date: February 6, 2025. Image datum: WGS-84.

The desk study and surface karst survey showed no surface karst features located within the 200-foot (61-meter)<sup>[1]</sup> survey area surrounding the spill delineation boundary (Figure 6).

No springs exist within the 305-meter (1,000-foot)<sup>[1]</sup> survey boundary (Figure 6).

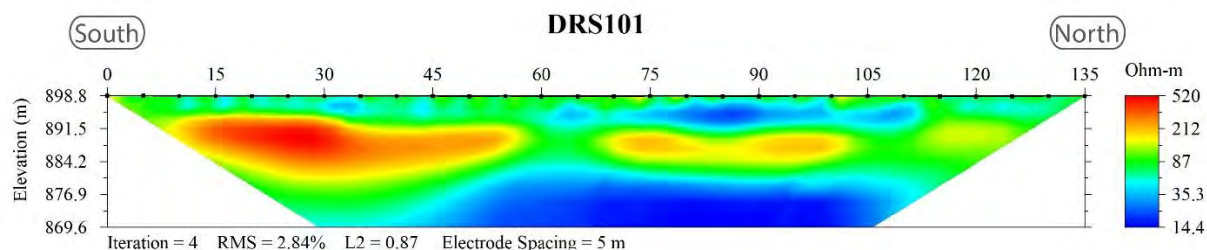
**Figure 7: 2D inverted resistivity section. Reds and oranges indicate higher resistivity values. Yellows and greens are medium-resistivity values. Blues are low-resistivity values. Please note that the color scale is relative.**

The results of this study indicate a well-layered geologic system with low resistivities between 14.4 and 220 Ohm-m with one slightly higher-than-average area of 520 Ohm-m (**Figure 7**). Please keep in mind when viewing the 2D inverted resistivity sections that color maps can be widely different for each view. Always check the color map located on the right side of the image when viewing the 2D images to ensure you understand the range of resistivities presented. Distances along the top and depths along the left side are in meters. The color map along the right side is in Ohm-m. Due to the nature of the survey, shallower zones have higher resolution between electrodes than deeper zones; therefore, small features at depth will not be visible.

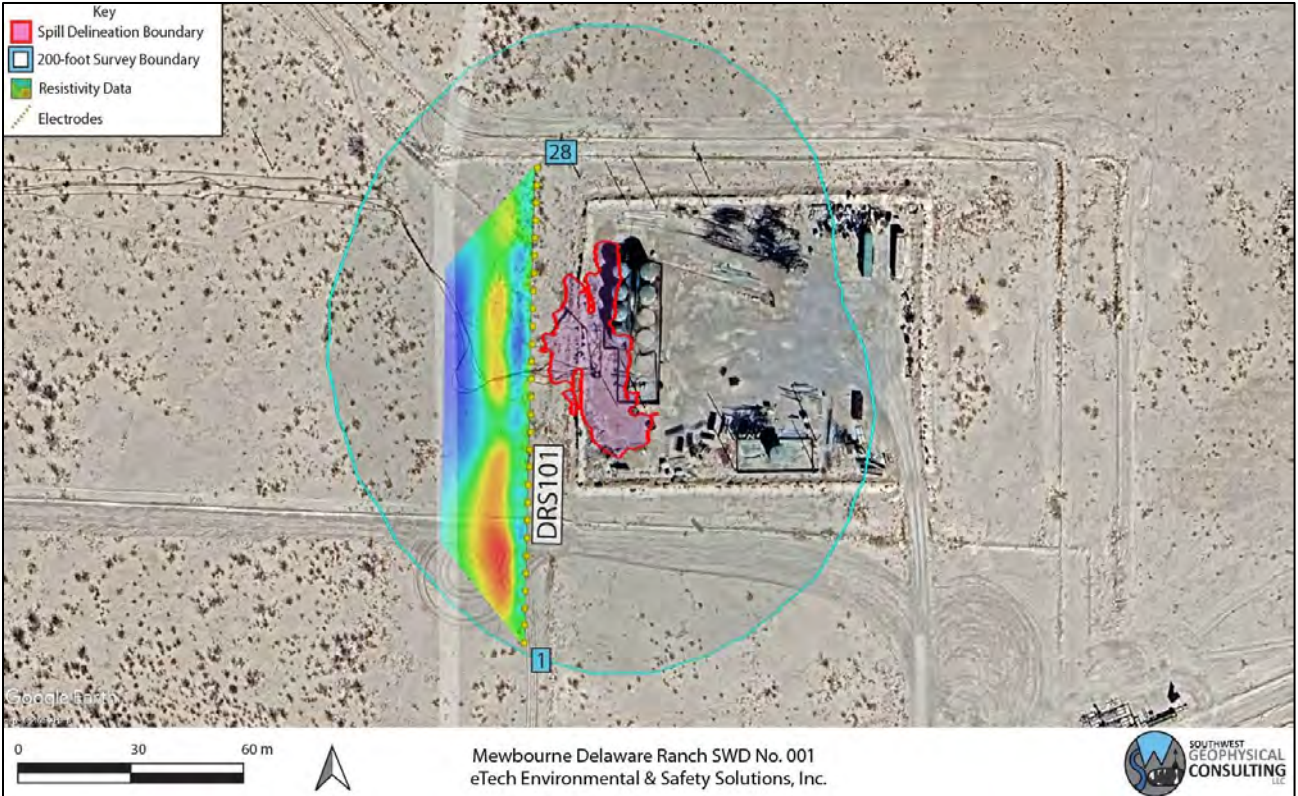
Figure 8: Data overlay. Colored trapezoid is the 2D inverted resistivity line. Background image credit: Google Earth. Image date: February 6, 2025.
