Middle Mesa CDP Water Gathering Line/ Incident nAPP2600240811

**RE: Northeast Blanco Unit Middle Mesa CDP Water Gathering Line
Incident nAPP2600240811
Closure Report
San Juan County, New Mexico**

**NEBU Middle Mesa CDP
 Project Map
 Simcoe LLC**

NEBU Middle Mesa CDP
Photographic Log
Simcoe LLC

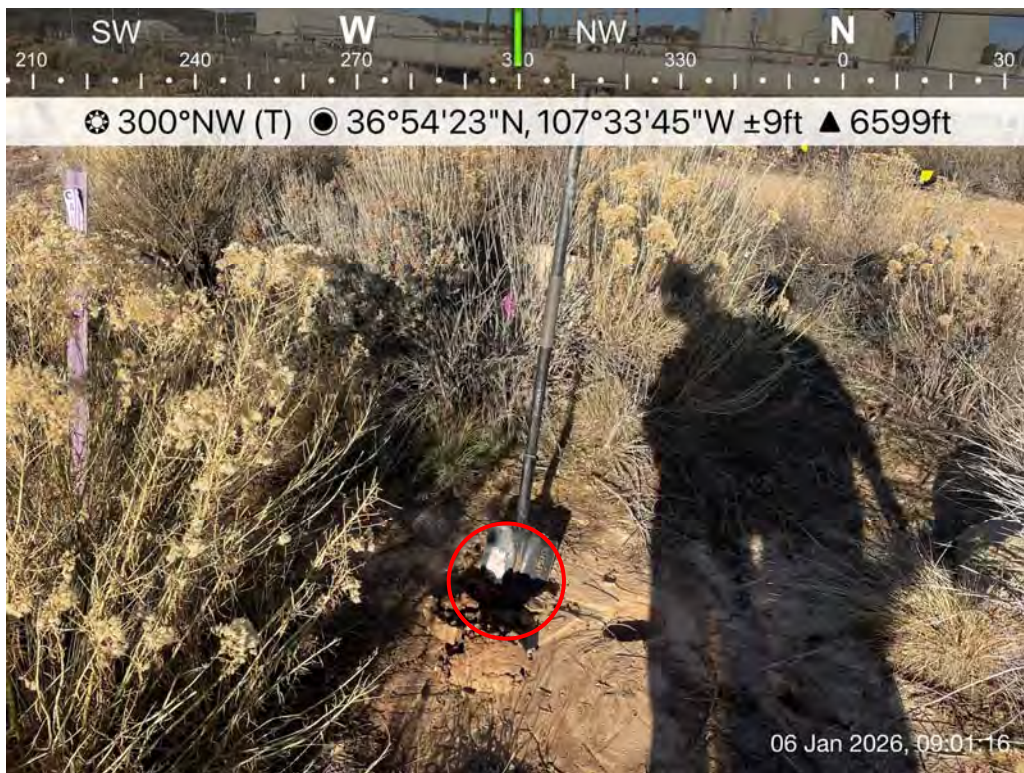
Photo 2: SS01 collected adjacent to POR.

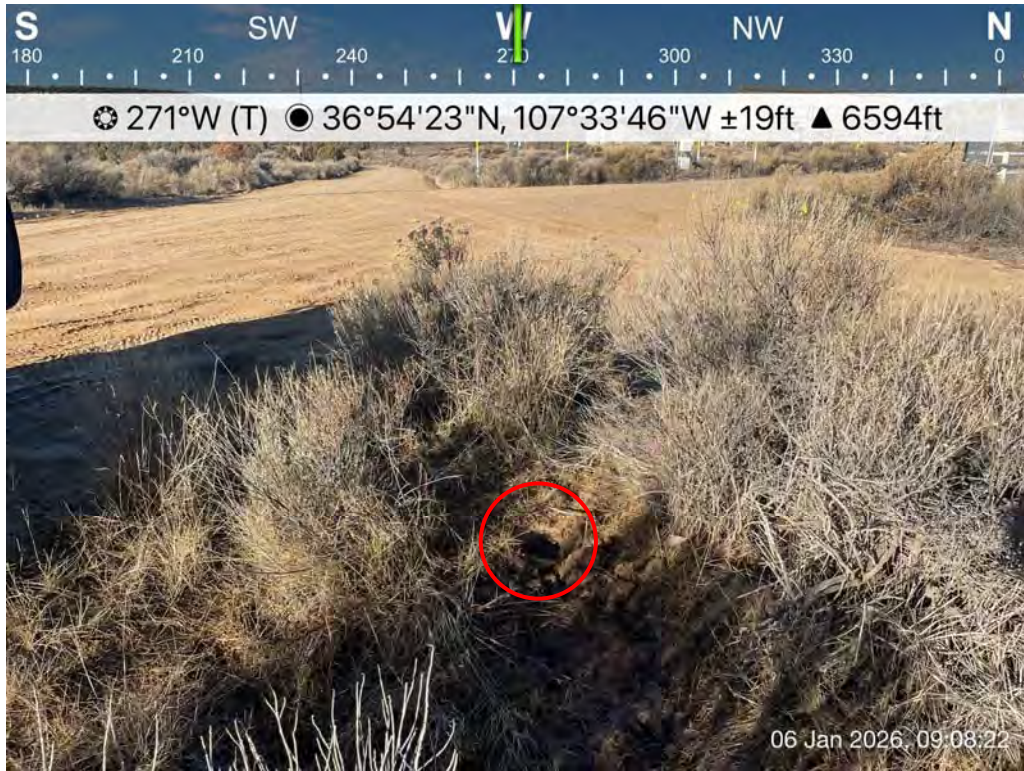
Photo 3: SS02 collected from release area.

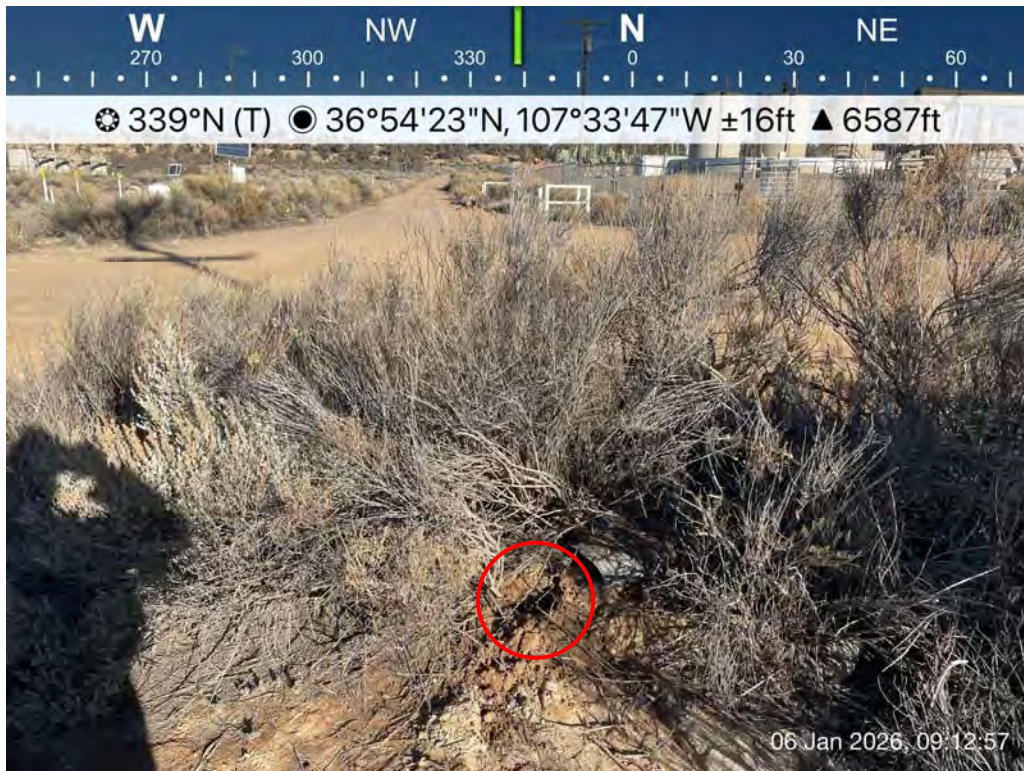
Photo 4: SS03 collected downgradient of culvert.

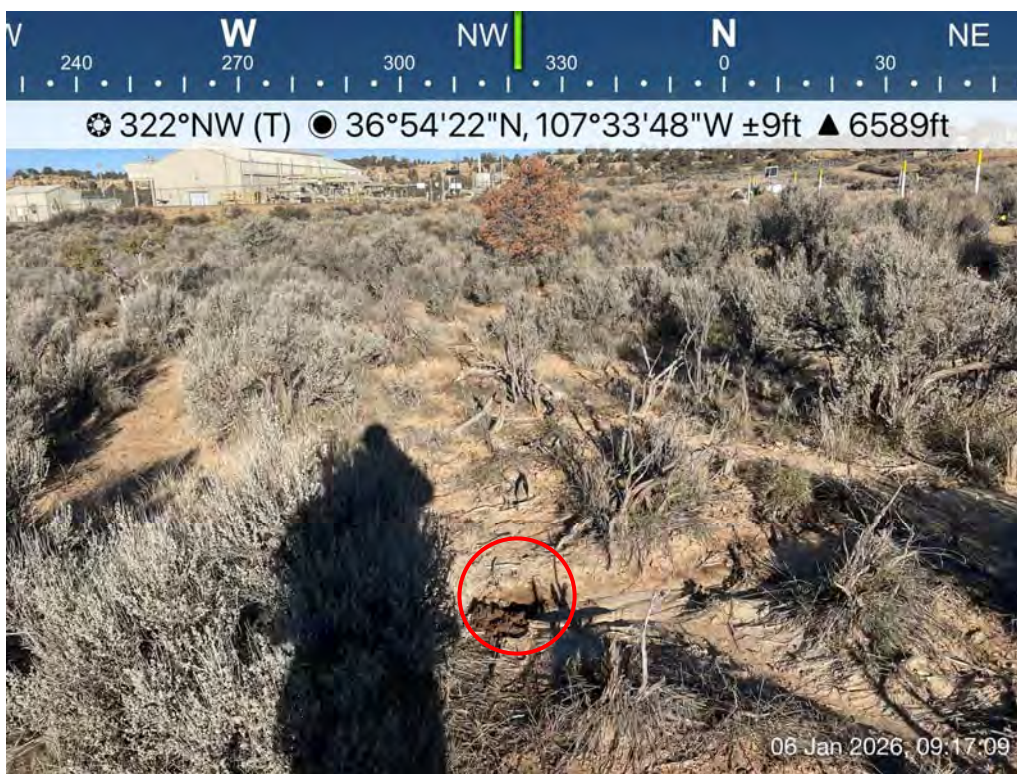
Photo 5: SS04 collected downgradient of SS03 within drainage.

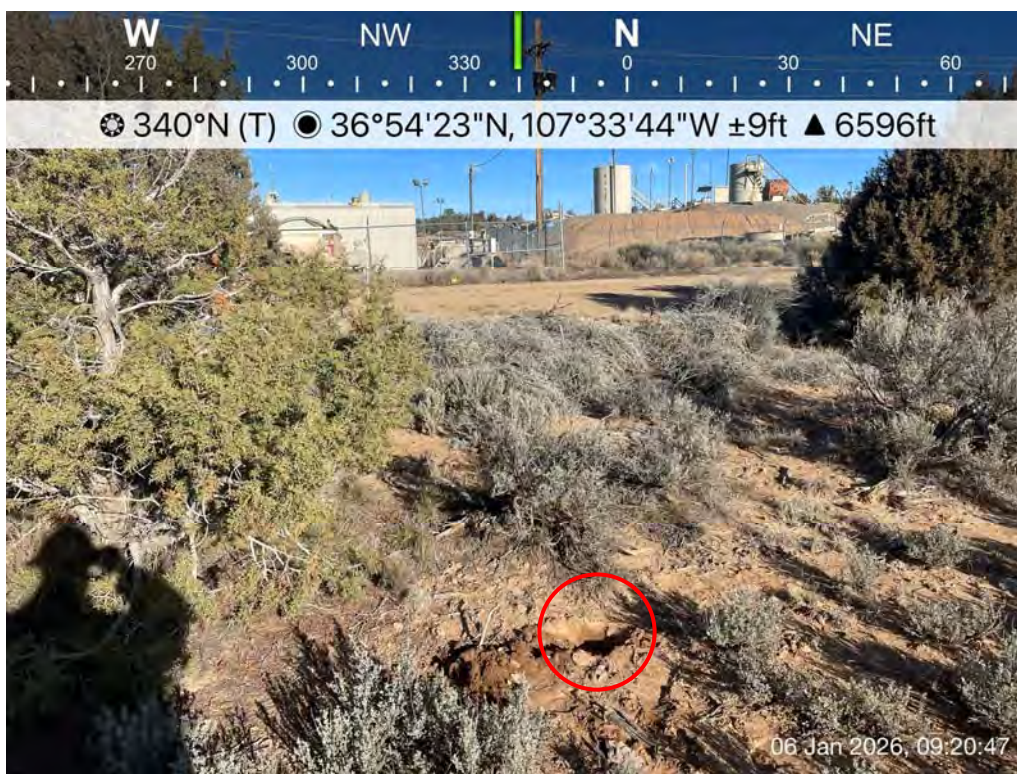
Photo 6: BG01 collected upgradient of POR and from undisturbed soils.

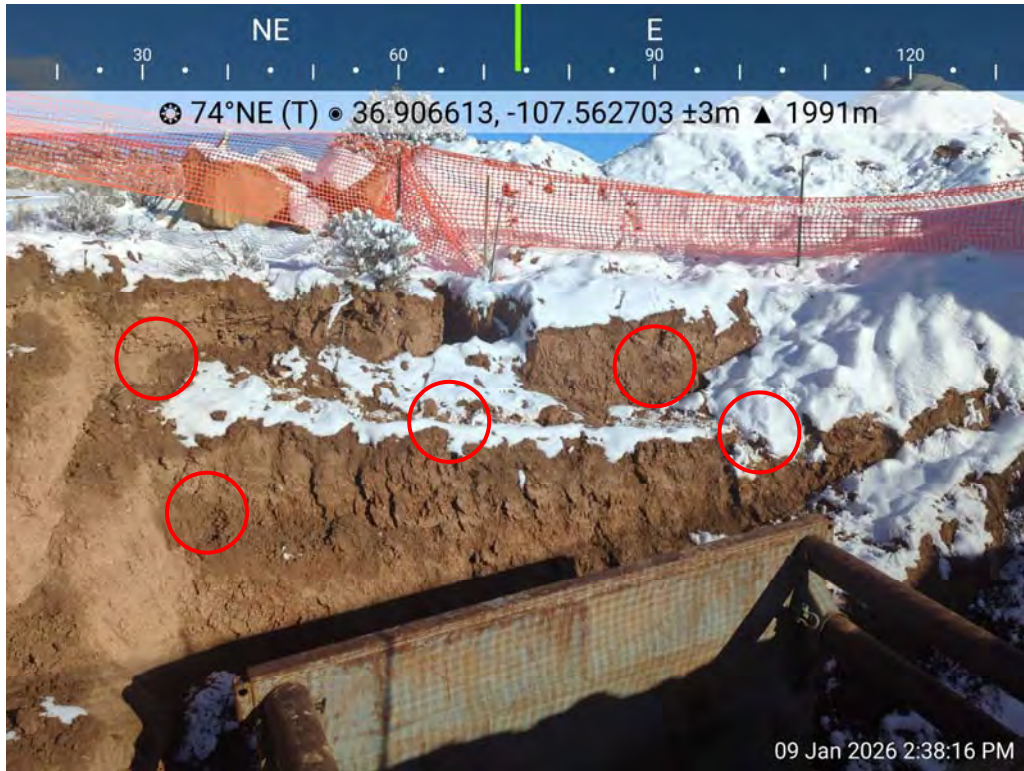
Photo 7: SS05 is a five-point composite sample collected from upper portion of east wall of excavation area.

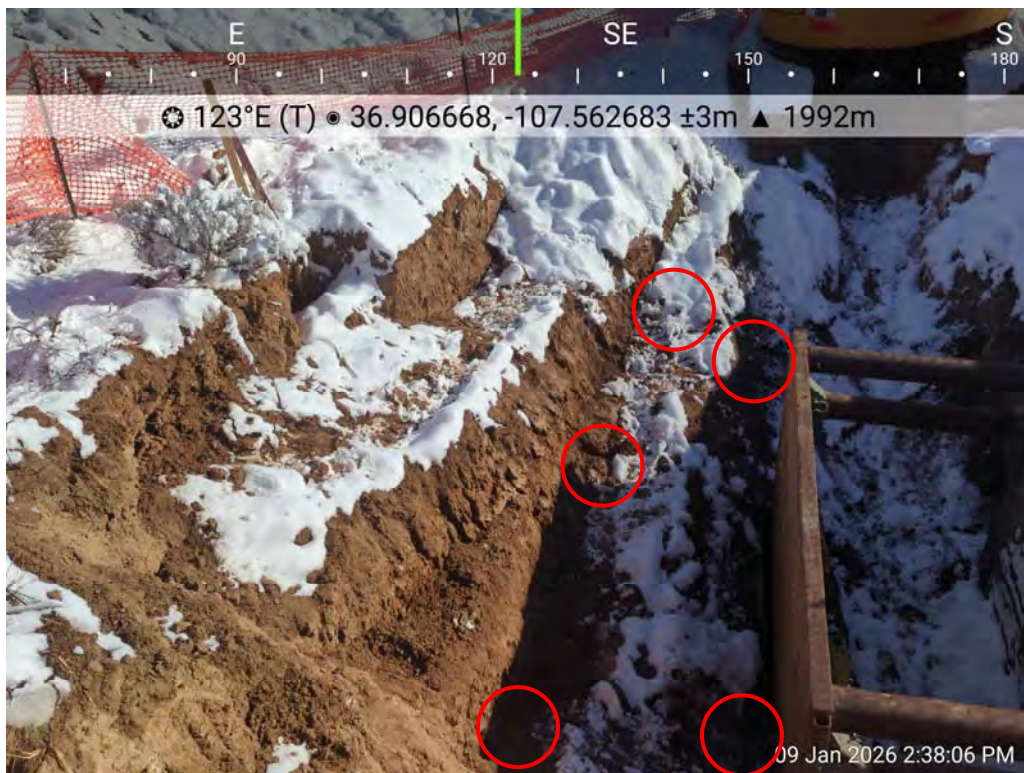
Photo 8: SS06 is a five-point composite sample collected from lower portion of east wall of excavation area.

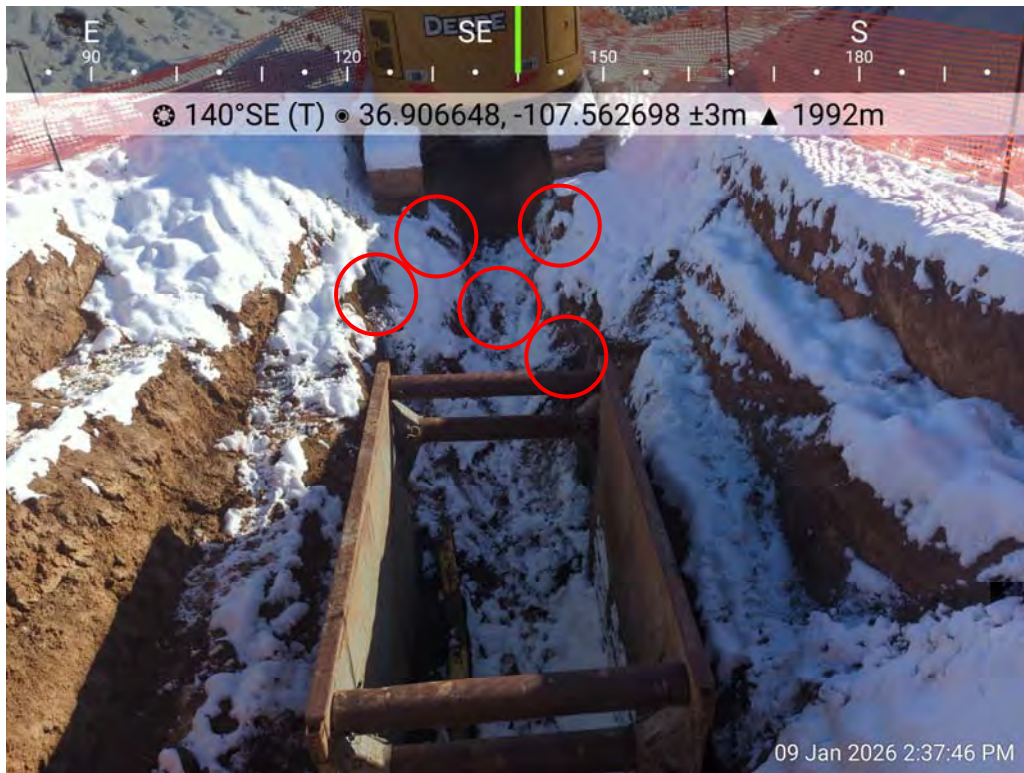
Photo 9: SS07 is a five-point composite sample collected from south wall of excavation area.

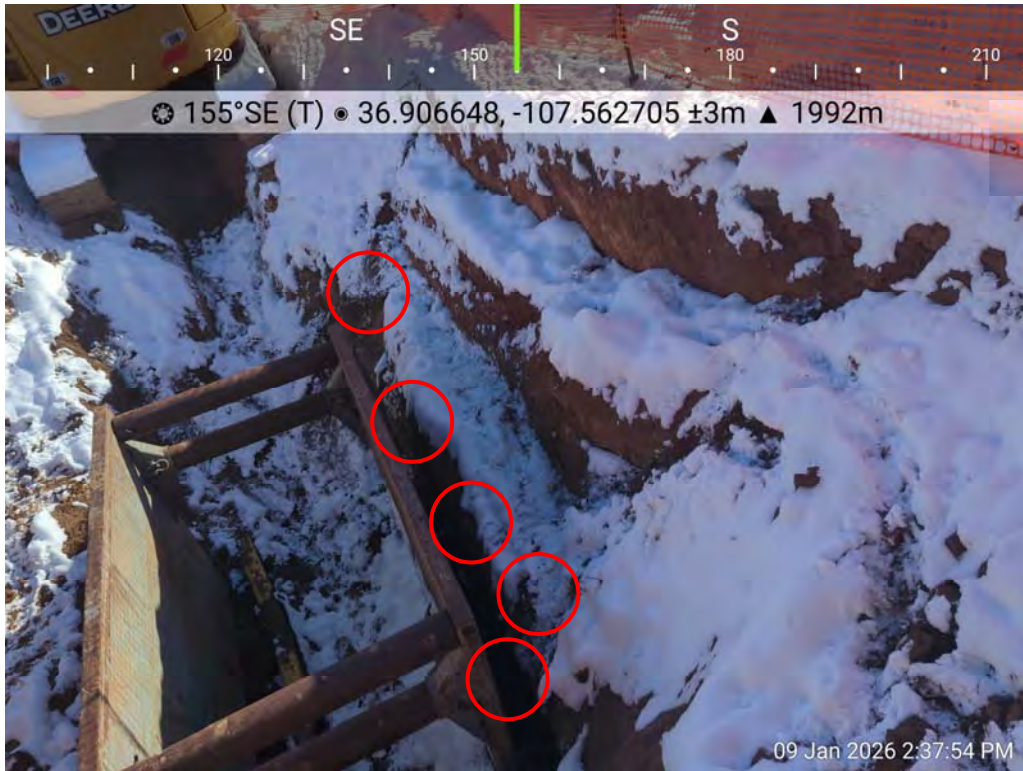
Photo 11: SS09 is a five-point composite sample collected from lower portion of west wall of excavation area.

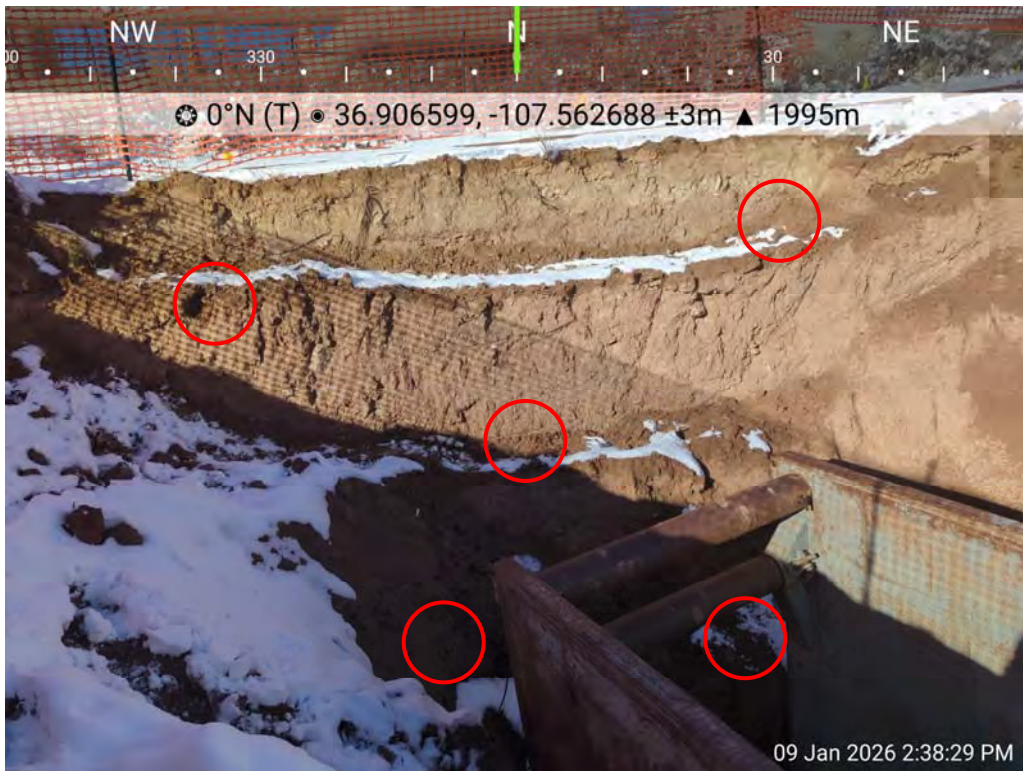
Photo 12: SS10 is a five-point composite sample collected from north wall of excavation area.

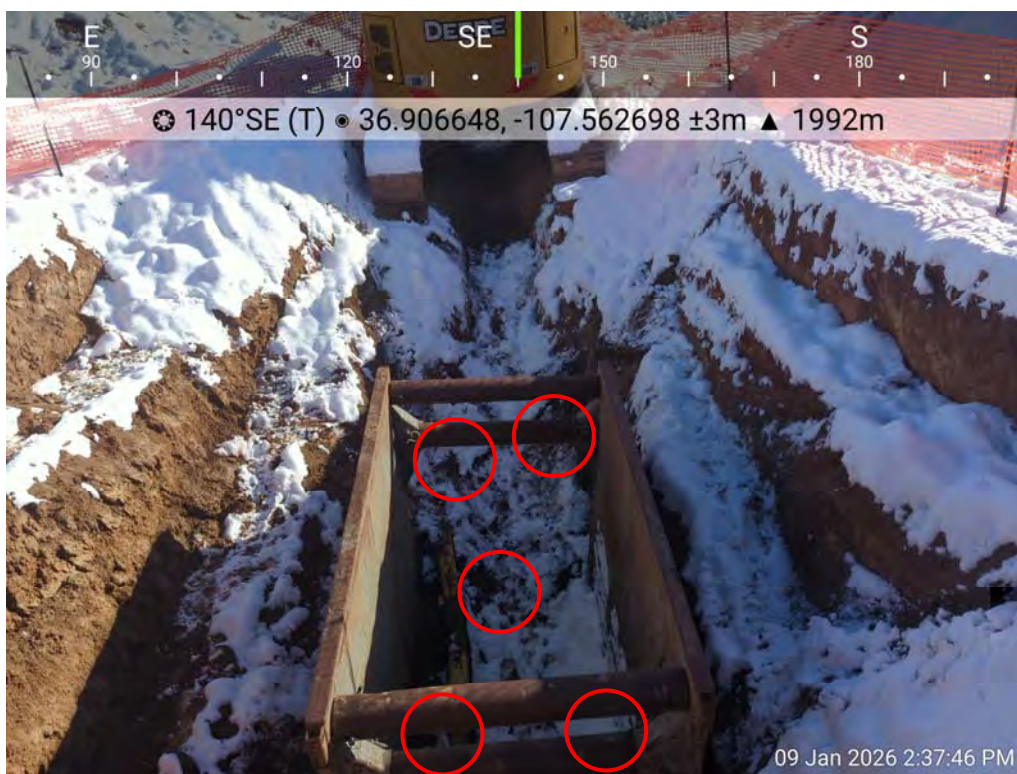
Photo 13: SS11 is a five-point composite sample collected from base of excavation area.

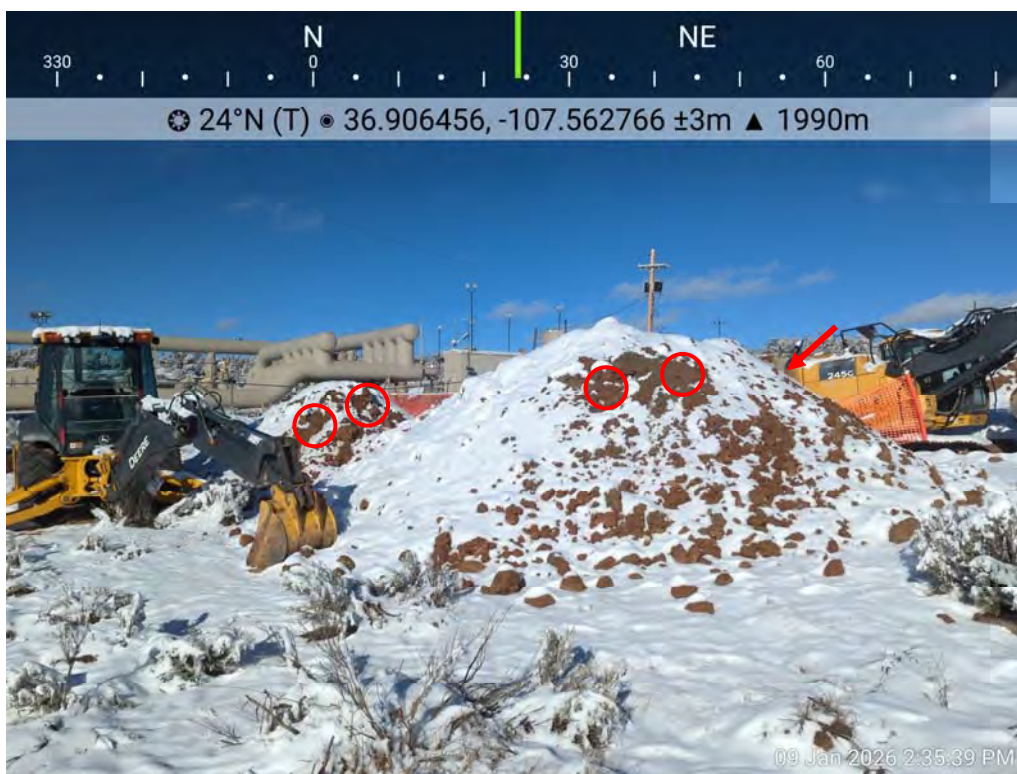
Photo 14: SS12 is a five-point composite sample collected from north spoils piles. Red arrow indicates sample point locations not visible in photograph.

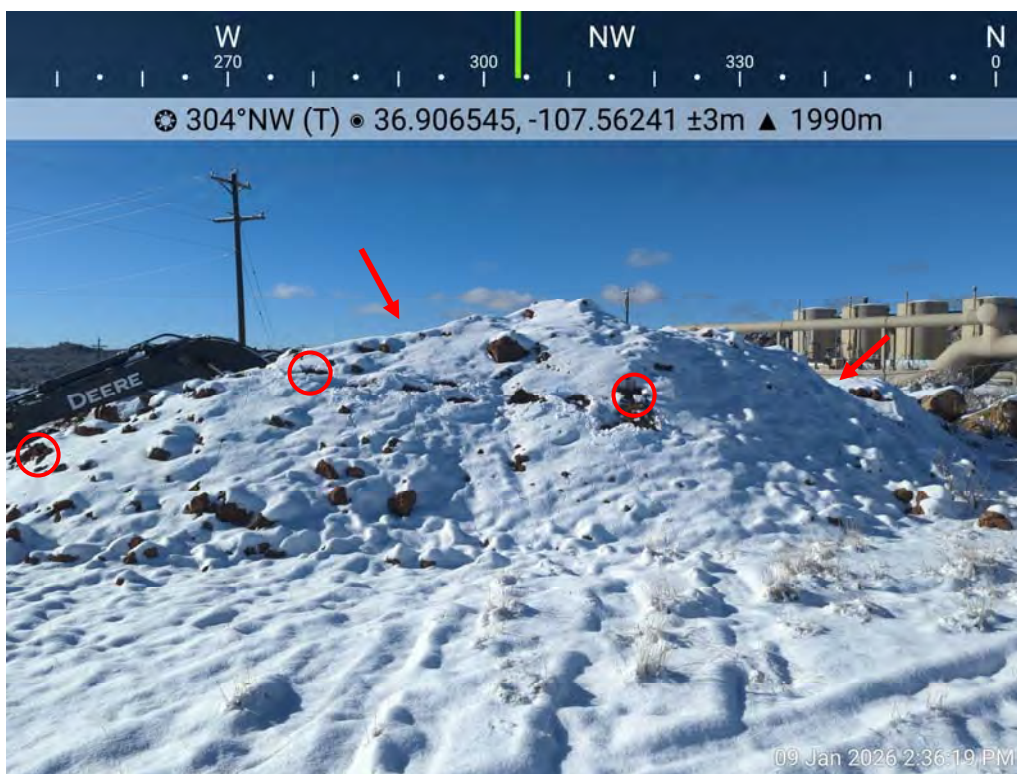
Photo 15: SS13 is a five-point composite sample collected from south spoils pile. Red arrow indicates sample point locations not visible in photograph.
