**Re: Site Assessment and Closure Report
 Halberd North St Com TB
 GPS: Latitude 32.81204 Longitude -104.15424
 UL "D", Sec. 26, T17S, R28E
 Eddy County, NM
 NMOCD Ref. No. NAPP2514729654**

Paragon Environmental, LLC (Paragon) has been contracted by Spur Energy Partners (Spur) to perform a spill assessment, conduct remediation activities, and write a closure report for the release site known as the Halberd North St Com TB (Halberd). Details of the release are summarized below:

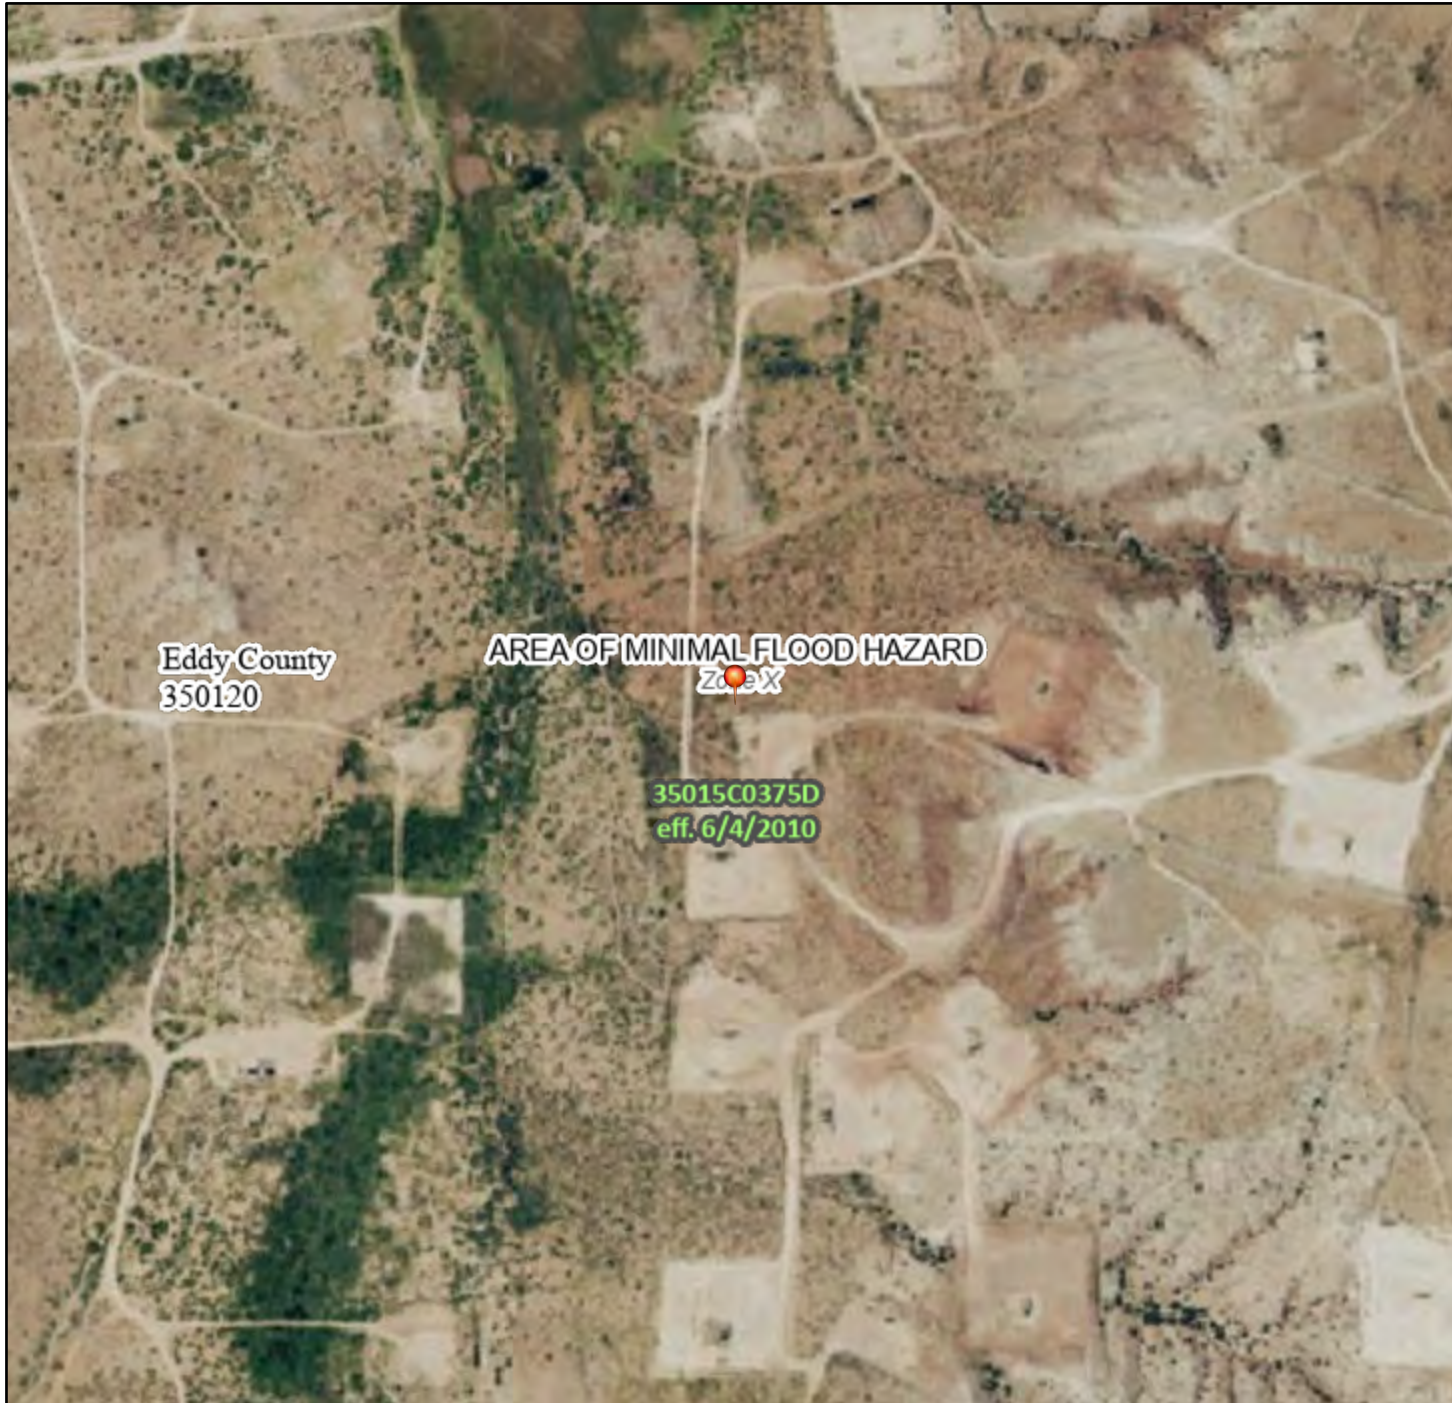
National Flood Hazard Layer FIRMette

AREA OF MINIMAL FLOOD HAZARD
Zone X

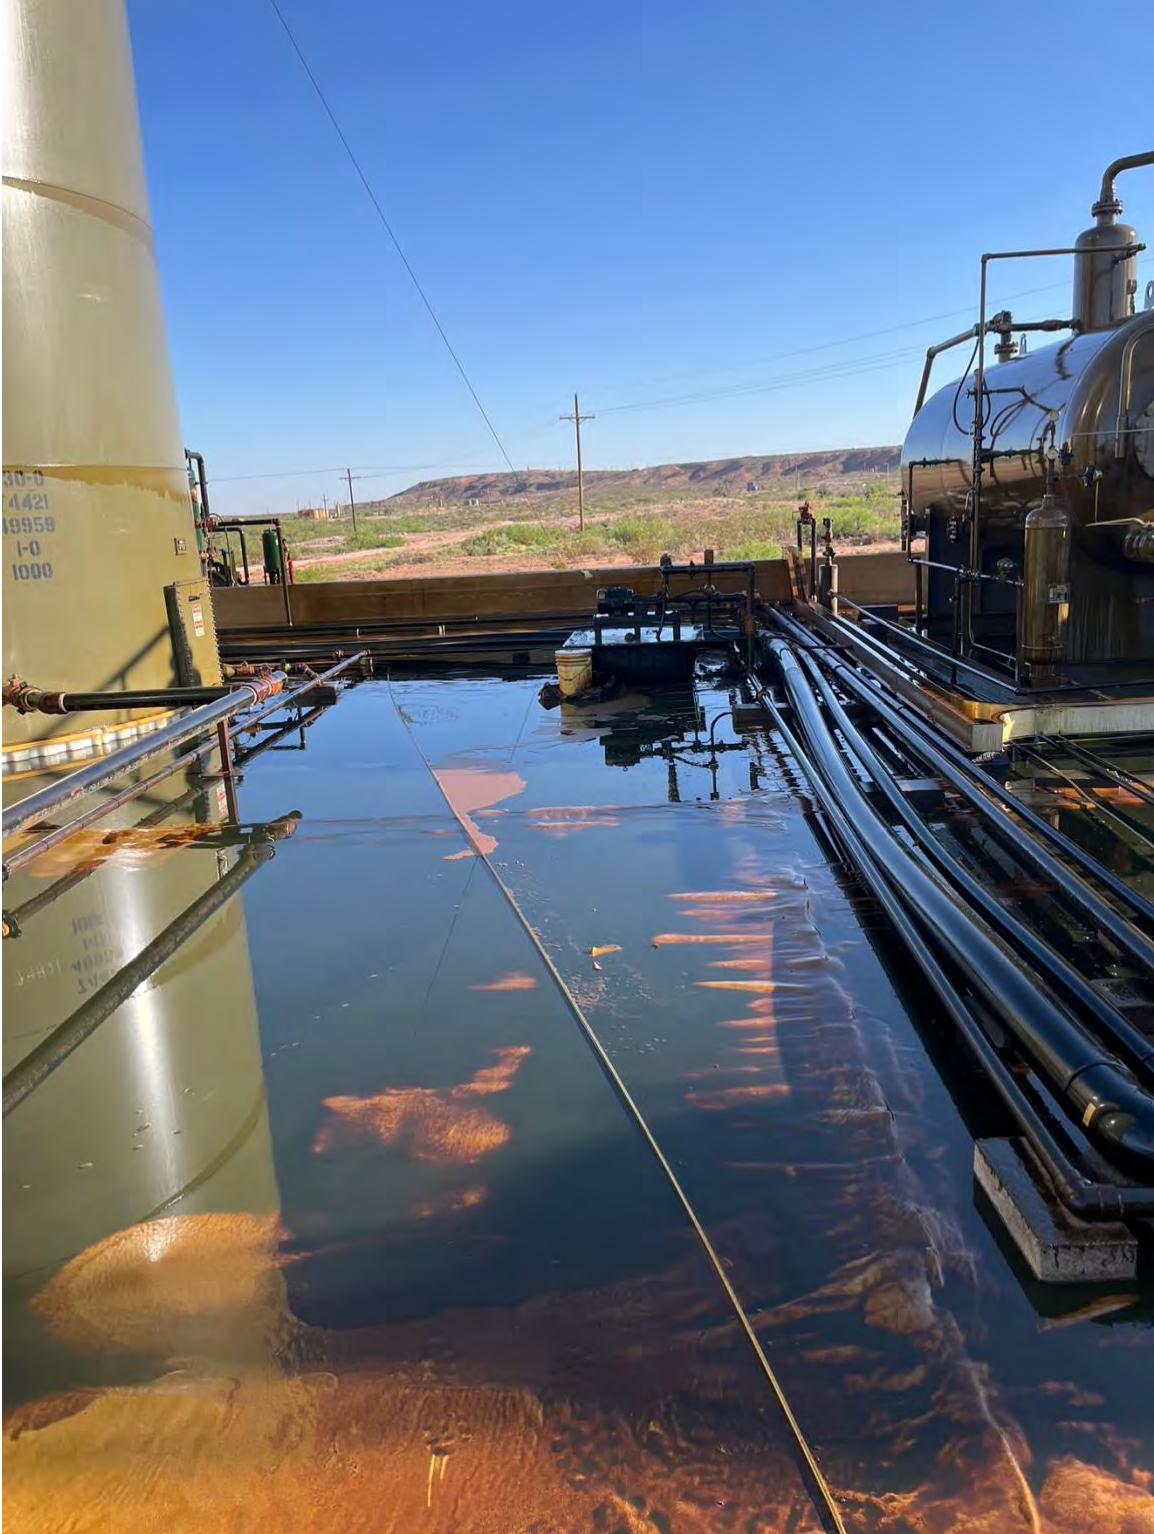
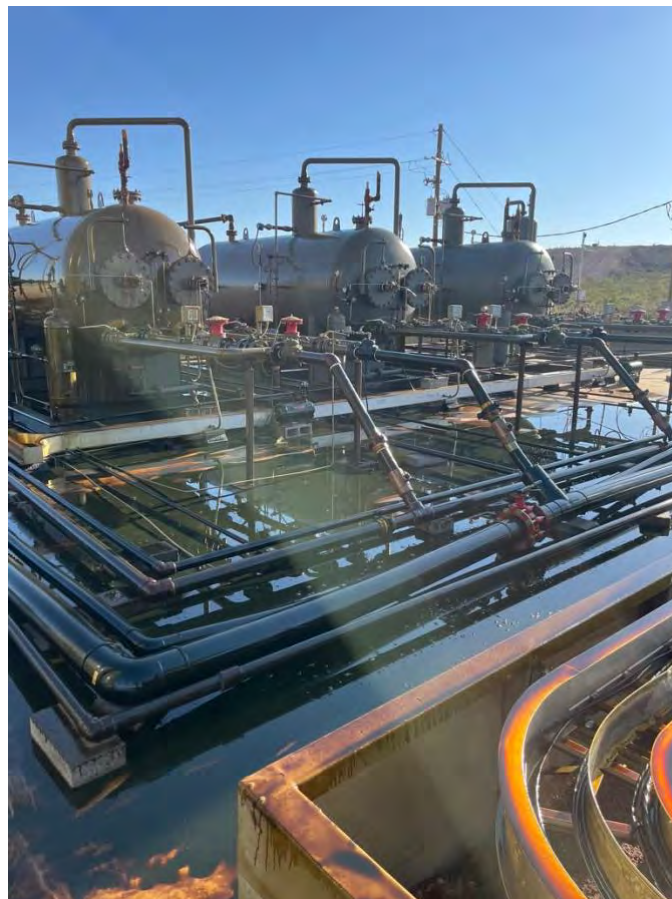
**Photographic Documentation
Incident Pics**

| Release Details | | | |
|---|---|--|---|
| The circulating pump nipple snapped off releasing oil into the lined containment. | | | |

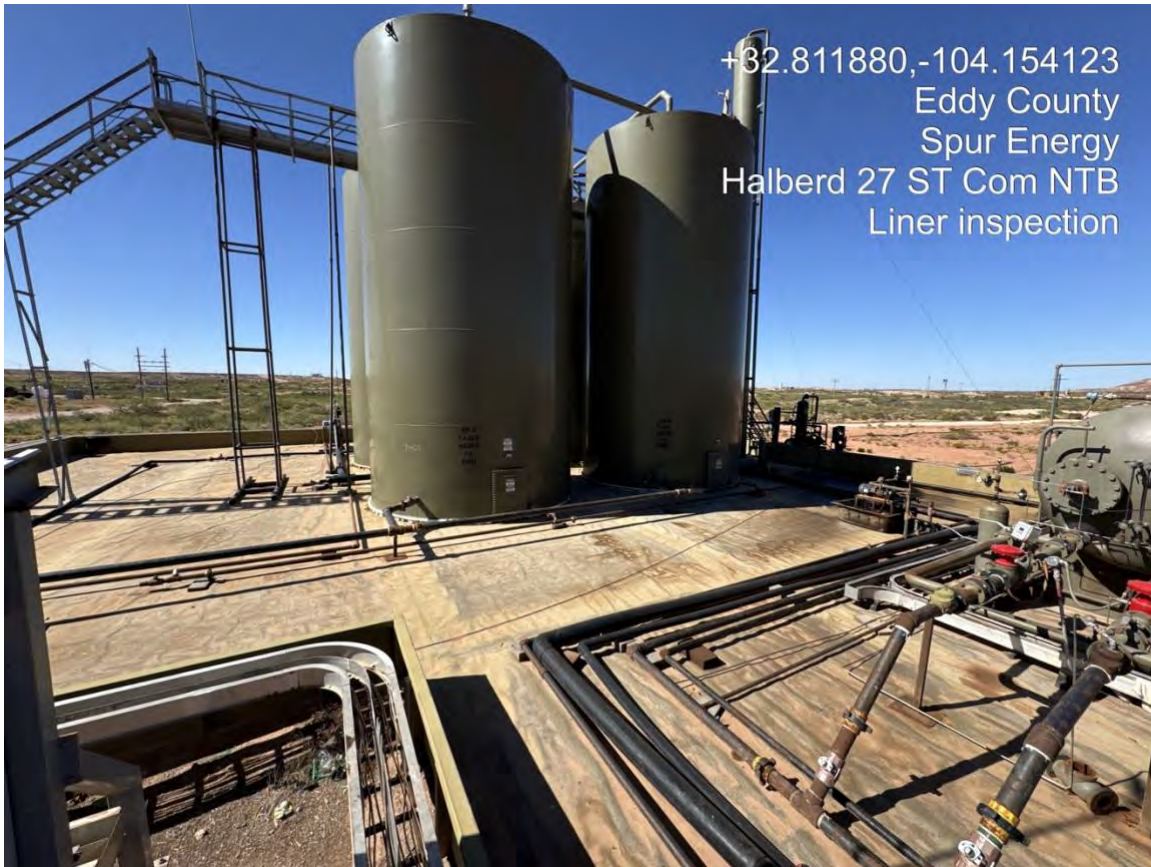
Completed and Liner Inspection

+32.811880,-104.154123
Eddy County
Spur Energy
Halberd 27 ST Com NTB
Liner inspection

The stained area measured approximately 1500 s/f. We sprayed degreaser, followed by heated water to power wash the liner clean. A vac truck was on site, sucking up the fluids as the crew sprayed the liner down and used a squeegee to move the fluids to the vac truck.

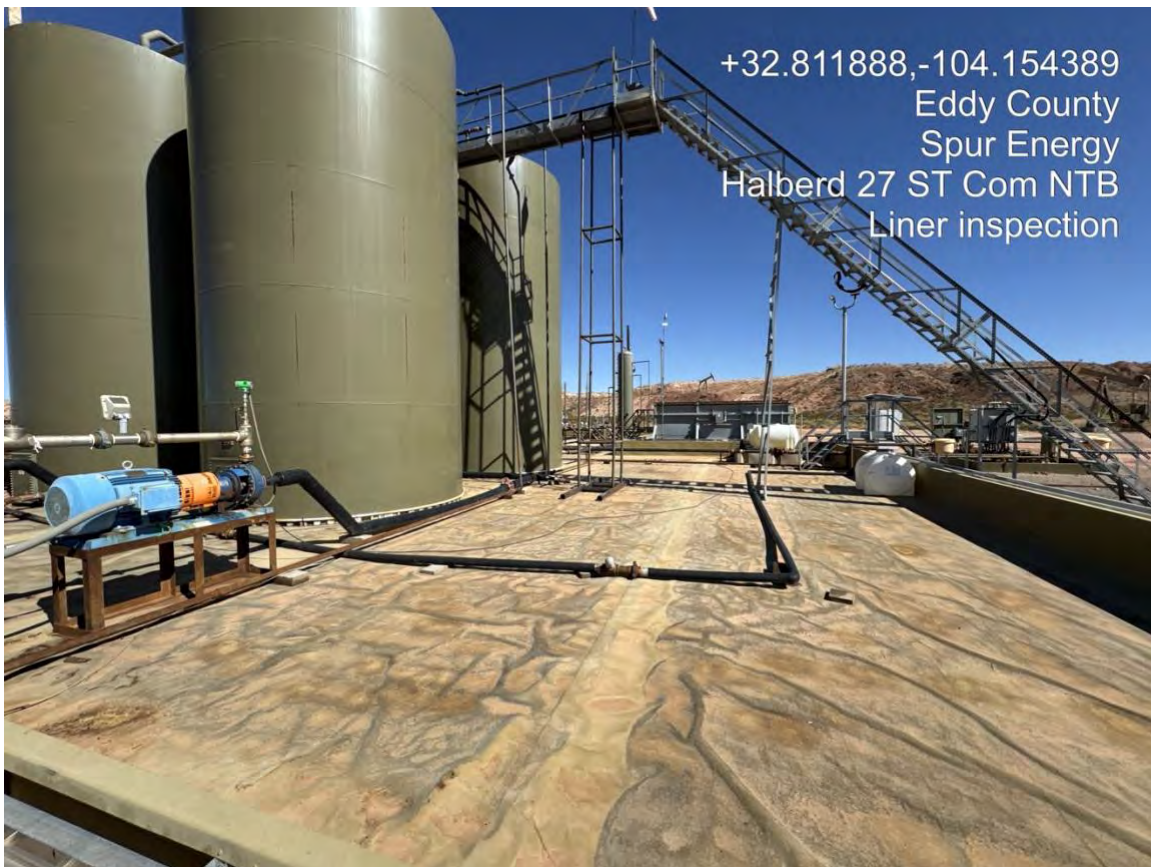
+32.811888,-104.154389
Eddy County
Spur Energy
Halberd 27 ST Com NTB
Liner inspection
