Re: Status Report – 1st Quarter 2026
Fifield 5 No. 1 (SE ¼, SW ¼, Sec. 5, T29N, R11W)
Hilcorp Energy Company
San Juan County, New Mexico
OCD Incident No. NVF1718155324

On behalf of Hilcorp Energy Company (Hilcorp), Timberwolf Environmental, LLC (Timberwolf) presents this report to document activities conducted during the 1st quarter of 2026 (1Q26) at the Fifield 5 No. 1 (Site). The Site is a plugged well site in northeast San Juan County, New Mexico (Figures 1 through 3). Coordinates for the Site: 36.749847° N / 108.019561° W.

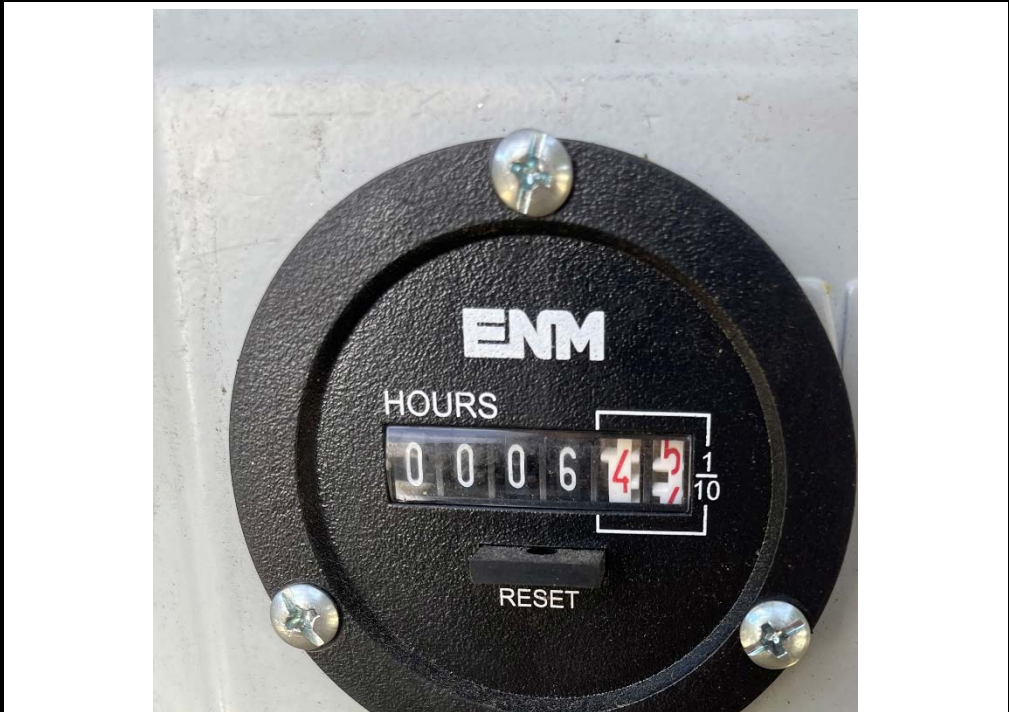
Photo No.:
5

Comments:
View of hour meter on 03/11/26. After installation

On 03/11/26, an hour meter dedicated to the new electric-driven vacuum pump was installed; the original hour meter was abandoned. Total runtime was calculated using both hour meters alongside Cygnet telemetry data. Photographs of relevant meter readings are documented in the attached Photographic Log.

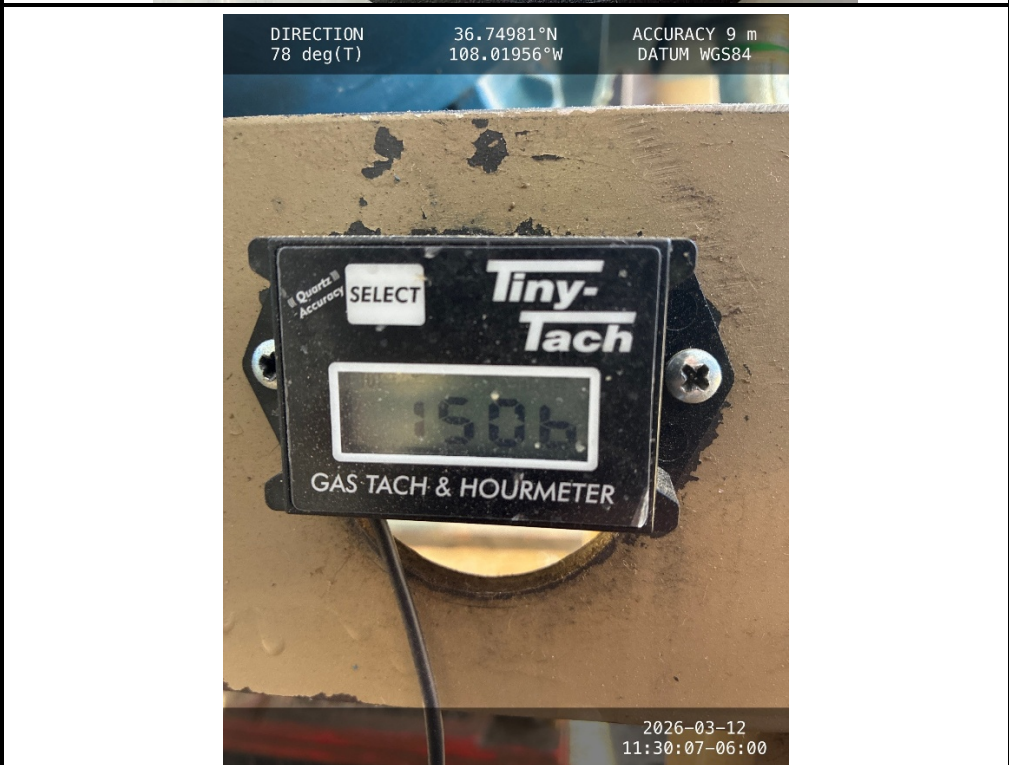
Photo No.:
6

Comments:
View of hour meter on 03/12/26. Before being changed for a new meter

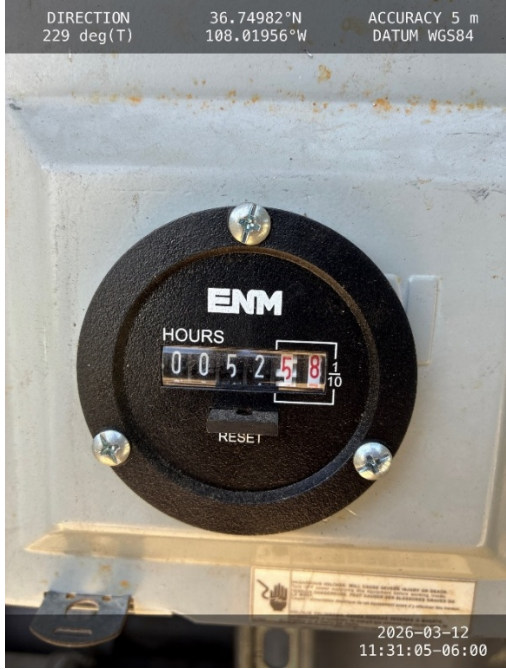
Project No.:	HEC-190009	Client:	Hilcorp Energy Company
Project Name:	Fifield 5 No. 1	Site Location:	San Juan County, New Mexico
Task Description:	Status Report – 1st Quarter 2026	Date:	January – March, 2026
Photo No.: 7

<p>DIRECTION 229 deg(T) 36.74982°N ACCURACY 5 m 108.01956°W DATUM WGS84</p> <p>2026-03-12 11:31:05-06:00</p>		
Direction: N/A			
Comments: View of hour meter on 03/12/26. After new meter installed			
Photo No.: 8

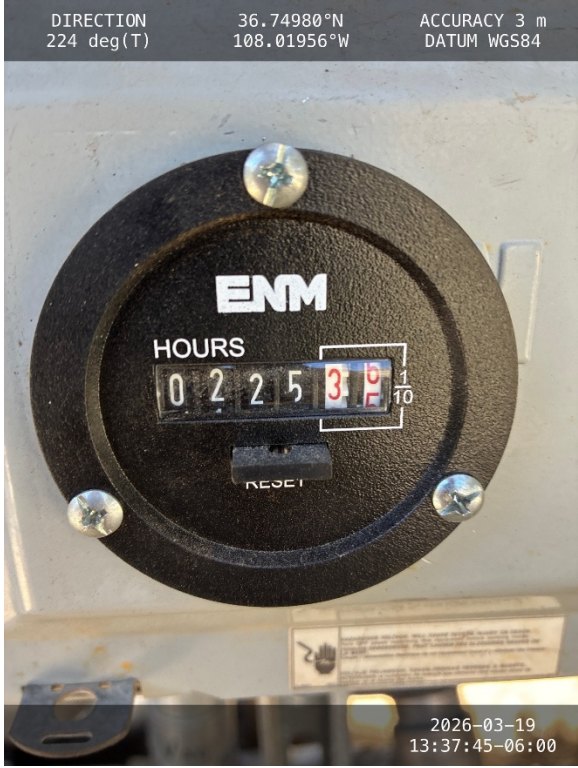
<p>DIRECTION 224 deg(T) 36.74980°N ACCURACY 3 m 108.01956°W DATUM WGS84</p> <p>2026-03-19 13:37:45-06:00</p>		
Direction: N/A			
Comments: View of hour meter on 03/19/26.
