Site Characterization and Liner Inspection Report
FEDERAL 12-01 BATTERY
nAPP2602753511
32.400321, -103.7381
M-12-22S-31E

Introduction

Liner Inspection Activities

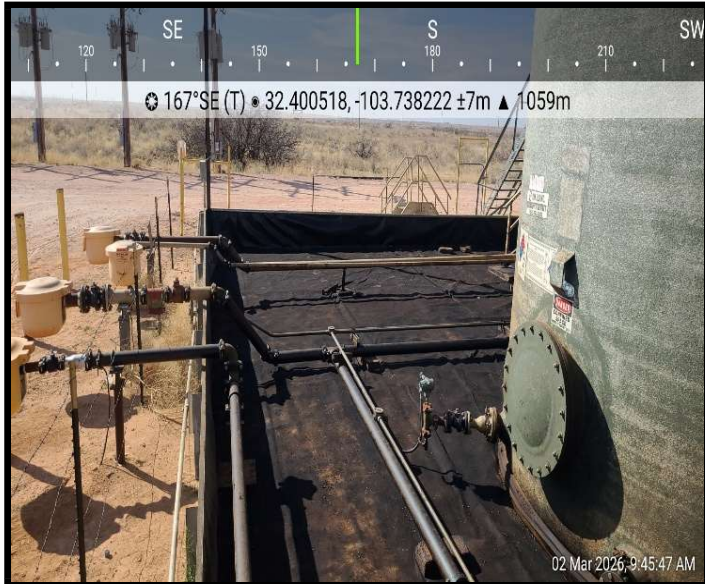
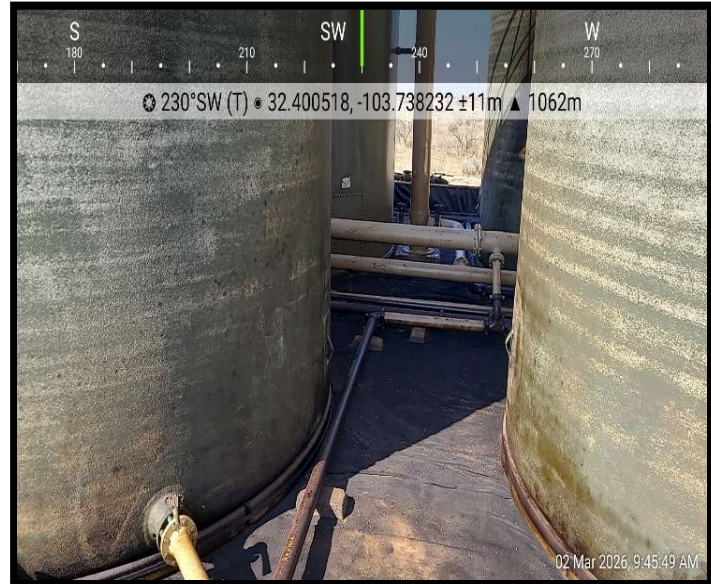
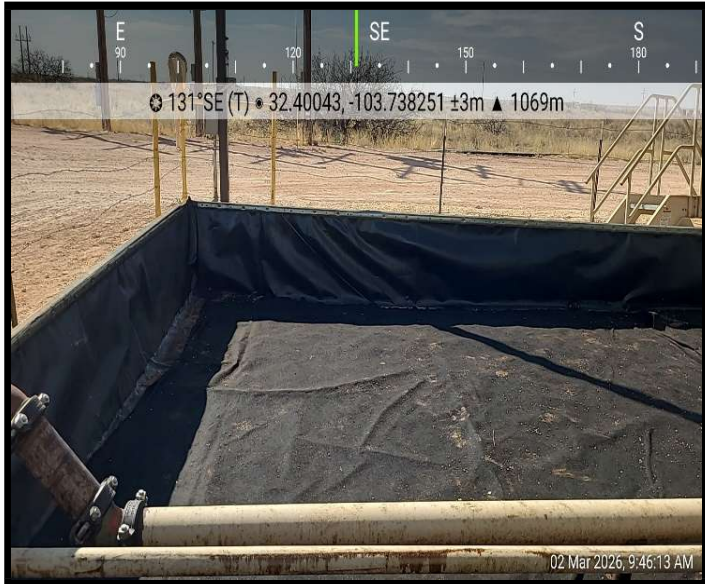
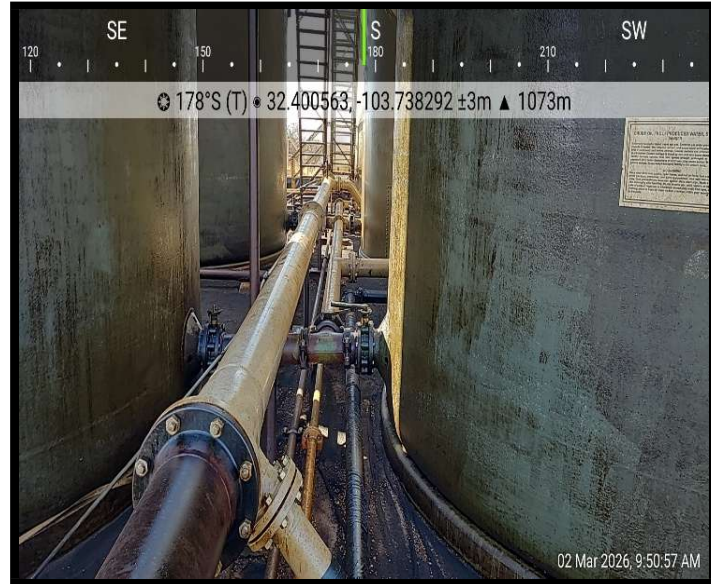
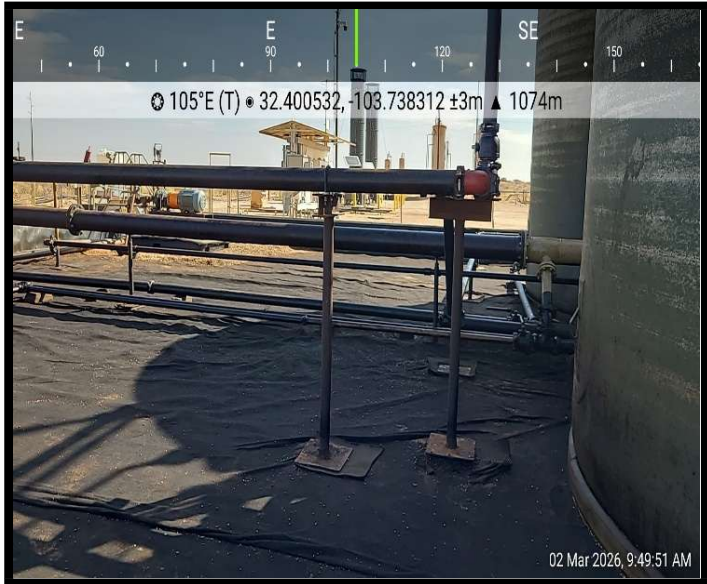
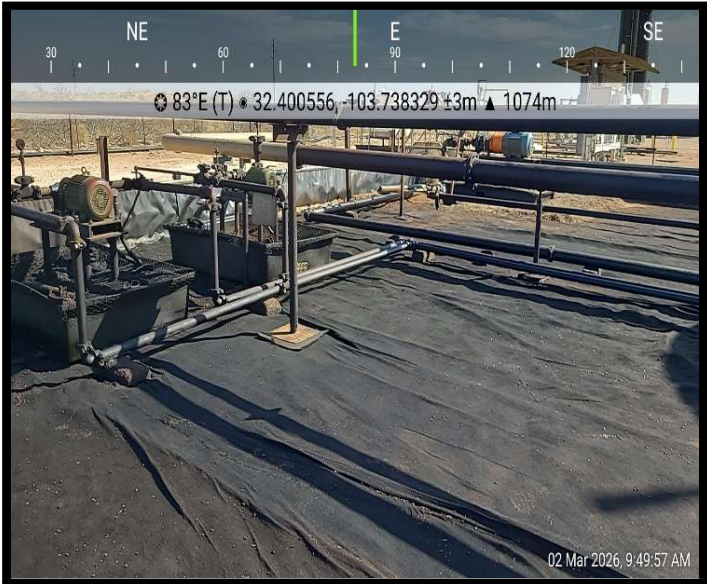
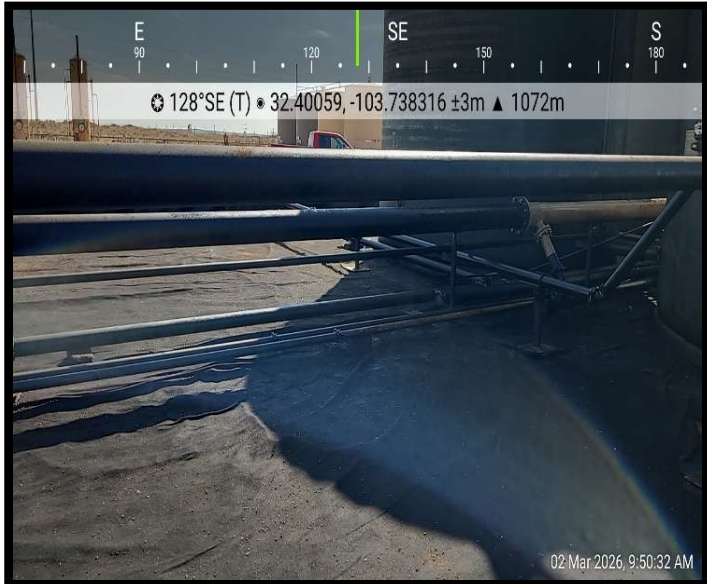
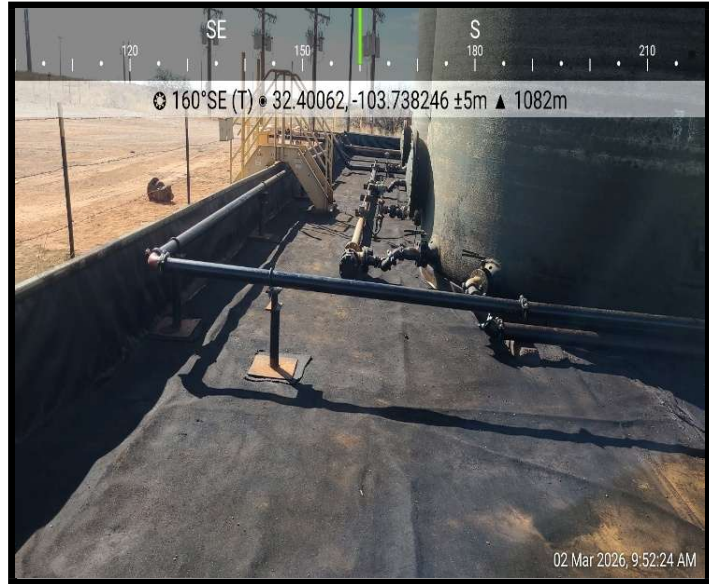
After the liner was cleaned on March 2, 2026, Standard performed a liner inspection. The liner was free of any standing fluid. The liner integrity was intact with no breaches or holes discovered during the inspection. The plastic liner within the secondary containment utilizes a black felt layer laid on top as a traction mat. Photographs taken during the liner inspection can be found under Attachment C: Photographic Log.

View of Secondary Containment
