RECLAMATION CLOSURE REPORT

PREPARED FOR:
DEVON ENERGY PRODUCTION, LP.

PREPARED BY:
PIMA ENVIRONMENTAL SERVICES, LLC.

RE: Reclamation Closure Report
LOCATION: Cotton Draw Unit #605H
WELL API #: 30-015-47297
GPS (NAD 83): 32.1953226, -103.751473
INCIDENT LOCATION: C-26-T24S-R31E
COUNTY: Eddy
NMOCD REF. NO: nAPP2311446508

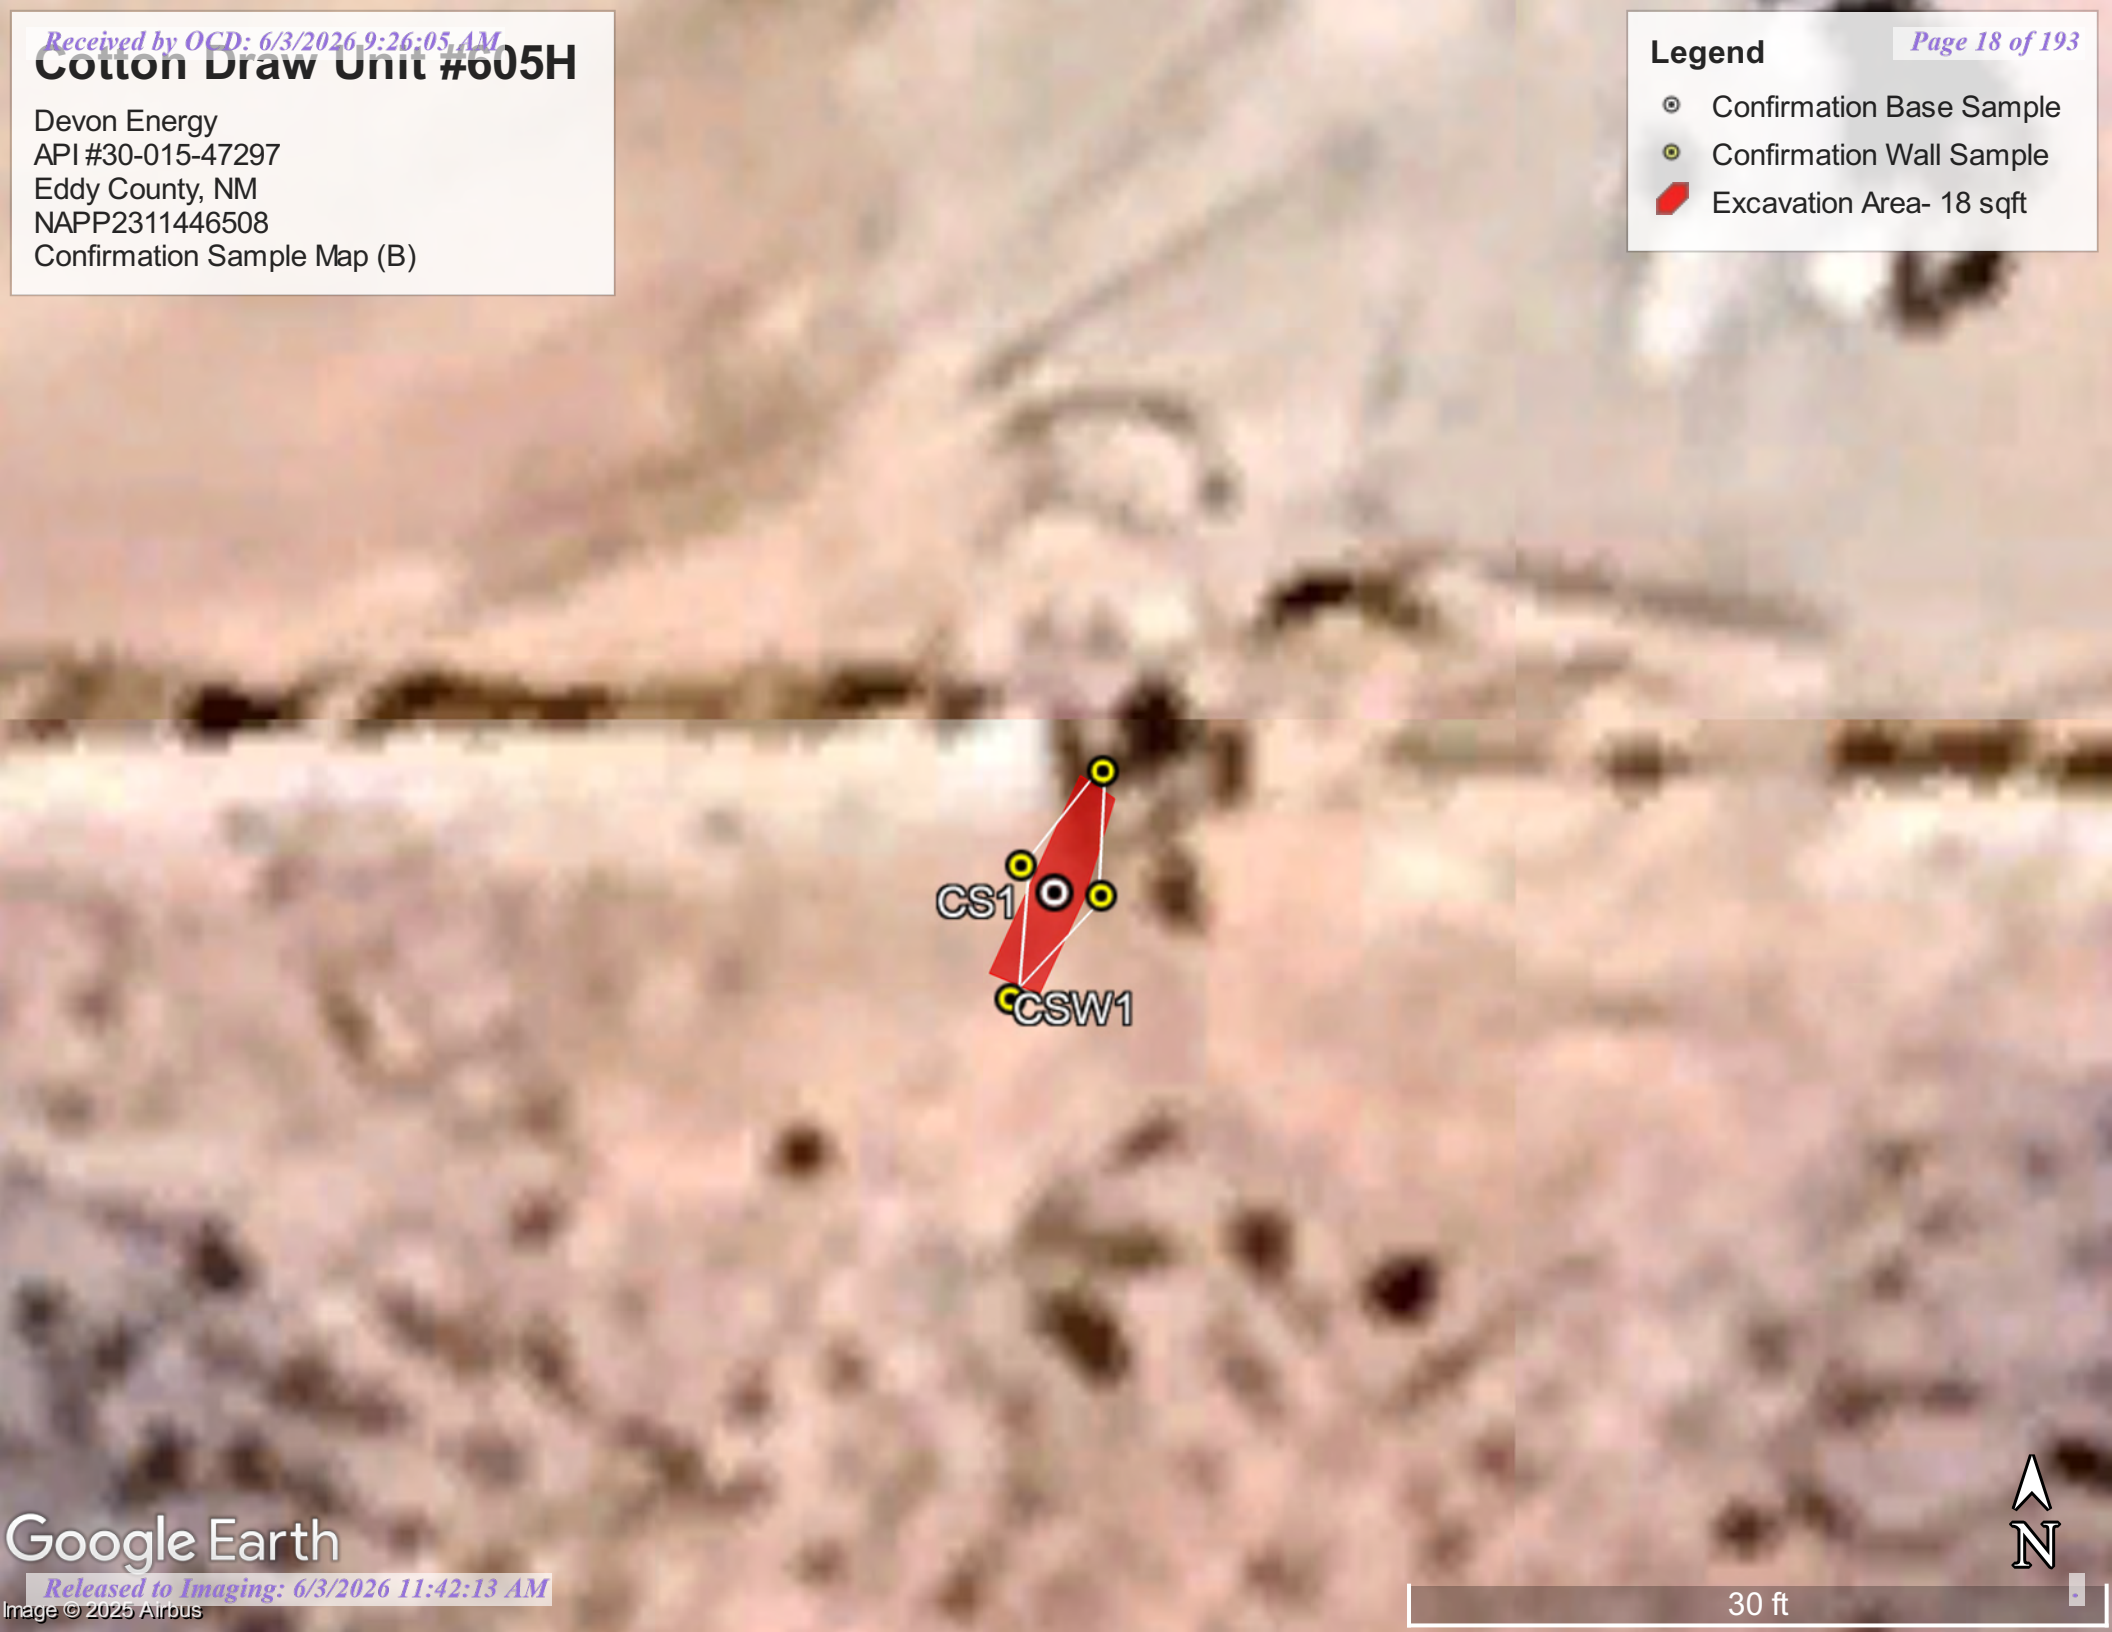
- Confirmation Base Sample
- Confirmation Wall Sample
- Excavation Area- 18 sqft

This incident was remediated to reclamation standards ensuring 4' feet of soil in this area includes non-waste containing, earthen material with chloride levels that are less than 600 mg/kg and TPH concentrations less than 100 mg/kg per 19.15.29.13 NMAC Pima Environmental returned to the site on April 24, 2026, to collect two 5-point composite backfill samples from the area that was previously excavated and backfilled with clean material. The results of this sampling event can be found in Figure 4. A complete Laboratory Report can be found in Appendix E.

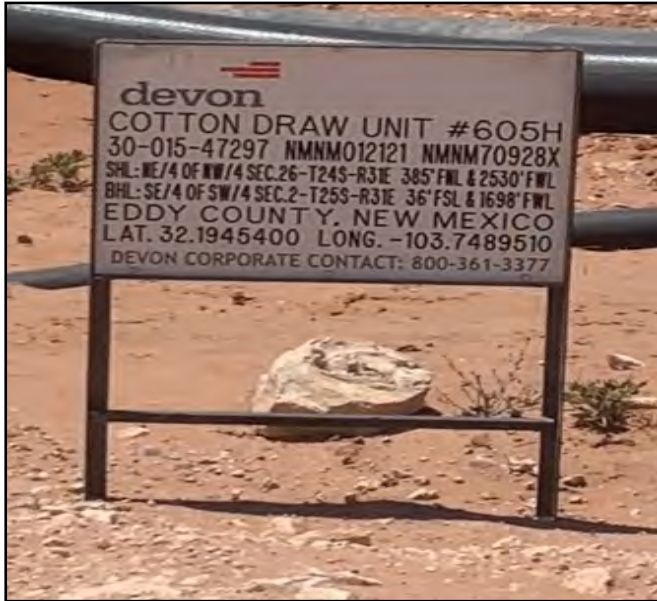
Site Information Sign.

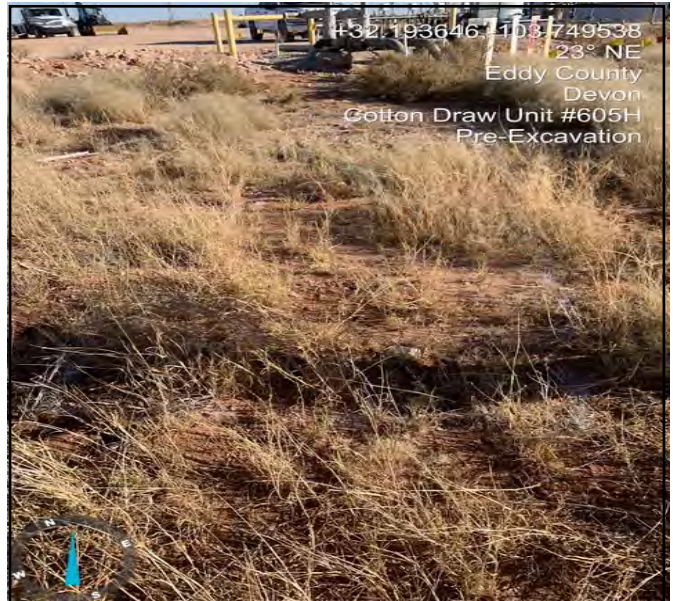
Photograph taken pre-excavation process facing northeast.

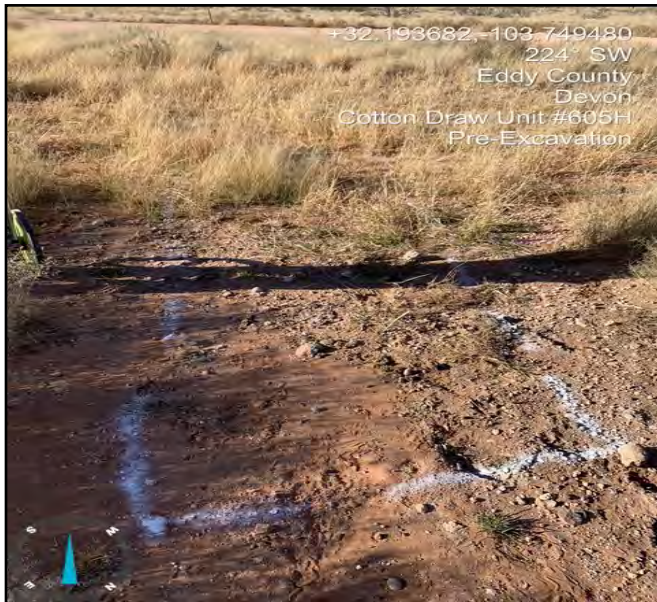
Photograph taken pre-excavation process facing southwest.

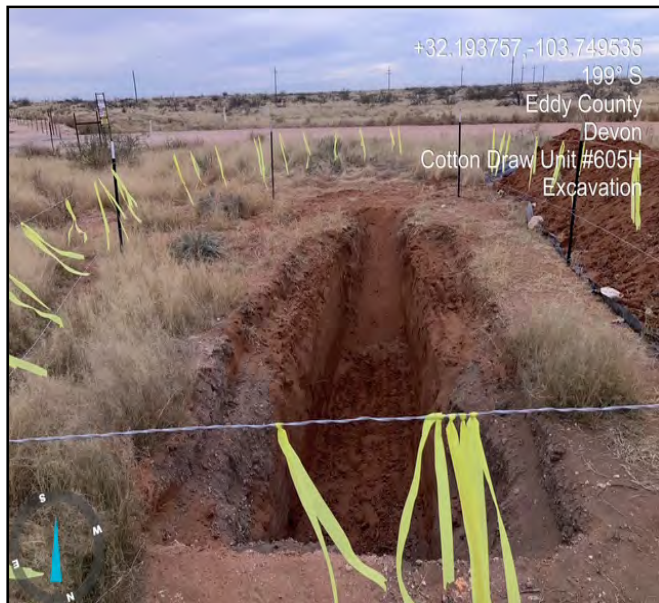
Photo taken during excavation process facing south.

1/24/2025 – The sample point S2 was excavated to a depth of 2.5' bgs, removing the previously found contamination. The S1 sample point was resampled at 1' increments to 4' bgs to ensure the TPH contaminants have been removed (as per the conditionally approved remediation work plan).

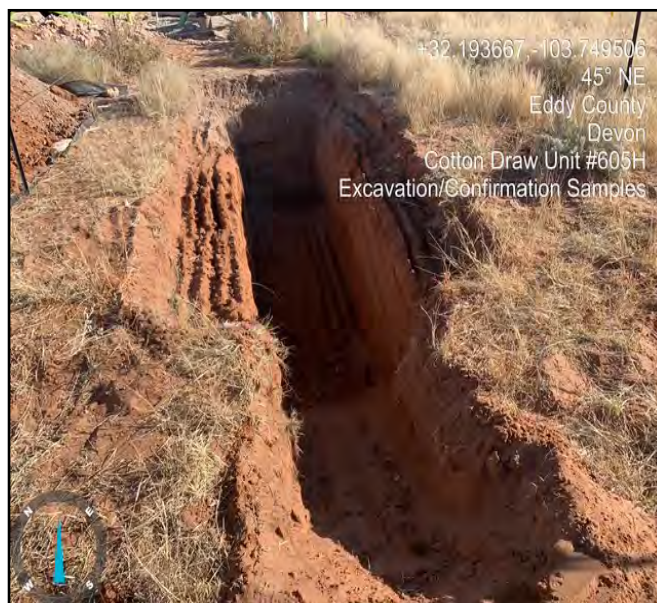
Photo taken during excavation process facing northeast.

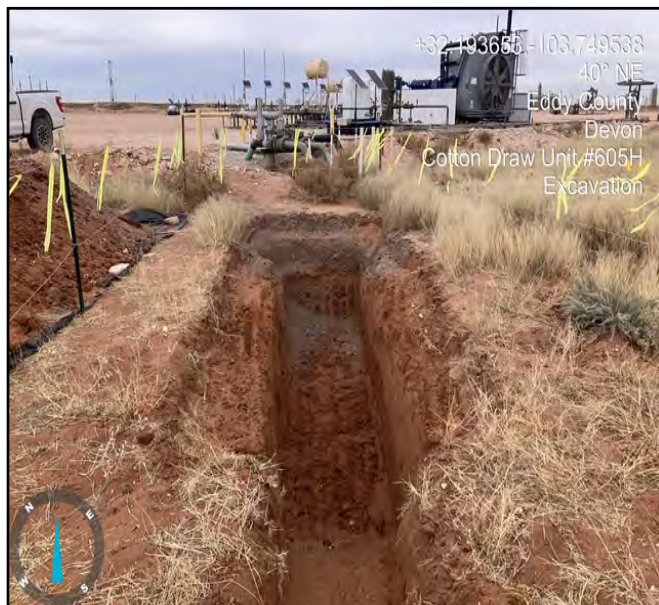
Photo taken during excavation process facing northeast.

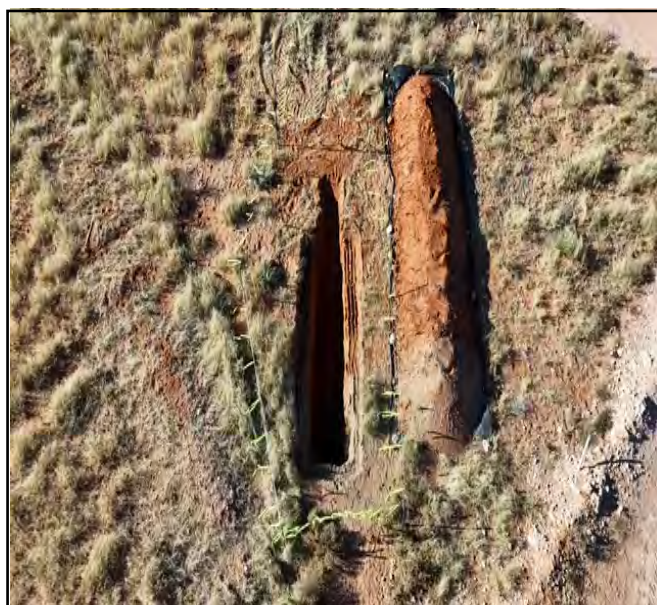
Photo taken during excavation process.

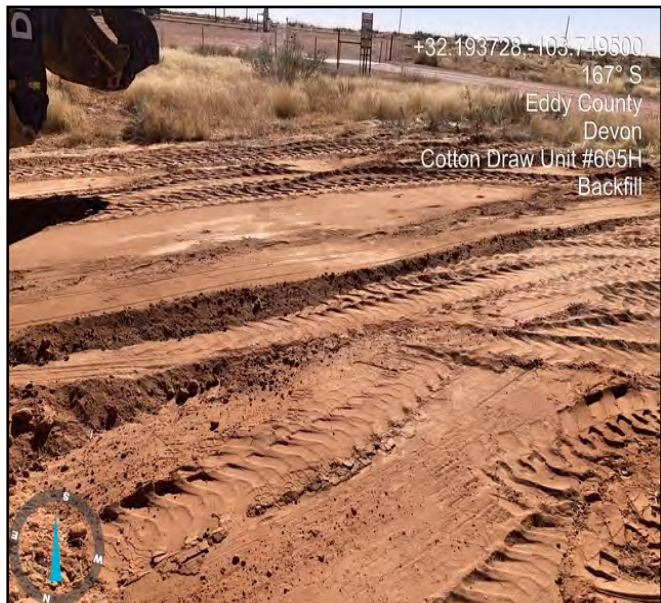
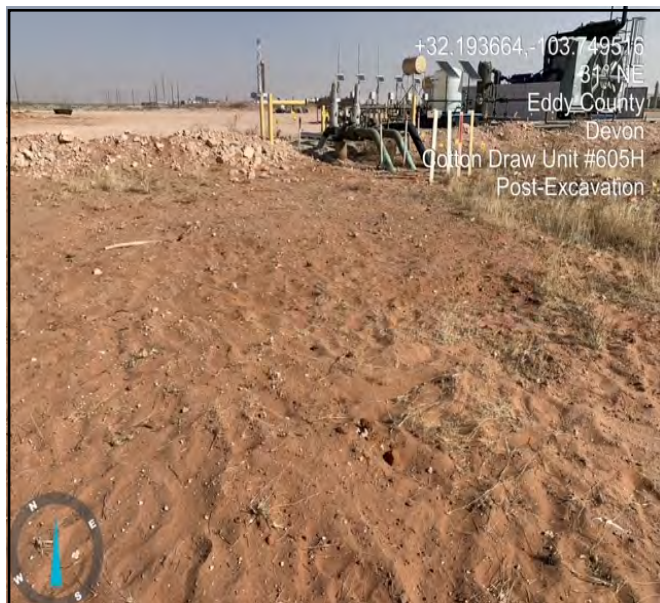
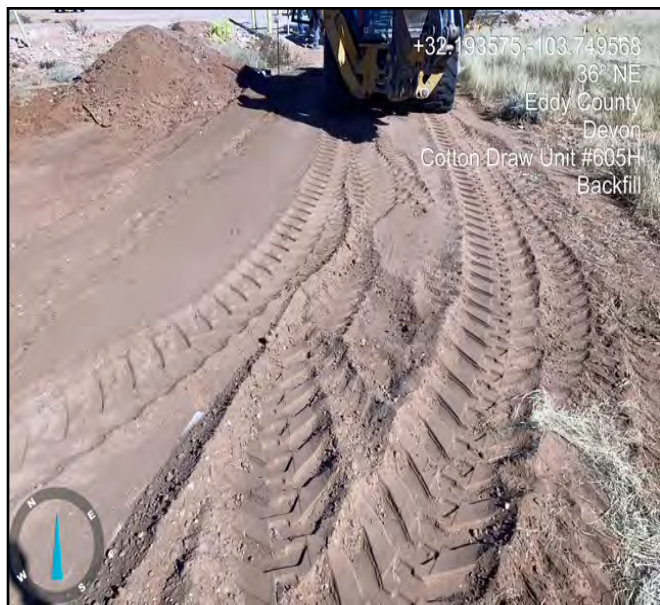
Photo taken post backfill.
