**Re: Closure Request
Remuda 100 Battery
Incident Number nAPP2600549577
Eddy County, New Mexico**

XTO Energy, Inc
Closure Request
Remuda 100 Battery

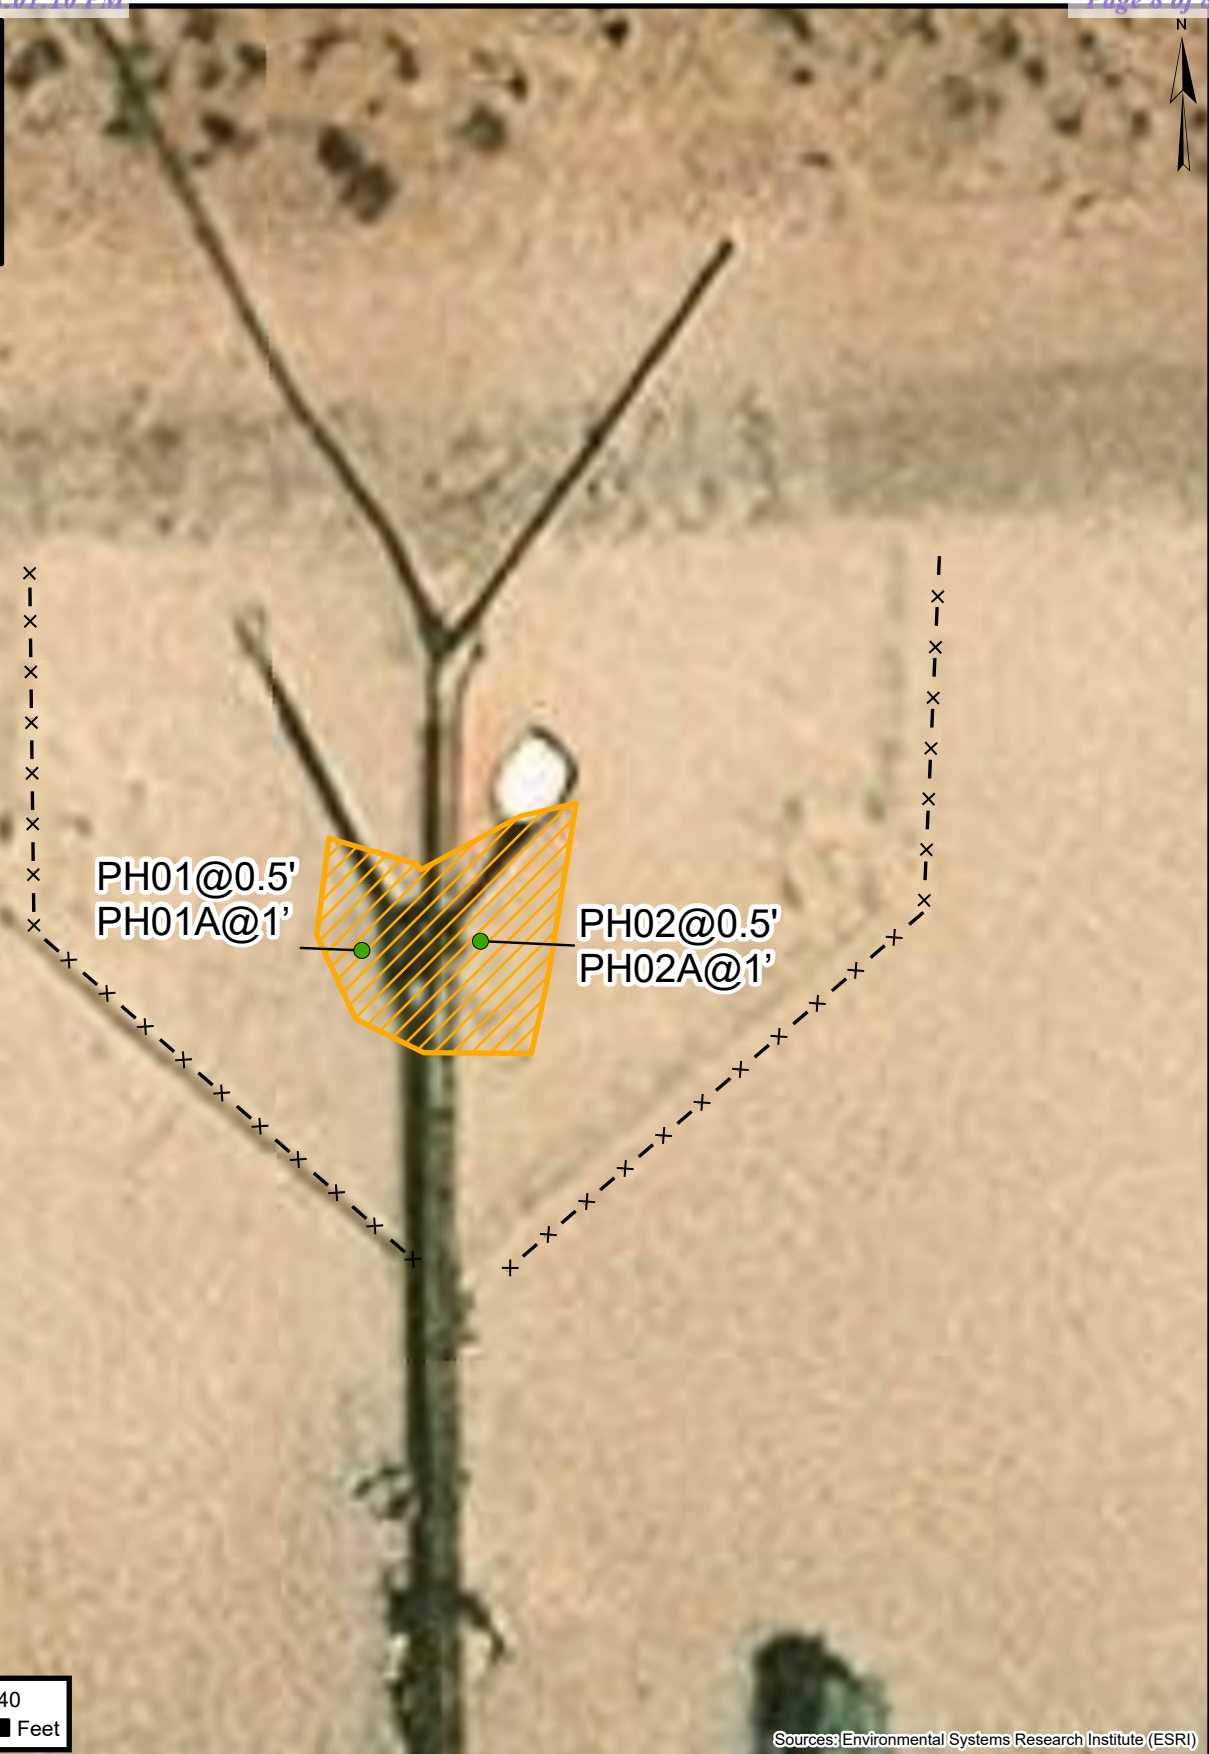
FIGURE
2

Delineation Soil Sample Locations

Between January 21, 2026 and April 16, 2026, Ensolum personnel oversaw delineation and remediation activities at the Site. Two potholes (PH01 and PH02) were advanced to a terminal depth of 1-foot bgs, with discrete samples collected at 0.5 feet and 1-foot bgs. The surficial staining and scorching identified on the pad surface was scraped by heavy equipment, and two areas within the scraped extent were excavated to a depth of 1-foot bgs. Following remediation activities, four 5-point composite soil samples (CS01, CS02A, CS03, and CS04A) were collected from the final excavation extents at depths ranging from 0.25 feet to 1-foot bgs at a frequency no greater than 200 square feet. One sidewall sample (SW01) was taken from the edges of the scraped extent area, from depths ranging from ground surface to 0.5 feet bgs. Two soil samples (SW02 and SW03) were taken along the sidewalls of the excavated areas from ground surface to a depth 1-foot bgs. The 5-point composite samples were collected by placing five equivalent aliquots of soil into a 1-gallon, resealable plastic bag and homogenizing the samples by thoroughly mixing. The delineation and confirmation soil samples were field screened for volatile organic compounds (VOCs) utilizing a calibrated photoionization detector (PID) and chloride using Hach® chloride QuanTab® test strips.

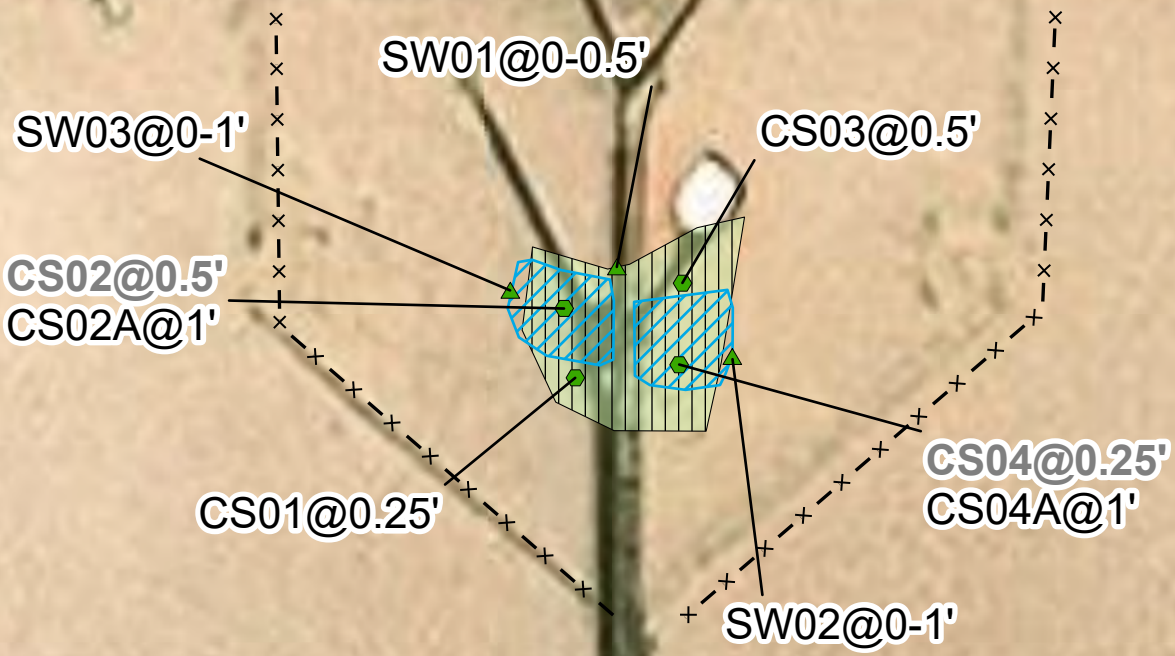
FIGURE

Confirmation Soil Sample Location

Laboratory analytical results for all delineation soil samples collected indicated all COC concentrations were compliant with Closure Criteria. Laboratory analytical results for CS02 and CS04, at 0.5 and 0.25 feet bgs respectively, indicated elevated chloride concentrations that exceeded the Closure Criteria. Both sampling areas were over-excavated during the April 16, 2026, excavation activities. Sidewall confirmation samples SW01 through SW03 collected at depths ranging from ground surface to 1-foot bgs indicated all COC concentrations were compliant with Closure Criteria. All other final confirmation soil samples reported all COC concentrations compliant with Closure Criteria. Laboratory analytical results are summarized in Table 1, and the complete laboratory analytical reports are included as Appendix D.

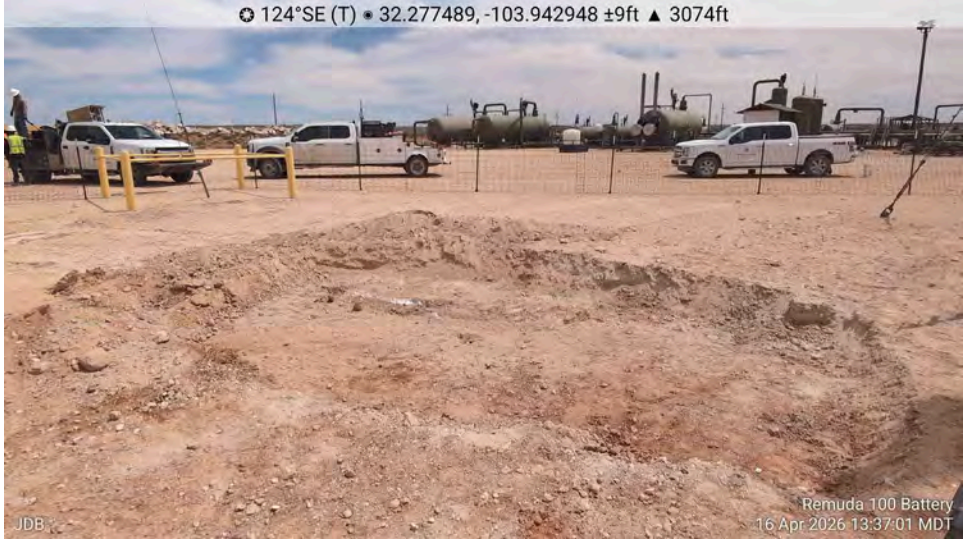
<p><u>Photograph</u> 9</p>	<p><u>Date</u> 04/16/2026</p>

<p><u>Description</u> Excavation activities, CS04A</p>		
<p><u>View</u> Southeast</p>		
<p><u>Photograph</u> 10</p>	<p><u>Date</u> 04/16/2026</p>

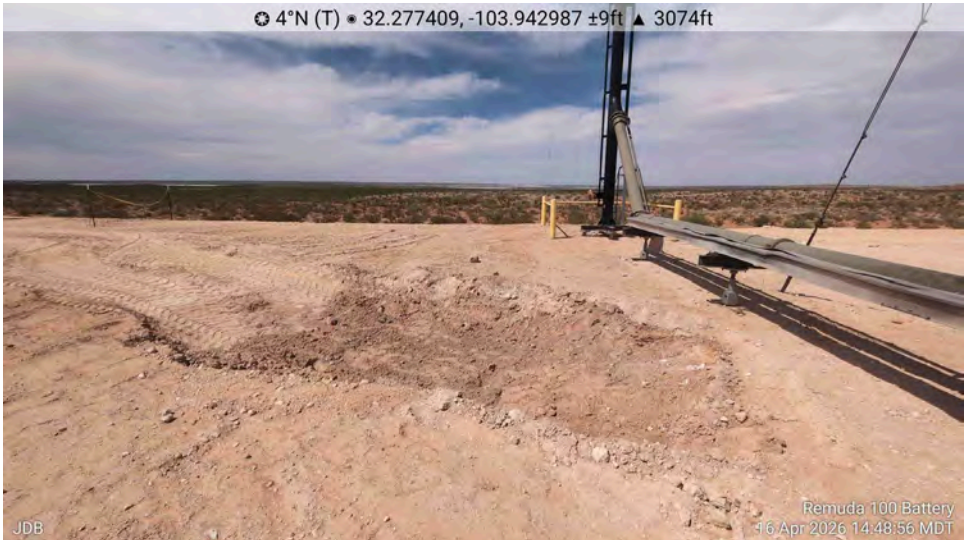
<p><u>Description</u> Excavation activities, CS02A</p>		
<p><u>View</u> North</p>

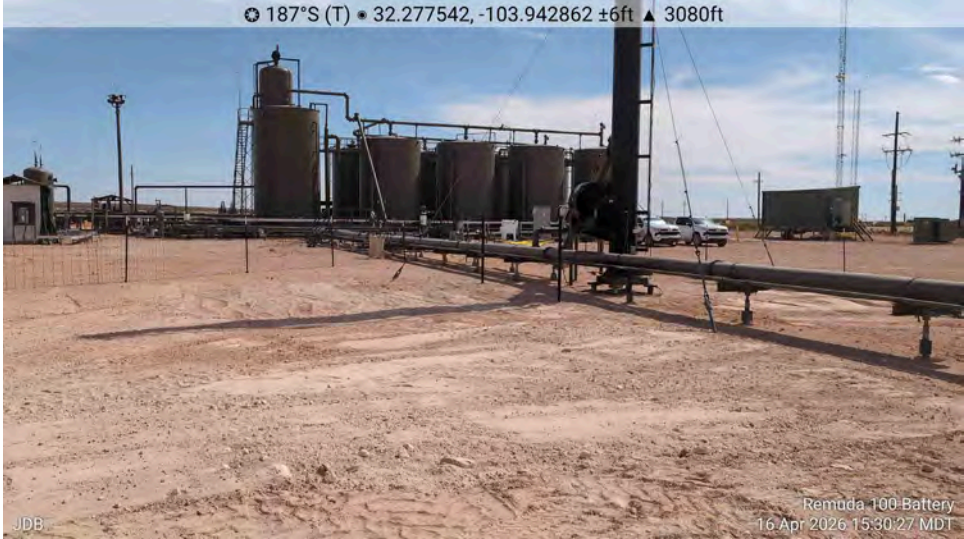
<p><u>Photograph</u> 11</p>	<p><u>Date</u> 04/16/2026</p>

<p><u>Description</u> Backfilled excavation, CS04A</p>		
<p><u>View</u> South</p>		
<p><u>Photograph</u> 12</p>	<p><u>Date</u> 04/16/2026</p>

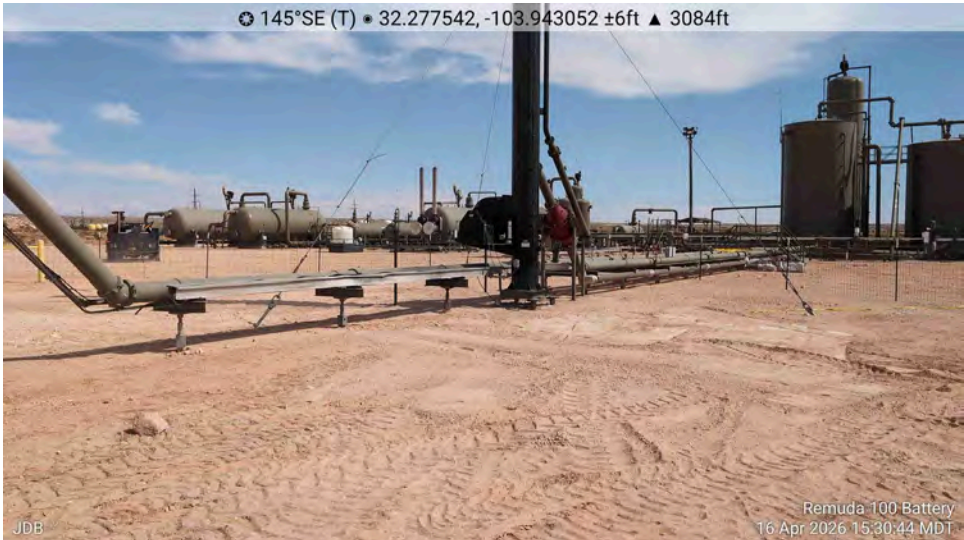
<p><u>Description</u> Backfilled excavation, CS02A</p>		
<p><u>View</u> Southeast</p>
