Re: Closure Report
Sneaky Snake 24 CTB 1
Incident Number: nAPP2606123234 & nAPP2609130005
Lea County, New Mexico

Devon Energy Production Company, LP
Sneaky Snake 24 CTB 1
nAPP2606123234 and nAPP2609130005
Closure Report

Field Inspection Photo Log | Sneaky Snake 24 CTB 1

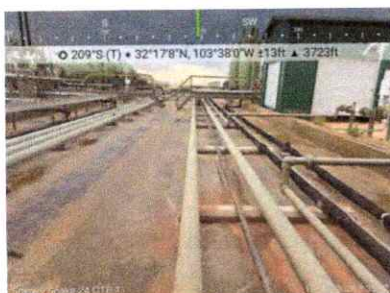
Secondary containment — berm top, SSW view

Berm top looking SSW with multiple process pipe runs. Berm surface wet from rainfall during inspection. No observations of brine staining or standing fluid attributable to a release. Containment wall intact.

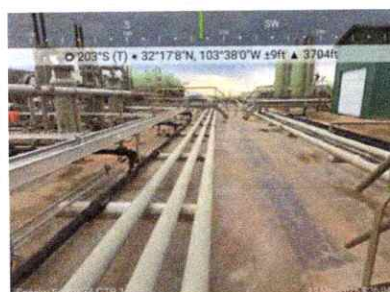
Secondary containment — berm top, south view

South view down berm top with pipe runs and pipe rack crossing. Berm surface wet from rainfall. No observations of release. Containment wall intact.

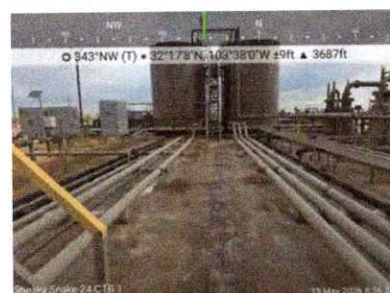
Secondary containment — berm top, NW view toward storage tanks

Looking NW toward storage tanks. Multiple pipe runs on berm surface. Berm wet from rainfall. No staining or release observations. Containment wall intact.

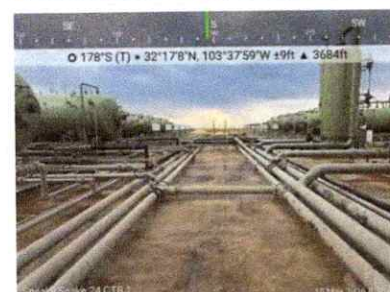
Secondary containment — manifold area, south view

Wide south view of manifold area with flanged pipe headers and gate valves at berm level. Berm surface wet from rainfall. No observations of release. Containment wall intact on both sides.

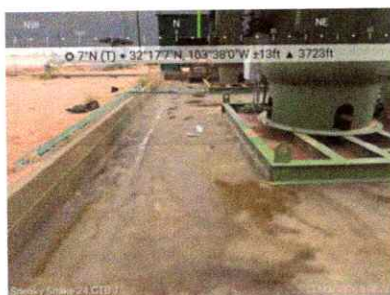
Secondary containment — berm walkway, north view
08:38:22 7°N 32°17'7"N 103°38'0"W

Berm walkway looking north beside large vessel base. Berm surface wet from rainfall. Loose black trash bag on exterior ground — housekeeping item. Containment wall intact.

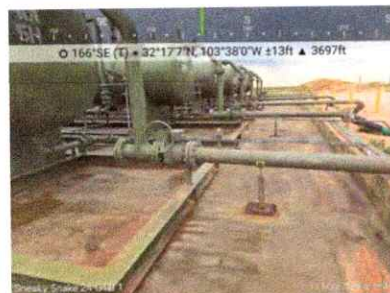
Secondary containment — berm surface, separator vessel row
08:38:46 166°SE 32°17'7"N 103°38'0"W

Separator vessel row (V103/2H) with gate valve and pipe headers. Berm surface wet from rainfall. Drain/vent stub with base plate present on berm surface. Containment wall intact. Exterior desert terrain visible and dry.

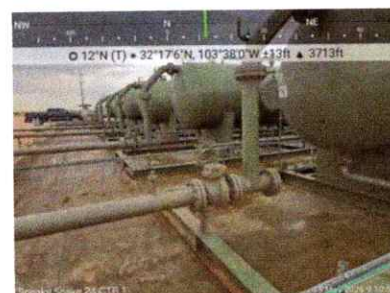
Secondary containment — north view, V117/302N
09:10:57 12°N 32°17'6"N 103°38'0"W

Looking north between separator vessels (V117/302N). Berm surface wet from rainfall. No observations of release or breach. Containment wall intact.

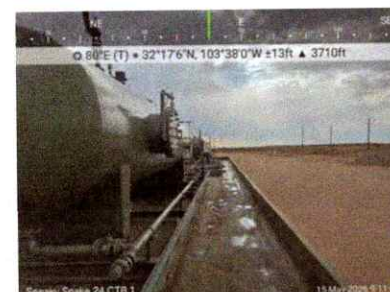
Secondary containment — east berm, long view
09:11:05 80°E 32°17'6"N 103°38'0"W

East-facing long view of berm. Berm surface wet from rainfall. Some prior salt/brine residue from operations also visible. Exterior sandy ground dry — no staining outside berm. Containment wall intact.

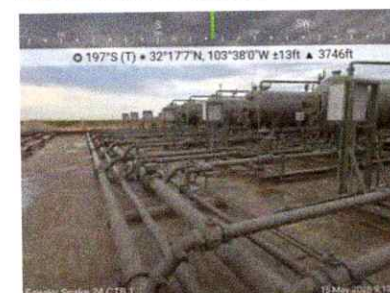
Secondary containment — manifold berm, south view
09:13:51 197°S 32°17'7"N 103°38'0"W

Dense pipe manifold with headers and flanged connections. Berm surface wet from rainfall. No observations of release. Containment wall intact.

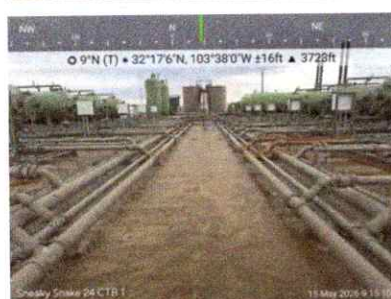
#39 Secondary containment — manifold berm center, north view
 09:15:10 9°N 32°17'6"N 103°38'0"W

Wide north view down manifold berm with pipe headers on both sides. Berm surface wet from rainfall. No observations of release. Containment wall intact along full observed length.

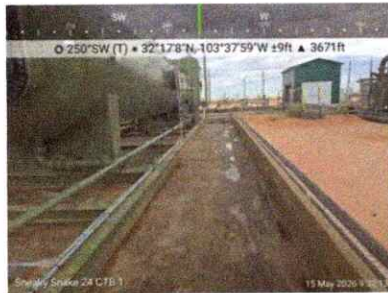
#44 Secondary containment — west berm edge, SW view

West-facing view along berm edge. Rainwater on berm surface. Exterior perimeter ground dry. No staining observed outside berm. Containment wall intact.

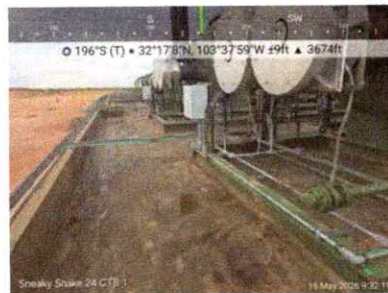
#45 Secondary containment — south berm edge, compressor skid

South berm edge at compressor/motor skid. Rainwater on berm surface. Loose black conduit draped across berm wall onto exterior ground — housekeeping item to address. Containment wall intact.
