## CLOSURE REQUEST

Yarrow BHY State Battery  
Incident Number nAPP2613240247  
Lea County, New Mexico  
Unit A, Section 32, T23S, R33E  
32.26573, -103.58902

**Re: Closure Request  
Yarrow BHY State Battery  
Incident Number nAPP2613240247  
Lea County, New Mexico**

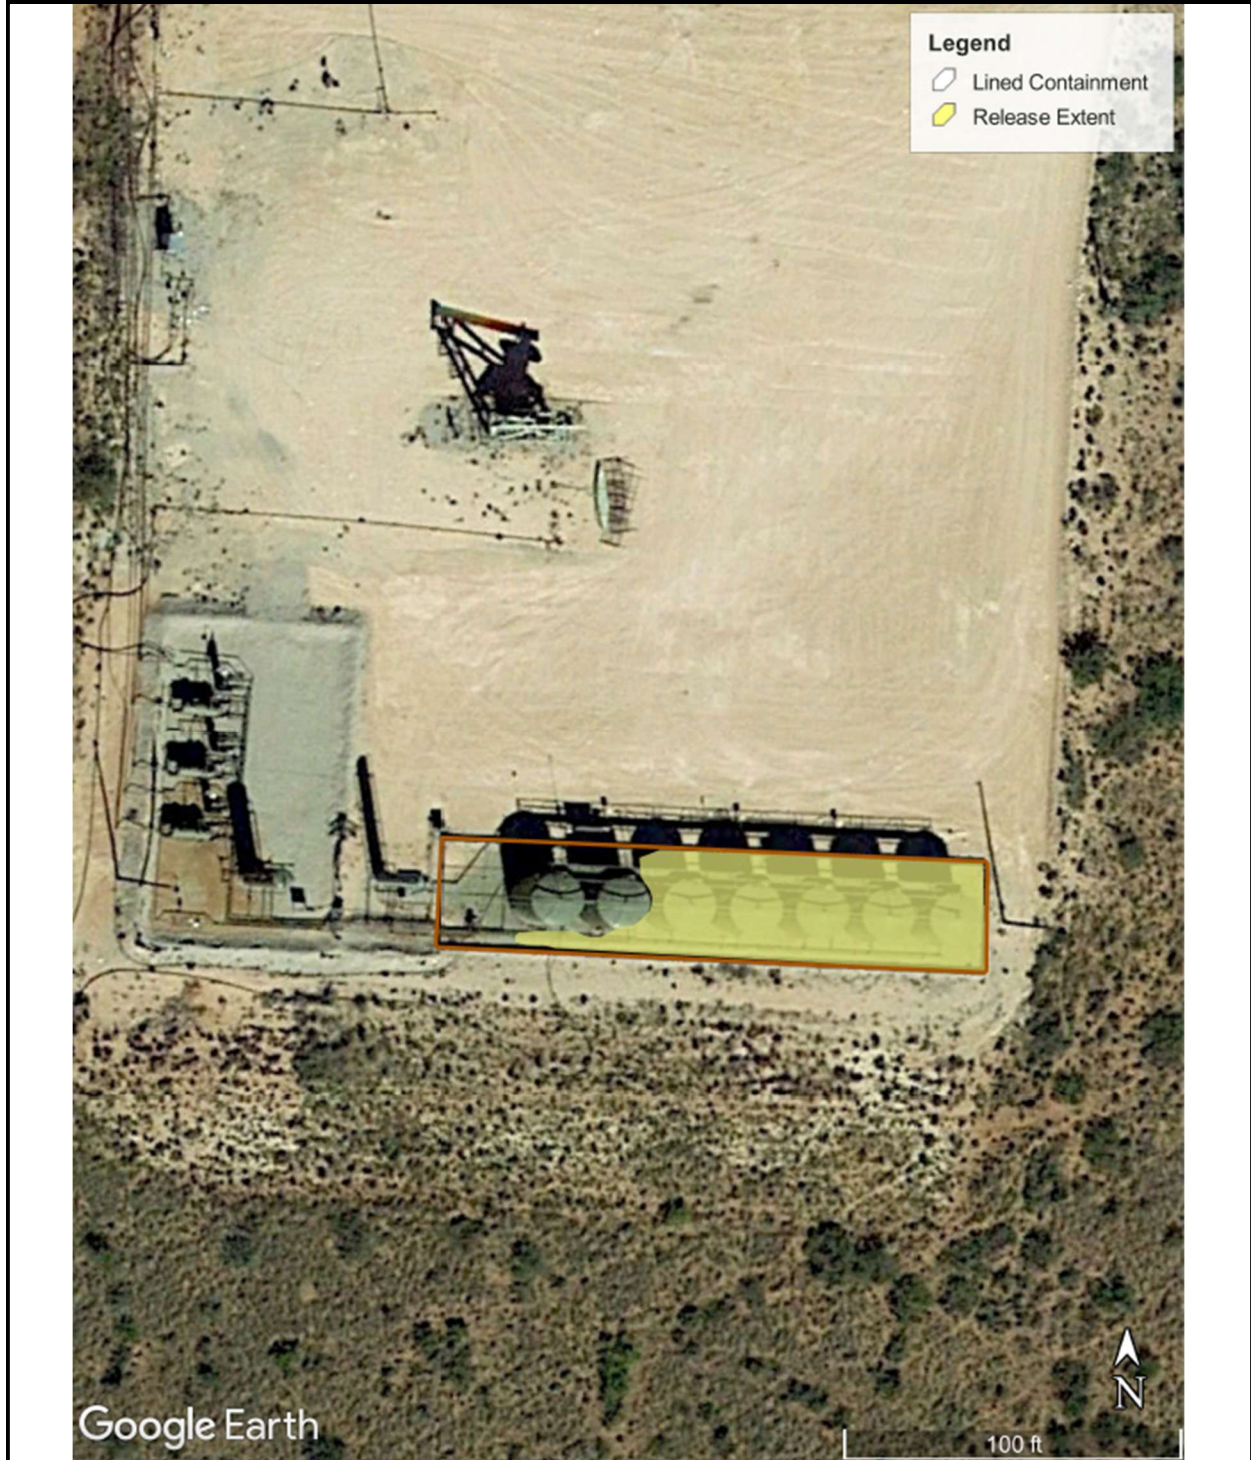
<p><b>Release Map</b> EOG Resources, Inc. Yarrow BHY State Battery Incident Number nAPP2613240247 Unit A, Section 32, T23S, R33E Lea County, New Mexico</p>	<p><b>FIGURE 3</b></p>
--	---	----------------------------

On May 11, 2026, corrosion of oil tank 3 resulted in the release of approximately 50 barrels (bbls) of crude oil into a lined containment. A vacuum truck was dispatched to the Site to recover free-standing fluids; approximately all 50 bbls of crude oil were recovered. The lined containment was power washed to remove any residual fluids. EOG reported the release to the New Mexico Oil Conservation Division (NMOCD) via a Notification of Release (NOR) on May 12, 2026, and subsequently on a Release Notification Form C-141 (C-141) on May 18, 2026. The release was assigned Incident Number nAPP2613240247.

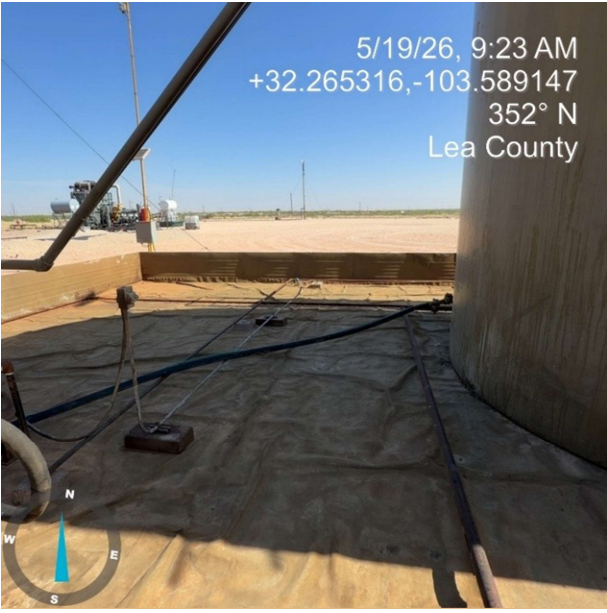
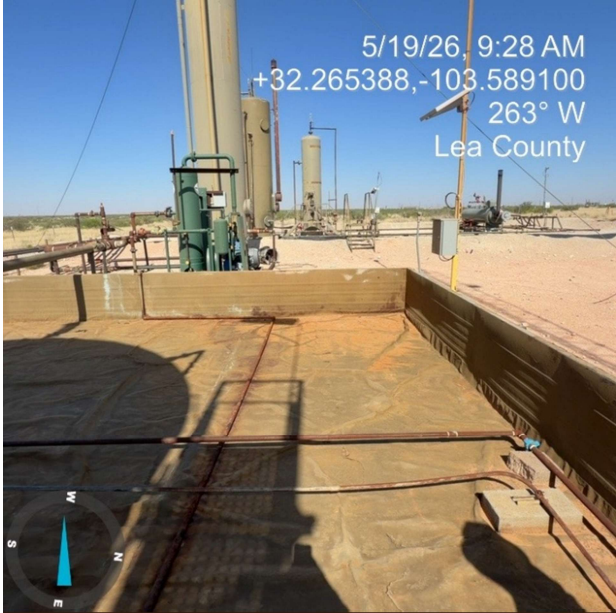
<p>5/19/26, 9:28 AM      +32.265388,-103.589100      263° W      Lea County</p>
<p>Photograph: 25      Date: 5/19/2026</p> <p>Description: Liner inspection activities</p>	<p>Photograph: 26      Date: 5/19/2026</p> <p>Description: Liner inspection activities</p>

A 48-hour advance notice of the liner inspection was submitted to the NMOCD on May 14, 2026. Prior to conducting the liner integrity inspection, EOG operations power washed the liner to remove dirt and debris and recover any residual produced water. A liner integrity inspection was conducted by EOG personnel on May 19, 2026. Upon inspection, no rips, tears, holes, or damage was observed. The liner was determined to be sufficient to contain fluids, and all released fluids have been removed. Photographic documentation of the inspection is included in Appendix B.

Liner integrity inspection activities were conducted following a release of crude oil within a lined containment at the Site. A liner integrity inspection was conducted by EOG personnel on May 19, 2026. Upon inspection, no rips, tears, holes, or damage were observed, and the liner was determined to be sufficient to contain fluids. The release was contained laterally by the lined containment, and the liner was performing as designed. Based on initial response efforts and the liner operating as designed, EOG respectfully requests closure for Incident Number nAPP2613240247.
