CIMAREX ENERGY
PALMILLO STATE COM 2
EDDY, NM

Liner Integrity Certification

Prerequisites	
Incident ID (n#)	nAPP2517874248
Incident Name	NAPP2517874248 PALMILLO STATE COM 2 @ FAPP2202644234
Incident Type	Oil Release
Incident Status	Initial C-141 Approved
Incident Facility	[fAPP2202644234] PALMILLO STATE COM 2

Operator: Coterra Energy Operating Co. 6001 Deauville Blvd Midland, TX 79706	OGRID: 215099
	Action Number: 588204
	Action Type: [C-141] Remediation Closure Request C-141 (C-141-v-Closure)

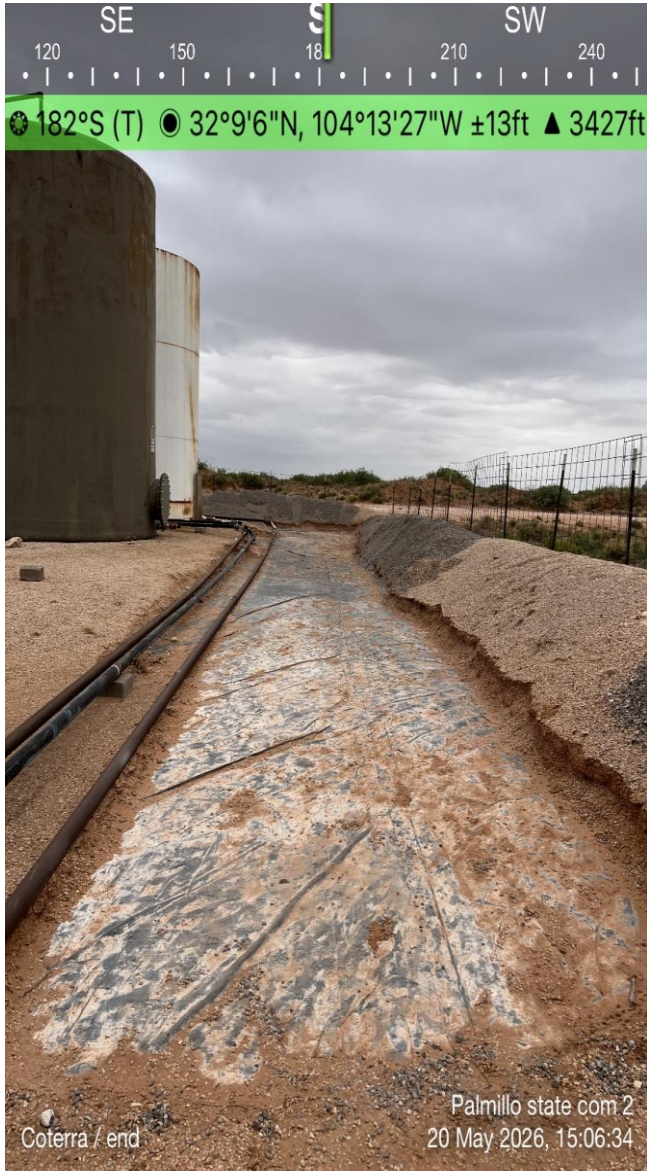
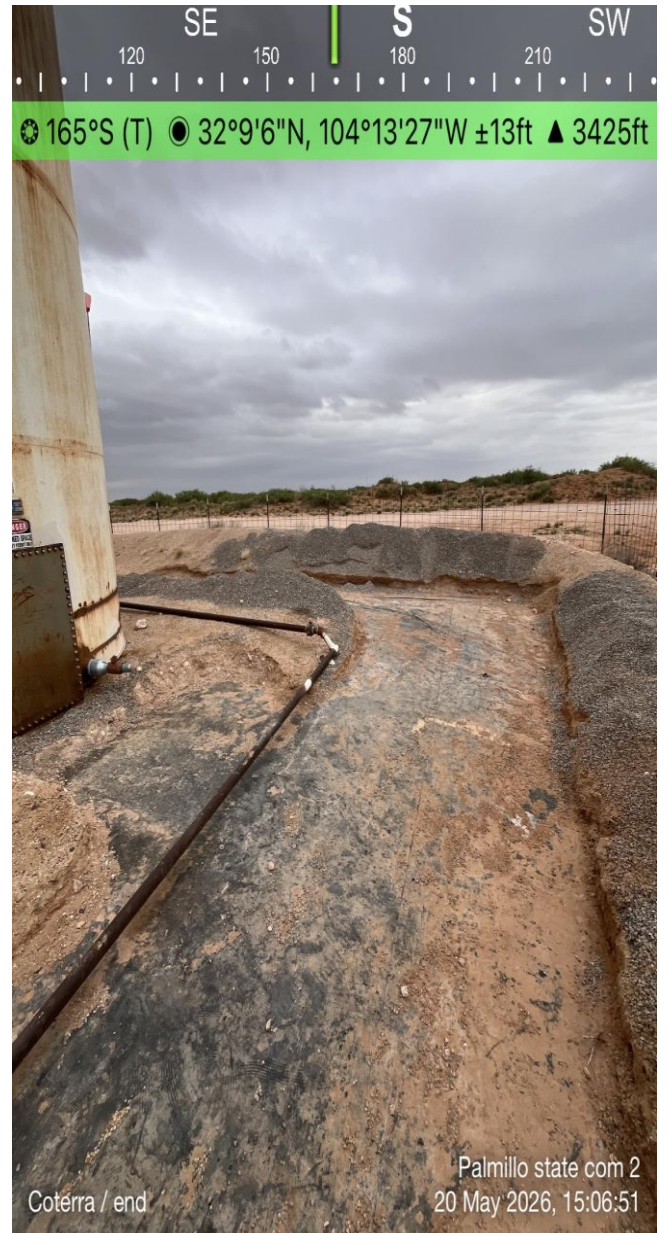
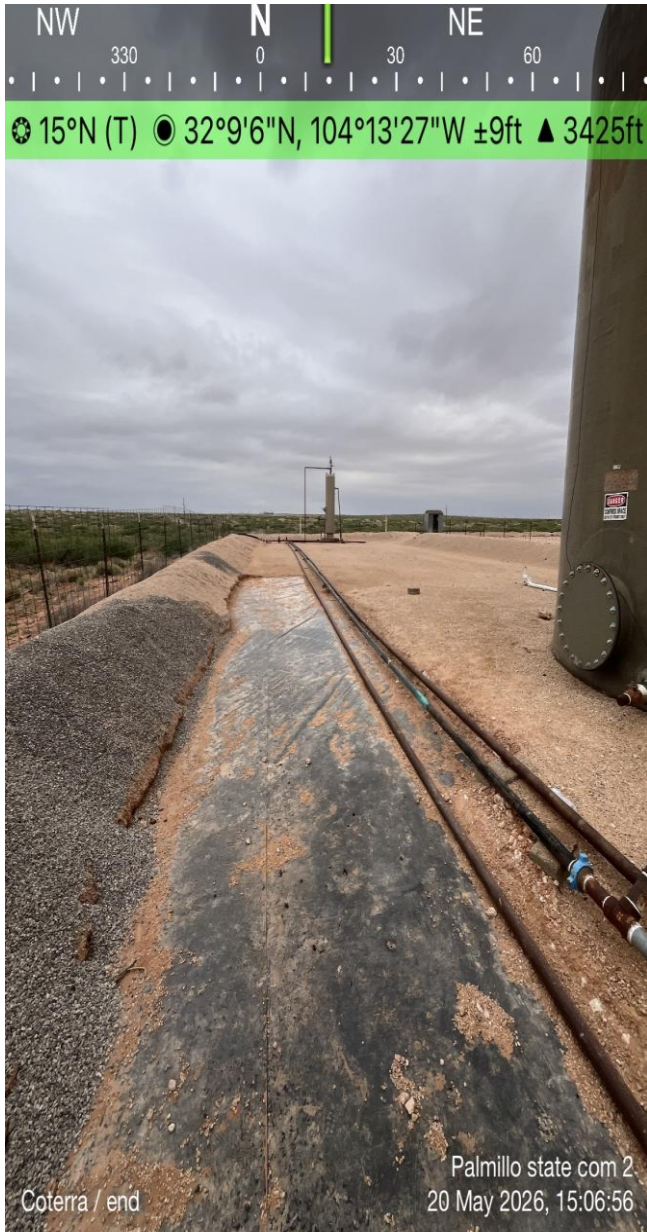
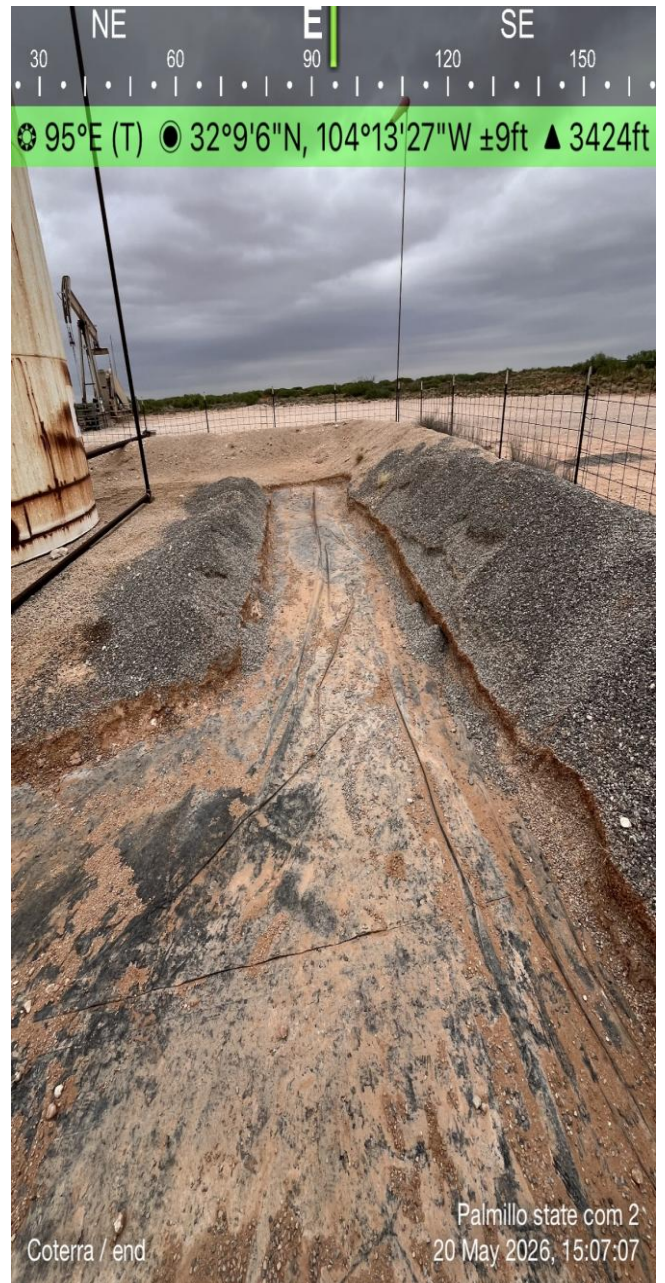
- Responsible Party has visually inspected the liner.
- Liner remains intact and was able to contain the leak in question.
- At least two business days' notice was given to the appropriate division district office before conducting the liner inspection.
- Photographs illustrating liner integrity are included.
