SUBJECT: Site Assessment Report for the Ojo Chiso SWD #001 Release
nAPP2603737153 GRAMA RIDGE DISPOSAL, LLC @ 30-025-24459 Lea County, New Mexico

Ojo Chiso SWD #001 Liner inspection nAPP2603737153
March 25, 2026

Liner Inspection Photos **nAPP2603737153**

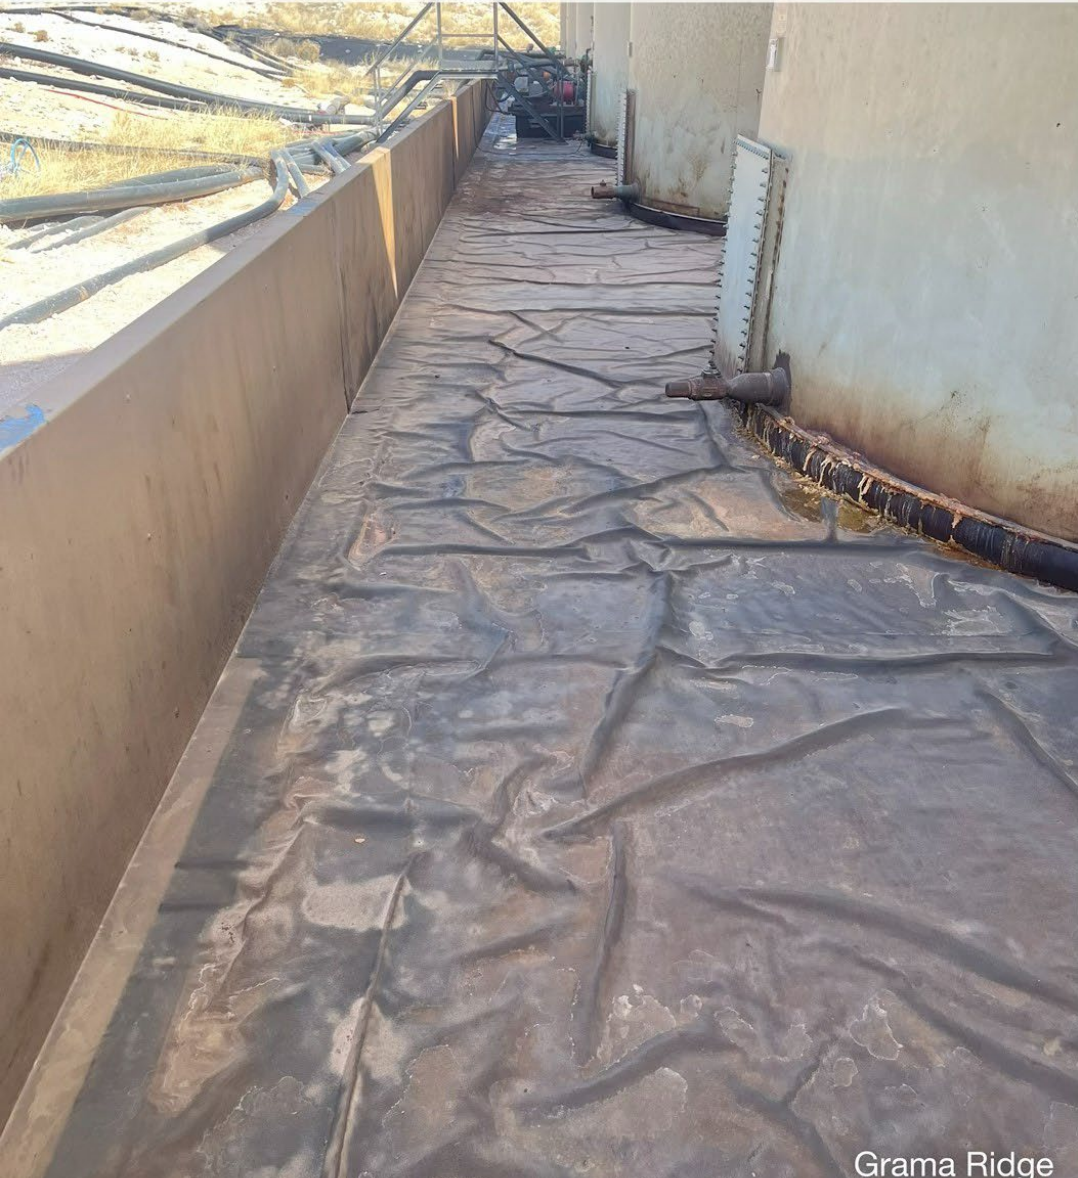
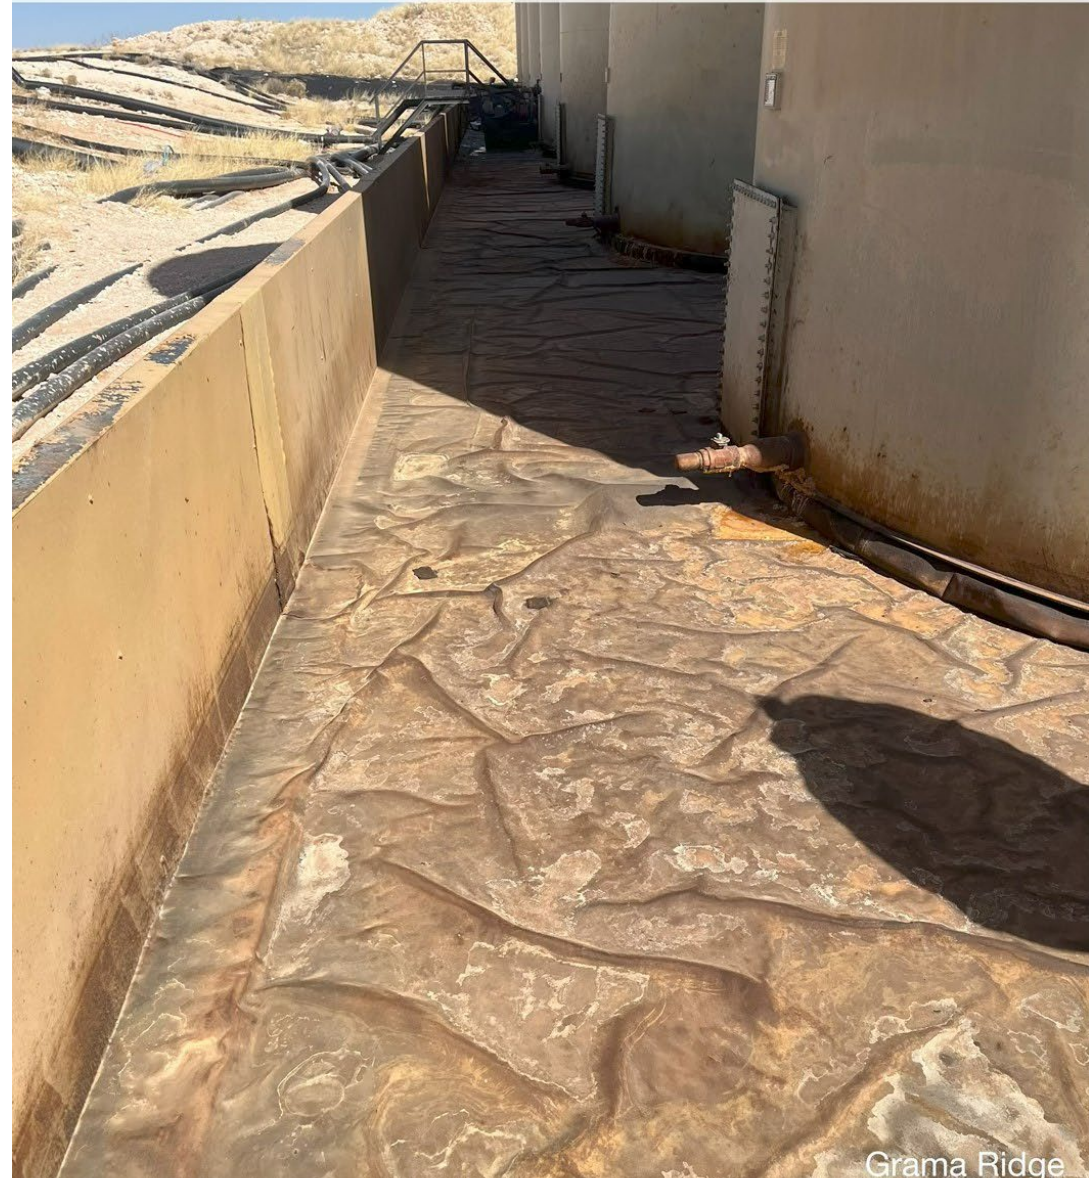
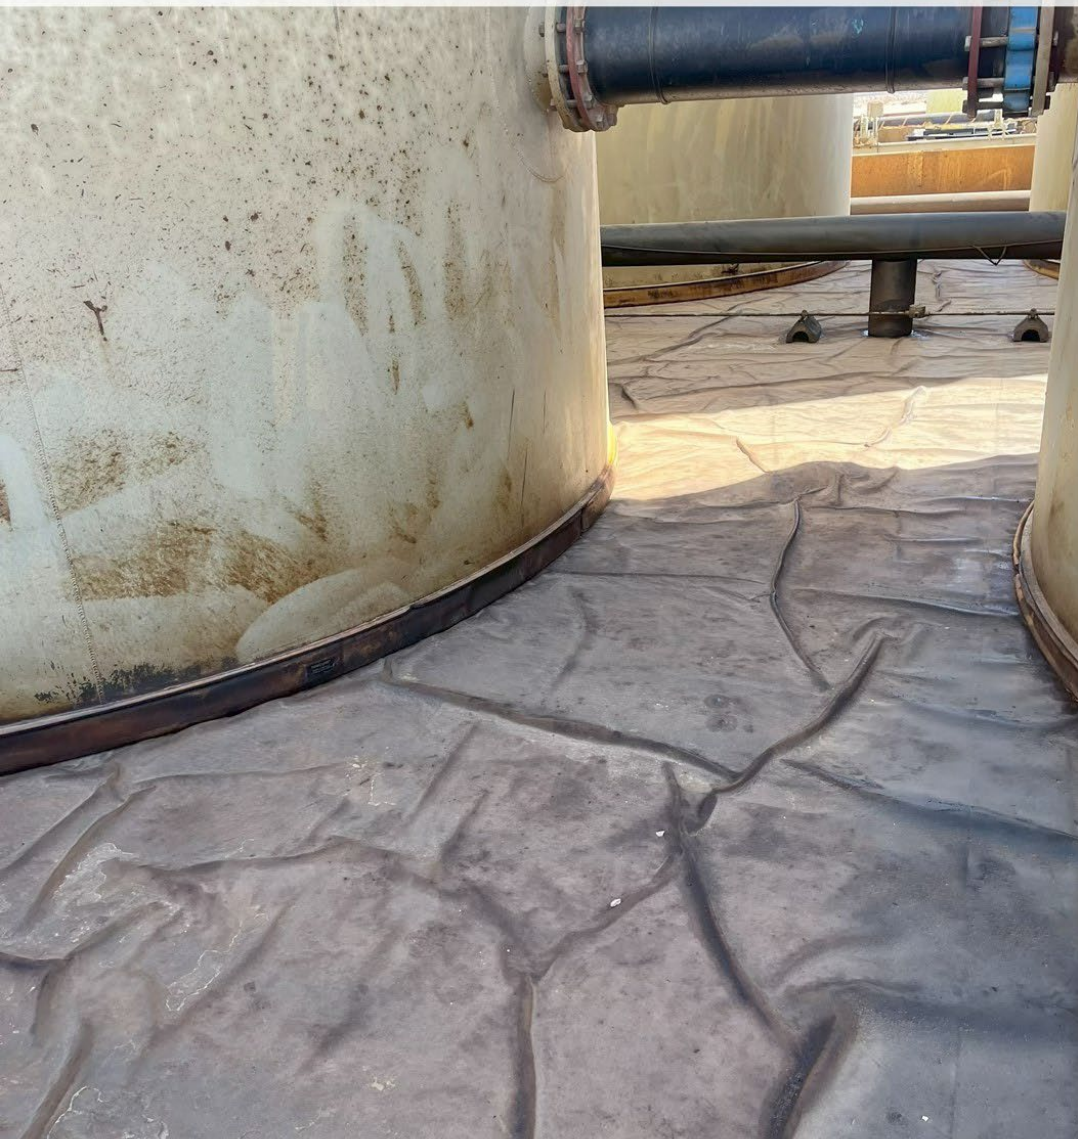
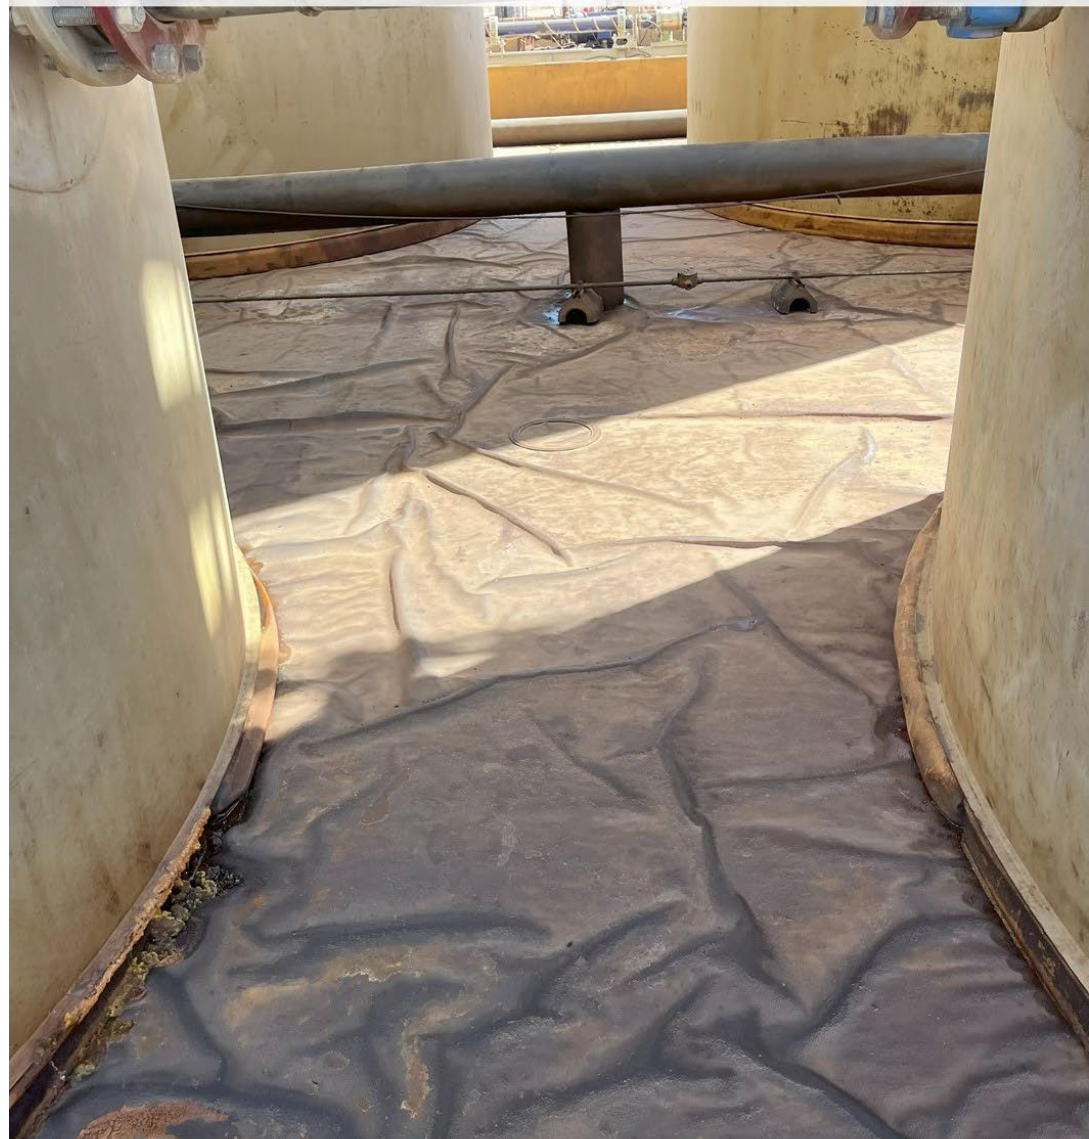
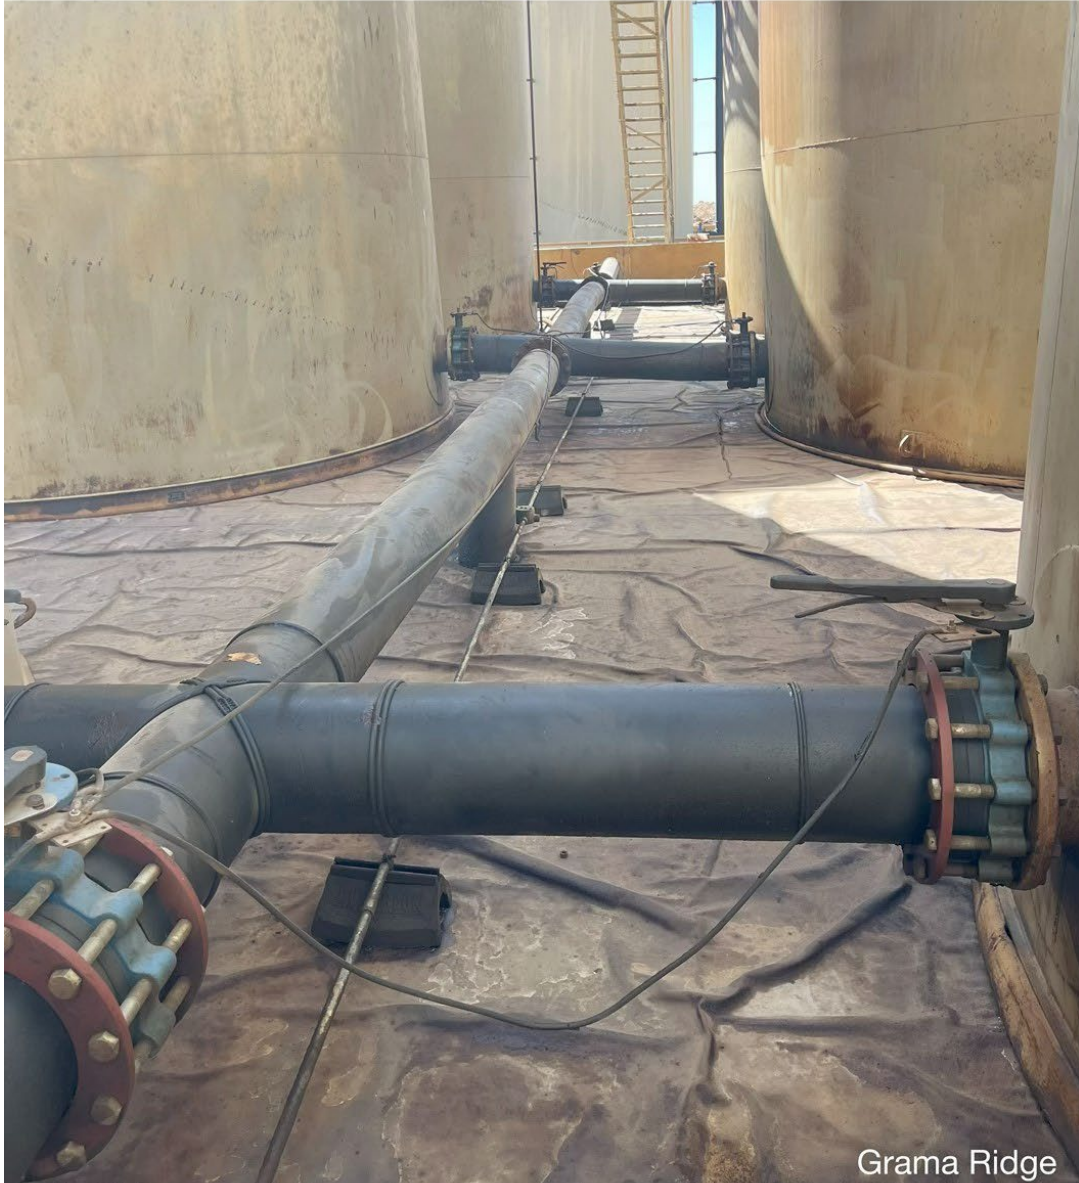
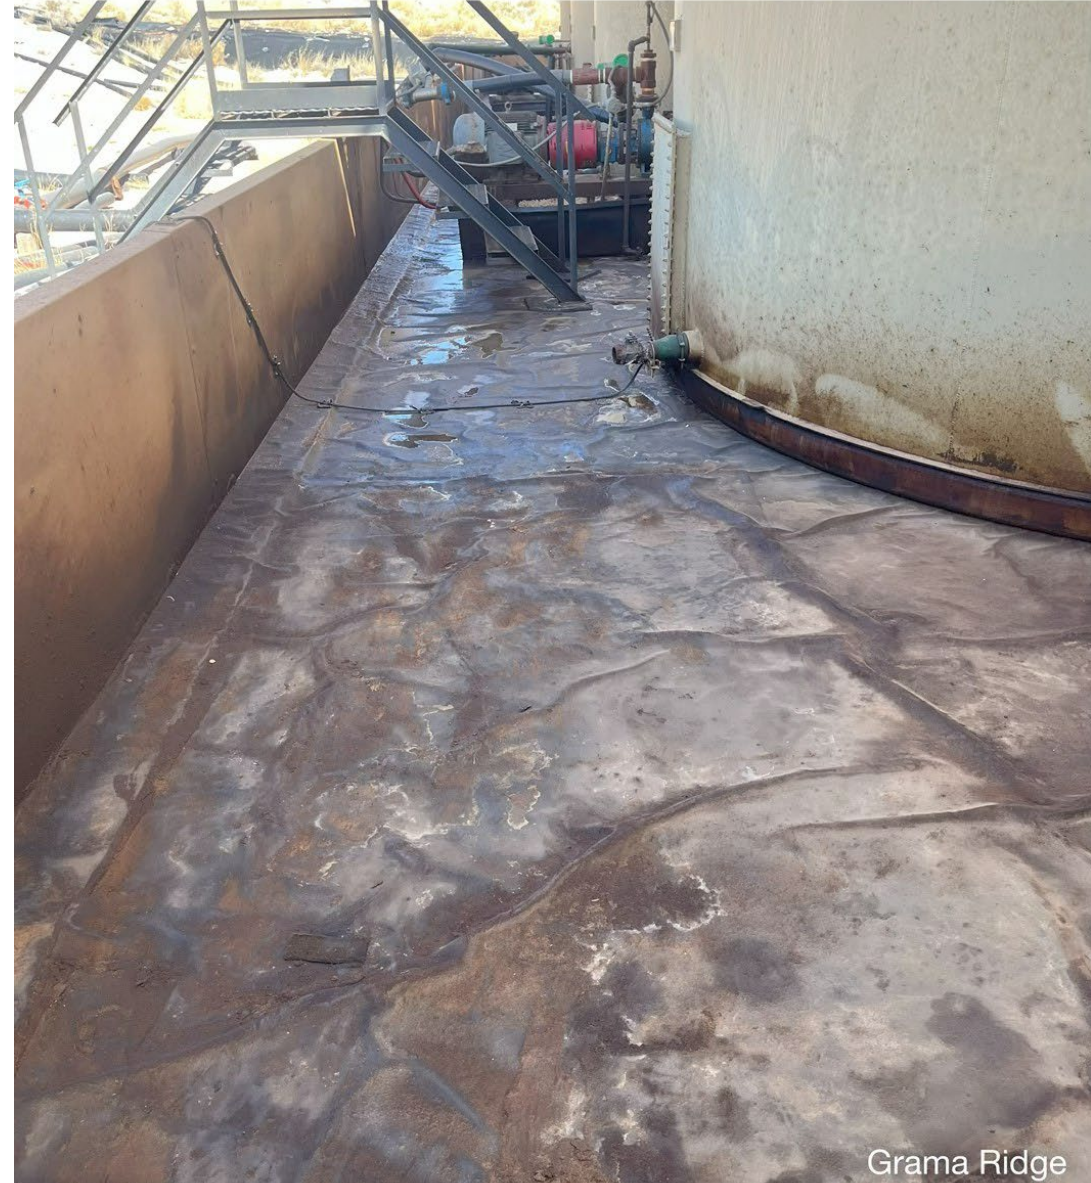
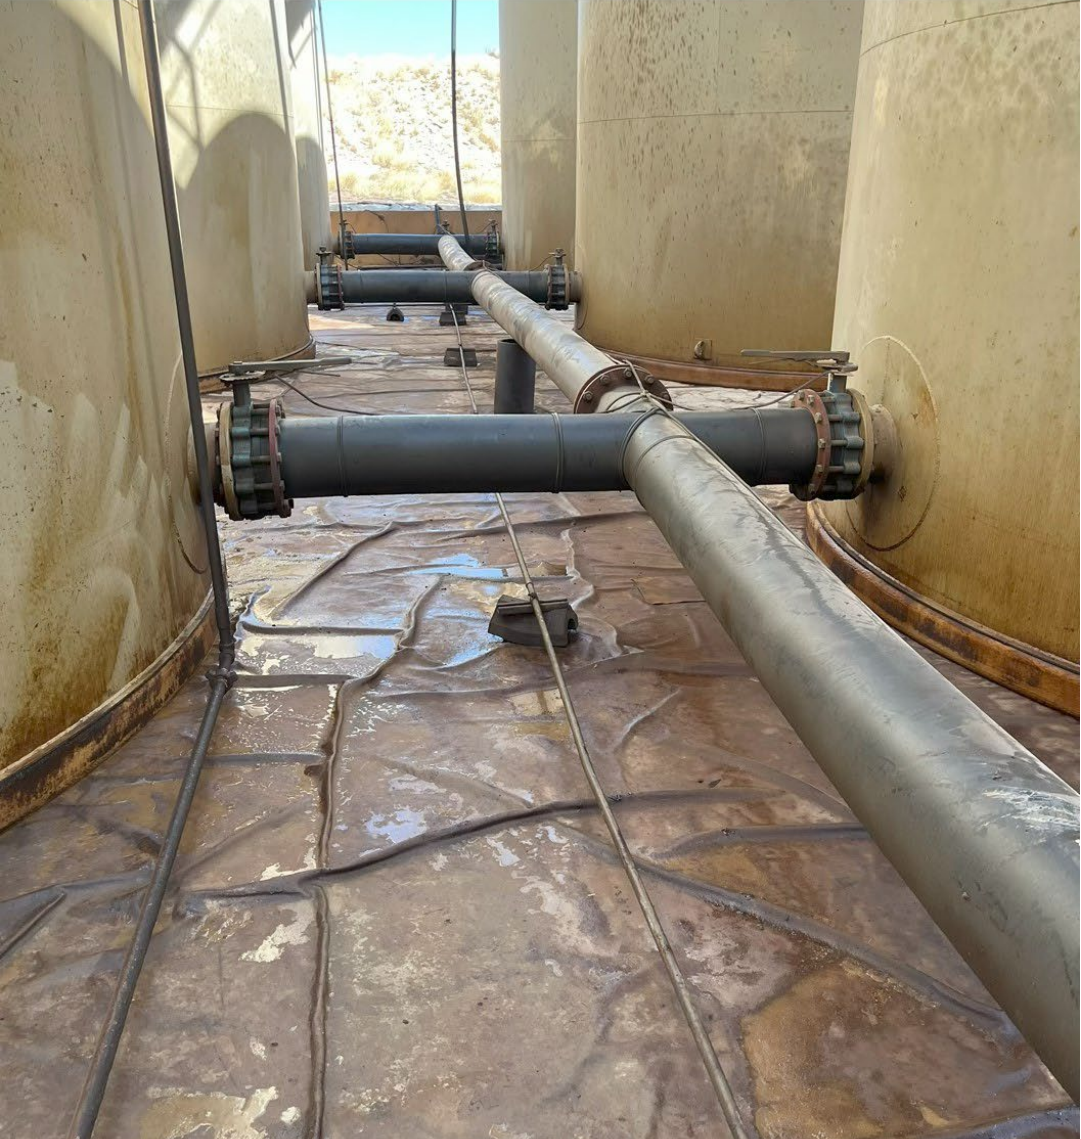
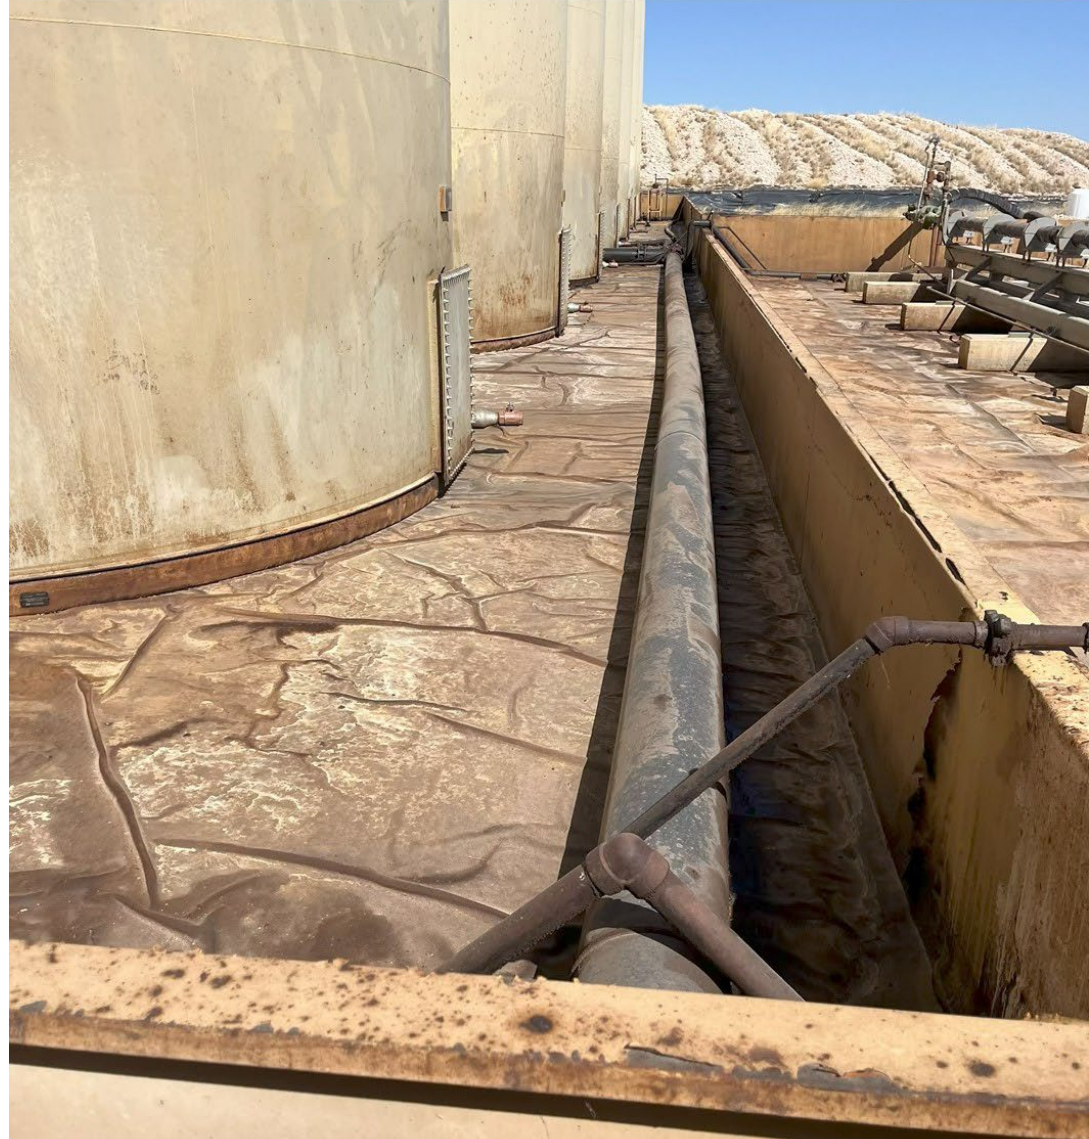
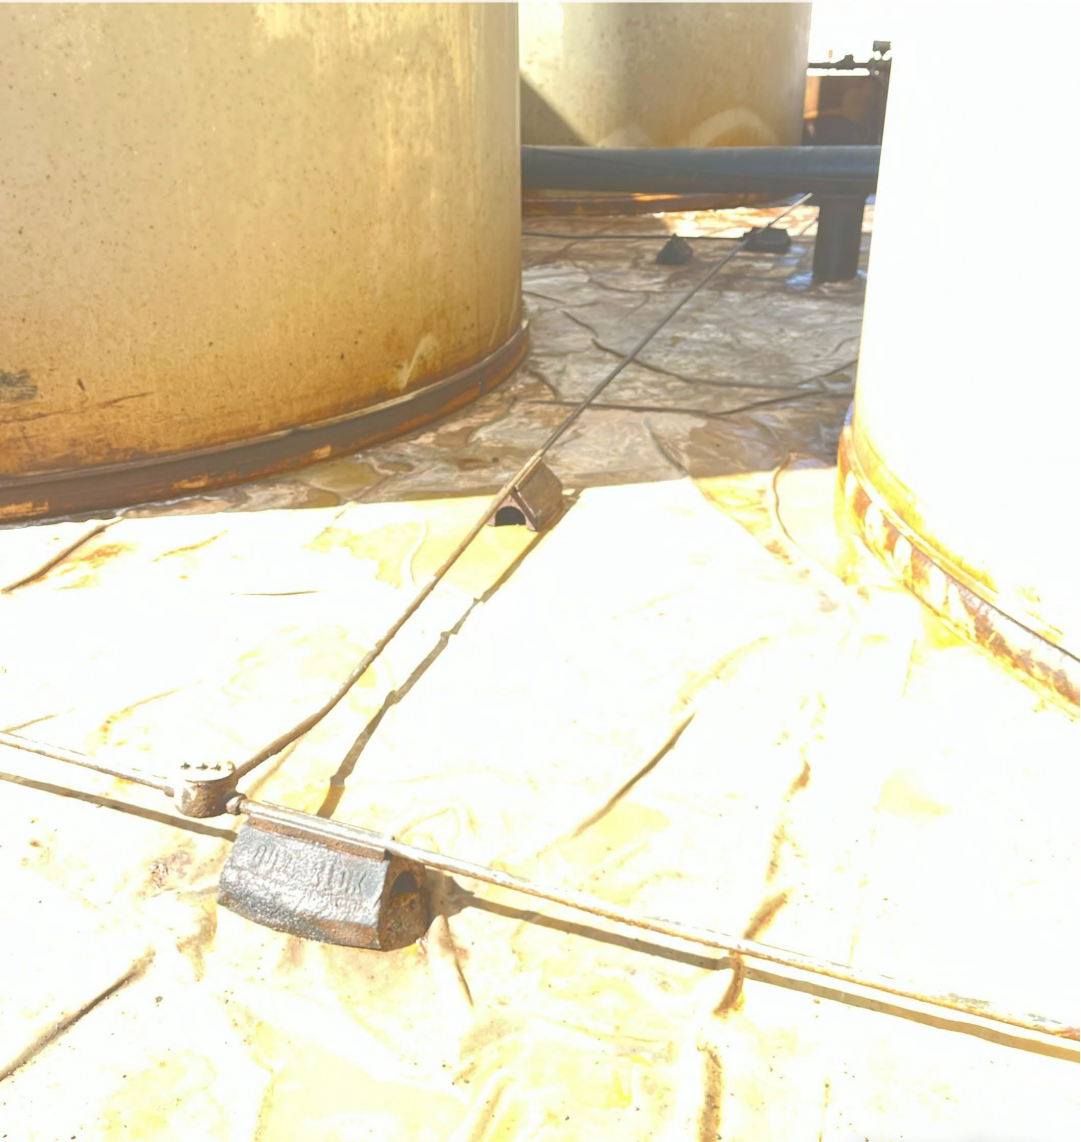
Pursuant to 19.15.29.11.A NMAC, Grama notified NMOCD of the liner inspection on 02/26/2026 via the C141L. In accordance with the Grama submitted C141L (ID 558232), AEA performed a liner inspection after 10:00 am on 03/03/2026. Liner was found to be in good order with no holes or other issues. The liner inspection form is attached in the tables and photos are in the appendix C.

LINER IS CLEAN AND IN GOOD
ORDER & DOES APPEAR TO BE ABLE TO
CONTAIN A RELEASE
