STRAWBERRY BOOSTER STATION

Remediation Summary & Closure Report

NMOCD Incident No. nAPP2604750695
UL "P", Sec. 16, T19S, R31E
32.65527°, -103.869468°
Eddy County, New Mexico

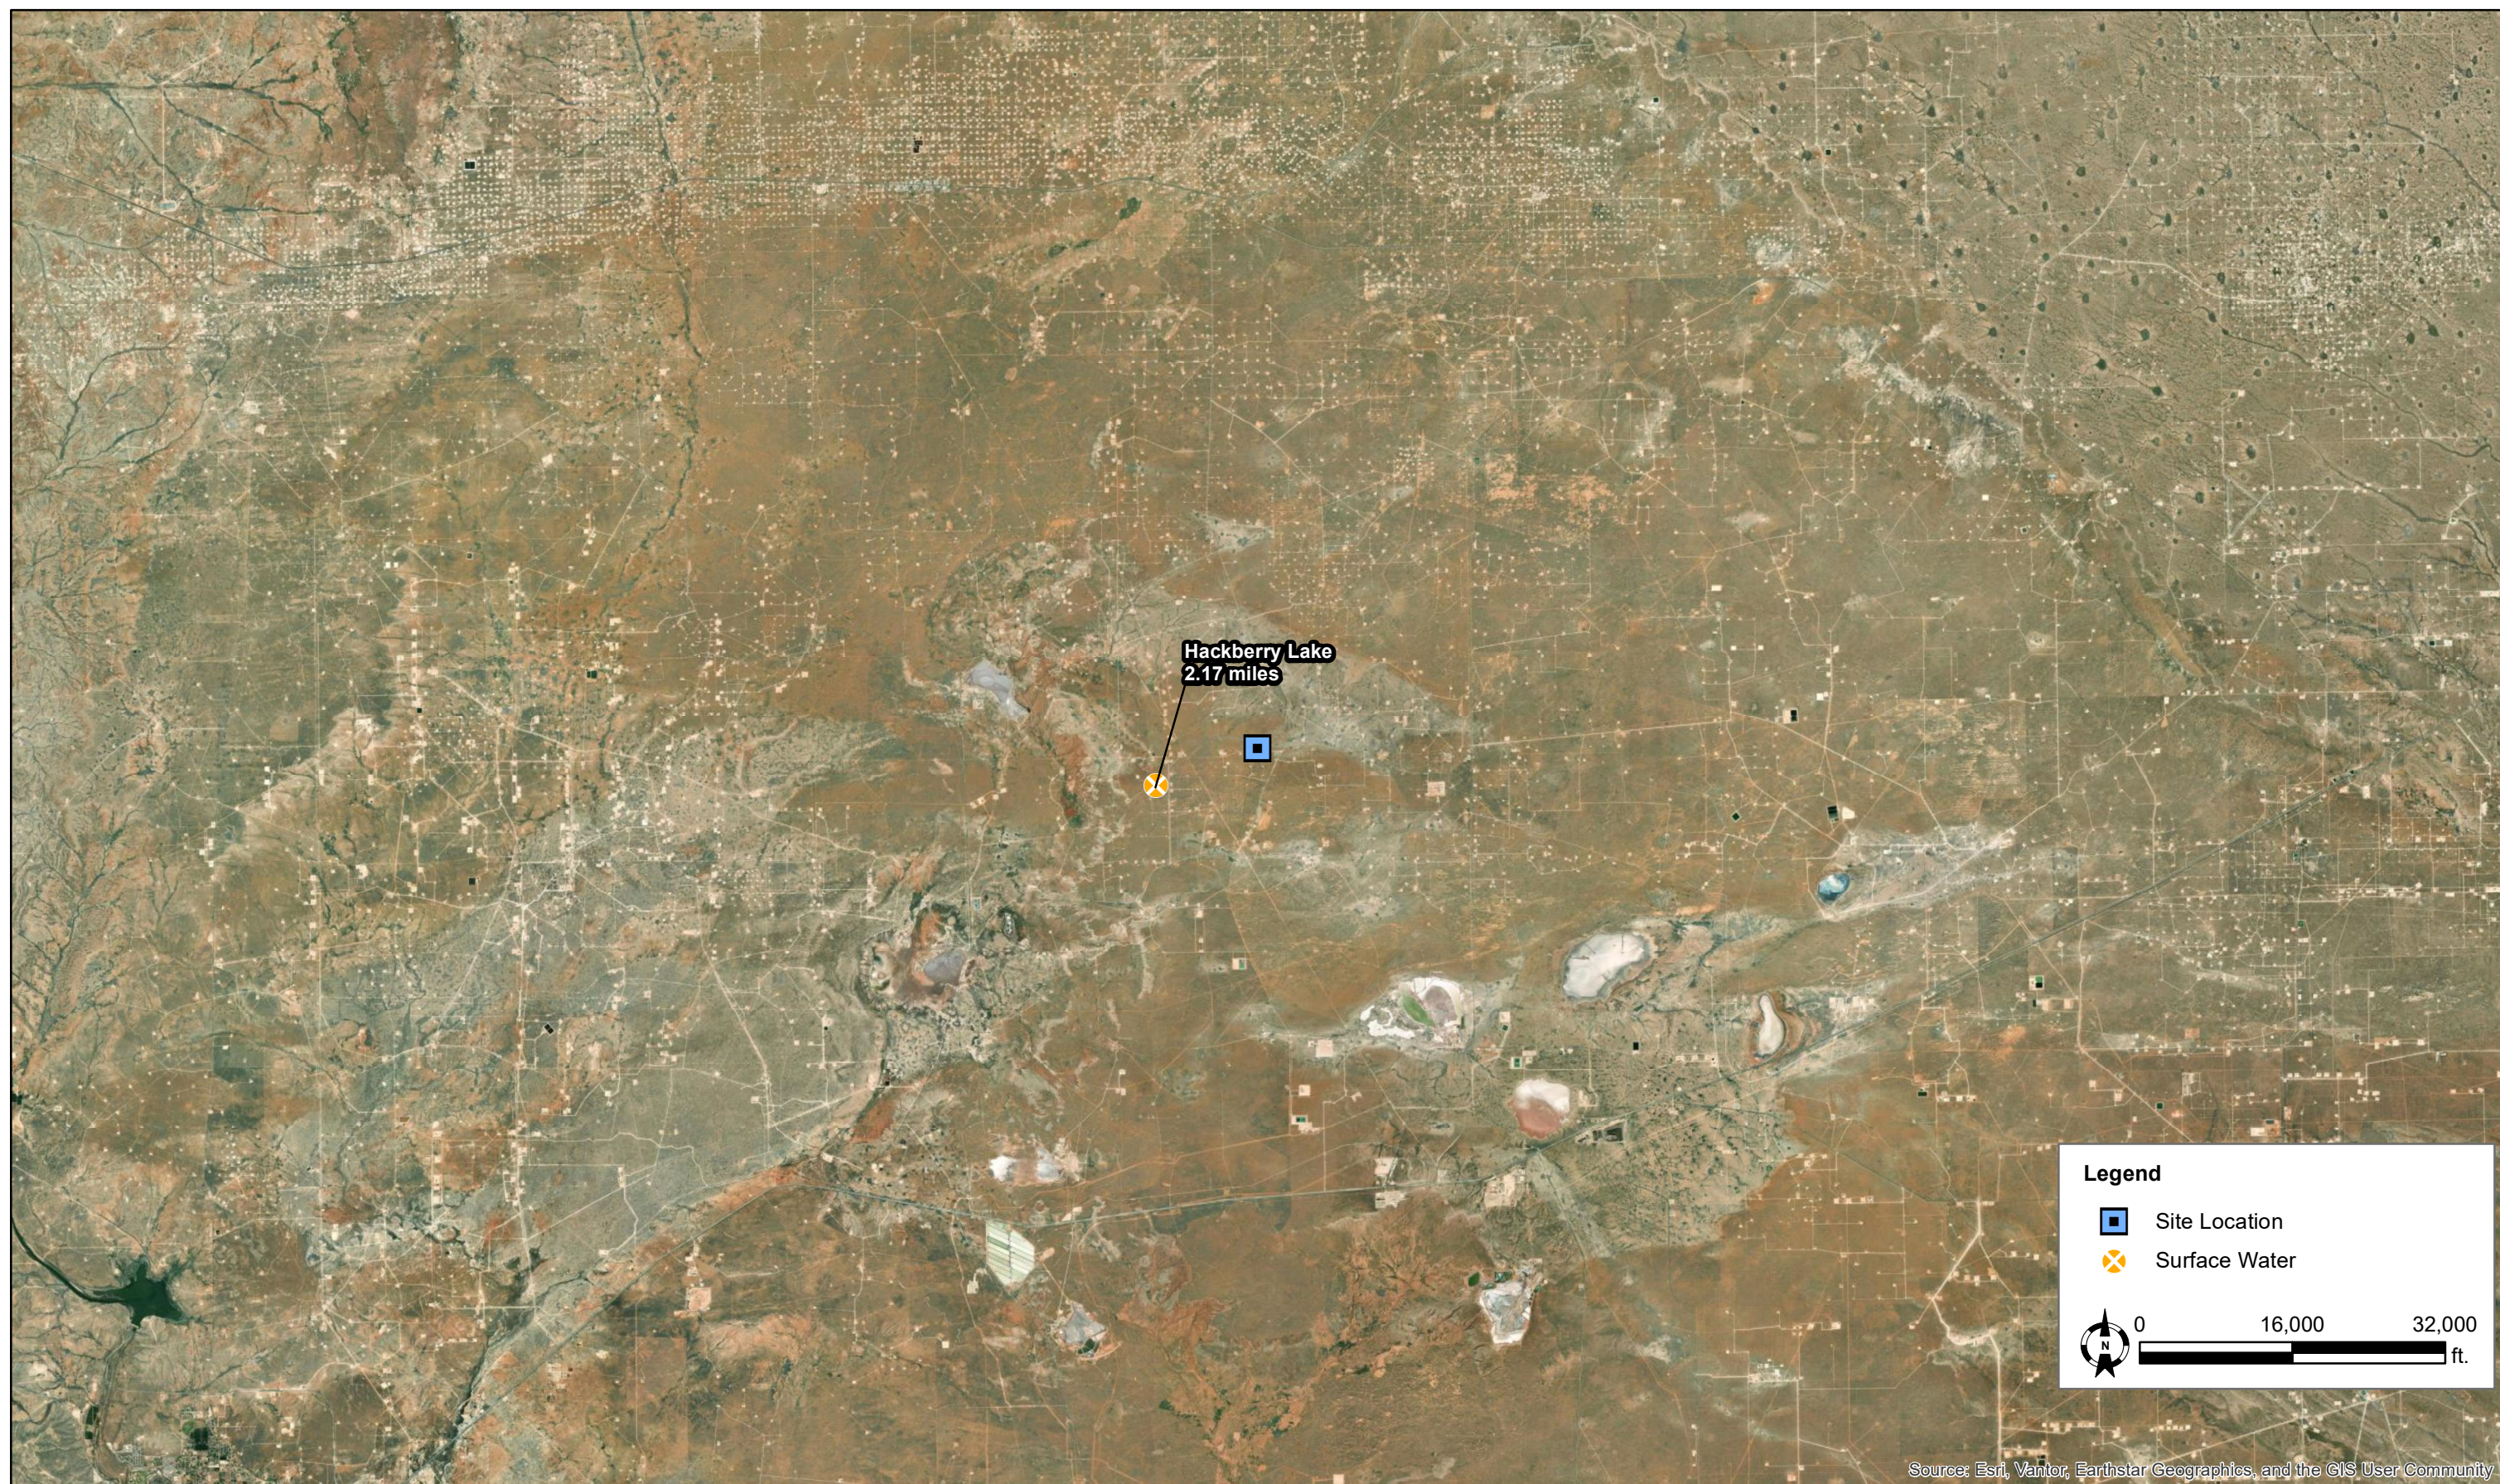
Figure
3

Tasman reviewed aerial imagery and the National Wetland Inventory Map, published by the U.S. Fish and Wildlife Service, for wetlands and surface water in the vicinity of the site. The nearest wetland, riverine, is located approximately 0.09 miles northeast of the site. The nearest significant surface water was identified as Hackberry Lake, located 2.17 miles from the site. The location of the nearest wetland and surface water body can be seen on Figures 1 and 3.

Surface Water Map

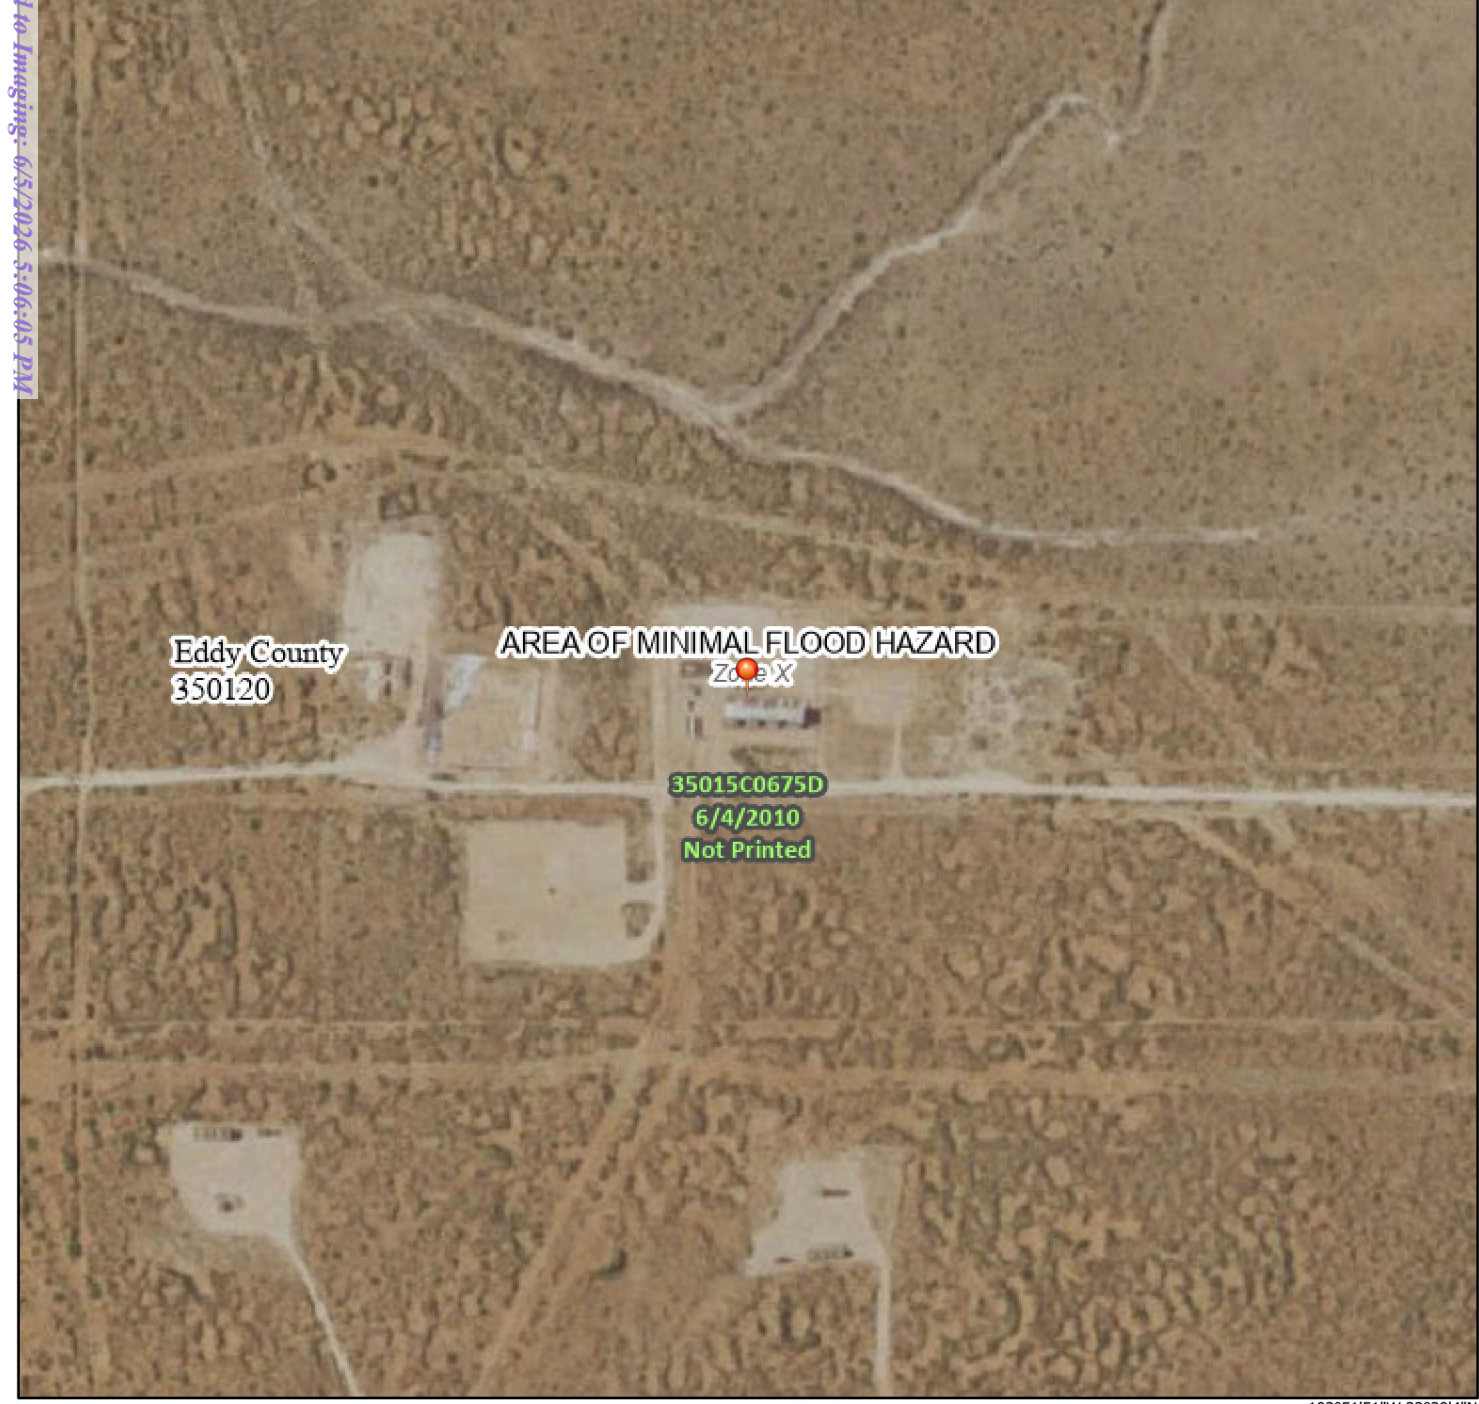
National Flood Hazard Layer FIRMette

Review of flood map data published by the Federal Emergency Management Agency (FEMA) indicates the site is not located within a 100-year floodplain. A copy of the FEMA FIRMetete Map can be found attached as Figure 4.

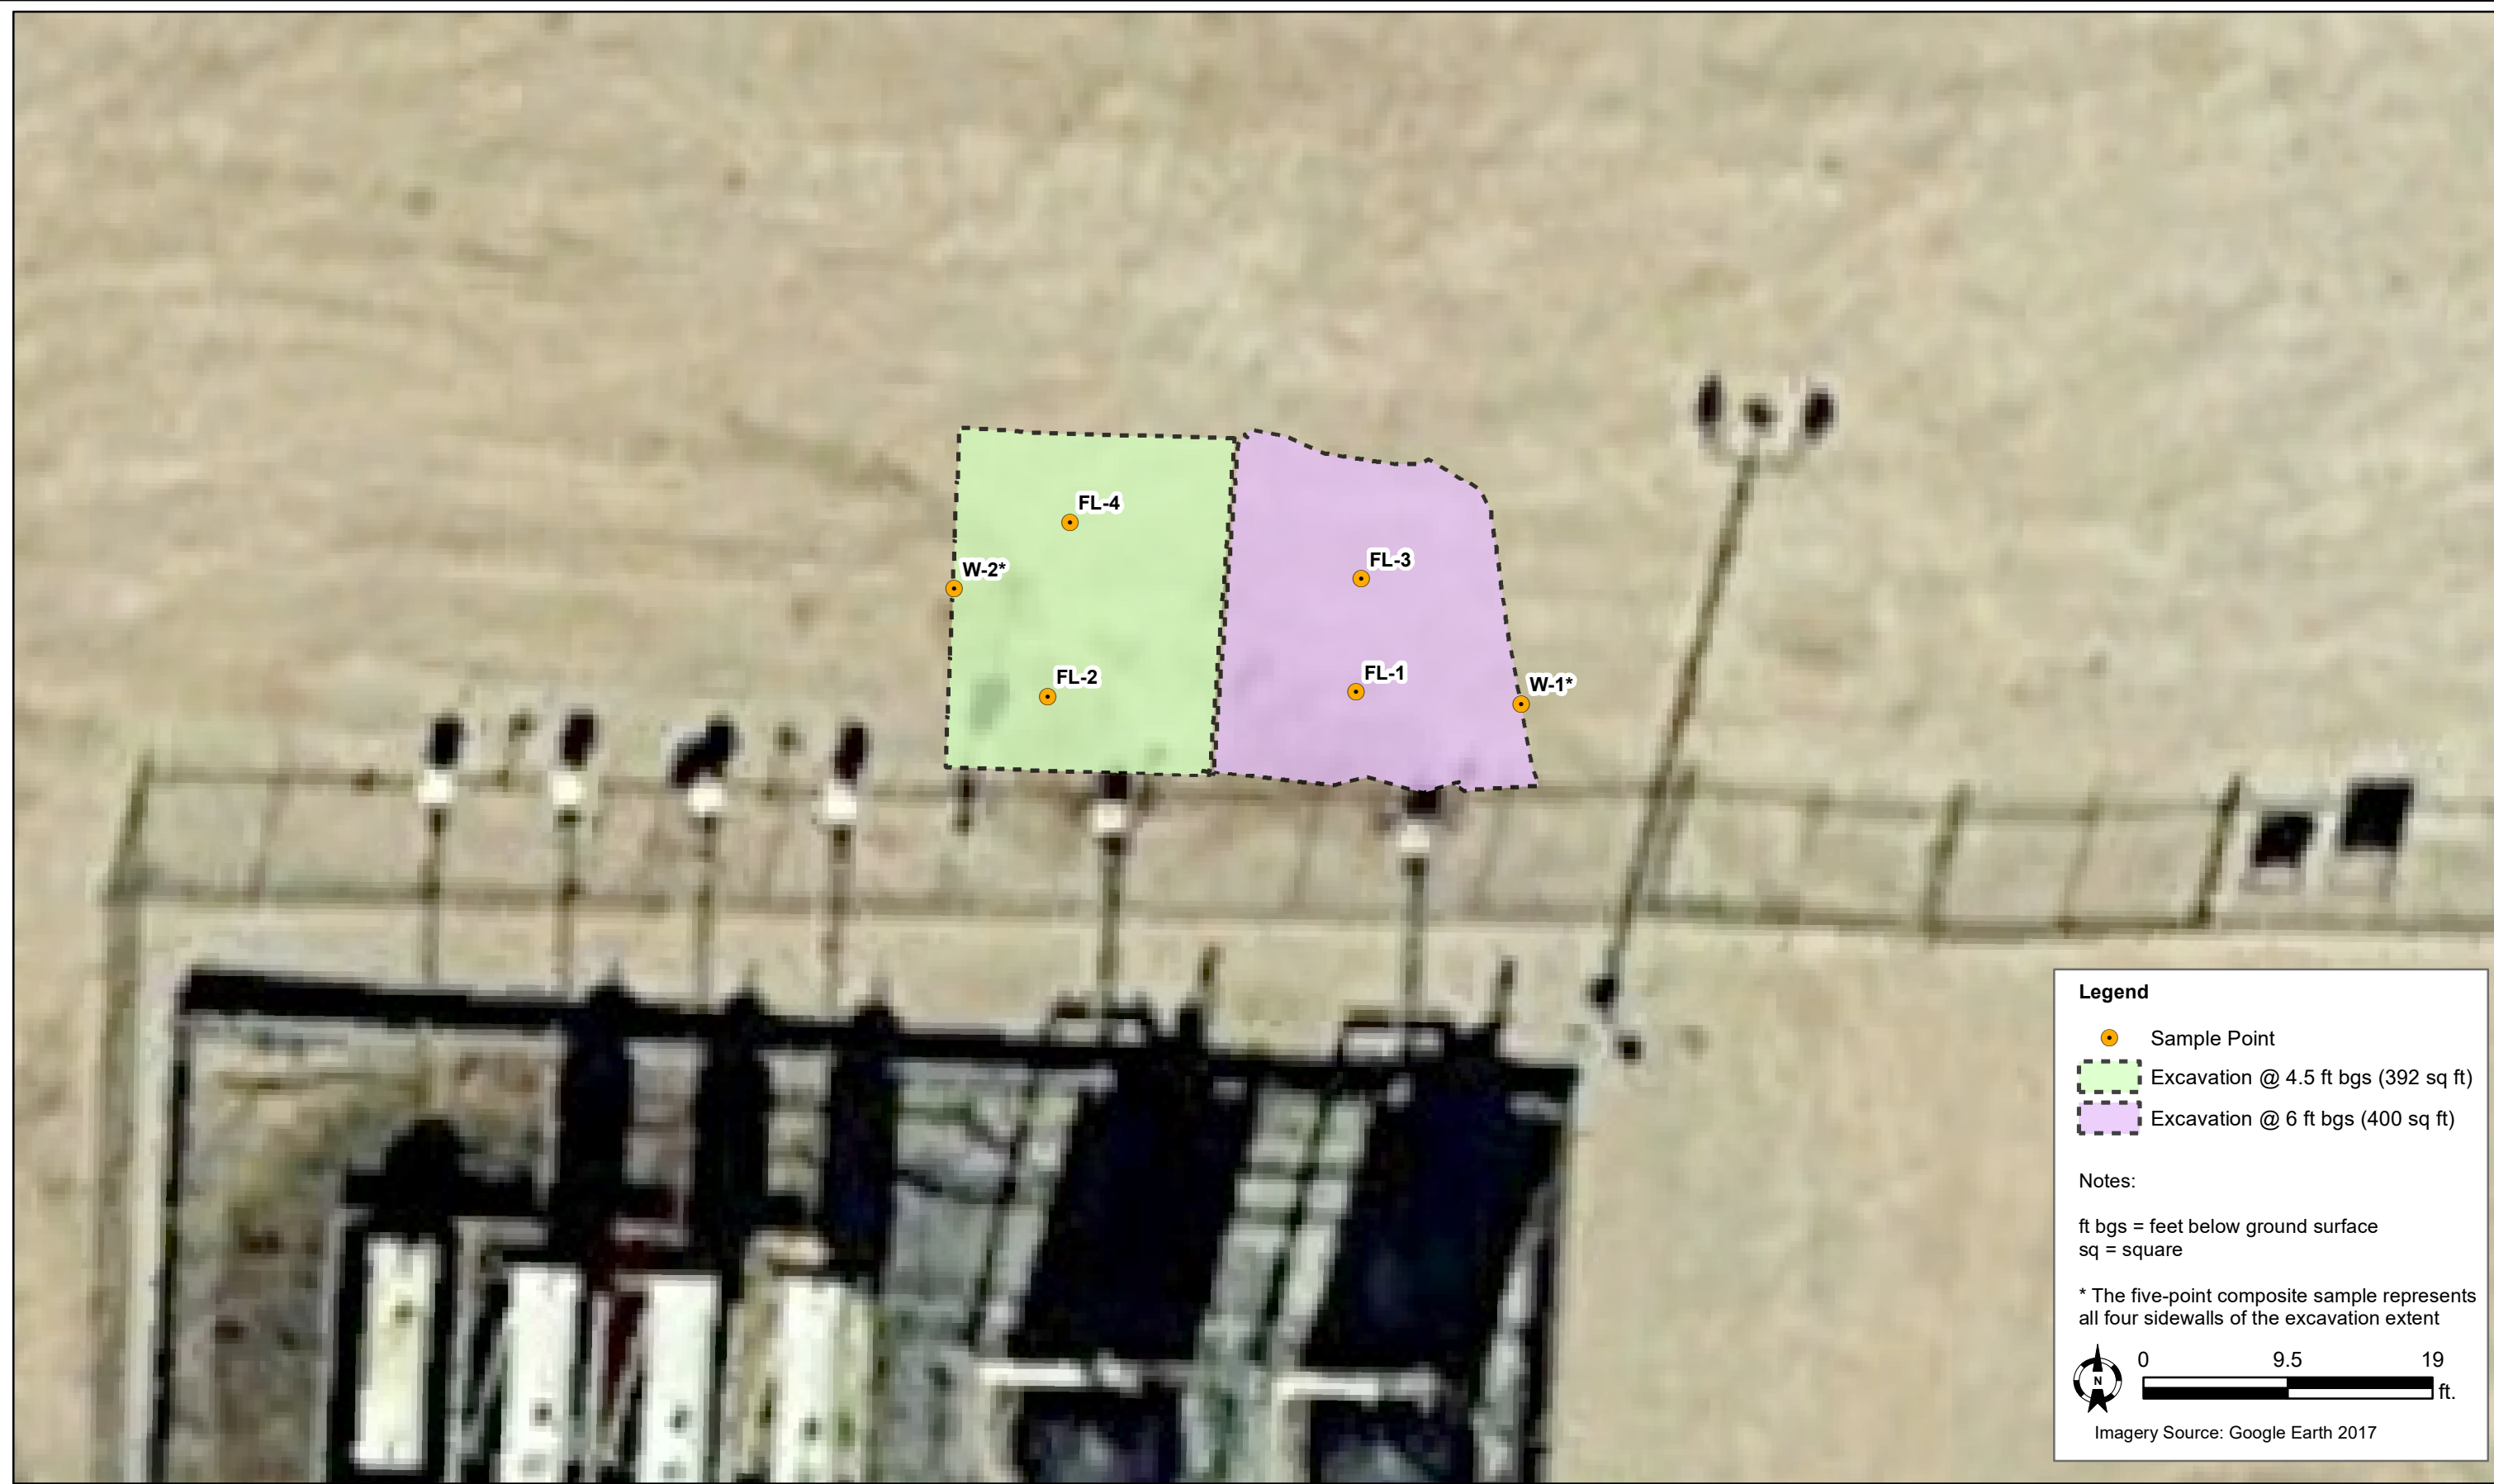
The remedial final excavations measured approximately 36 feet long by 22 feet wide ranging from 4.5 to 6 feet bgs. A total of 240 cubic yards of excavated material was exported to Lea Land, LLC Landfill.

Concentrations of total TPH were detected above NMOCD Action Levels in FL-2 at 4 feet bgs (791 milligrams per kilogram [mg/kg]) and FL-4 at 4 feet bgs (126 mg/kg). Each of these areas were addressed by further excavation. Additional samples were collected in each of these areas, which did not exhibit concentrations of total TPH above laboratory detection limits.

A summary of soil analytical results is provided as Table 1 and certified laboratory analytical reports are provided in Appendix D. The attached Figure 5 illustrates excavation extents and confirmation sample locations.

- Sample Point
- ▭ Excavation @ 4.5 ft bgs (392 sq ft)
- ▭ Excavation @ 6 ft bgs (400 sq ft)

Excavation Overview Map

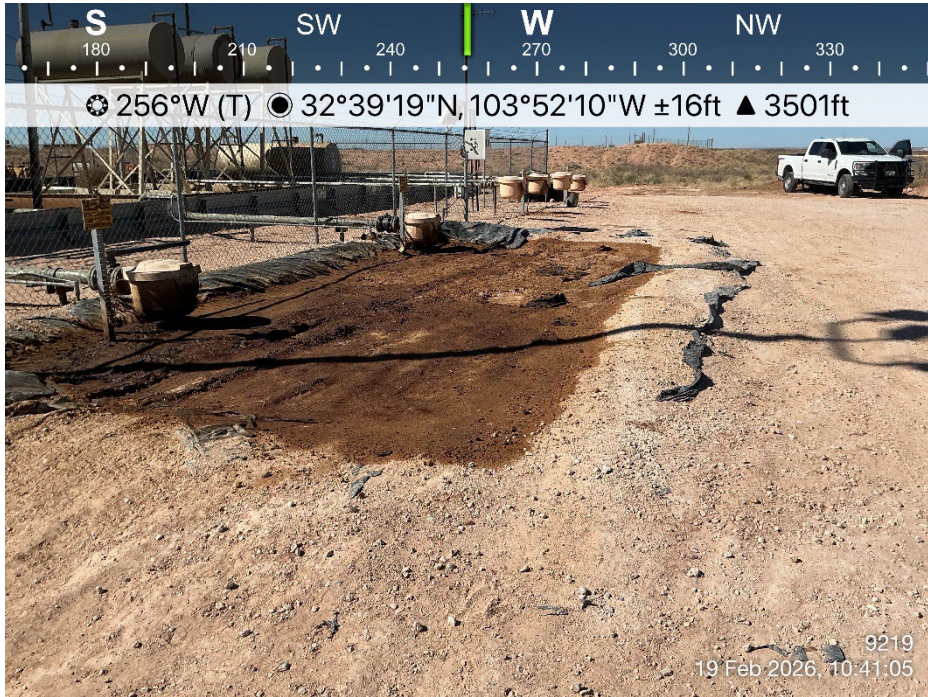
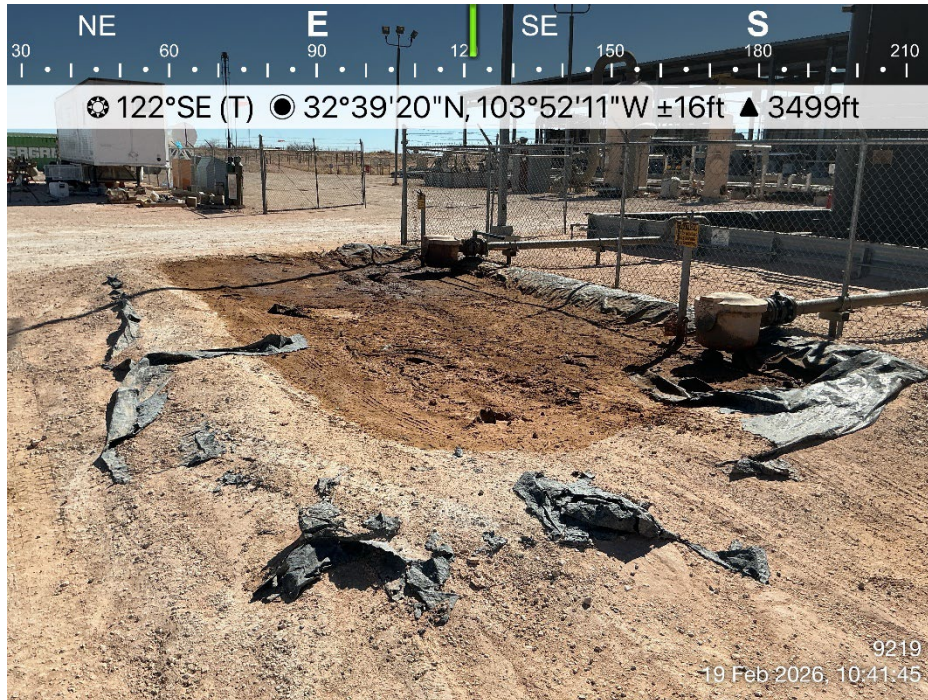
2/19/2026

On February 19, 2026, Tasman conducted liner inspection and found that the integrity of the liner had failed with multiple rips/tears at the base and sidewalls of the line containment area. Tasman notified DCP personnel of liner failure and recommended delineation and remediation of lined containment area.

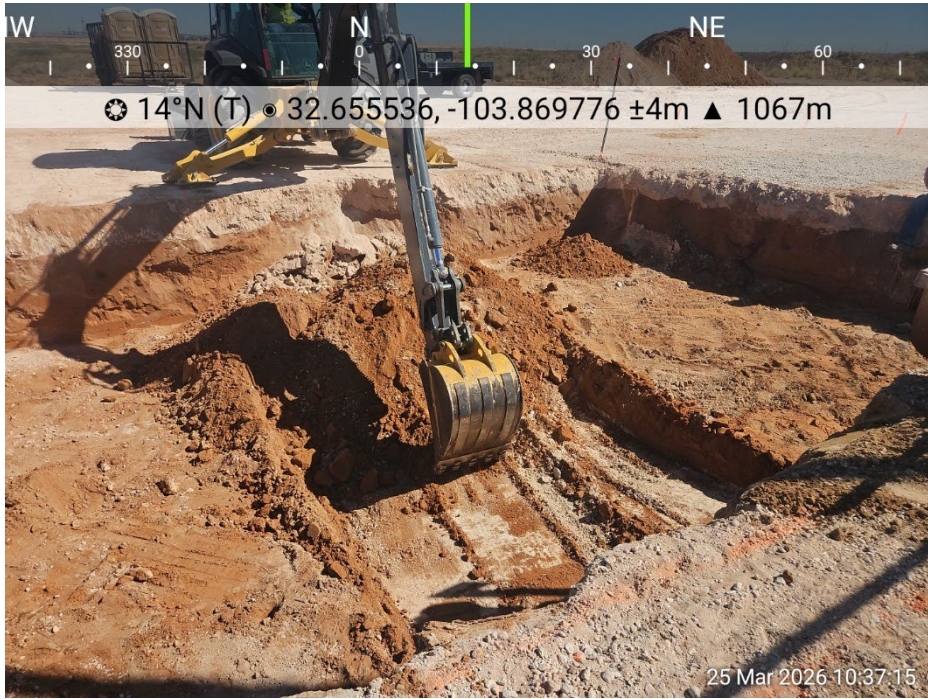
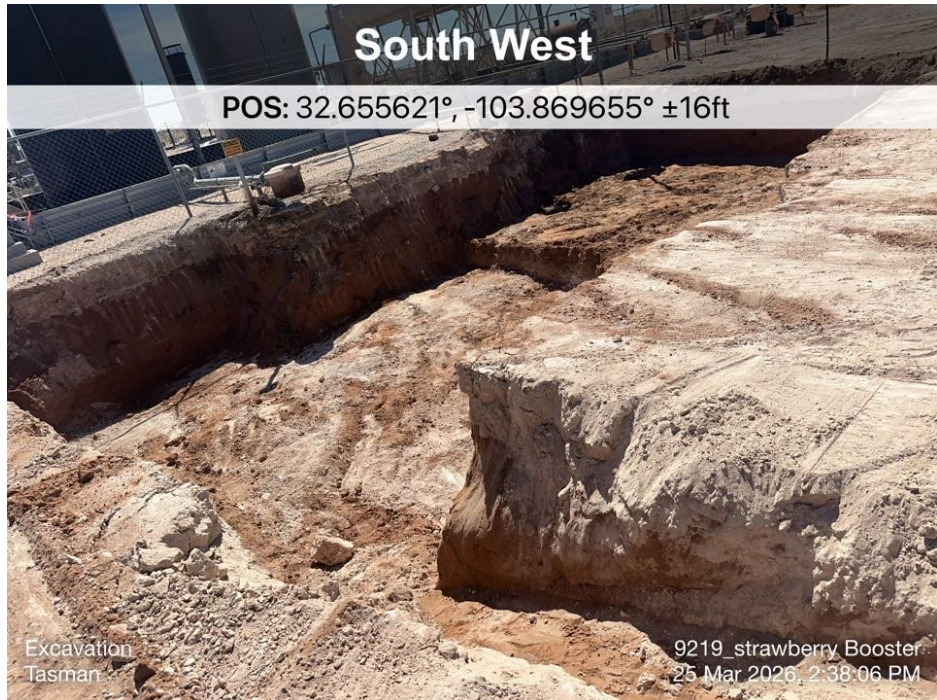
3.25.2026

From March 24 to April 17, 2026, Tasman utilized heavy equipment to excavate impacted soil from within the release margins. Excavated material was stockpiled on-site atop a polyethylene
