**Re: Deferral Request
Sharps Battery
Incident Number nAPP2521159402
Hilcorp Energy Company
Lea County, New Mexico**

Ensolum, LLC (Ensolum), on behalf of Hilcorp Energy Company (Hilcorp), has prepared the following *Deferral Request* for the Sharps Battery (Site). This Deferral Request provides additional information requested in a denial by the New Mexico Oil Conservation Division (NMOCD) of a previously submitted *Remediation Work Plan* (Work Plan), submitted on February 9, 2026. In the denial, NMOCD expressed concern that the *Work Plan* did not provide full delineation at Site, an estimated volume of impacted material to be remediated, a proposed remediation technique, and timeline for remediation activities. As such, Hilcorp is providing the additional information requested by NMOCD and, after evaluation of the soil type and review of safe excavation distances, submitting this *Deferral Request*, describing Site assessment, delineation, and excavation activities that have occurred at the Site. Hilcorp is requesting deferral of remediation for Incident Number nAPP2521159402 until the Site is reconstructed, and/or the well pad is abandoned.

Hilcorp Energy Company
Deferral Requ

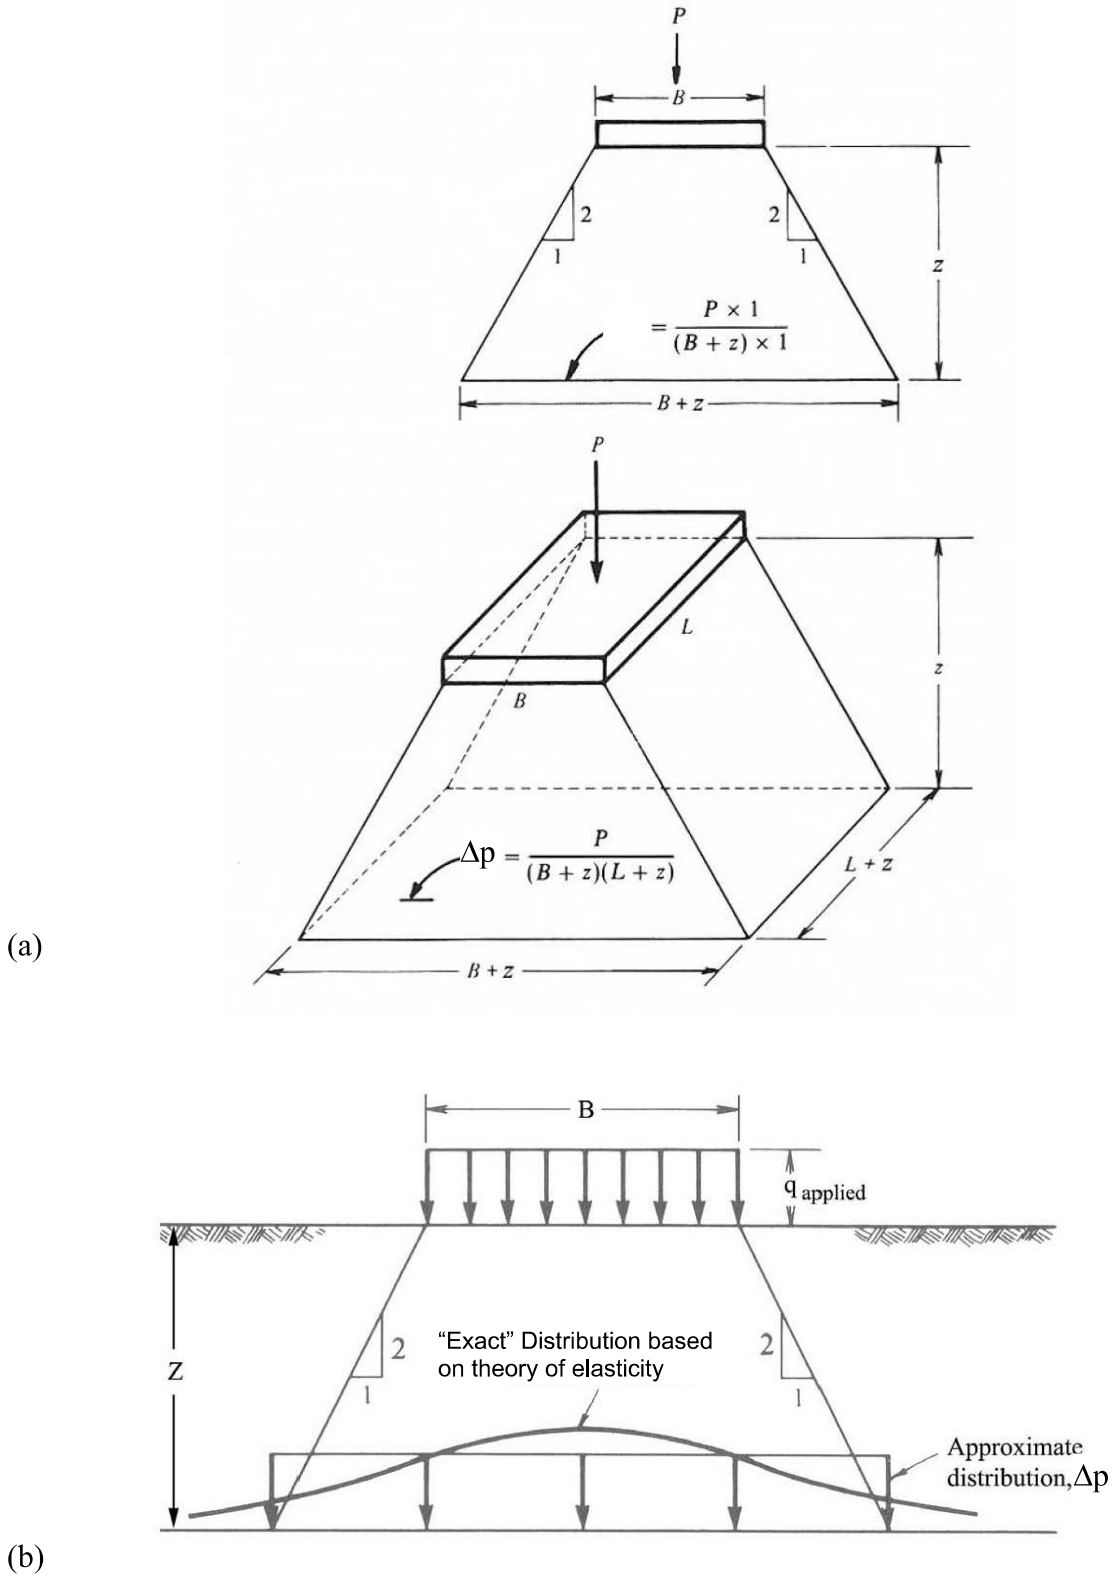
Figure 2-10. Distribution of vertical stress by the 2:1 method (after Perloff and Baron, 1976).

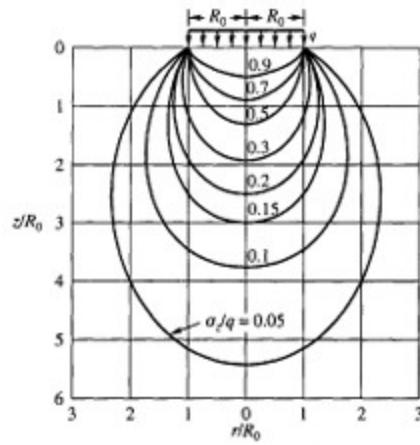
Figure 6.22 Pressure isobars based on Boussinesq equation for uniformly loaded circular footings

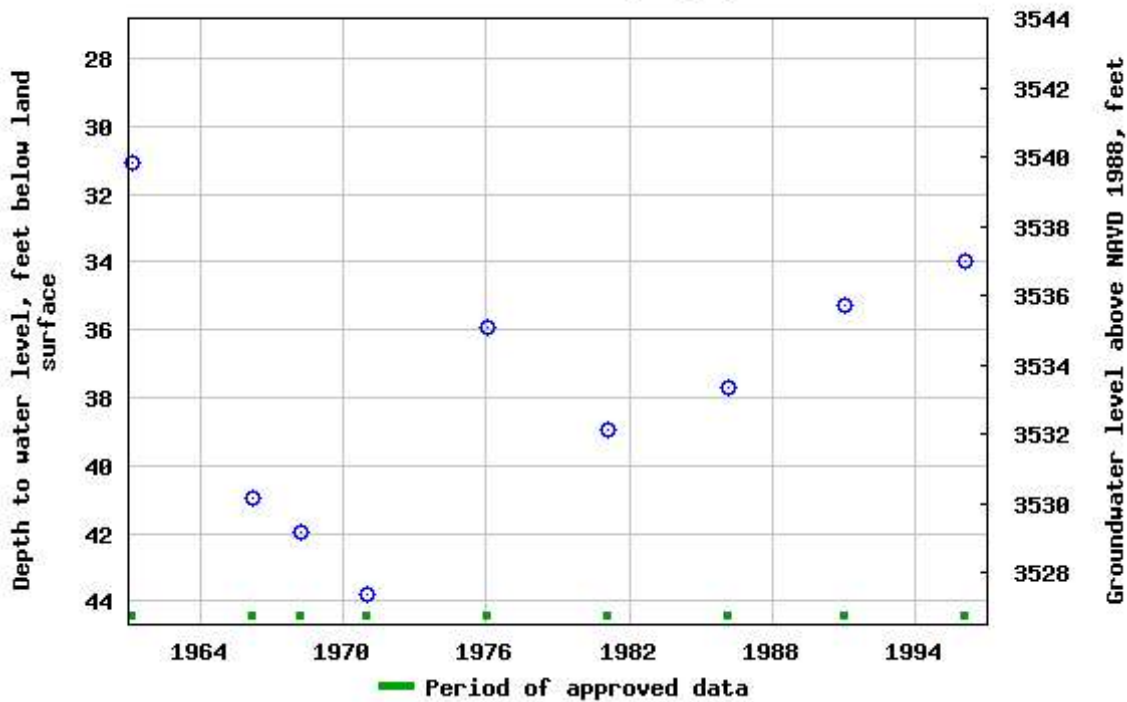
USGS 323415103061801 20S.38E.13.141224

Breaks in the plot represent a gap of at least one year between field measurements. [Download a presentation-quality graph](#)

Based on the results of the Site Characterization desktop review and the NMOCD recommendation of recent groundwater data within last 25 years, the following NMOCD Table I Closure Criteria (Closure Criteria) apply:

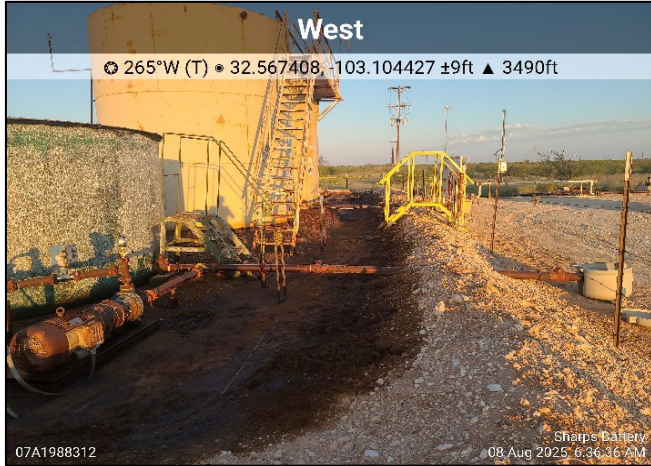
Photograph: 1 Date: 8/8/2025
Description: Soil staining in release footprint
View: West

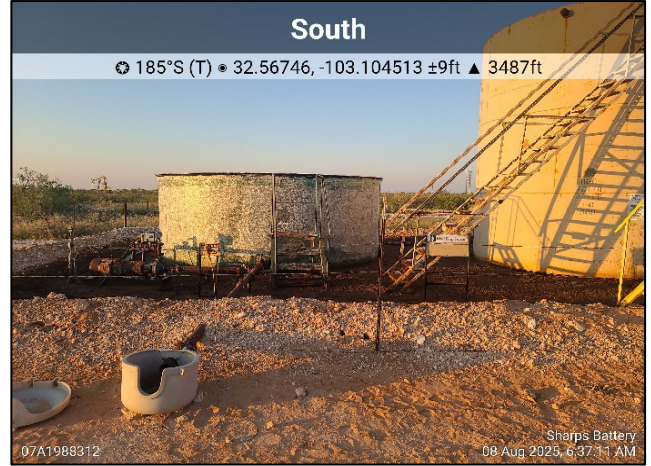
Photograph: 2 Date: 8/8/2025
Description: Soil staining in release footprint
View: South

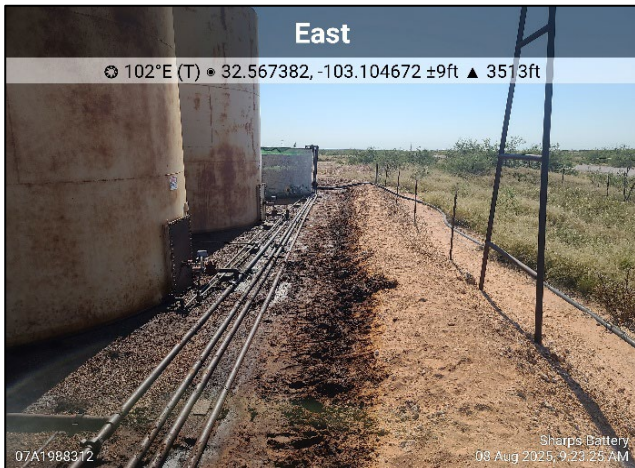
Photograph: 3 Date: 8/8/2025
Description: Soil staining in release footprint
View: East

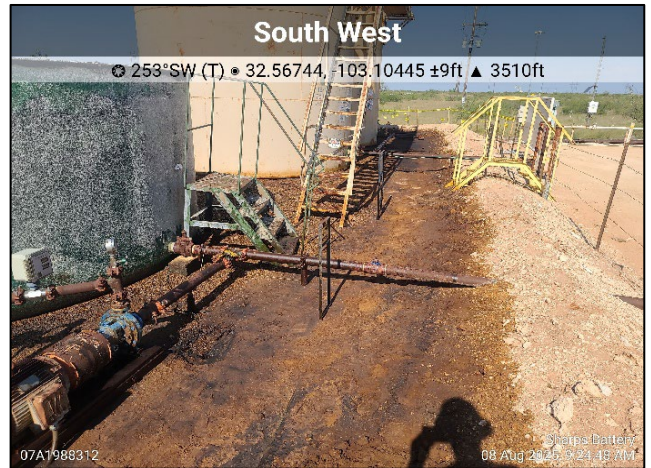
Photograph: 4 Date: 8/8/2025
Description: Delineation activities
View: Southwest

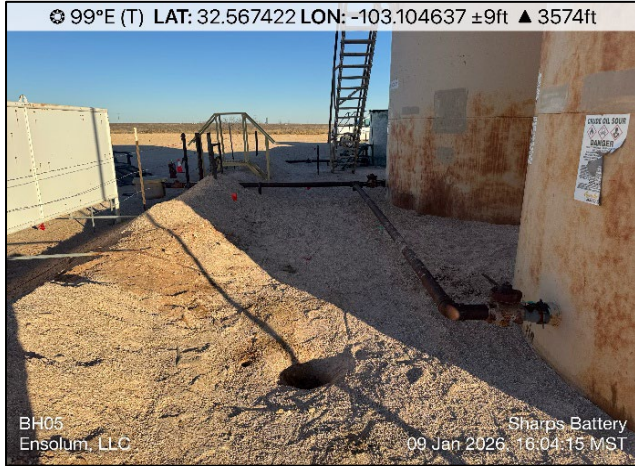
Photograph: 5 Date: 1/9/2026
Description: Delineation activities - BH05
View: East

Sample Name: BH05	Date: 1/9/2026
								Site Name: Sharps Battery	
								Incident Number: nAPP2521159402	
								Job Number: 07A1988312	
LITHOLOGIC / SOIL SAMPLING LOG								Logged By: Alex Ferrell	Method: Core-drill
Coordinates: 32.567442, -103.103856								Hole Diameter: 1.5"	Total Depth: 6'
Comments: Field screening conducted with HACH Chloride Test Strips and PID for chloride and vapor, respectively. Chloride test performed with 1:4 dilution factor of soil to distilled water. A 40% correction factor is included.									
Moisture Content	Chloride (ppm)	Vapor (ppm)	Staining	Sample ID	Sample Depth (ft bgs)	Depth (ft bgs)	USCS/Rock Symbol	Lithologic Descriptions	
M	2,391	556	Y	BH05	0.5	0	CCHE	[0-2'] CALICHE, light brown to off white, some sand and gravel, well graded, unconsolidated, strong diesel odor	
M	1,943	595	Y	BH05A	1	1			
M	1,814	147	Y	-	-	2	SP	[2-4'] SAND, dark brown, fine grained, little silt, poorly graded, unconsolidated, cohesive, low plasticity, no stain, strong chemical odor

M	286	46.2	Y	-	-	3			
M	< 176	21.8	N	-	-	4	CCHE	[4-6'] CALICHE, light gray to light brown, some fine grained sand, very hard to moderately consolidated, no stain, no odor	
D	< 176	44.8	N	-	-	5			
	246	51.8	N	-	-	5.5			
M	246	11.6	N	BH05B	6	6			
Total depth at 6' BGS.

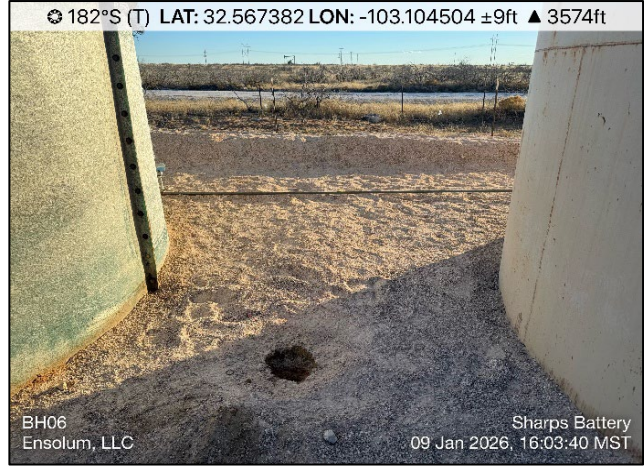
Photograph: 6 Date: 1/9/2026
Description: Delineation activities - BH06
View: South

Sample Name: BH06	Date: 1/9/2026
								Site Name: Sharps Battery	
								Incident Number: nAPP2521159402	
								Job Number: 07A1988312	
LITHOLOGIC / SOIL SAMPLING LOG								Logged By: Alex Ferrell	Method: Core-drill
Coordinates: 32.567442, -103.103856								Hole Diameter: 1.5"	Total Depth: 6'
Comments: Field screening conducted with HACH Chloride Test Strips and PID for chloride and vapor, respectively. Chloride test performed with 1:4 dilution factor of soil to distilled water. A 40% correction factor is included.									
Moisture Content	Chloride (ppm)	Vapor (ppm)	Staining	Sample ID	Sample Depth (ft bgs)	Depth (ft bgs)	USCS/Rock Symbol	Lithologic Descriptions	
M	< 176	553	Y	BH06	0.5	0	CCHE	[0-2] CALICHE, light brown to off white, some sand and gravel, well graded, unconsolidated, strong diesel odor	
M	< 176	719	Y	-	-	1			
M	< 176	1,690	Y	BH06A	2	2	SP	[2-5'] SAND, dark brown, fine grained, little silt, poorly graded, unconsolidated, cohesive, low plasticity, black stain, strong diesel to chemical odor

M	< 176	1,479	Y	-	-	3			
M	< 176	1,315	Y	-	-	4			
D	< 176	10.1	N	-	-	5	CCHE	[5-5.5'] CALICHE, light gray to light brown, some fine grained sand, very hard, no stain, no odor	
D	< 176	10.2	N	BH06B	5.5	5.5			
Total Depth at 5.5' BGS.

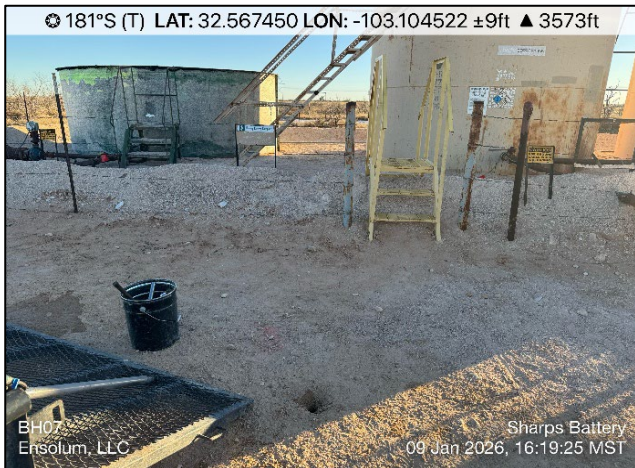
Photograph: 7 Date: 1/9/2026
Description: Delineation activities - BH07
View: South

Sample Name: BH07		Date: 1/9/2026				
		Site Name: Sharps Battery						
		Incident Number: nAPP2521159402						
		Job Number: 07A1988312						
LITHOLOGIC / SOIL SAMPLING LOG				Logged By: Alex Ferrell		Method: Core-drill		
Coordinates: 32.567442, -103.103856				Hole Diameter: 1.5"		Total Depth: 6'		
Comments: Field screening conducted with HACH Chloride Test Strips and PID for chloride and vapor, respectively. Chloride test performed with 1:4 dilution factor of soil to distilled water. A 40% correction factor is included.								
Moisture Content	Chloride (ppm)	Vapor (ppm)	Staining	Sample ID	Sample Depth (ft bgs)	Depth (ft bgs)	USCS/Rock Symbol	Lithologic Descriptions
D	< 176	4.7	N	BH07	0.5	0	CCHE	[0-2] CALICHE, light brown to off white, some sand and gravel, well graded, unconsolidated
D	246	3.6	N	-	-	1		
M	330	2.1	N	-	-	2	SP	[2-4'] SAND dark brown, fine grained, little silt, poorly graded, unconsolidated, cohesive, low plasticity

M	246	1.8	N	-	-	3		
M	426	3.0	N	BH07A	4	4	CCHE	[4-6'] CALICHE, brown to off white, some fine grained sand and gravel, moderately consolidated, no stain, no odor
D	246	0.3	N	-	-	5		
D	213	3.5	N	BH07B	6	6		
Total depth at 6' BGS.

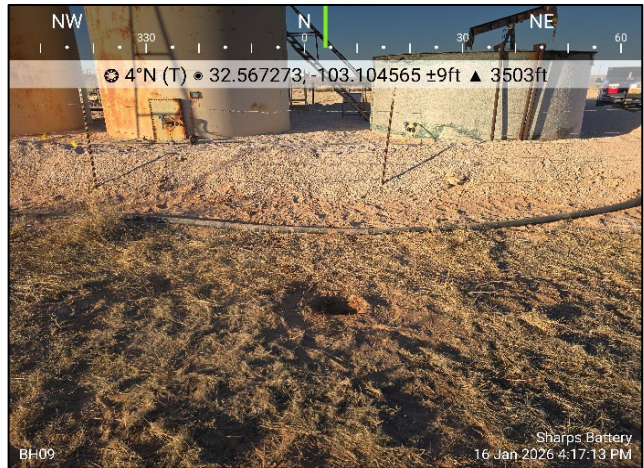
Photograph: 8 Date: 1/16/2026
Description: Delineation activities - BH09
View: North

Sample Name: BH09	Date: 1/16/2026
								Site Name: Sharps Battery	
								Incident Number: nAPP2521159402	
								Job Number: 07A1988312	
LITHOLOGIC / SOIL SAMPLING LOG								Logged By: Mario Sarkis	Method: Core-drill
Coordinates: 32.567442, -103.103856								Hole Diameter: 1.5"	Total Depth: 6'
Comments: Field screening conducted with HACH Chloride Test Strips and PID for chloride and vapor, respectively. Chloride test performed with 1:4 dilution factor of soil to distilled water. A 40% correction factor is included.									
Moisture Content	Chloride (ppm)	Vapor (ppm)	Staining	Sample ID	Sample Depth (ft bgs)	Depth (ft bgs)	USCS/Rock Symbol	Lithologic Descriptions	
D	< 176	0.6	N	BH09	0.5	0	SP	[0-2'] SAND, reddish brown, fine grained silty to clayey sand, non-cohesive to cohesive, trace caliche, low plasticity at 2'	
D	< 176	0.2	N	-	-	1			
D	< 176	0.4	N	-	-	2	CCHE	[2-6'] CALICHE, tan to white, very fine to fine grained, consolidated; color change to dark tan from 4-6' with clayey sand

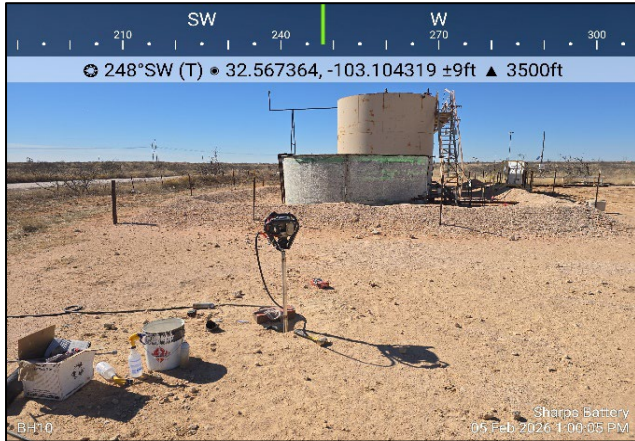
Photograph: 9 Date: 2/5/2026
Description: Delineation activities - BH10
View: Southwest

Sample Name: BH10		Date: 2/5/2026	
								Site Name: Sharps Battery			
								Incident Number: nAPP2521159402			
								Job Number: 07A1988312			
LITHOLOGIC / SOIL SAMPLING LOG								Logged By: Mario Sarkis		Method: Core-drill	
Coordinates: 32.567442, -103.103856								Hole Diameter: 1.5"		Total Depth: 6'	
Comments: Field screening conducted with HACH Chloride Test Strips and PID for chloride and vapor, respectively. Chloride test performed with 1:4 dilution factor of soil to distilled water. A 40% correction factor is included.											
Moisture Content	Chloride (ppm)	Vapor (ppm)	Staining	Sample ID	Sample Depth (ft bgs)	Depth (ft bgs)	USCS/Rock Symbol	Lithologic Descriptions			
D	< 176	0.9	N	BH10	0.5	0	CCHE	[0.5-1'] CALICHE, pad caliche			
D	< 176	1.0	N	-	-	1	SP	[1-3'] SAND, reddish brown, fine grained clayey sand, cohesive, non-plastic			
D	< 176	1.5	N	-	-	2					
D	< 176	0.5	N	BH10A	3	3	CCHE	[3-6'] CALICHE, tan to white, some clayey sand, fine grained, cohesive, non-plastic, consolidated

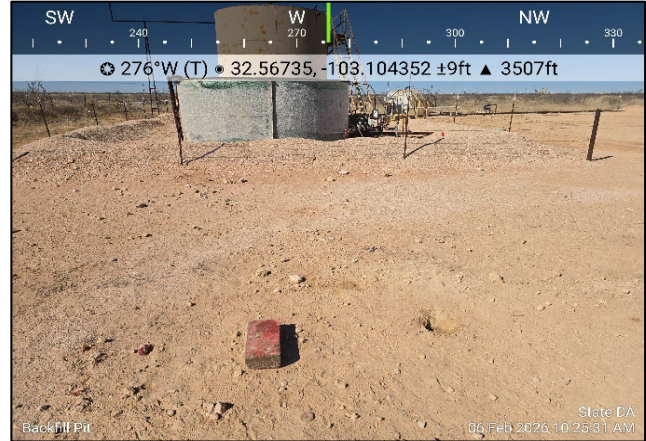
Photograph: 10 Date: 2/6/2026
Description: Delineation activities - BH10
View: West

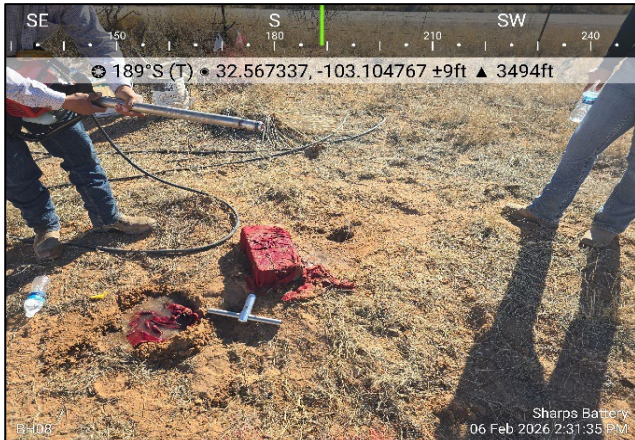
Photograph: 11 Date: 2/6/2026
Description: Delineation activities - BH08
View: South

Sample Name: BH08	Date: 2/6/2026
								Site Name: Sharps Battery	
								Incident Number: nAPP2521159402	
								Job Number: 07A1988312	
LITHOLOGIC / SOIL SAMPLING LOG								Logged By: Mario Sarkis	Method: Core-drill
Coordinates: 32.567442, -103.103856								Hole Diameter: 1.5"	Total Depth: 6'
Comments: Field screening conducted with HACH Chloride Test Strips and PID for chloride and vapor, respectively. Chloride test performed with 1:4 dilution factor of soil to distilled water. A 40% correction factor is included.									
Moisture Content	Chloride (ppm)	Vapor (ppm)	Staining	Sample ID	Sample Depth (ft bgs)	Depth (ft bgs)	USCS/Rock Symbol	Lithologic Descriptions	
D	< 176	14.7	N	BH08	0.5	0	SP	[0-5'] SAND, reddish brown, fine grained silty sand, cohesive, non-plastic	
D	< 176	13.6	N	-	-	1			
D	< 176	9.5	N	-	-	2			
D	< 176	4.4	N	BH08A	3	3			
D	< 176	3.9	N	-	-	4			
D	< 176	11.6	N	-	-	5	CCHE	[5-6'] CALICHE, tan to white, clayey caliche, fine grained, cohesive, non-plastic

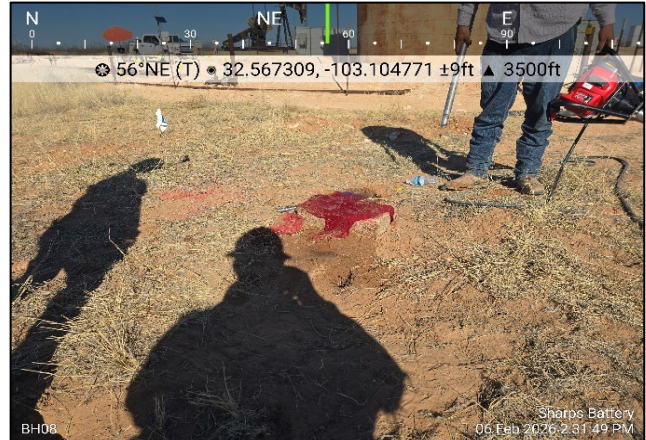
Photograph: 12 Date: 2/6/2026
Description: Delineation activities - BH08
View: Northeast
