Re: Closure Report  
Sneaky Snake 24 CTB 1  
Incident Number: nAPP2606123234 & nAPP2609130005  
Lea County, New Mexico

**Devon Energy Production Company, LP**  
**Sneaky Snake 24 CTB 1**  
**nAPP2606123234 and nAPP2609130005**  
**Closure Report**

# Field Inspection Photo Log | Sneaky Snake 24 CTB 1

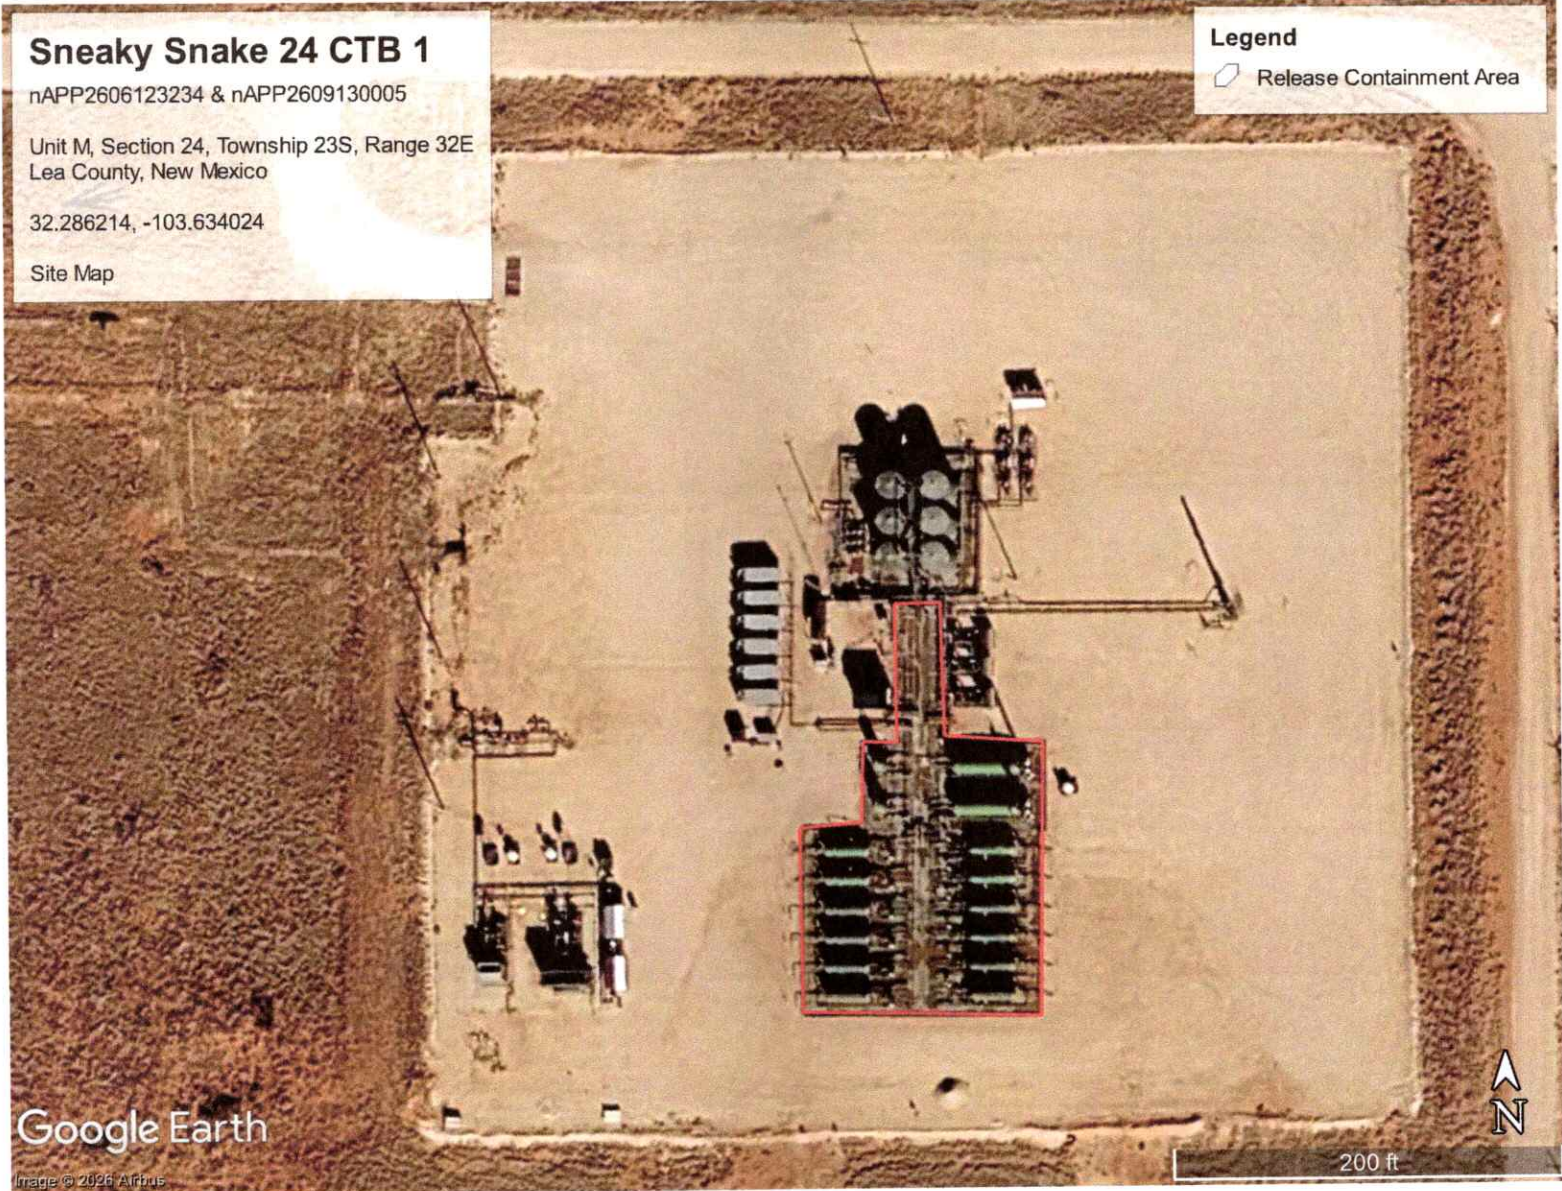
## Figure 1. Site Vicinity and Receptor Map

The Site was characterized to assess the applicability of Table I Closure Criteria for Soils Impacted by a Release, as specified in 19.15.29 NMAC. Results of the desktop review are summarized below; receptors are identified in Figure 1, with supporting well records provided in Appendix A.

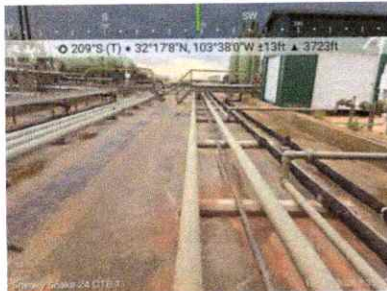
**Secondary containment — berm top, SSW view**

Berm top looking SSW with multiple process pipe runs. Berm surface wet from rainfall during inspection. No observations of brine staining or standing fluid attributable to a release. Containment wall intact.

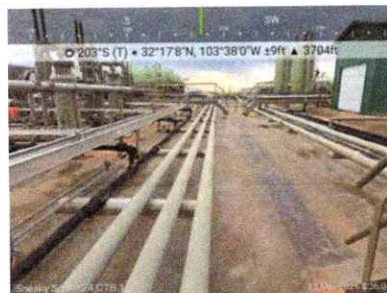
**Secondary containment — berm top, south view**

South view down berm top with pipe runs and pipe rack crossing. Berm surface wet from rainfall. No observations of release. Containment wall intact.

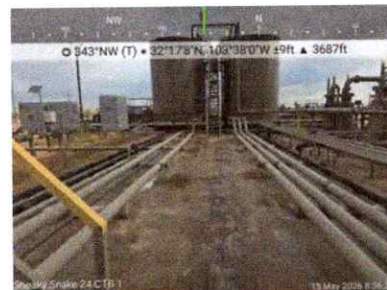
**Secondary containment — berm top, NW view toward storage tanks**

Looking NW toward storage tanks. Multiple pipe runs on berm surface. Berm wet from rainfall. No staining or release observations. Containment wall intact.

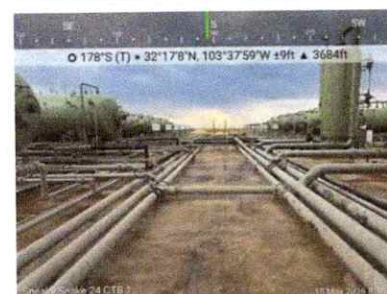
**Secondary containment — manifold area, south view**

Wide south view of manifold area with flanged pipe headers and gate valves at berm level. Berm surface wet from rainfall. No observations of release. Containment wall intact on both sides.

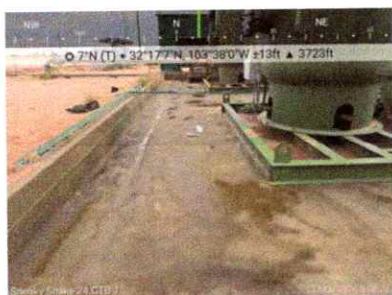
**Secondary containment — berm walkway, north view**  
 08:38:22 7°N 32°17'7"N 103°38'0"W

Berm walkway looking north beside large vessel base. Berm surface wet from rainfall. Loose black trash bag on exterior ground — housekeeping item. Containment wall intact.

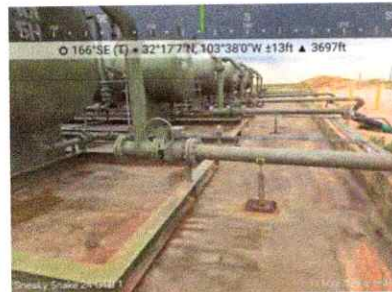
**Secondary containment — berm surface, separator vessel row**  
 08:38:46 166°SE 32°17'7"N 103°38'0"W

Separator vessel row (V103/2H) with gate valve and pipe headers. Berm surface wet from rainfall. Drain/vent stub with base plate present on berm surface. Containment wall intact. Exterior desert terrain visible and dry.

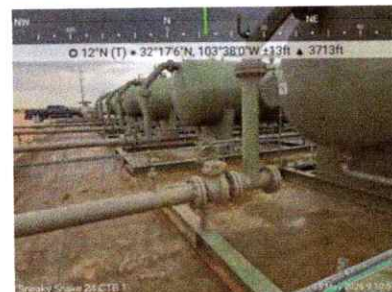
**Secondary containment — north view, V117/302N**  
 09:10:57 12°N 32°17'6"N 103°38'0"W

Looking north between separator vessels (V117/302N). Berm surface wet from rainfall. No observations of release or breach. Containment wall intact.

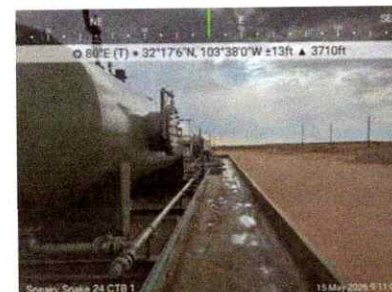
**Secondary containment — east berm, long view**  
 09:11:05 80°E 32°17'6"N 103°38'0"W

East-facing long view of berm. Berm surface wet from rainfall. Some prior salt/brine residue from operations also visible. Exterior sandy ground dry — no staining outside berm. Containment wall intact.

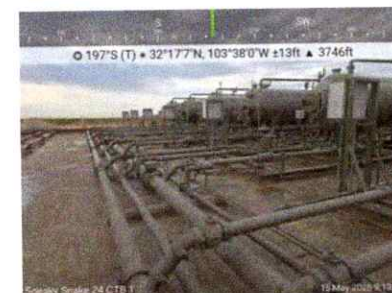
**Secondary containment — manifold berm, south view**  
 09:13:51 197°S 32°17'7"N 103°38'0"W

Dense pipe manifold with headers and flanged connections. Berm surface wet from rainfall. No observations of release. Containment wall intact.

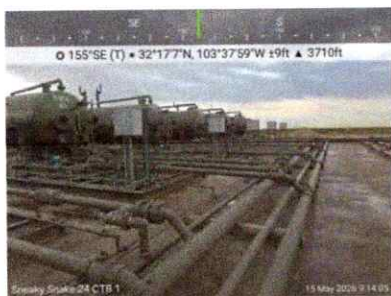
**Secondary containment — separator vessel row, SE view, V-104/4H**  
 09:14:05 155°SE 32°17'7"N 103°37'59"W

Separator vessel row (V-104/4H and others). Berm surface wet from rainfall. No observations of release or staining. Containment wall intact.

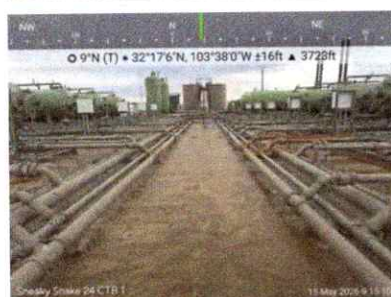
**#39 Secondary containment — manifold berm center, north view**  
 09:15:10 9°N 32°17'6"N 103°38'0"W

Wide north view down manifold berm with pipe headers on both sides. Berm surface wet from rainfall. No observations of release. Containment wall intact along full observed length.

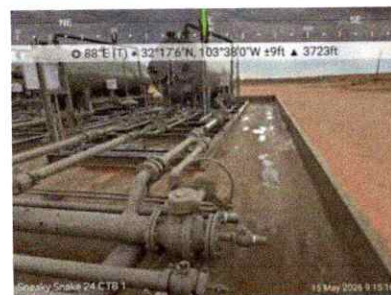
**#40 Secondary containment — east berm edge, ball valve**  
 09:15:16 88°E 32°17'6"N 103°38'0"W

Berm edge facing east with flanged ball valve and pipe headers. Berm surface wet from rainfall. Exterior ground beyond berm wall dry. No staining outside berm. Containment wall intact.

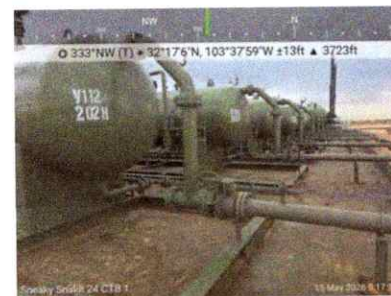
**#41 Secondary containment — NW view, V112/202H and V110/302H**  
 09:17:36 333°NW 32°17'6"N 103°37'59"W

Separator vessel row (V112/202H, V110/302H). Berm surface dry in this section. No staining or fluid observed. Containment wall intact.

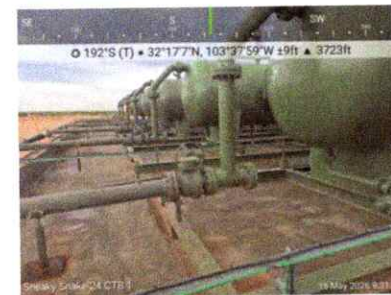
**#42 Secondary containment — south view, separator vessel row**  
 09:31:34 192°S 32°17'7"N 103°37'59"W

Separator vessel row with flanged ball valve and pipe headers. Berm surface dry to slightly wet from rainfall. No staining or release observations. Containment wall intact.

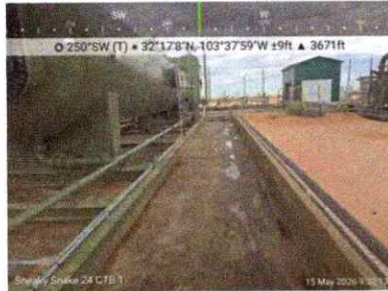
**#44 Secondary containment — west berm edge, SW view**

West-facing view along berm edge. Rainwater on berm surface. Exterior perimeter ground dry. No staining observed outside berm. Containment wall intact.

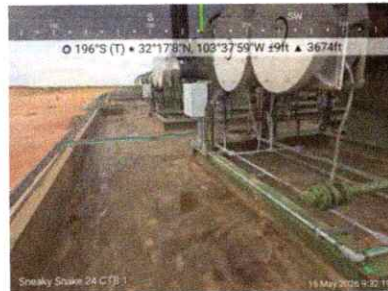
**#45 Secondary containment — south berm edge, compressor skid**

South berm edge at compressor/motor skid. Rainwater on berm surface. Loose black conduit draped across berm wall onto exterior ground — housekeeping item to address. Containment wall intact.
