## CLOSURE REPORT

**Blanco K-8**  
Unit Letter O, S 04, T 26 N R 6 W  
Rio Arriba County, New Mexico

**New Mexico EMNRD OCD Incident ID No. NAPP2610639005**

Ensolum Project No. 05A1226410

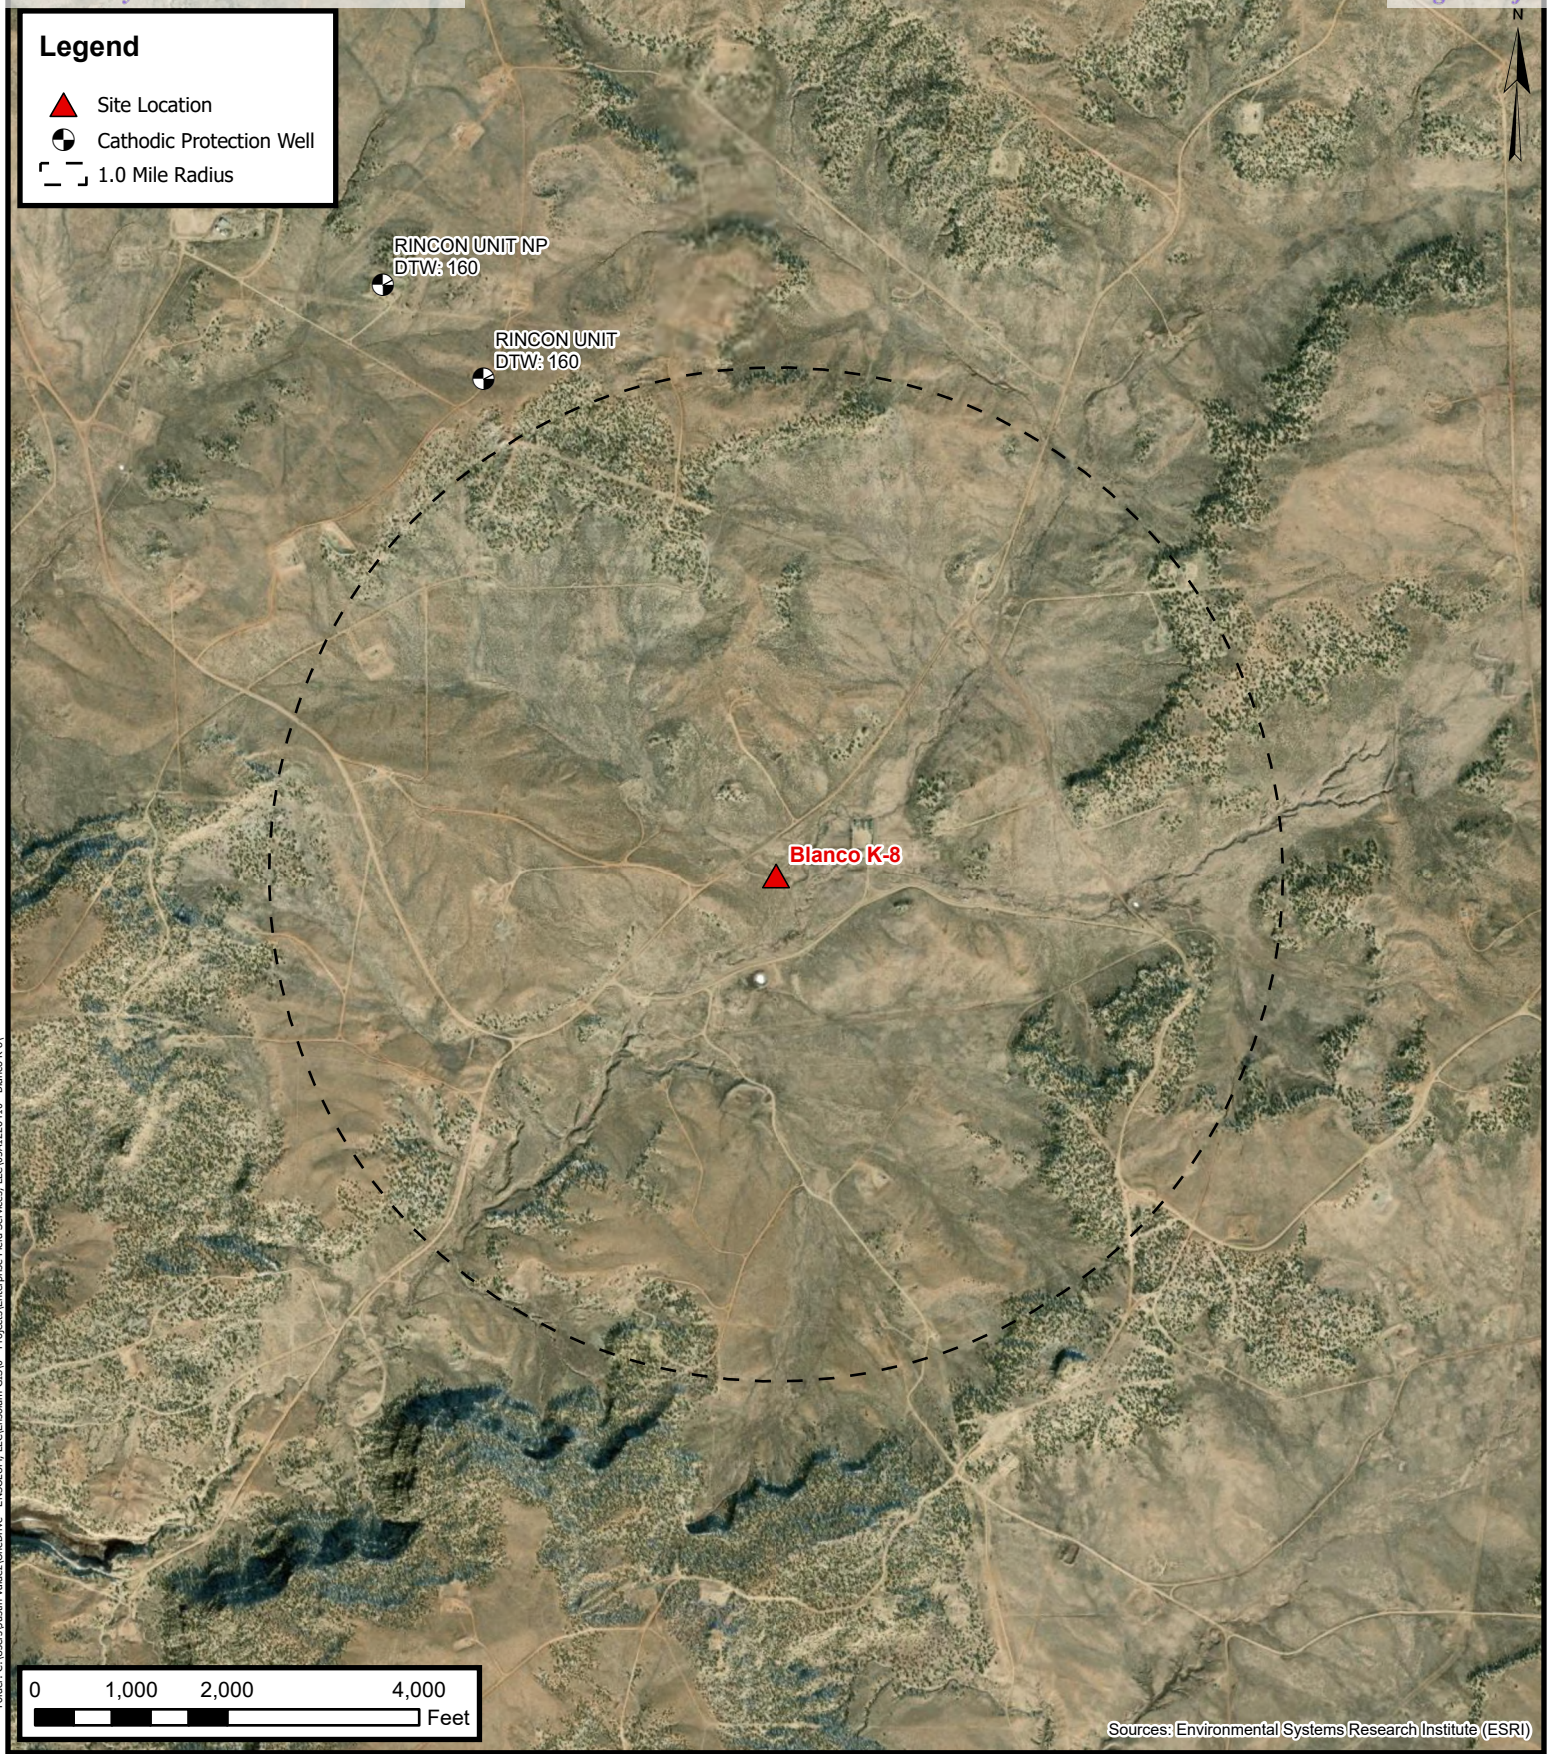
## FIGURE B

- No cathodic protection wells (CPWs) with recorded depths to water were identified in the NM EMNRD OCD imaging database within one mile of the Site (**Figure B, Appendix B**).

### Cathodic Protection Well Recorded Depth to Water

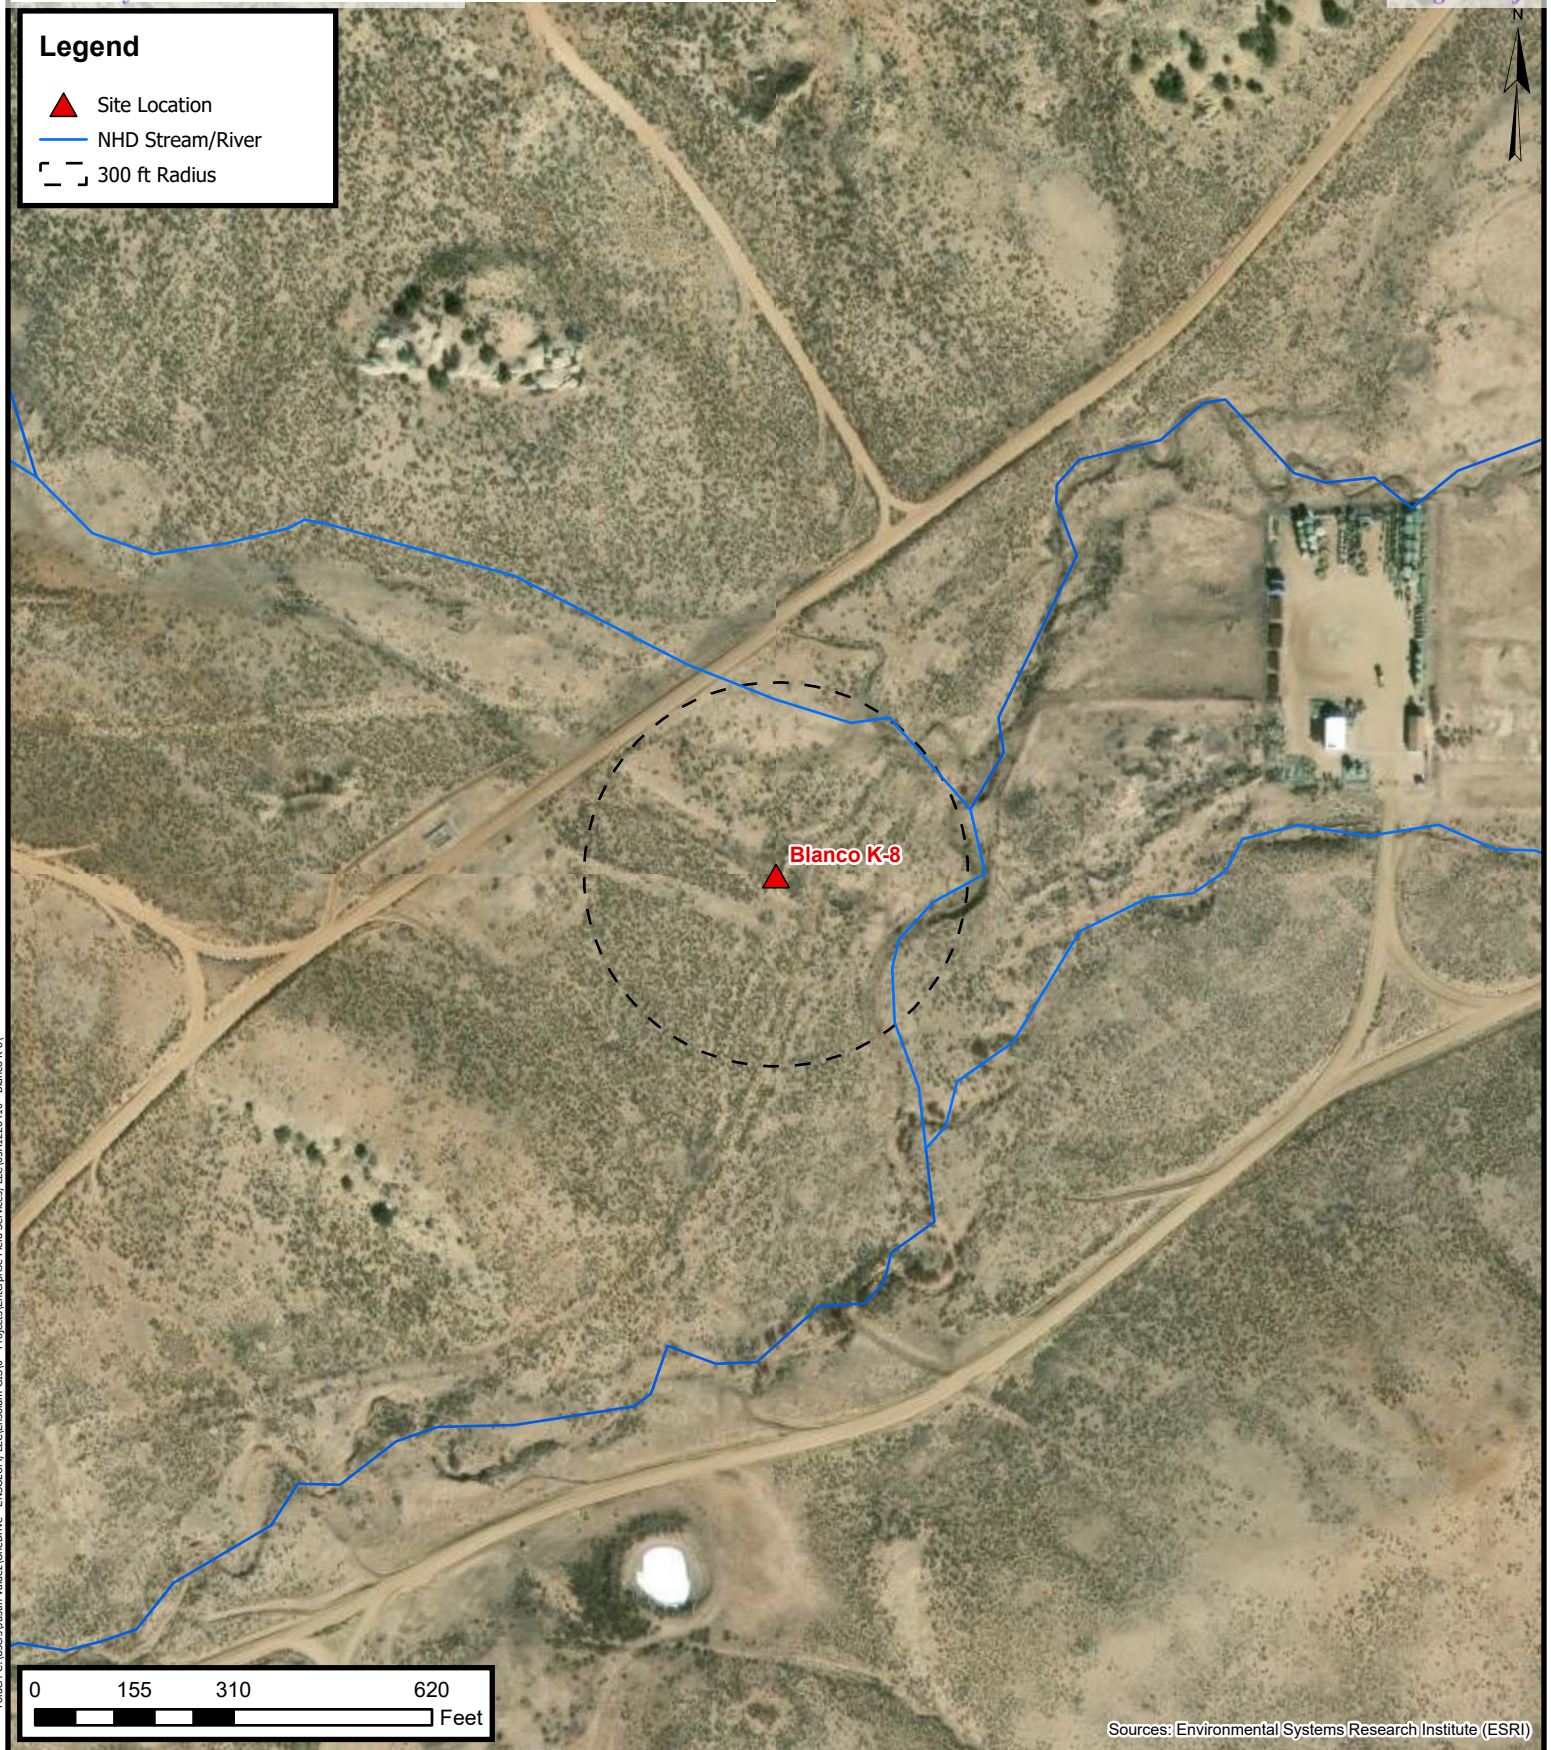
**FIGURE  
C**

- The Site is located within 300 feet of a NM EMNRD OCD-defined significant water course (**Figure C, Appendix B**). A “blue line” ephemeral wash is located approximately 155 feet southeast of the Site.

**300 Foot Radius Watercourse  
and Drainage Identification**  
Enterprise Field Services, LLC  
Blanco K-8  
Project Number: 05A1226410  
Unit N, Section 04, T 26N, R 06W, Rio Arriba County, New Mexico  
36.512562, -107.474384

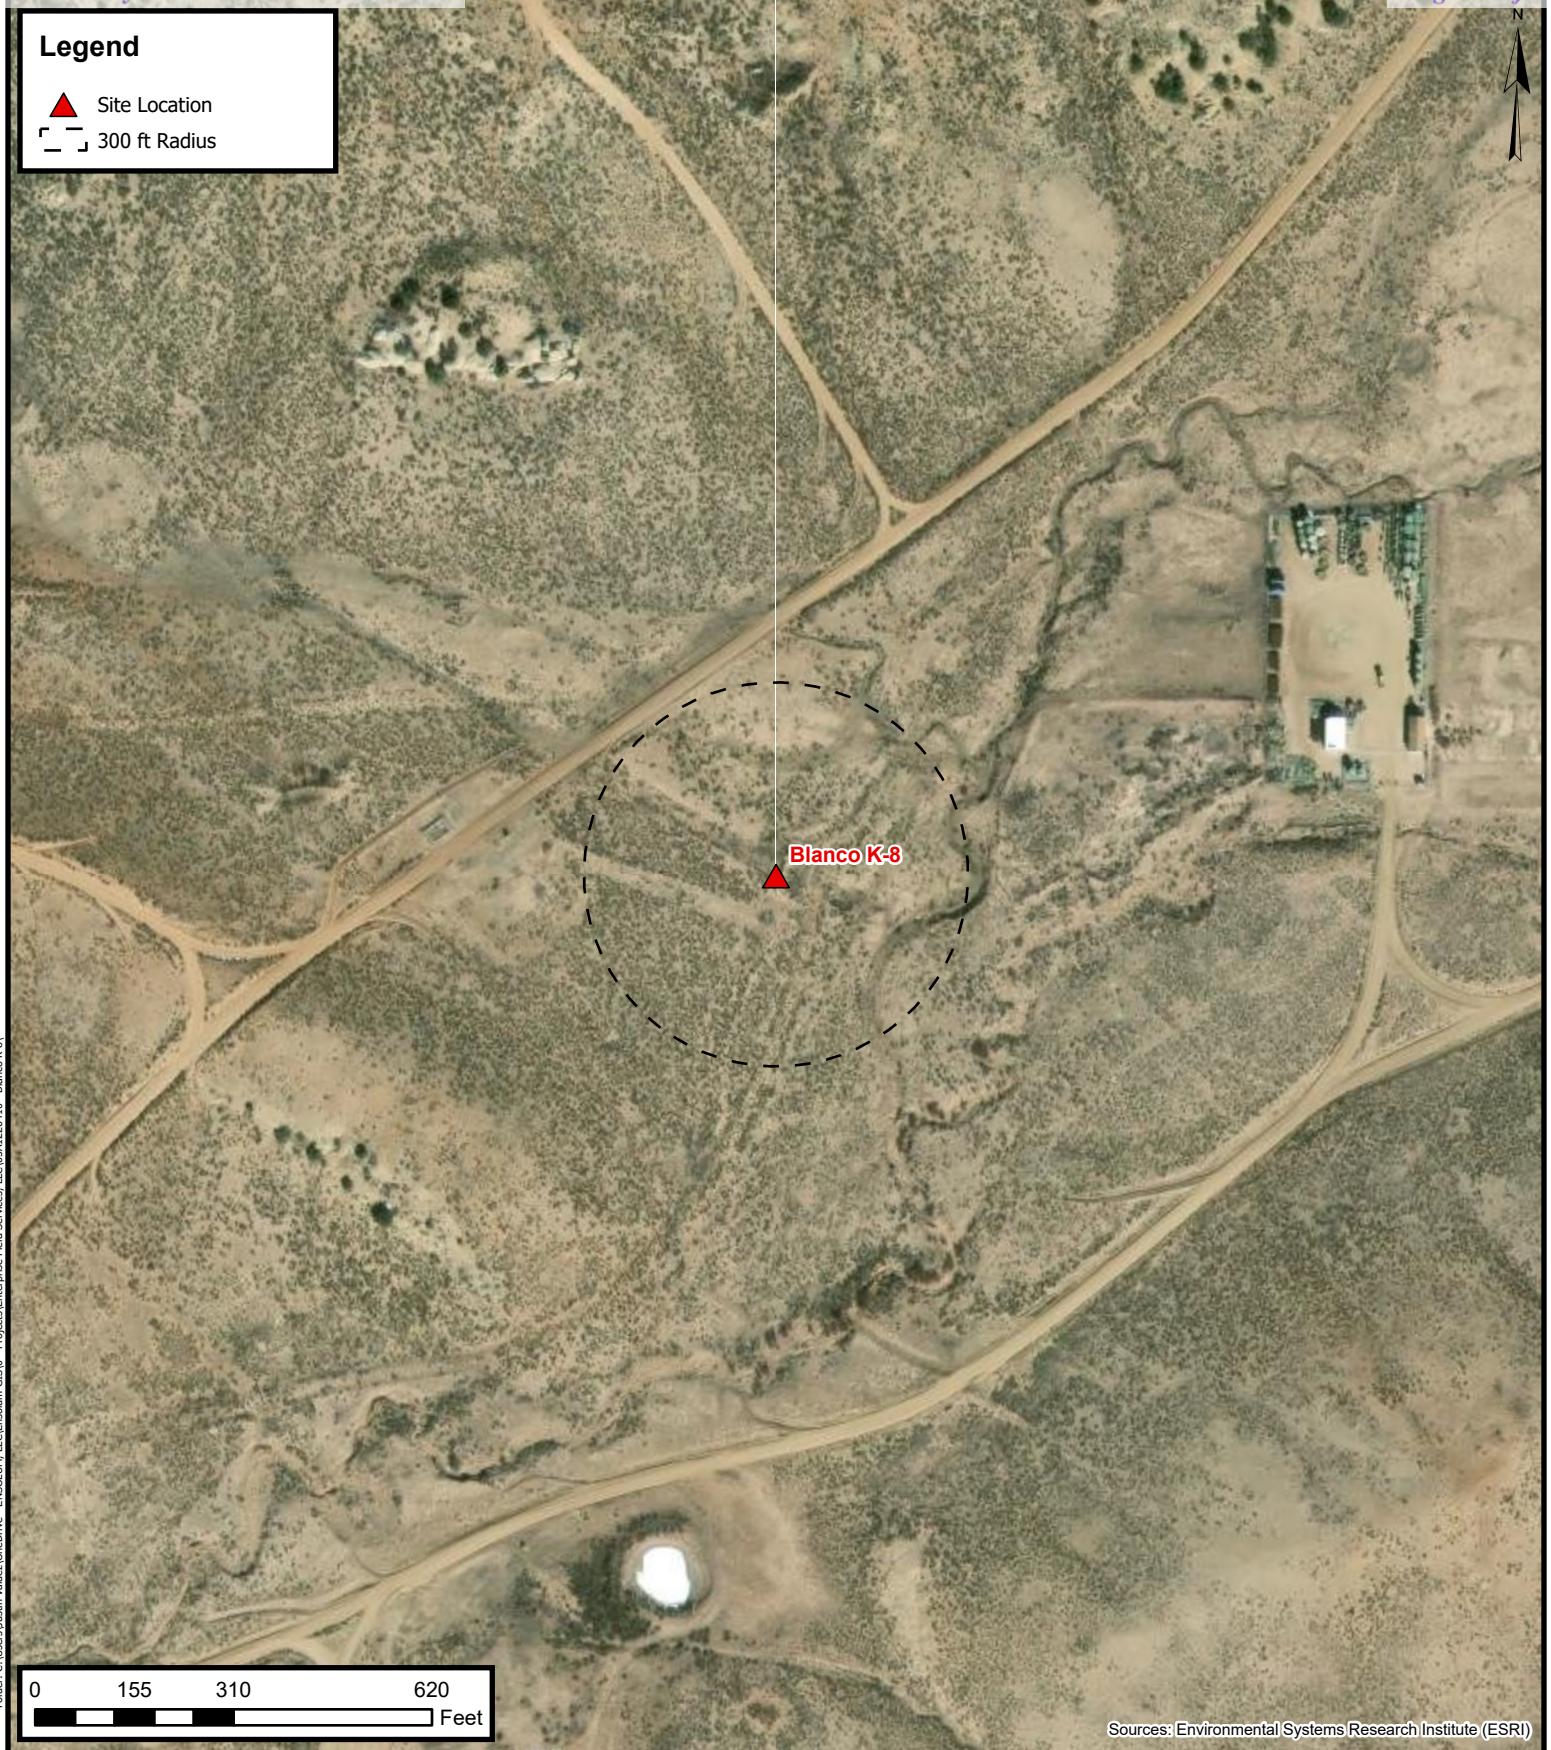
**FIGURE  
 D**

- The Site is not located within 200 feet of a lakebed, sinkhole, or playa lake.
- The Site is not located within 300 feet of a permanent residence, school, hospital, institution, or church (**Figure D, Appendix B**).

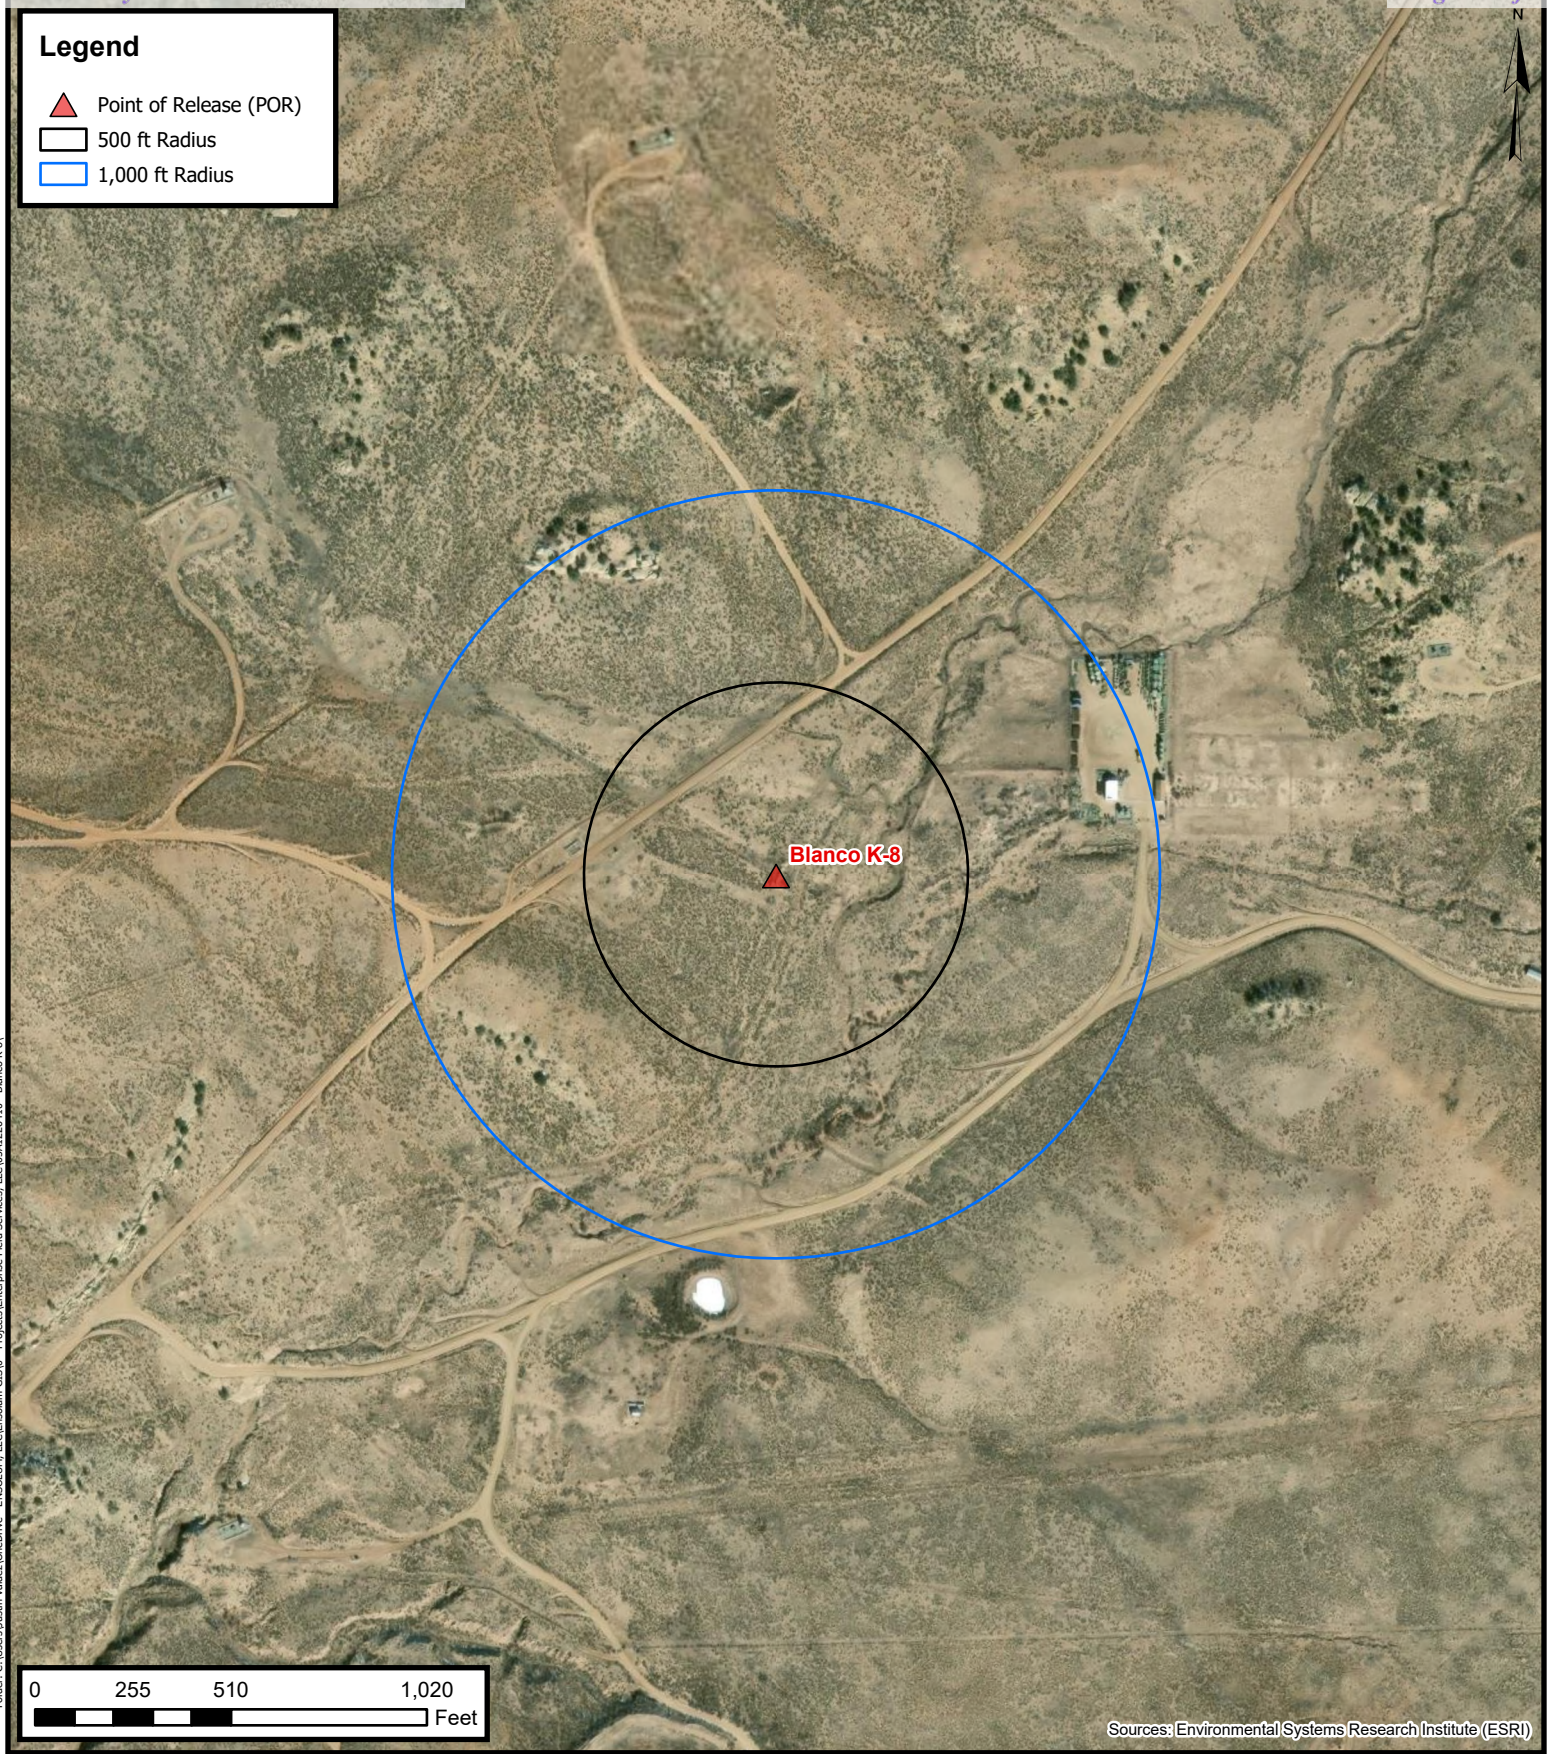
**FIGURE  
E**

- No springs or private domestic freshwater wells used by less than five households for domestic or stock watering purposes were identified within 500 feet of the Site (**Figure E, Appendix B**).

- The Site is not located within 1,000 feet of a spring (**Figure E, Appendix B**).
- The Site is not located within incorporated municipal boundaries or within a defined municipal fresh water well field covered under a municipal ordinance adopted pursuant to New Mexico Statutes Annotated (NMSA) 1978, Section 3-27-3. However, the Site is located in a designated Artesian Plan Area.

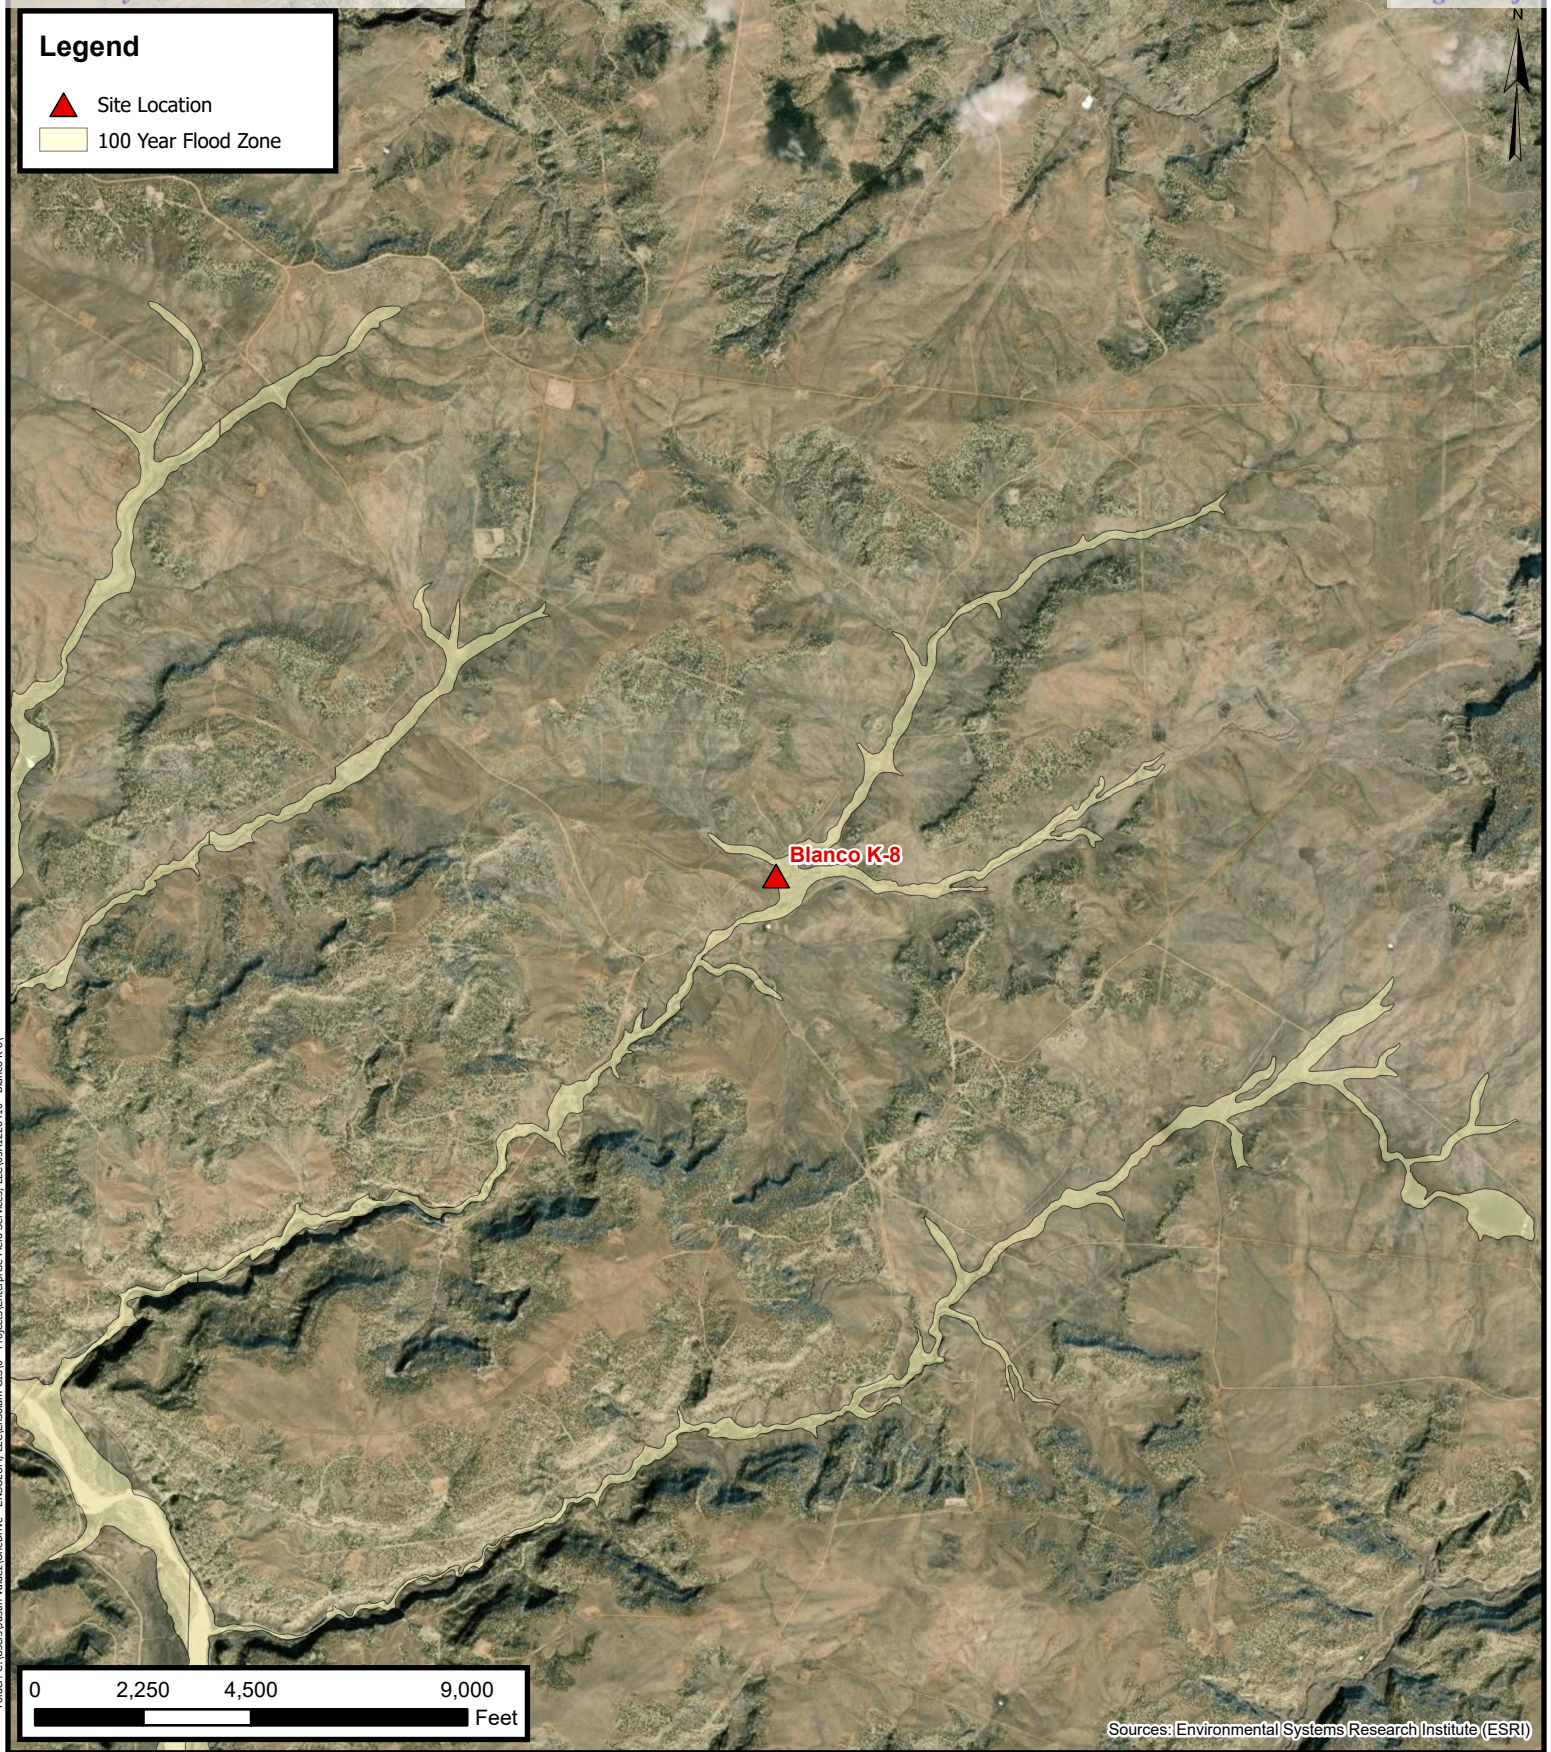
- The Site is not located within an unstable area per Paragraph (6) of Subsection U of 19.15.2.7 NMAC.
- Based on information provided by the Federal Emergency Management Agency (FEMA) National Flood Hazard Layer (NFHL) geospatial database, the Site is at the edge of a 100-year floodplain (**Figure H, Appendix B**).

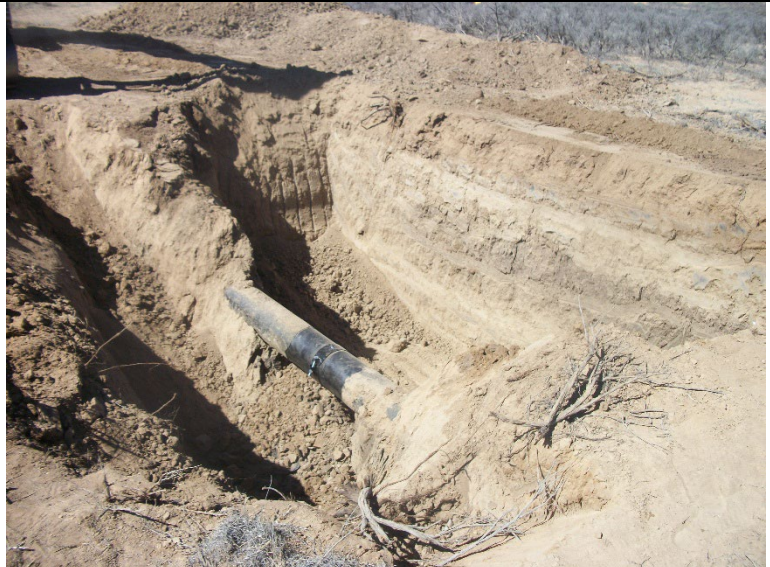
#### Photograph 4

Photograph Description: View of the in process excavation activities.

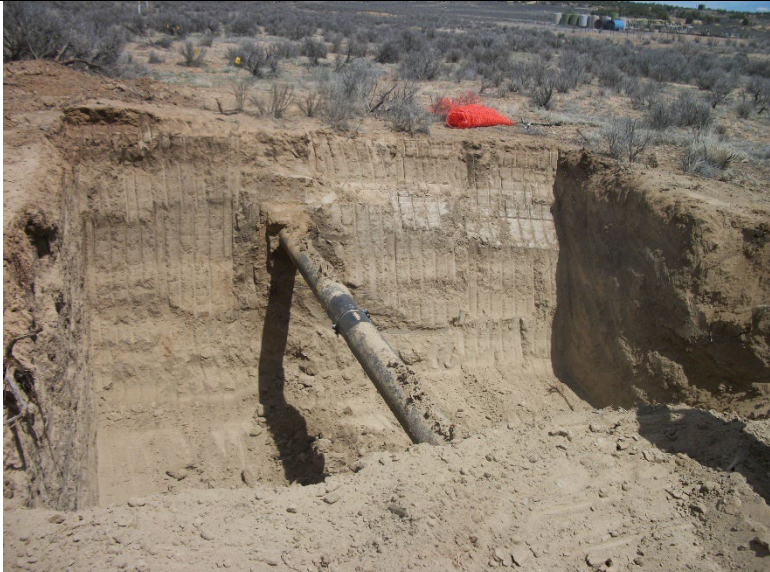
#### Photograph 5

The excavation measured approximately 18 feet by 27 feet at the maximum lateral extents. The calculated surface footprint is approximately 486 ft<sup>2</sup>. The maximum depth of the excavation measured approximately nine feet bgs. The lithology encountered during the completion of remediation activities consisted primarily of silty clayey sand.

Photograph Description: View of the final excavation activities.

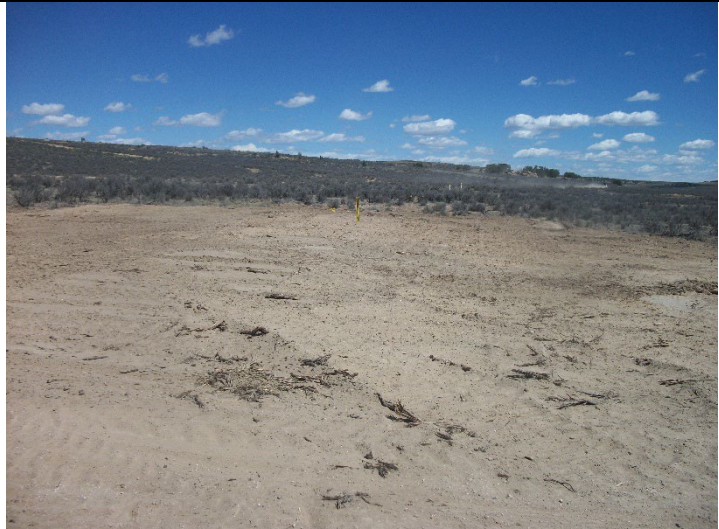
#### Photograph 6

Photograph Description: View of the final excavation after initial restoration.

The excavation was backfilled with imported fill and then contoured to the surrounding grade. The backfill and the upper four feet of the excavation have been analytically verified to be below the Tier I soil standards of 50 mg/kg BTEX, 10 mg/kg benzene, 100 mg/kg total combined TPH, and 600 mg/kg Chloride. See **Appendix D** and **Appendix F** for further documentation.
