April 27, 2026

**Re: Release Characterization and Remediation Work Plan
ConocoPhillips
Bobwhite 12 State Com 3H Release
Unit Letter O, Section 01, Township 21 South, and Range 33 East
Lea County, New Mexico
Incident ID: NAPP2602842731
Landowner: State (Merchant Livestock Company Agricultural Lease)**

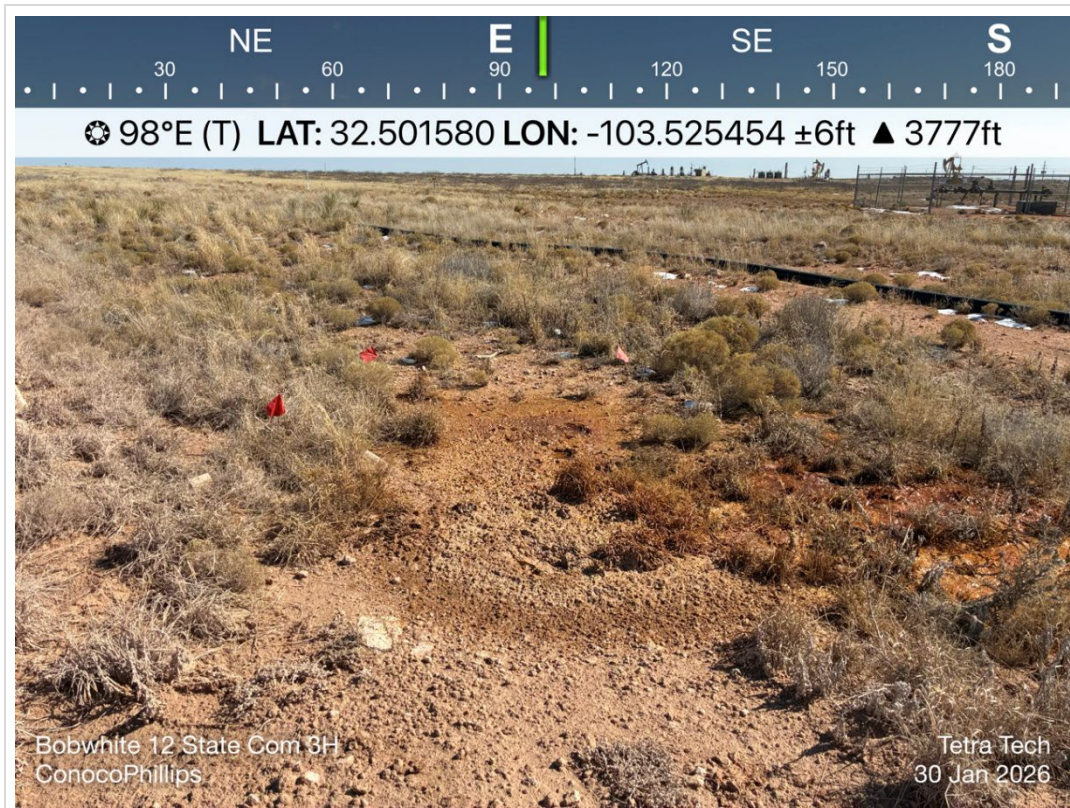
TETRA TECH, INC. PROJECT NO. 212C-MD-04132	DESCRIPTION	View east. View of release extent and gas line	1
	SITE NAME	BOBWHITE 12 STATE COM 3H	01/30/2026

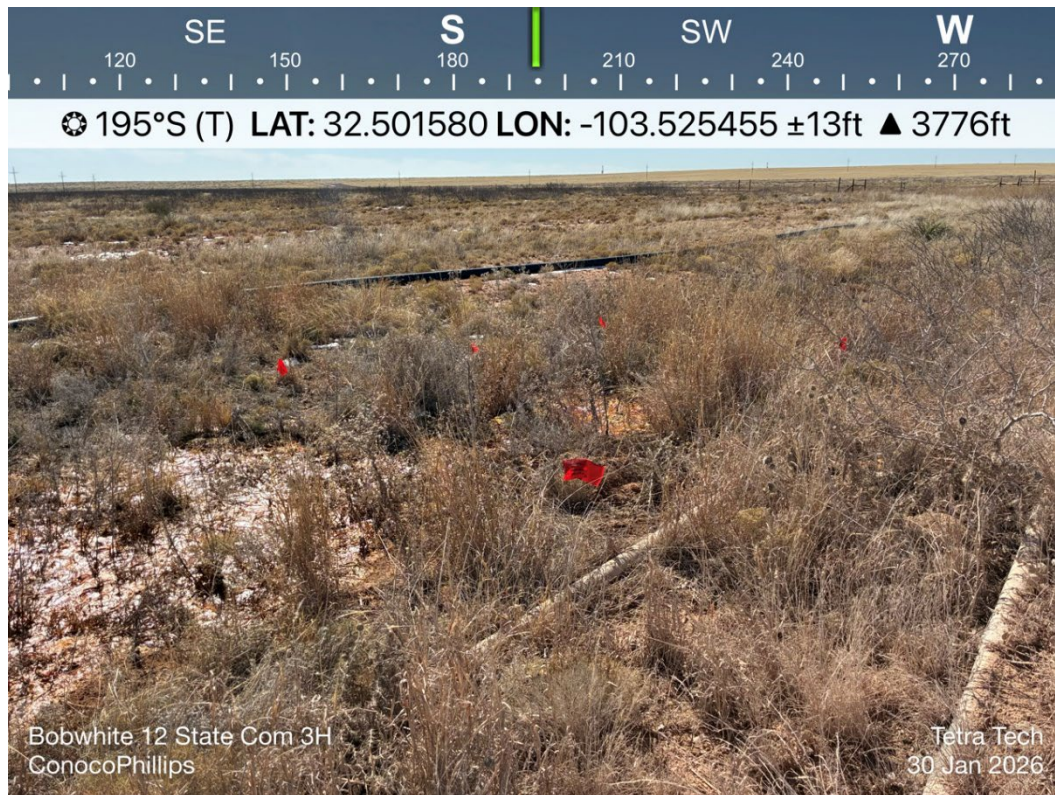
TETRA TECH, INC. PROJECT NO. 212C-MD-04132	DESCRIPTION	View south. View of release extent	2
	SITE NAME	BOBWHITE 12 STATE COM 3H	01/30/2026

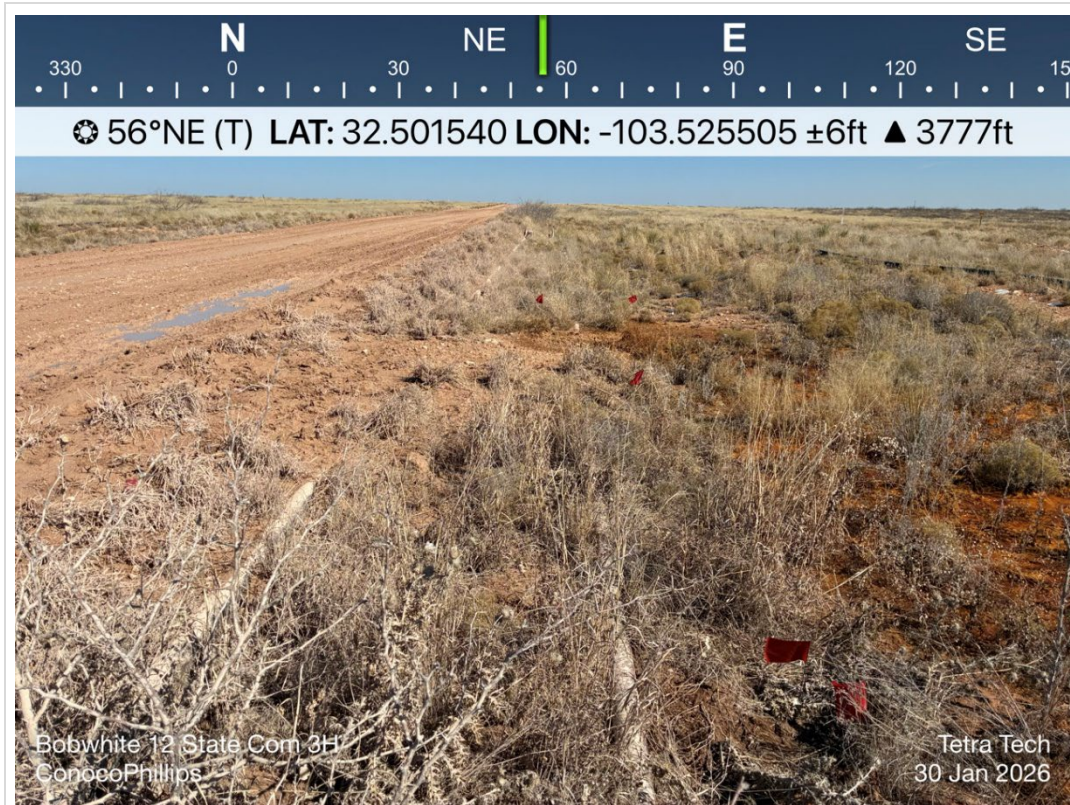
TETRA TECH, INC. PROJECT NO. 212C-MD-04132	DESCRIPTION	View northeast. View of release extent	6
	SITE NAME	BOBWHITE 12 STATE COM 3H	01/30/2026

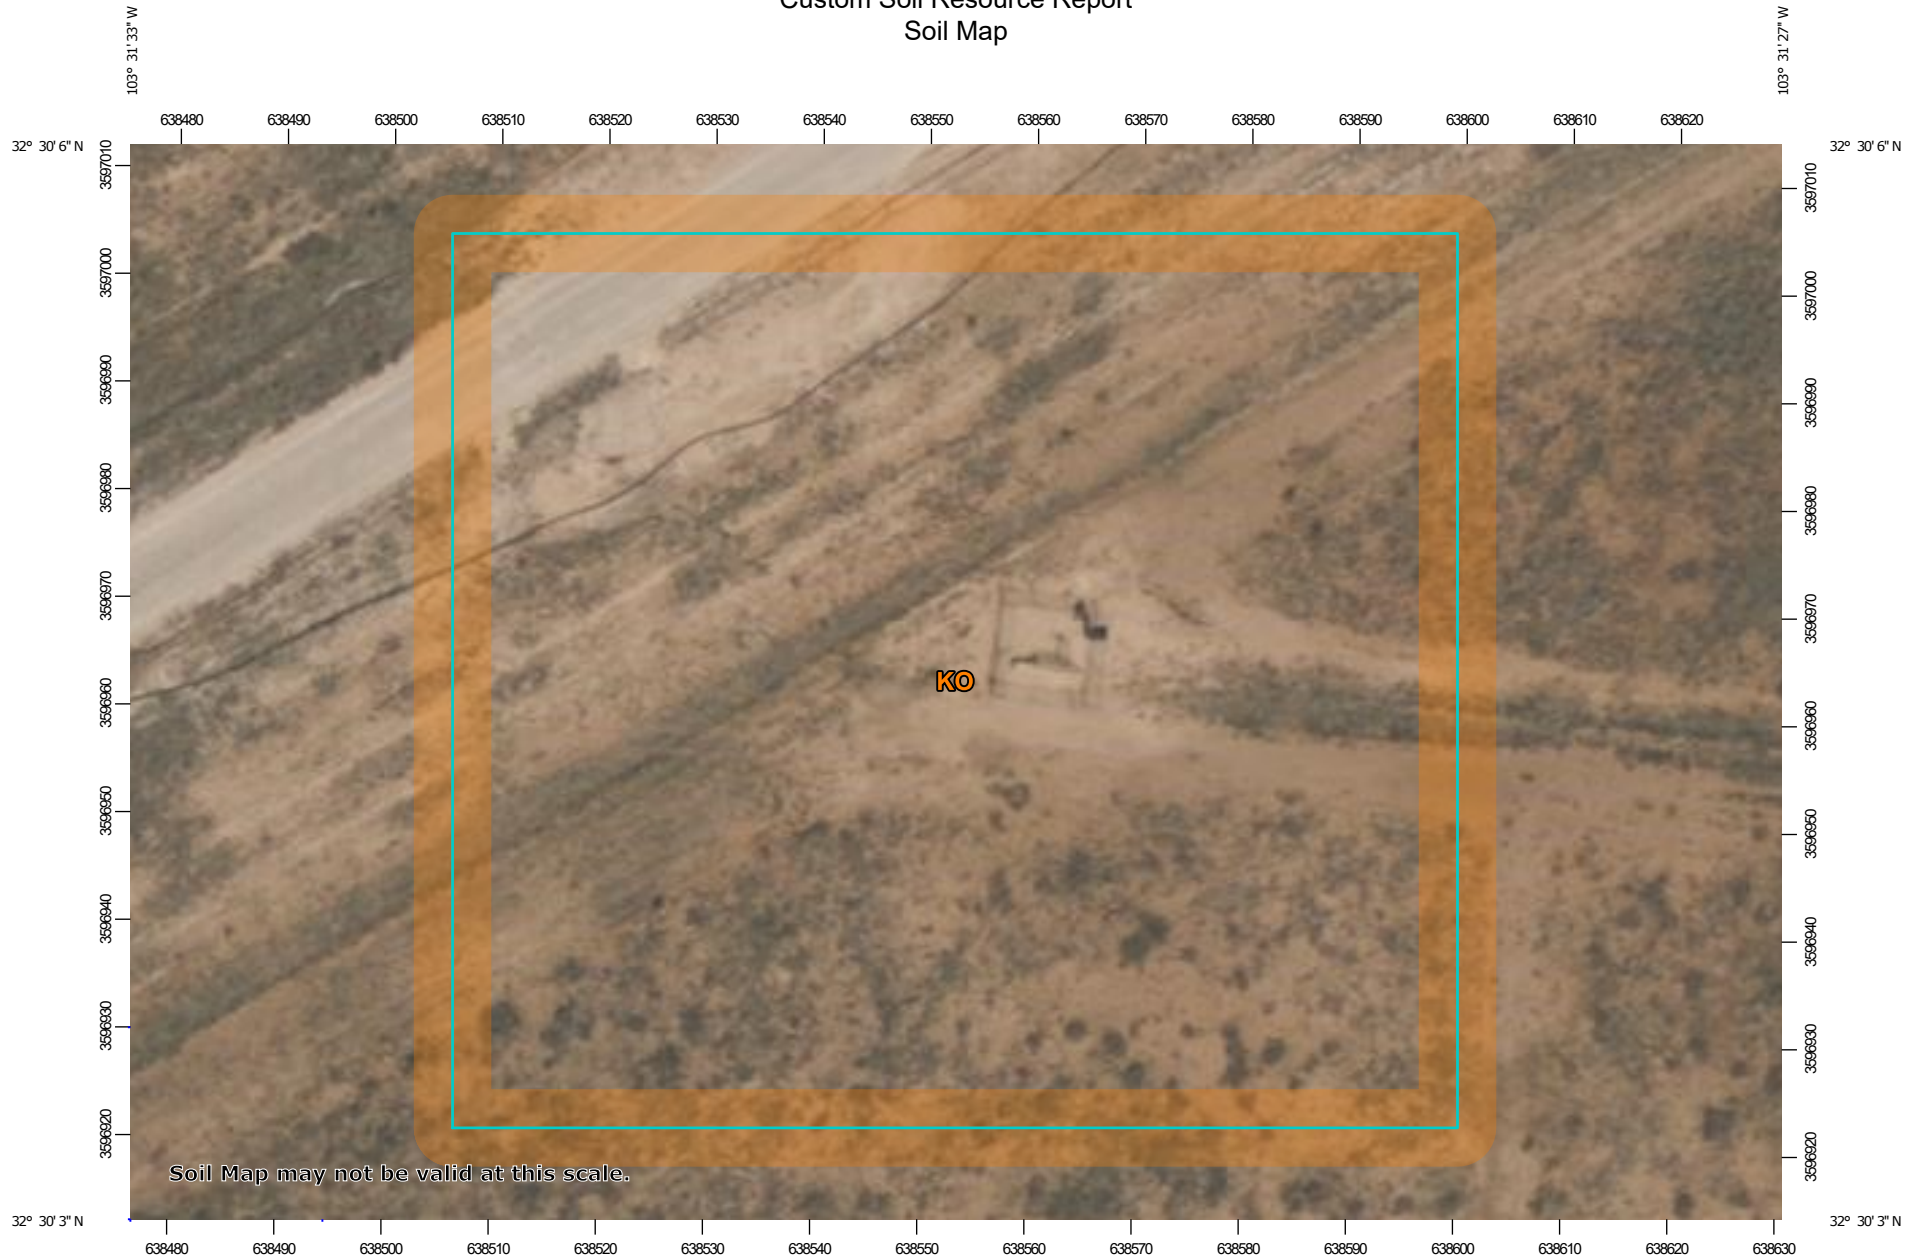
Custom Soil Resource Report Soil Map

The soil map section includes the soil map for the defined area of interest, a list of soil map units on the map and extent of each map unit, and cartographic symbols displayed on the map. Also presented are various metadata about data used to produce the map, and a description of each soil map unit.
