Closure Request

Catalina

Eddy County, NM

NMOCD Incident # nAPP2600641830

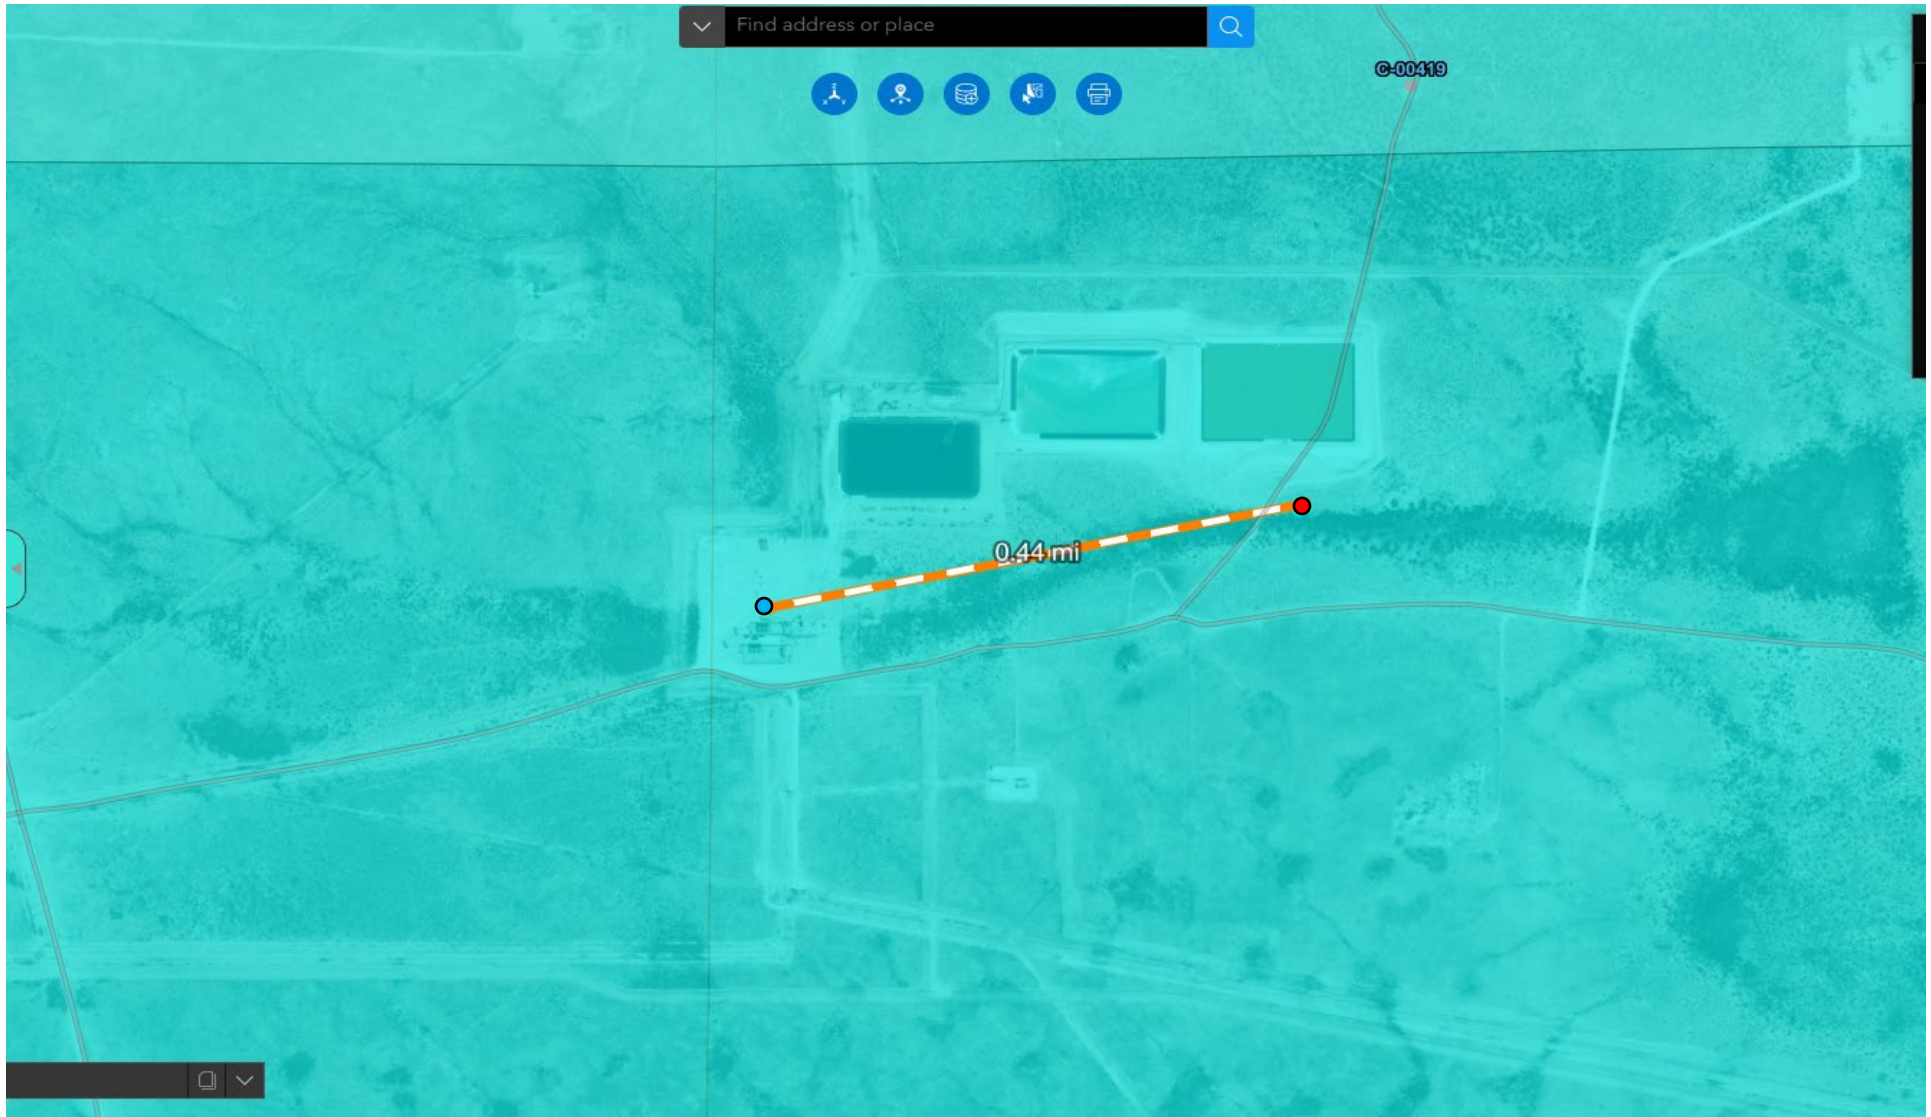
FIGURE 2
CATALINA – POD LOCATION MAP
Select Water
EDDY CO, NM
GPS: 32.54752, -104.32101

- Legend**
- Spill location
 - Well bore Catalina 30 EH ST #001 Location

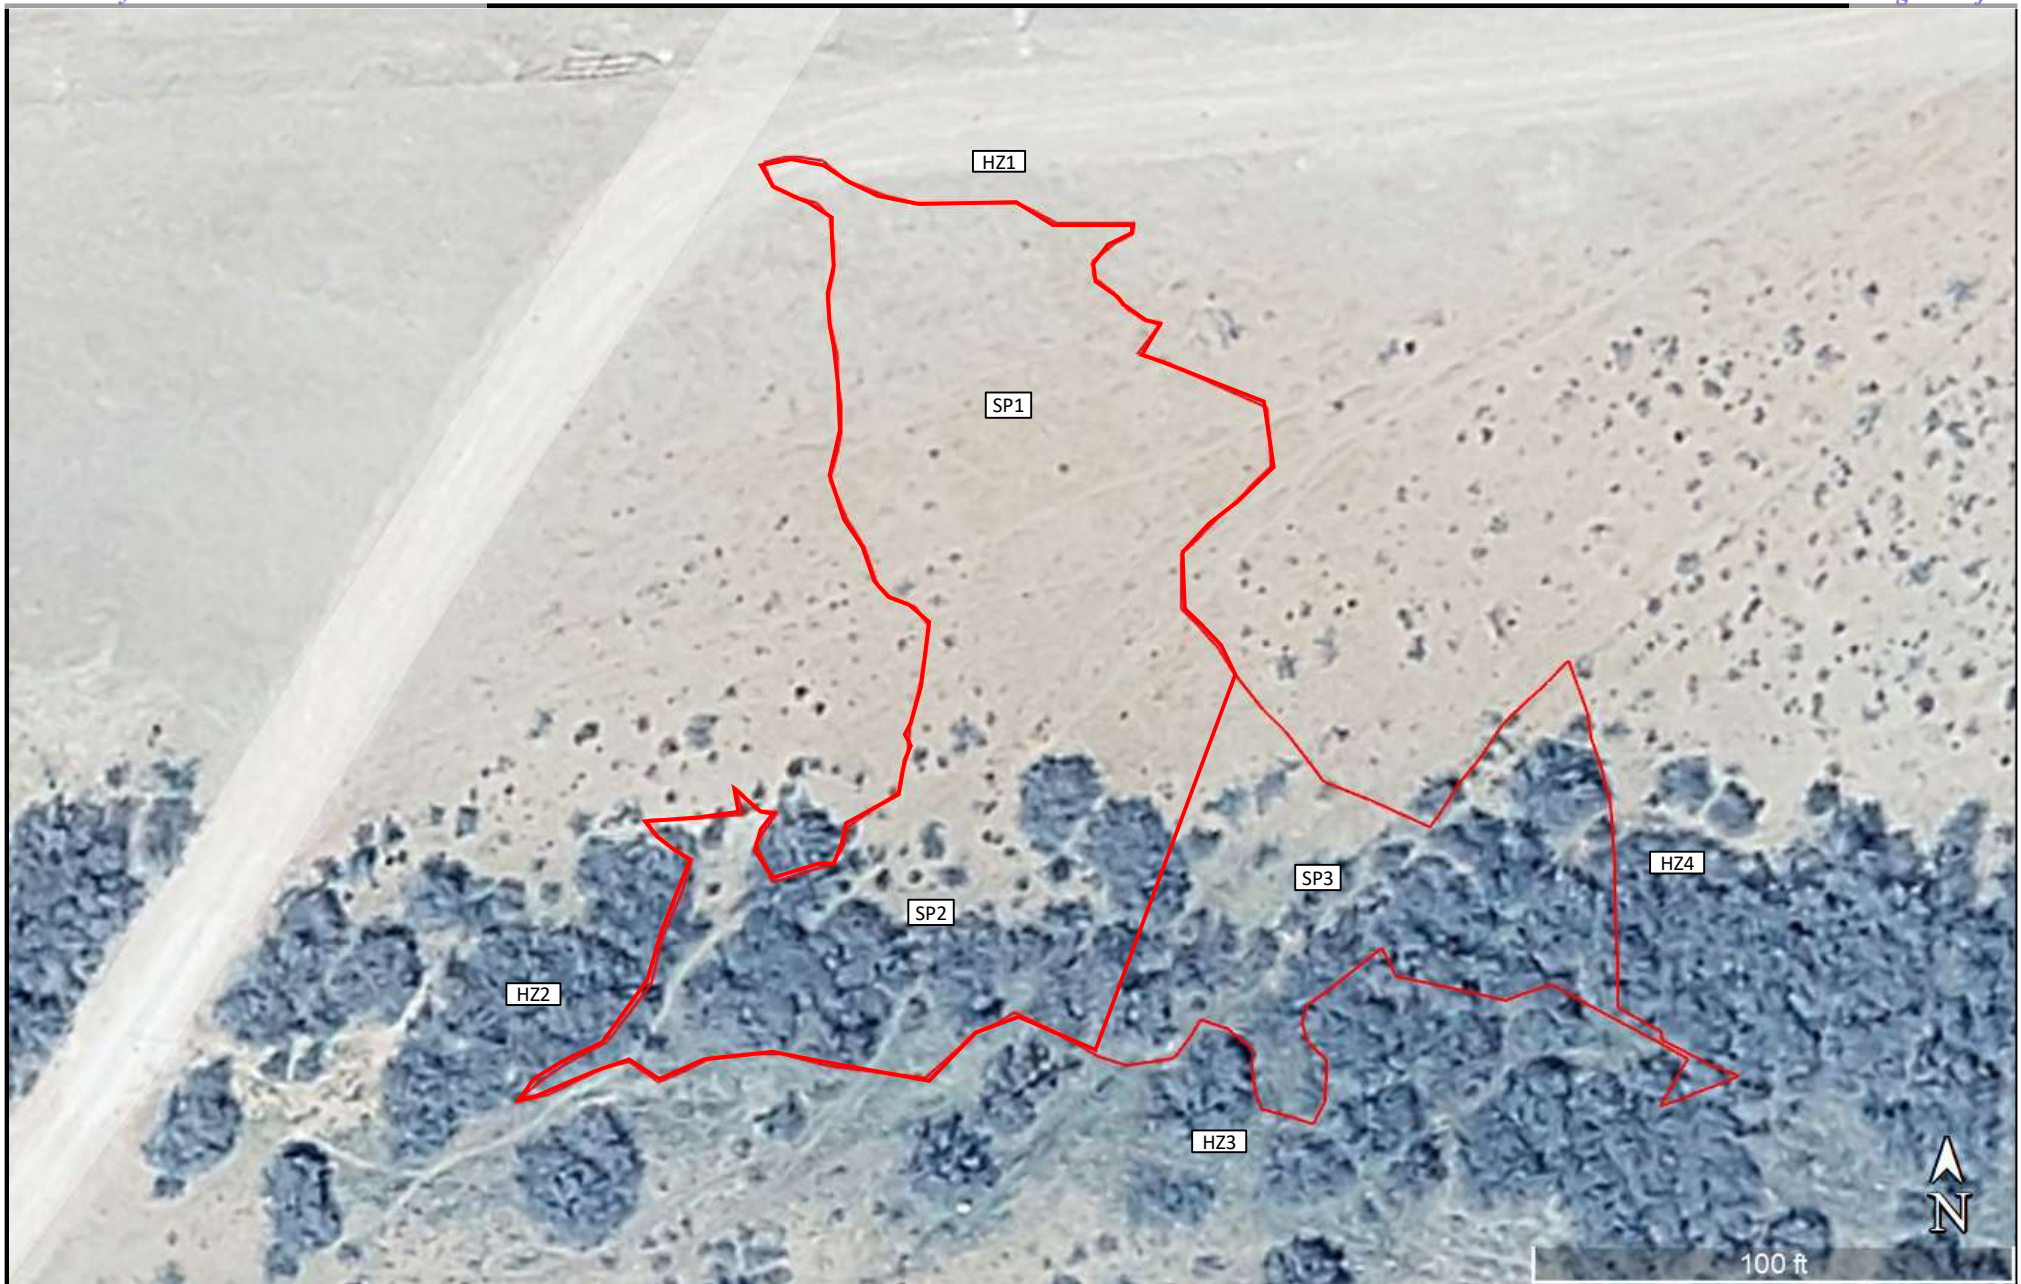
Figure 4

Delineation Sample Map
Select Water Solutions, LLC
Catalina
GPS: 32.547617, -104.321008
Eddy County

On April 29, 2026, Hungry Horse LLC was contracted to delineate the spill area. During delineation activities, sample test trenches were advanced in the release area in effort to determine the vertical extent of contamination. These sample locations are identified by S designation. In addition, sample test trenches were advanced along the outside edges of the release area in effort to determine the horizontal extent of contamination. These sample locations are identified by S designation. During the advancement of the test trenches, soil samples were collected and field screened for the presence of chloride concentrations utilizing a Hach Quantab® chloride test kit.

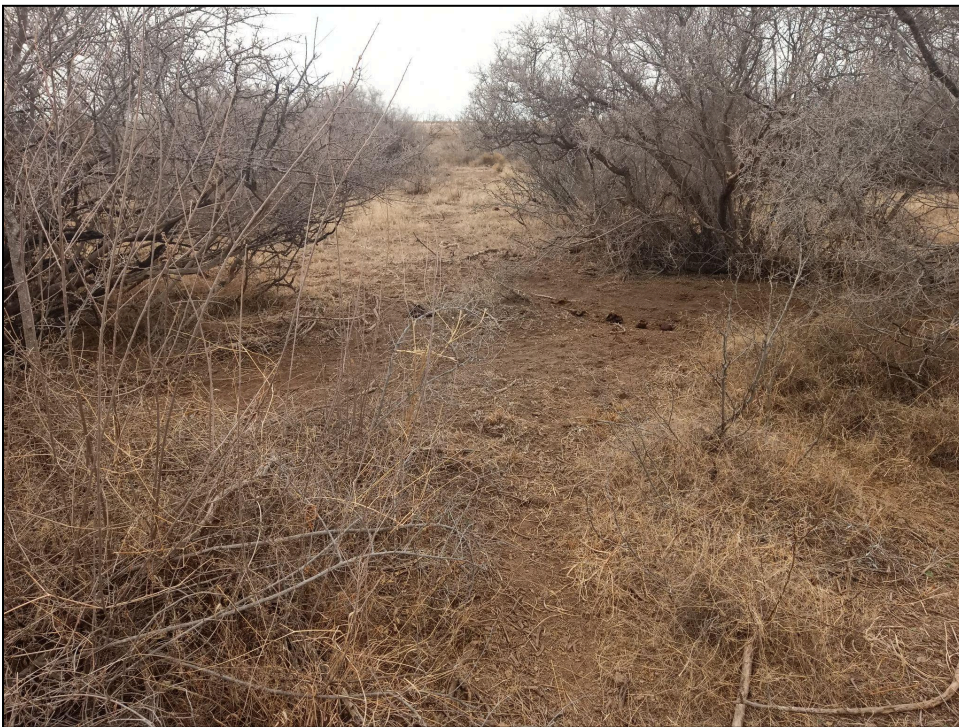
Photograph 6. View of observed NHD drainage MD01 within the proposed project survey area, facing south.

Based on the desktop review of the USGS NHD and USFWS NWI data, there was one NHD mapped surface water feature identified within 100 feet of the proposed project area (USGS 2025, USFWS 2025a). During the 2026 natural resources survey, one NHD was observed within the proposed project area (MD01, see Figure 4 in Appendix A and Photographs 6 and 7 in Appendix B). No additional surface water features were identified within the proposed project area during the 2026 natural resources survey.

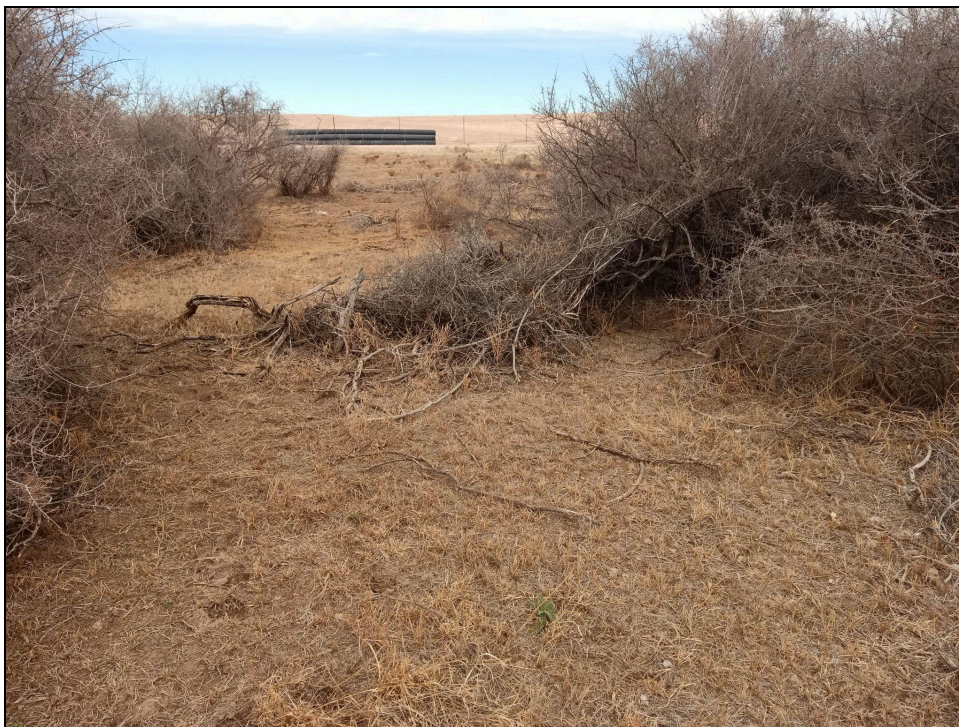
Photograph 7. View of observed NHD drainage MD01 within the proposed project survey area, facing north.

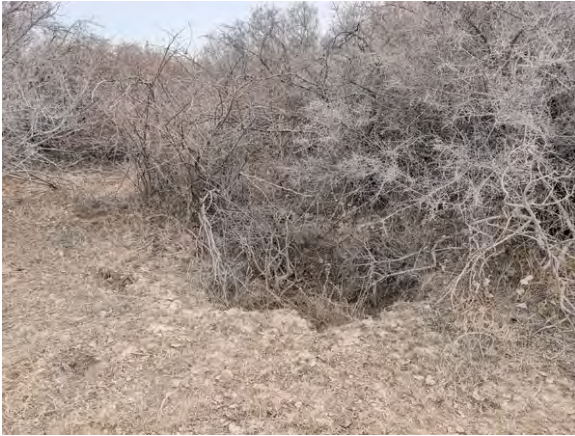
Feature KF-01, sinkhole

During the pedestrian survey, four surface karst features were identified; all soft sediment collapses within a vegetated draw. These features are likely pseudokarst caused by soil piping. All features are located at least 100 meters from the edge of the spill area.

Due to all features being pseudokarst and located at least 100 meters from the spill area, the buffer from the project area is recommended as sufficient.

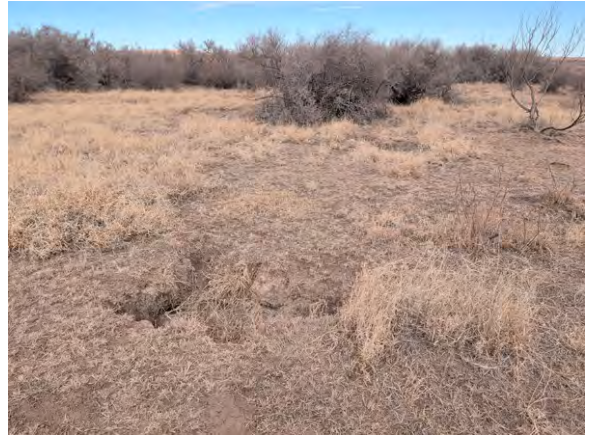
Feature KF-02, sinkhole

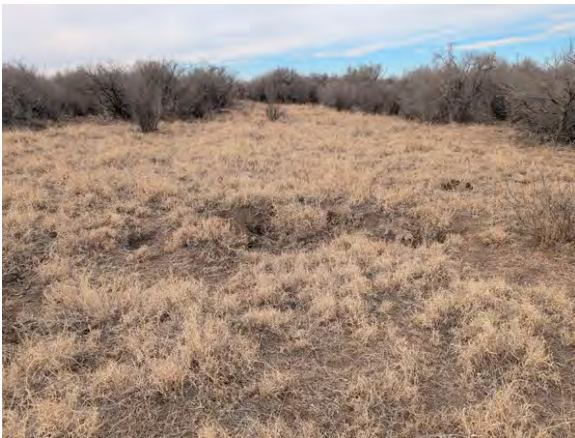
Feature KF-03, sinkhole

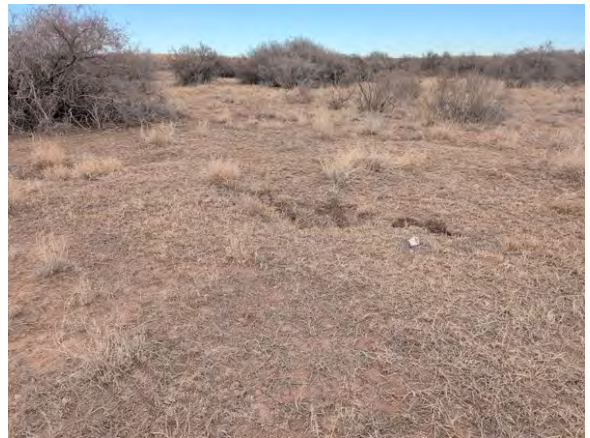
Feature KF-04, sinkhole

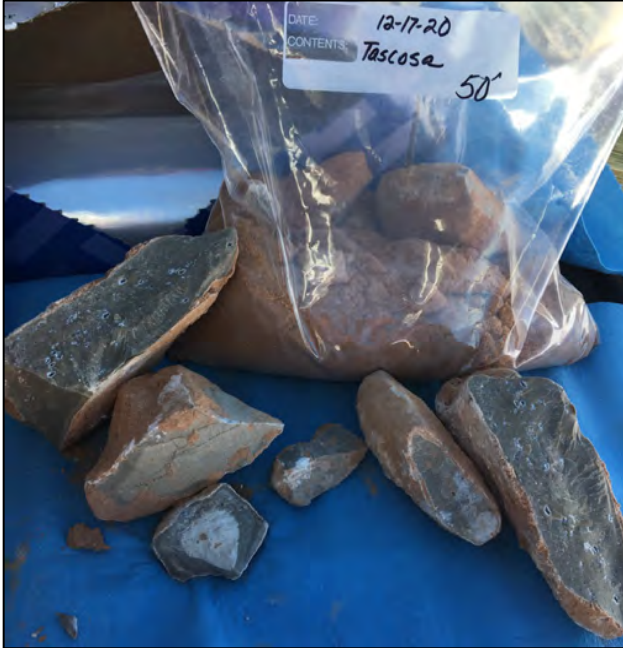
110-ft sample

- 74-94 feet Massive purple-red clay interbedded with white and pink gypsum; <5% green "sugar" dolomite clasts
- 94-110 feet Loose, medium red silt interbedded; 30% green/gray/yellow vesicular (1-2 mm) dolomite
- 110-113 feet Red-brown silt with thin layers of red-brown siltstone and gypsum (1-2 mm thick)
- 113-120 feet Dark red silt interbedded with 40% dolomite, green-gray, massive

Based on these observations, I am certain that no groundwater is present below the surface of this well site to 120 feet below ground surface (3,124 feet above sea level).

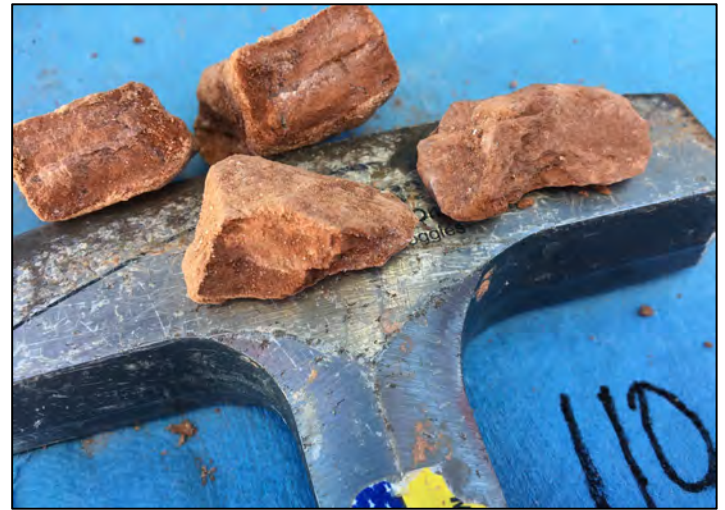
50-ft sample

- 10-18 feet Alluvium: brown, fine sand; caliche
- 18-63 feet Tan, loose siltstone with 10-30% interbedded green-gray dolomite. Dolomite beds are massive (1 mm-5 cm vesicles observed at 40 ft, most filled with siltstone)
- 63-68 feet Red, massive clay; minor tan silt, loose
- 68-74 feet Red, massive clay; clast and veins of white and clear gypsum/selenite
