Closure Report

Tatanka Federal 1H Battery (04.16.2021)

Incident ID: nAPP2110648325

Produced Water Release

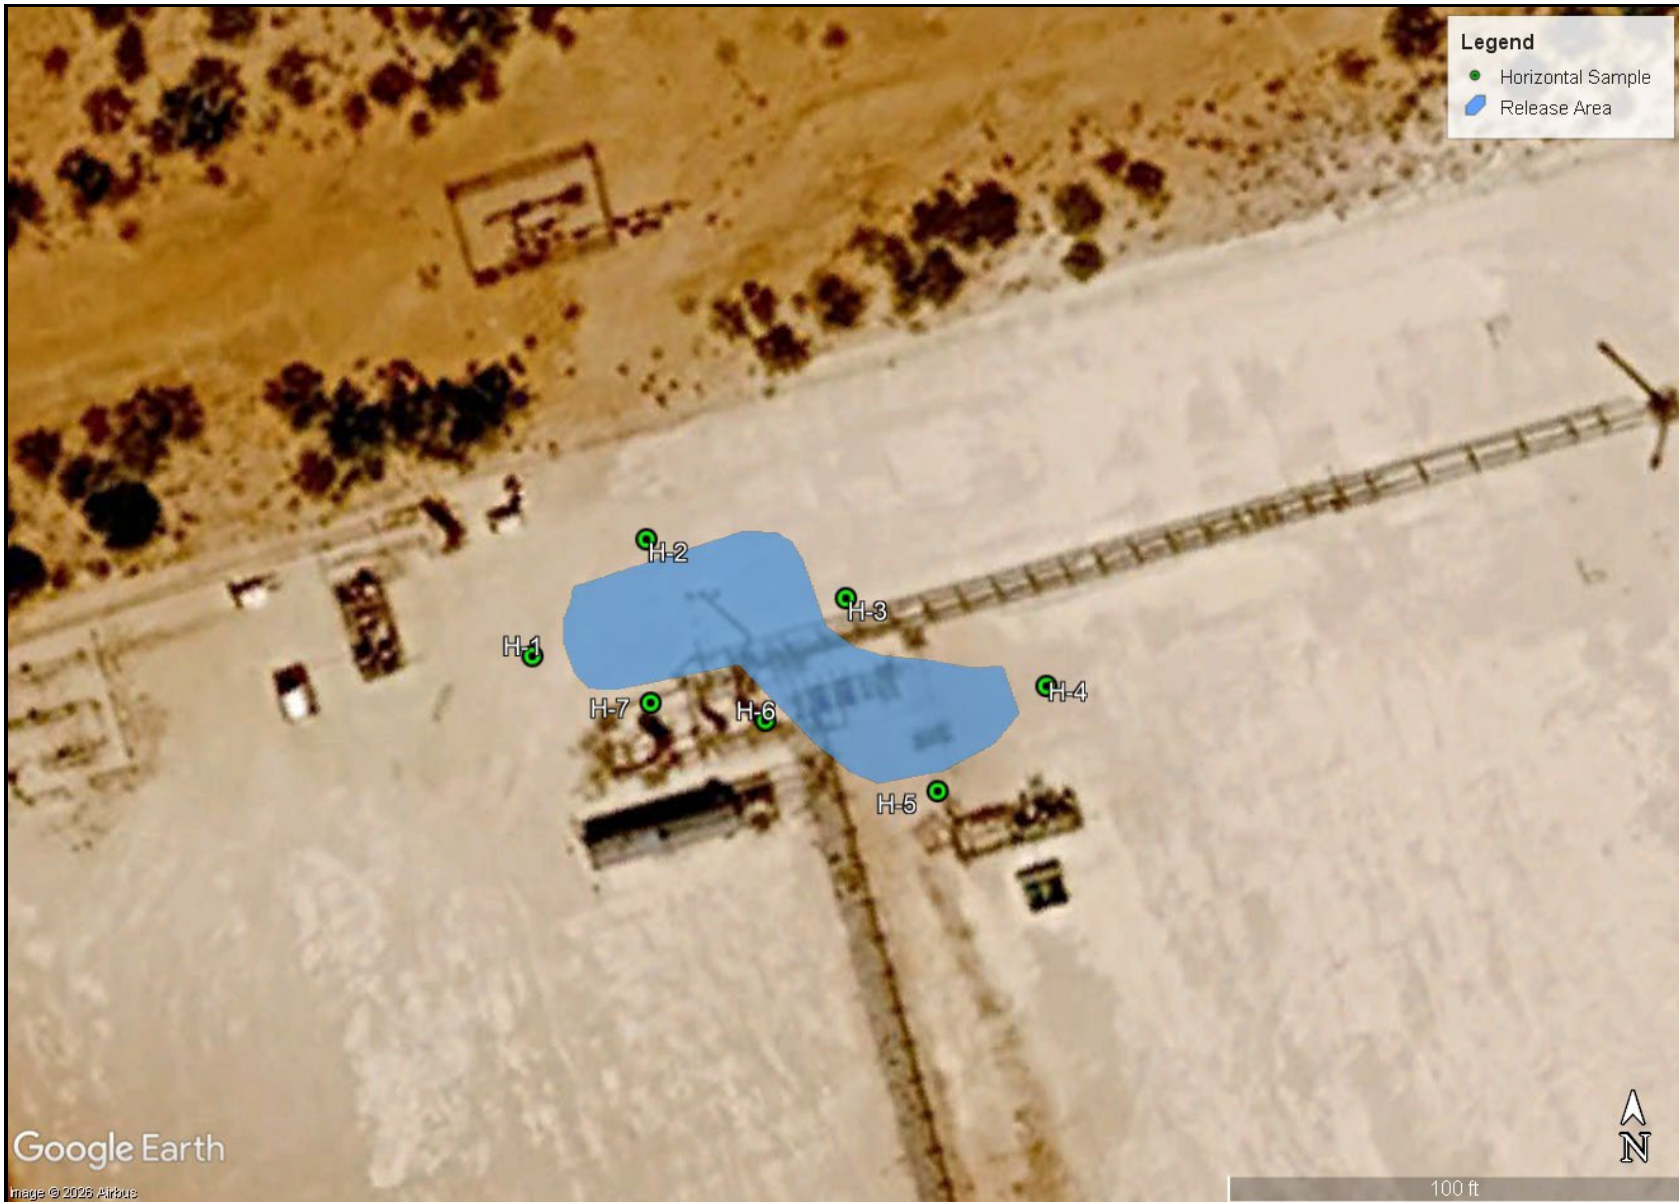
</p>	<p>FIGURE 3</p>
--	--	-----------------

<p>RELEASE AREA MAP COTERRA ENERGY OPERATING CO. TATANKA FEDERAL 1H BATTERY (04.16.2021) LEA COUNTY, NEW MEXICO 32.053758°, -103.331362°</p>	<p>CARMONA RESOURCES

Based on the Notification of Release obtained from the New Mexico Oil Conservation Division (NMOCD), the release was discovered on April 16, 2021, due to a dump line corrosion leak. The incident resulted in the release of fifteen (15) barrels of produced water, with zero (0) barrels recovered. The area affected by the release is approximately 2,300 square feet to 3,000 square feet. See Figure 3. The Notification of Release form is attached in Appendix C.

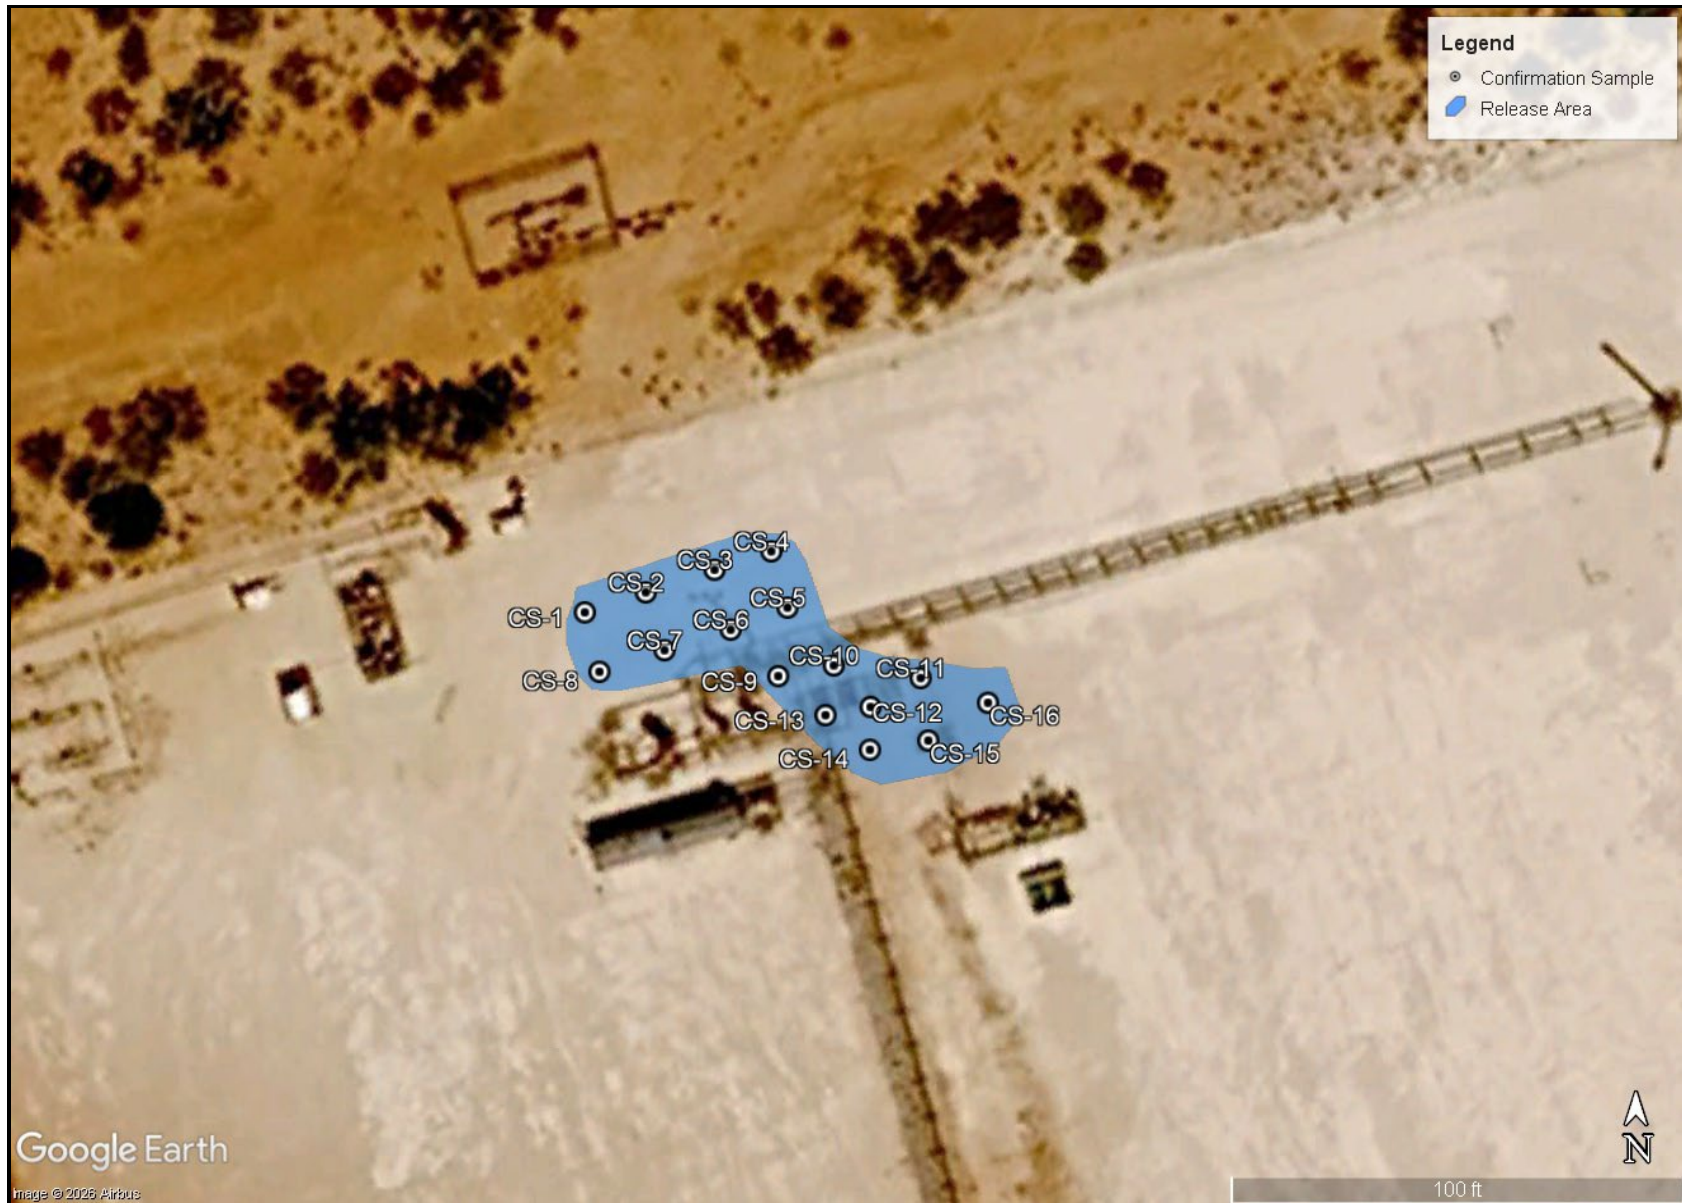
FIGURE 4

CONFIRMATION SAMPLING MAP
COTERRA ENERGY OPERATING CO.
TATANKA FEDERAL 1H BATTERY (04.16.2021)
LEA COUNTY, NEW MEXICO
32.053758°, -103.331362°

On April 30, 2026, Carmona Resources personnel were onsite to collect confirmation samples. Before collecting composite confirmation samples, the NMOCD division office was notified via NMOCD portal on April 24, 2026, per Subsection D of 19.15.29.12 NMAC, see Appendix C. To satisfy parts of the denial message mentioned above and to laterally define the area, a total of seven (7) horizontal samples (H-1 through H-7) were collected for horizontal delineation, and sixteen (16) confirmation floor samples (CS-1 through CS-16) were collected every 200 square feet to ensure the proper removal of contaminated soil. Composite confirmation sidewall samples were not collected due to the scraped area by the hand crew not exceeding 1.0 ft bgs. For chemical analysis, the soil samples were collected and placed into laboratory-provided sample containers, stored on ice, and transported under the proper chain-of-custody protocol to Eurofins Laboratories in Midland, Texas in accordance with established chain-of-custody protocols. All collected samples were analyzed for TPH analysis by EPA method 8015 modified, BTEX by EPA method 8021B, and Chloride by EPA method 300.0. Copies of laboratory analysis and chain-of-custody documentation are included in Appendix E.

All final confirmation samples were below the regulatory requirements for TPH, BTEX, and Chlorides. Refer to Table 1. The confirmation sample locations are shown in Figure 3.

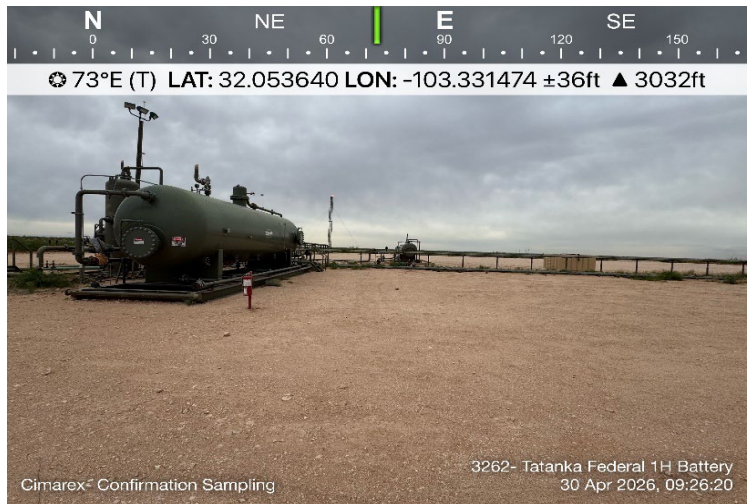
Photograph No. 2

Description:
View East, area of CS-1 through CS-8.

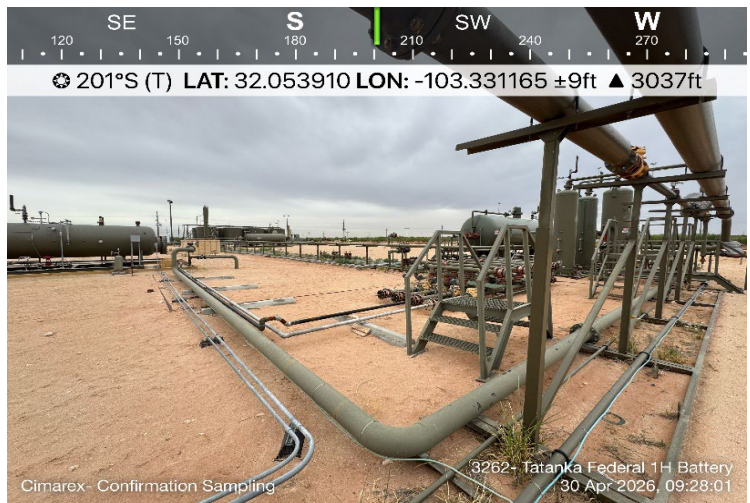
Photograph No. 3

Description:
View South, area of CS-9 through CS-16.

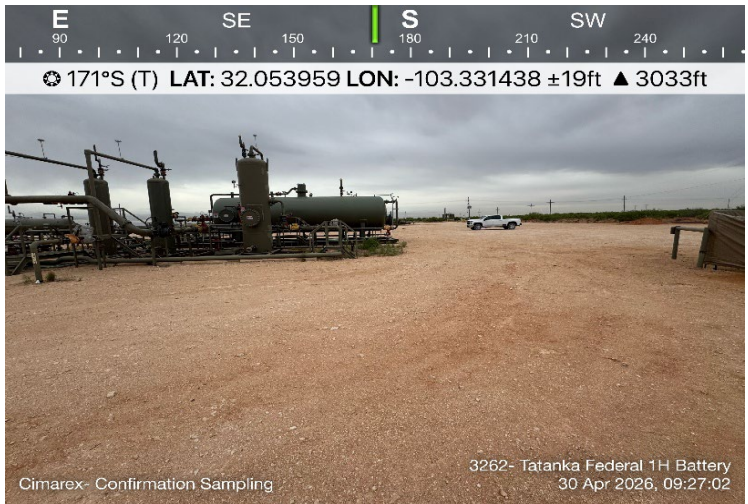
Description:
View South, area of CS-1 through CS-8.

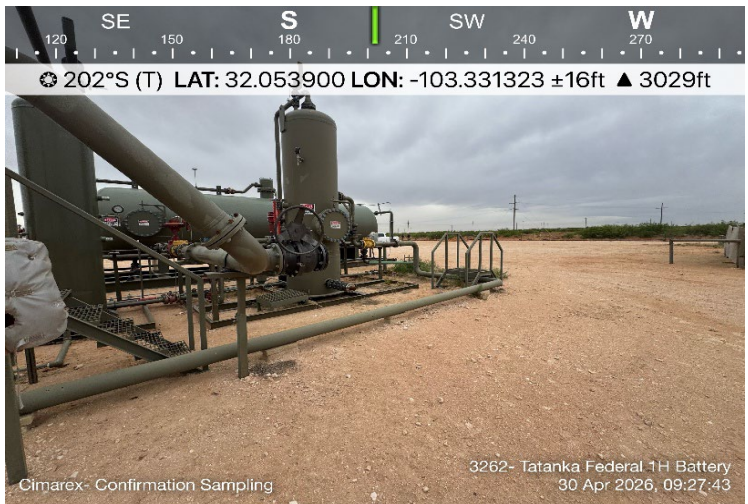
Photograph No. 5

Description:
View South, area of CS-1 through CS-8.

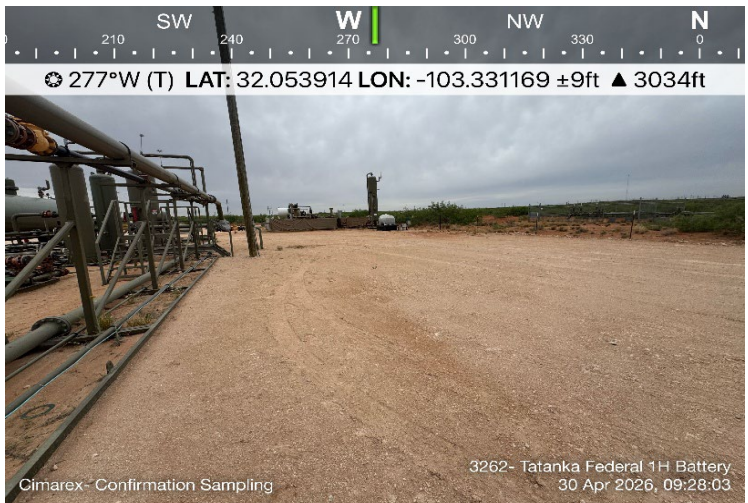
Photograph No. 6

Description:
View West, area of CS-1 through CS-8.

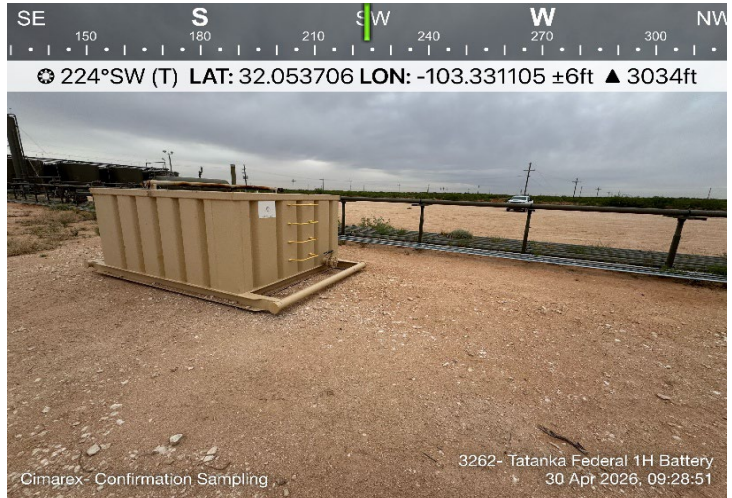
Description:
View Southwest, area of CS-9 through CS-16.

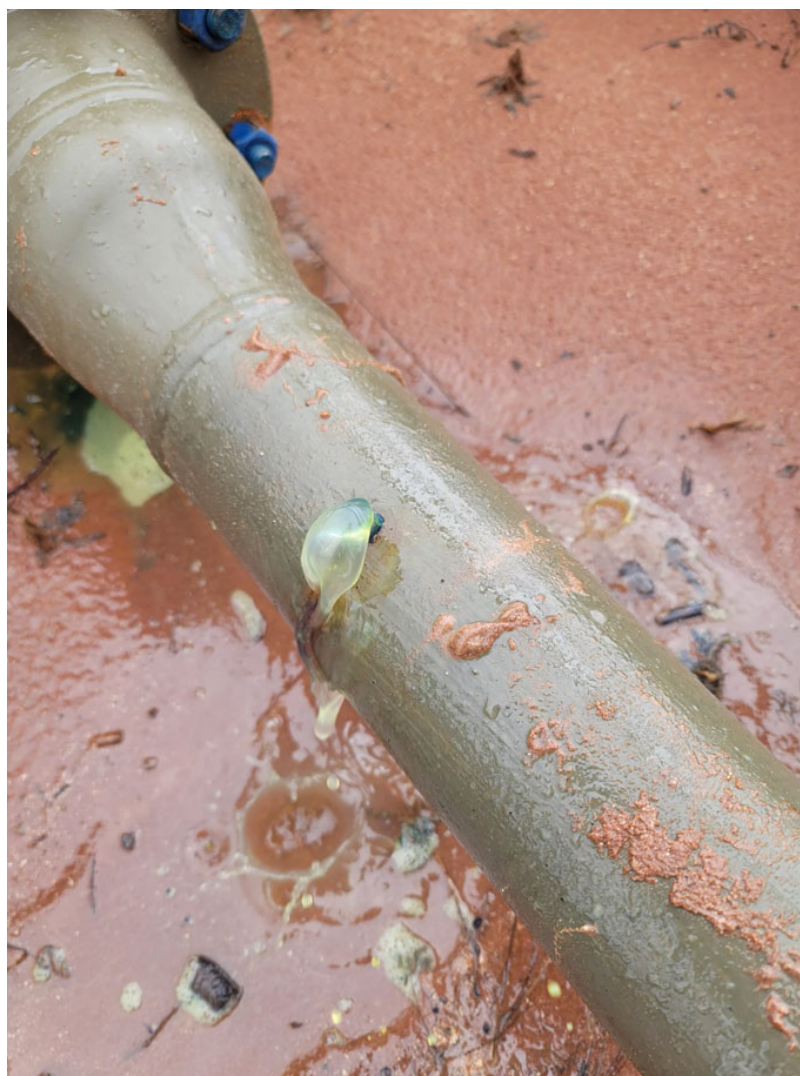
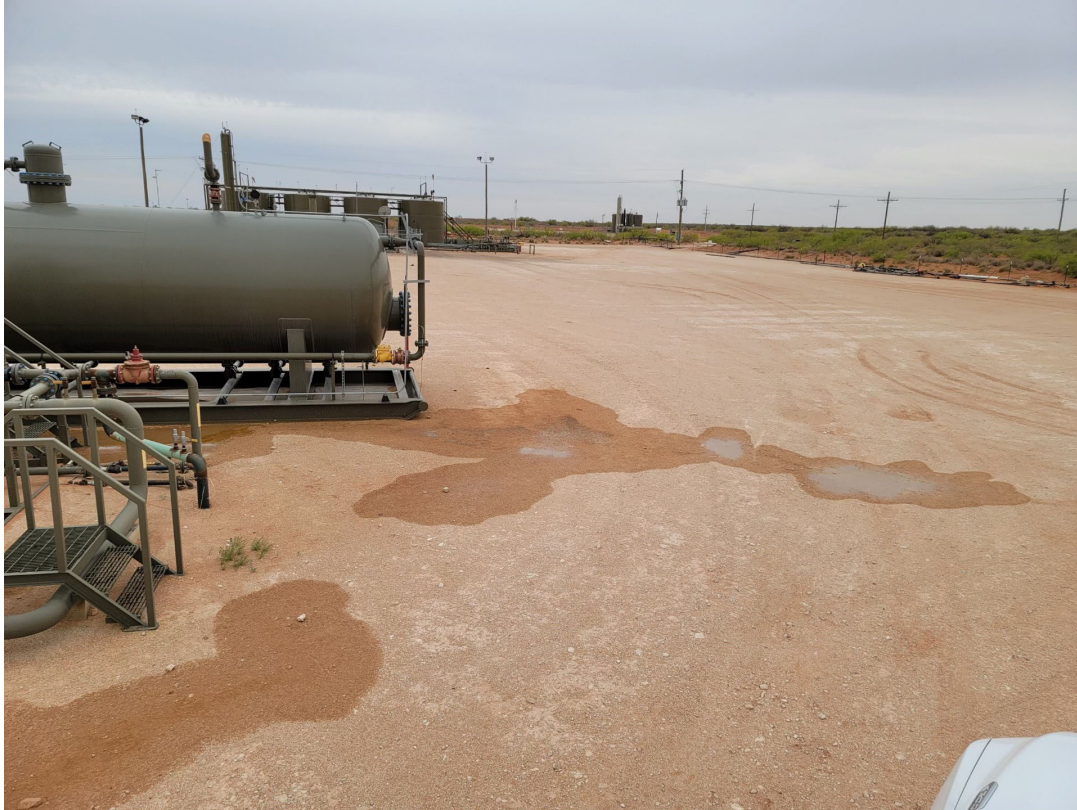
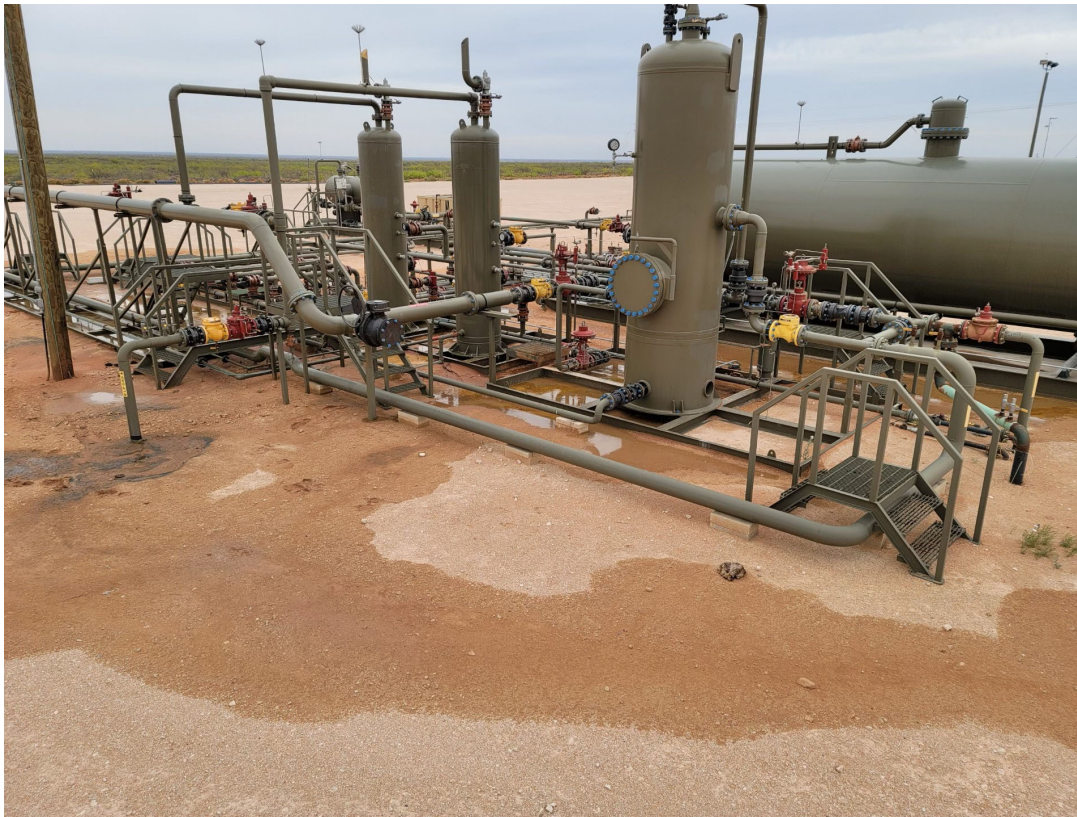
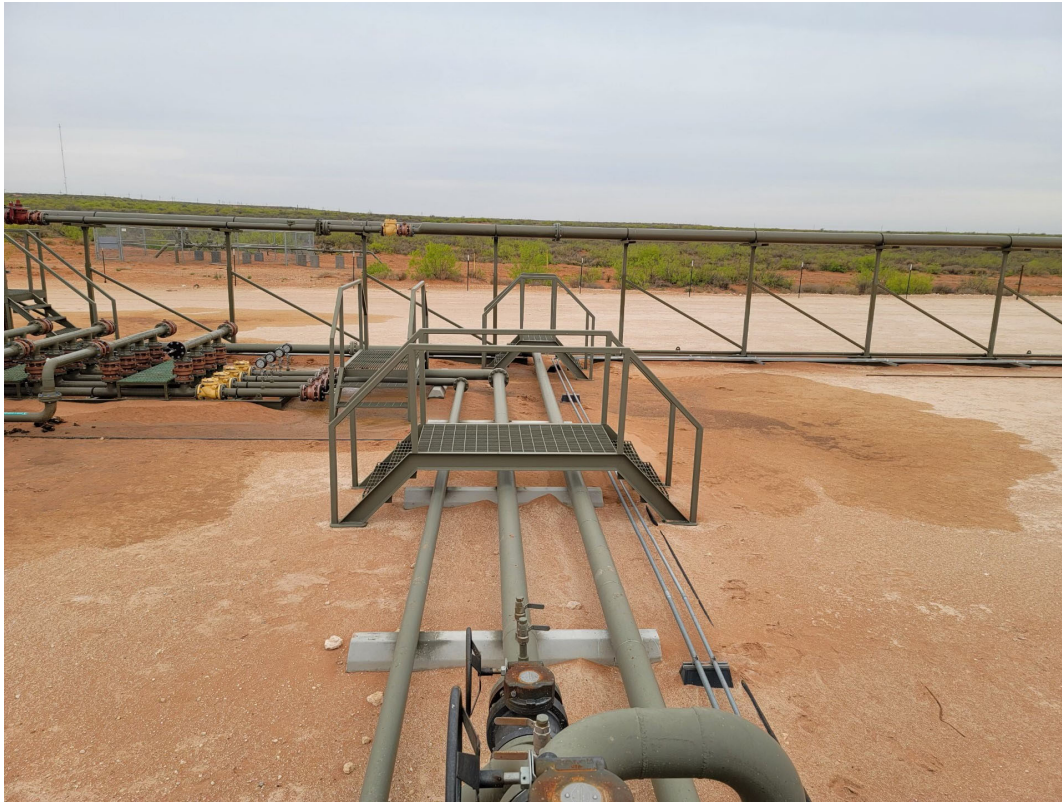
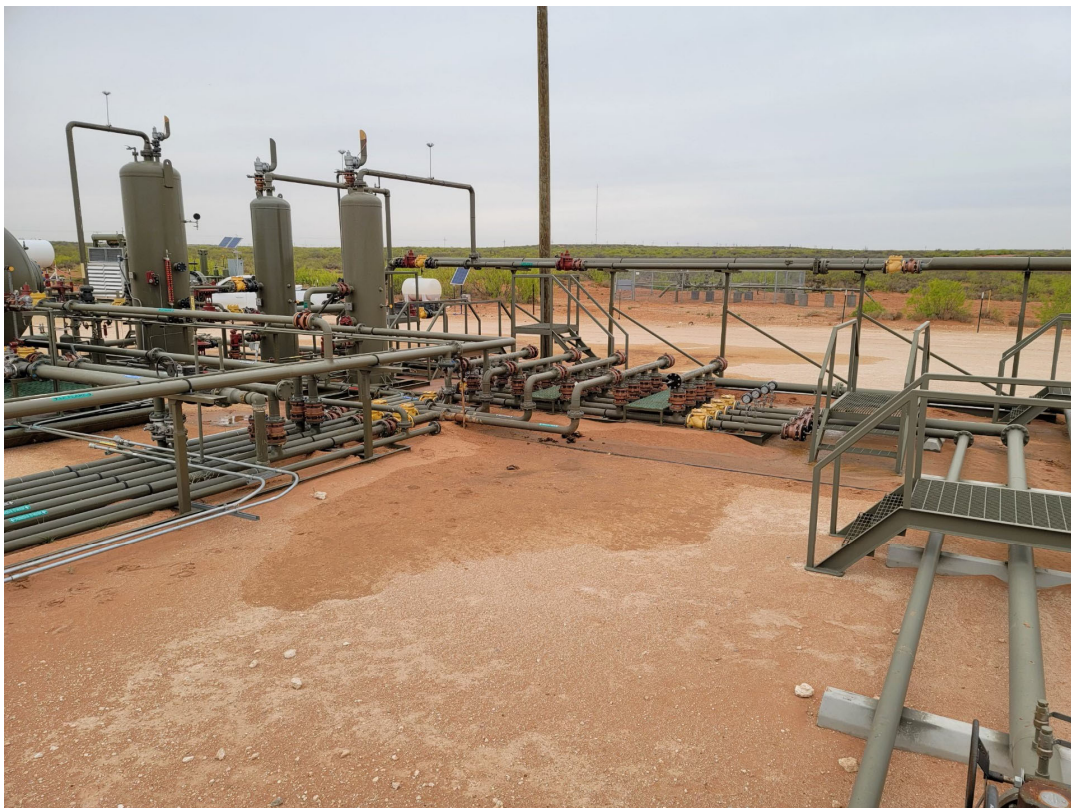
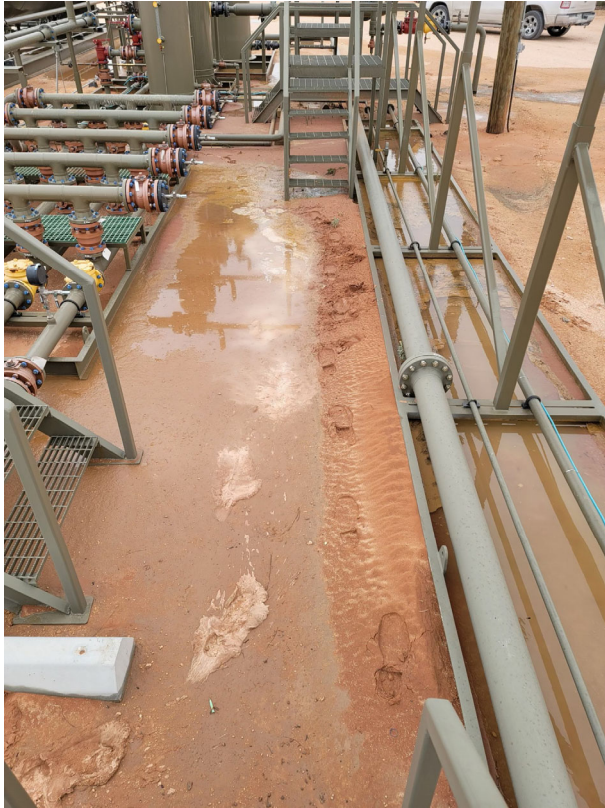
At 10:56 AM on 4/16/21, an offset operator notified Franklin Mountain Energy LLC employee, Clay Treadway, via a phone call of an observed and active leak at the Tatanka Federal 1H Battery. Well was immediately shut-in remotely. Via well site telemetry, it was confirmed that the well was shut-in by 11:05 AM on 4/16/21. Franklin Mountain Energy lease operator, Daniel Aylor, was on location by 11:25 AM. After arriving on location, a small pin hole leak was observed in the gas scrubber drain line, which transfers produced water (with small amounts of oil and condensate) from the gas scrubber to onsite storage tanks. The line was isolated and Franklin Mountain Lease operator confirmed the leak was completely isolated and stopped.

Dispatched vac truck to pick up all remaining fluid. Brought in skid steer and gang to dig out contaminated soil and replace with clean soil. Remediation work was completed 4/19/2021.
