**Re: Closure Request  
PLU 411  
Incident Number nAPP2525531138  
Eddy County, New Mexico**

Ensolum, LLC (Ensolum), on behalf of XTO Energy, Inc. (XTO), has prepared this *Closure Request* to document the findings of a liner integrity inspection and delineation activities completed at the PLU 411 (Site) following the release of produced water within a steel-walled lined containment housing storage tanks. Based on the liner integrity inspection and delineation activities, XTO is submitting this *Closure Request*, describing the inspection results and requesting closure for Incident Number nAPP2525531138.

XTO Energy, Inc.  
Closure Request  
PLU 411

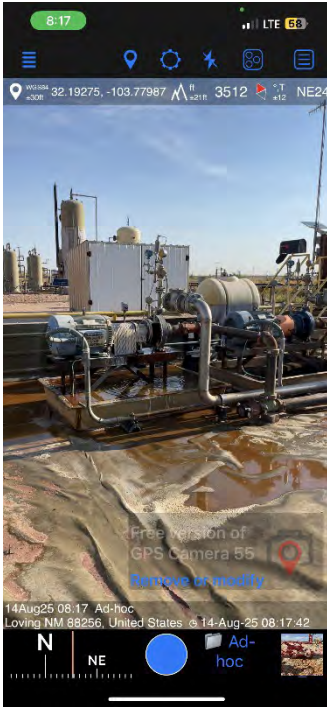
<p><u>Photograph</u> 1</p>	<p><u>Date</u> 8/14/2025</p>

<p><u>Description</u> Initial release in containment</p>		
<p><u>View</u> North</p>		
<p><u>Photograph</u> 2</p>	<p><u>Date</u> 8/14/2025</p>

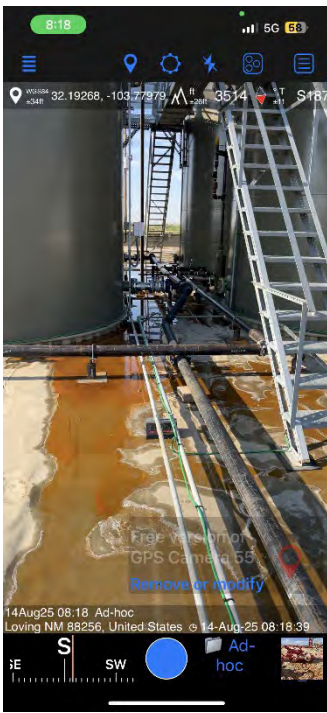
<p><u>Description</u> Initial release in containment</p>		
<p><u>View</u> North</p>

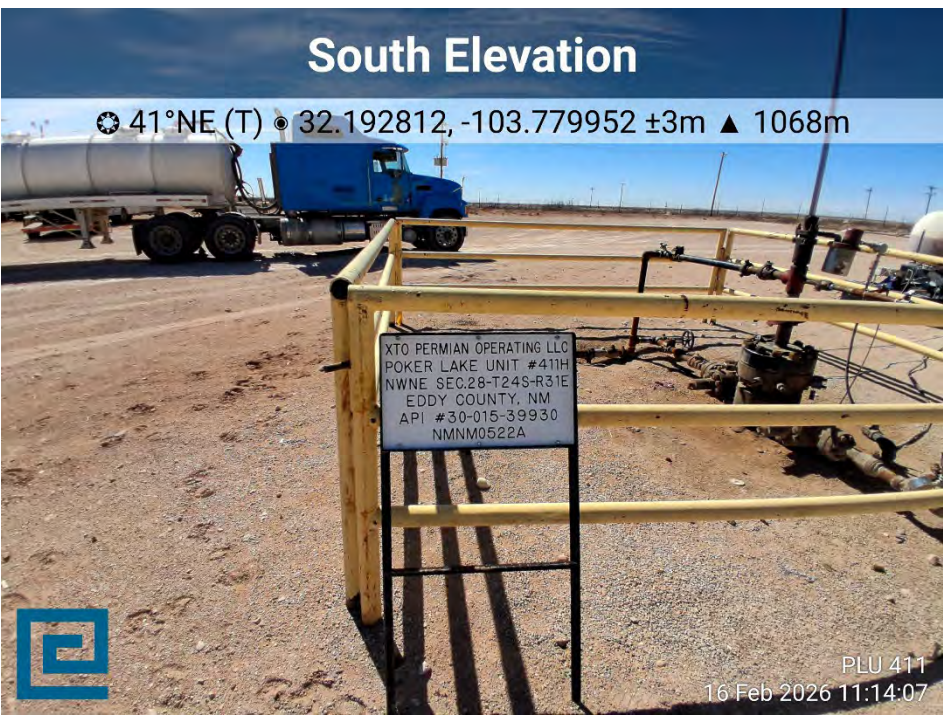
<p><u>Photograph</u> 3</p>	<p><u>Date</u> 2/16/2026</p>	<p style="text-align: center;"><b>South Elevation</b></p> <p style="text-align: center;">☉ 41°NE (T) ☉ 32.192812, -103.779952 ±3m ▲ 1068m</p>

<p style="text-align: right;">PLU 411 16 Feb 2026 11:14:07</p>
<p><u>Description</u> Well information</p>		
<p><u>View</u> Northwest</p>		
<p><u>Photograph</u> 4</p>	<p><u>Date</u> 2/16/2026</p>	<p style="text-align: center;"><b>East Elevation</b></p> <p style="text-align: center;">☉ 257°SW (T) ☉ 32.192811, -103.779958 ±4m ▲ 1068m</p>

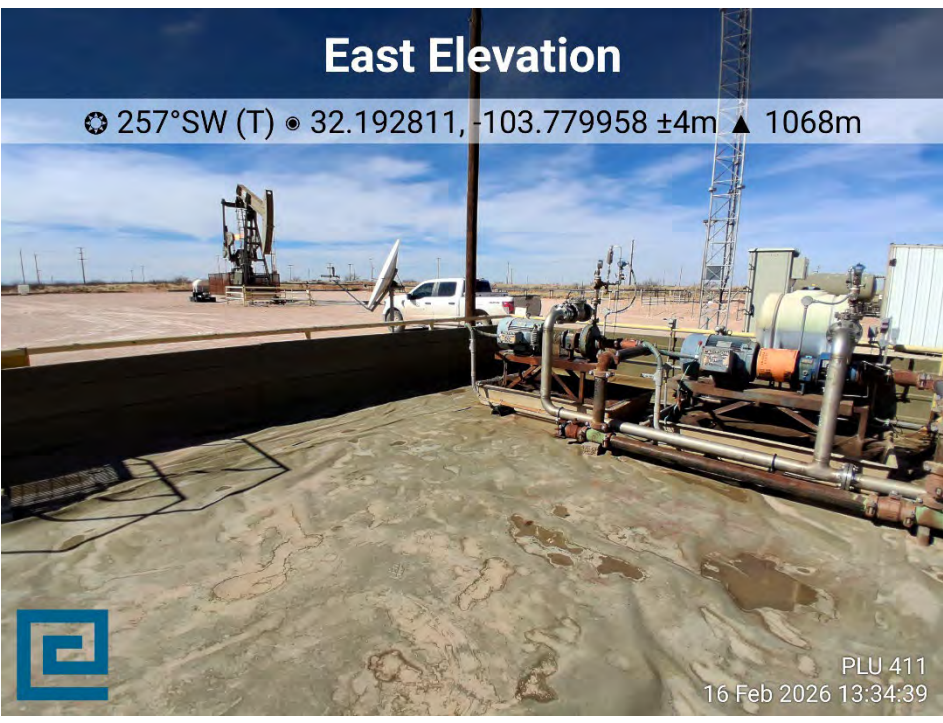
<p style="text-align: right;">PLU 411 16 Feb 2026 13:34:39</p>
<p><u>Description</u> Inspection activities</p>		
<p><u>View</u> Northwest</p>

The lined containment was cleaned of all debris, power washed and a 48-hour advance notice of the liner inspection was submitted to the NMOCD on February 11, 2026. On February 16, 2026, the lined containment was inspected by Ensolum personnel and was determined to contain five small tears within a 5-foot radius of each other on the liner floor along the northern edge of the containment. Delineation to determine the extent of the release was warranted. A site map of the lined containment is included in Figure 2. Photographic documentation of the inspection is included in Appendix B.

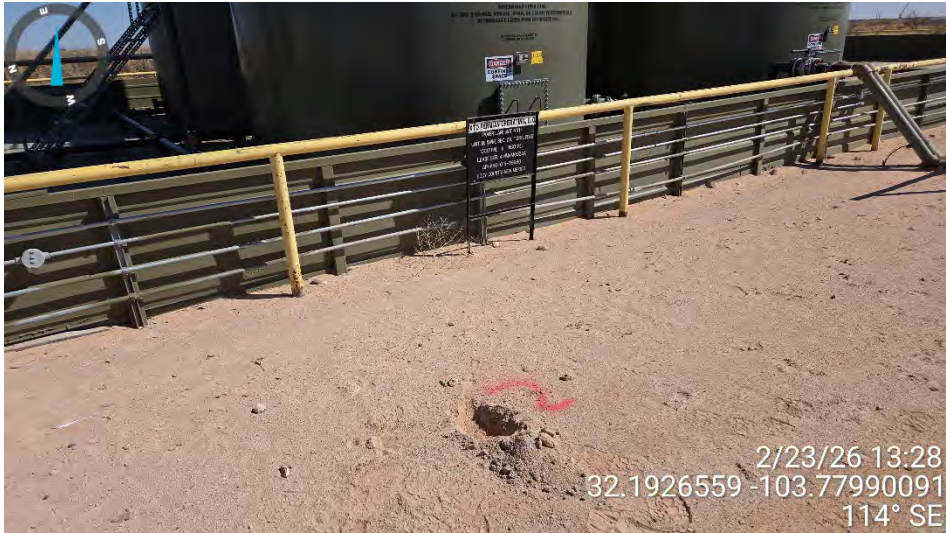
<p><u>Photograph</u> 11</p>	<p><u>Date</u> 2/23/2026</p>

<p>2/23/26 13:28 32.1926559 -103.77990091 114° SE</p>
<p><u>Description</u> Delineation activities, SS02</p>		
<p><u>View</u> Southeast</p>		
<p><u>Photograph</u> 12</p>	<p><u>Date</u> 2/23/2026</p>

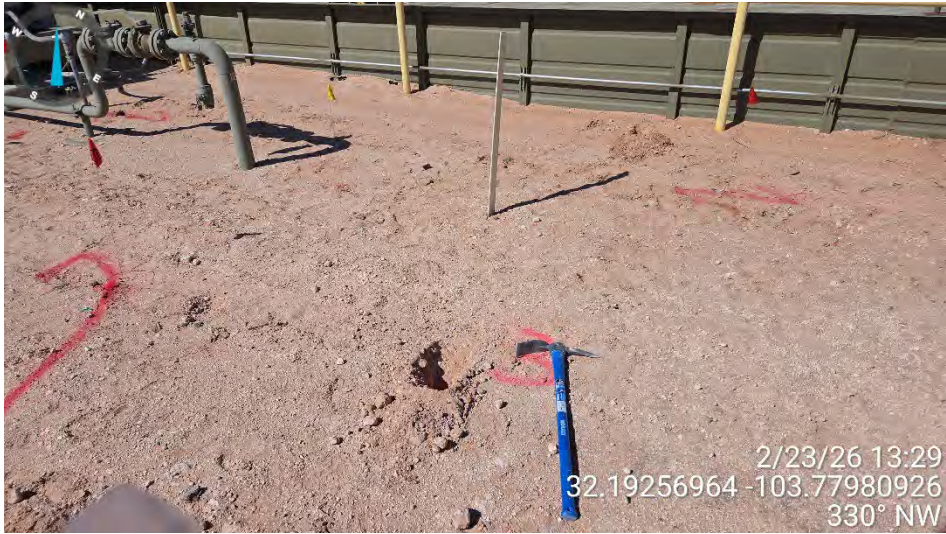
<p>2/23/26 13:29 32.19256964 -103.77980926 330° NW</p>
<p><u>Description</u> Delineation activities, SS03</p>		
<p><u>View</u> North</p>

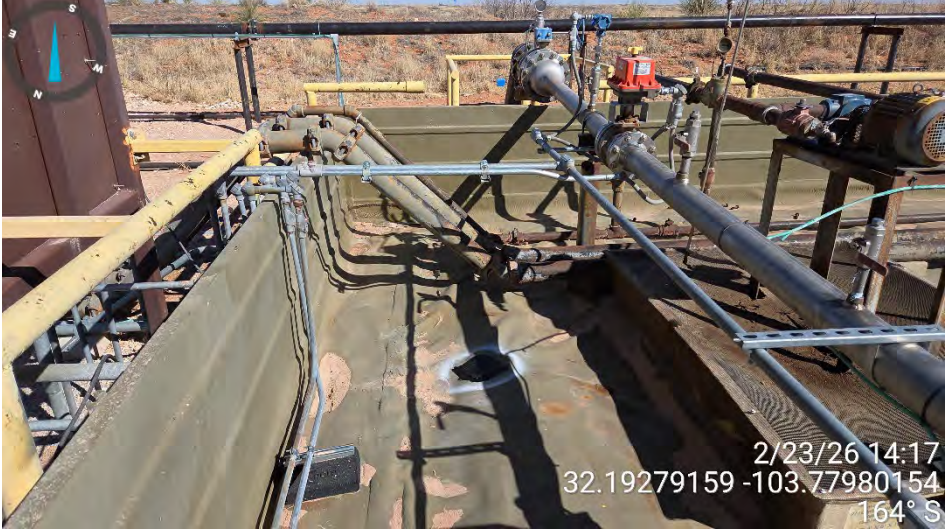
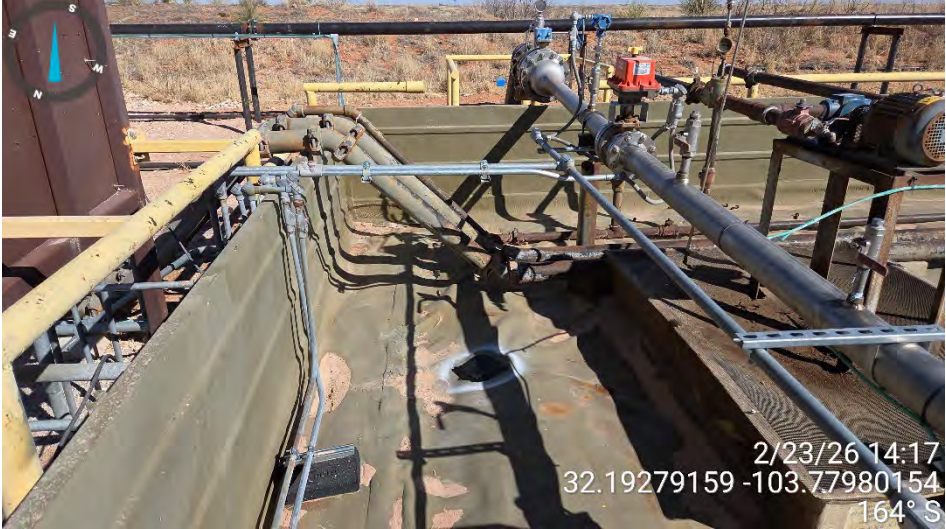
<p><u>Photograph</u> 13</p>	<p><u>Date</u> 2/23/2026</p>

<p><u>Description</u> Patched discovered hole</p>

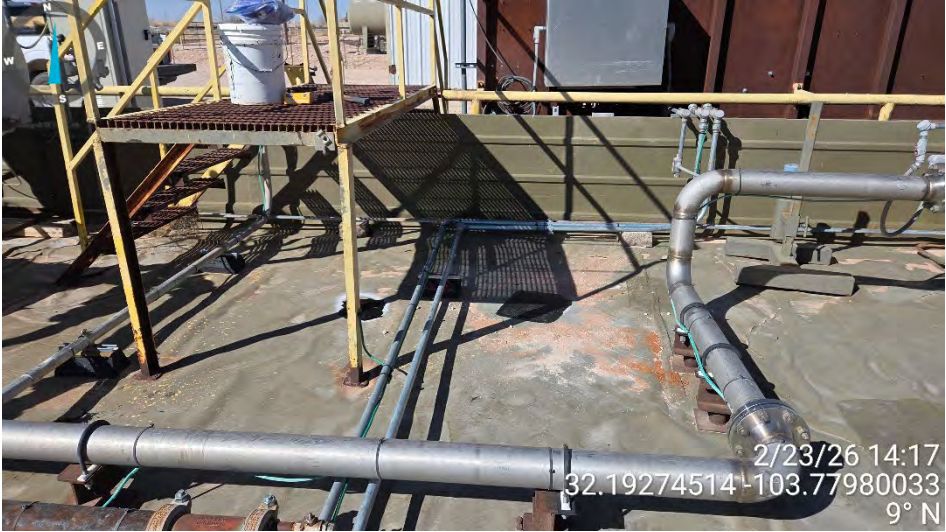
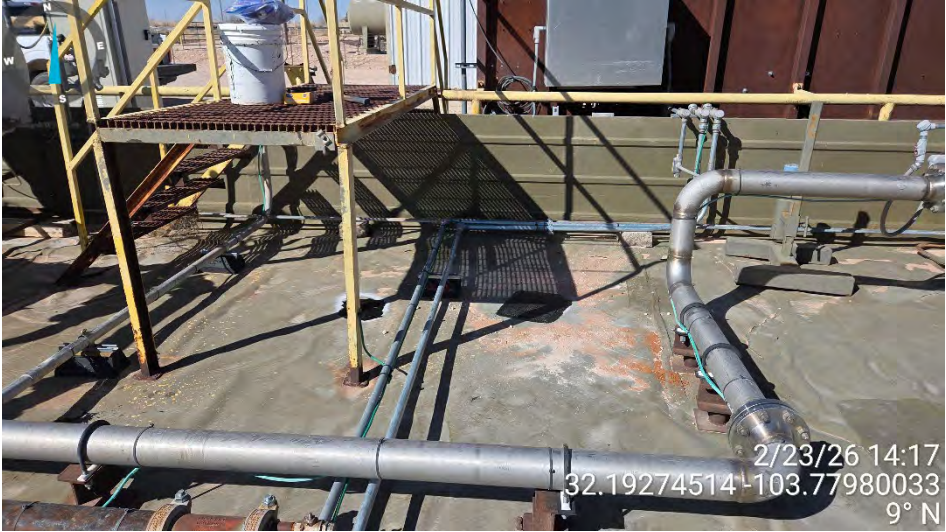
<p><u>Description</u> Patched holes, BH01 and BH05</p>
