SUBJECT: Liner Inspection and Closure Report for Cotton Draw Unit #089– May 22, 2026 Site Visit

Incident IDs: nAPP2603445332
API Number (Name): 30-015-31381 (COTTON DRAW UNIT #089)
Facility Location: Unit O of Section 3, Township 25 South, Range 31 East, New Mexico
Facility GPS Coordinates: 32.153093, -103.763266
Eddy County, New Mexico

Environmental Liner Inspection Field Notes & Photolog Report

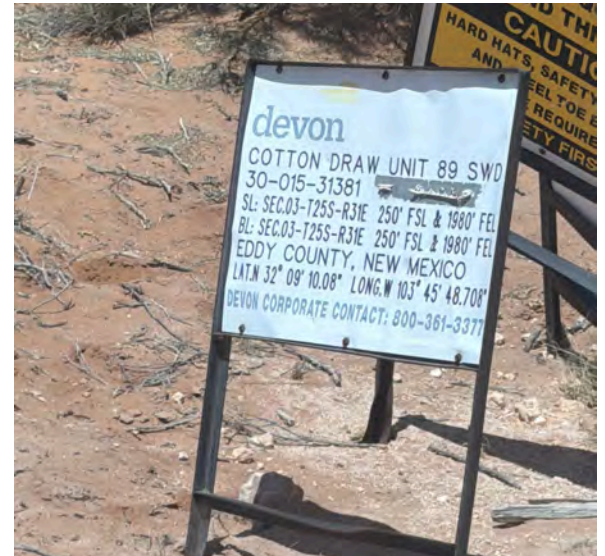
Field Notes nAPP2603445332 30-015-31381

- * Travel to site, Arrive at 12:45 PM, complete JHA
- * Check surroundings for hazards, check in w/ supervisor
- * Begin liner inspection by walking around the containment and visually inspecting the walls, base of liner and any areas that look like there is potential for weathering, stress cracking, or seam separation.
- * Observations of liner show there are no signs of UV damage, degradation, or pinch points near congested areas of flowlines and equipment.
- * No rips, tears, cuts, abrasions, or potential points of concern for a potential breach to the native ground.
- * Liner passes inspection and liner integrity is confirmed.
- * Photos taken at each cardinal direction as well as in between, along with areas where liner would have a potentially higher risk of degradation, between tanks and under piping.
- * No further action for containment.

- Inspection complete. Liner meets standards and is in compliance.
- No additional recommendations.
- Liner integrity confirmed.

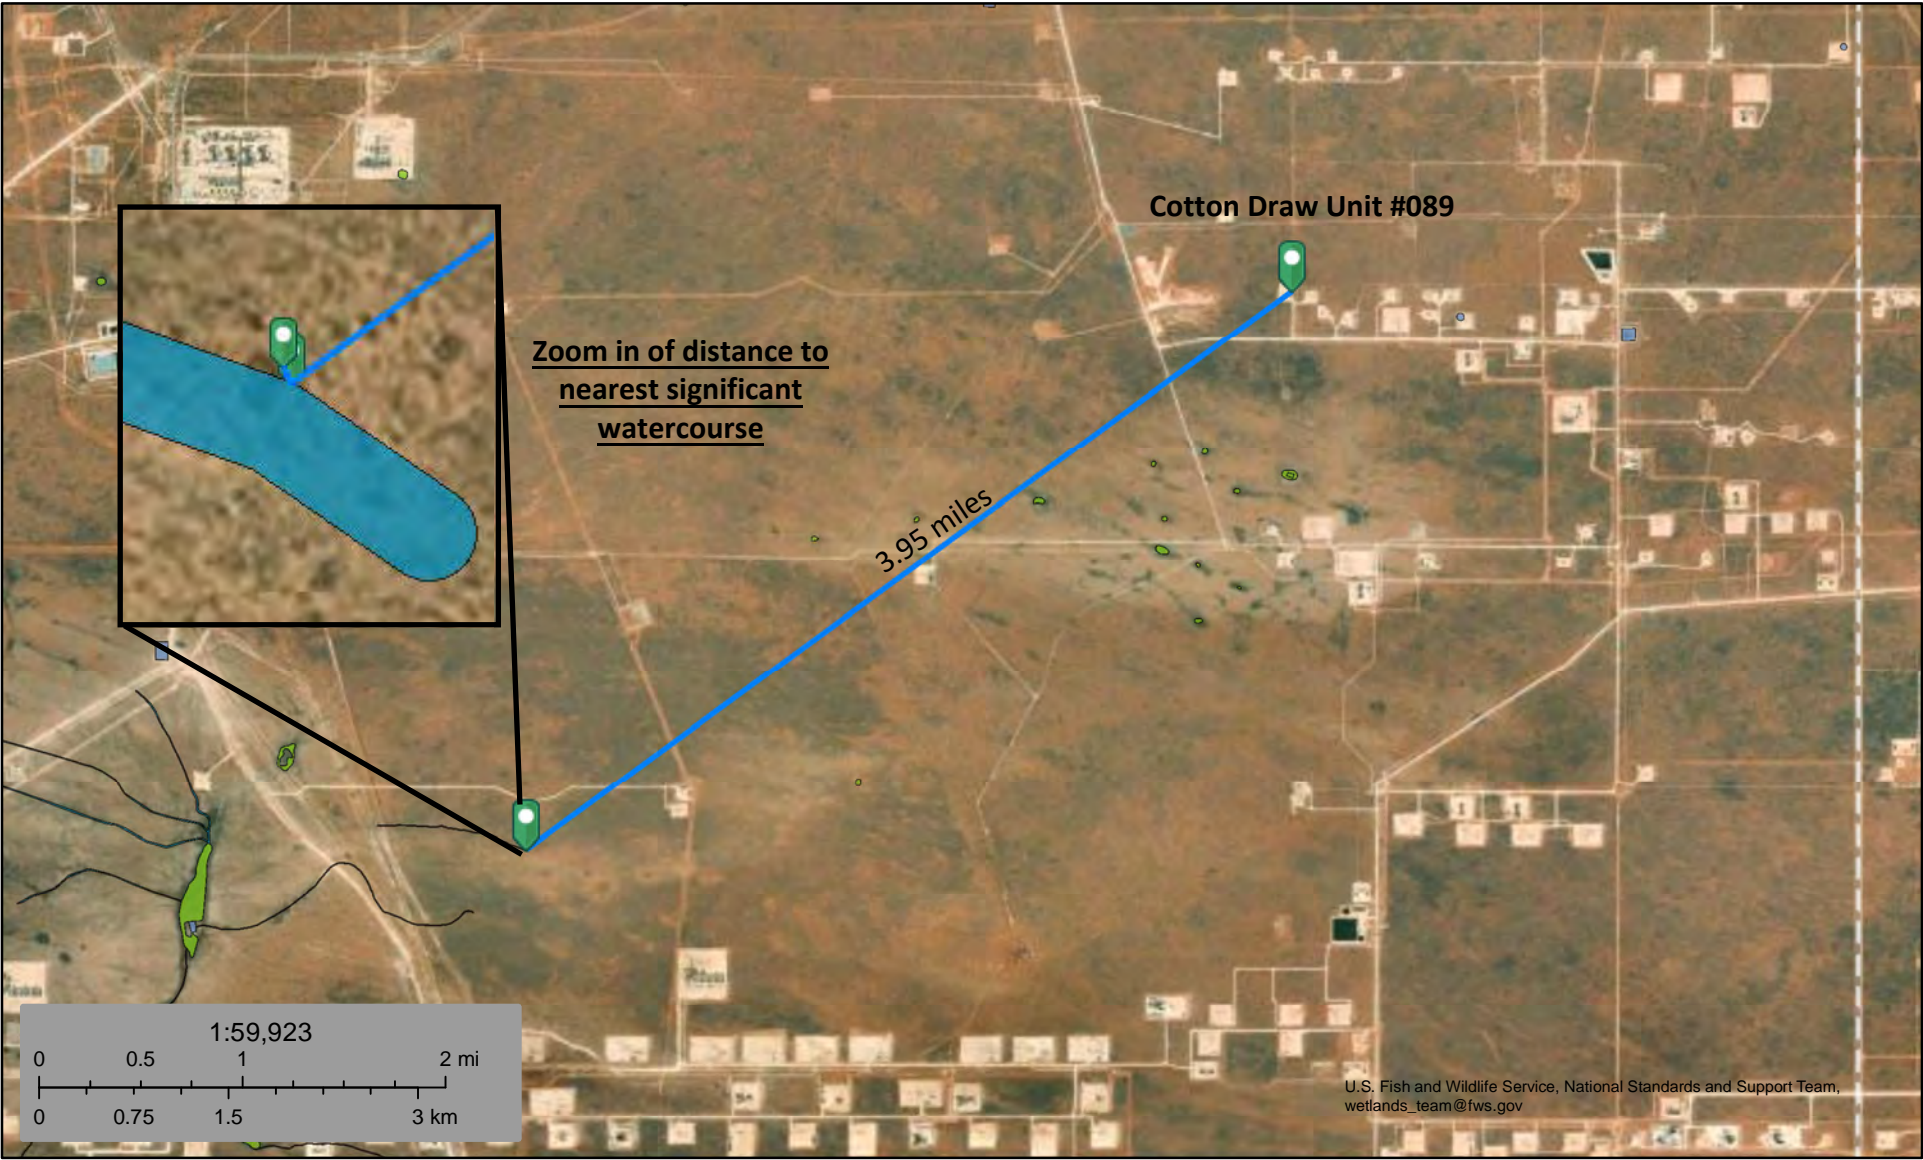
Nearest Significant Watercourse: Riverine

Distance: 3.95 miles

No surface water features were identified within 300 feet of the Site. The nearest significant watercourse is 3.95 miles southwest; the closest playa and wetland is 0.75 miles southwest. These distances comply with the requirements of 19.15.29.12(C)(4) NMAC.

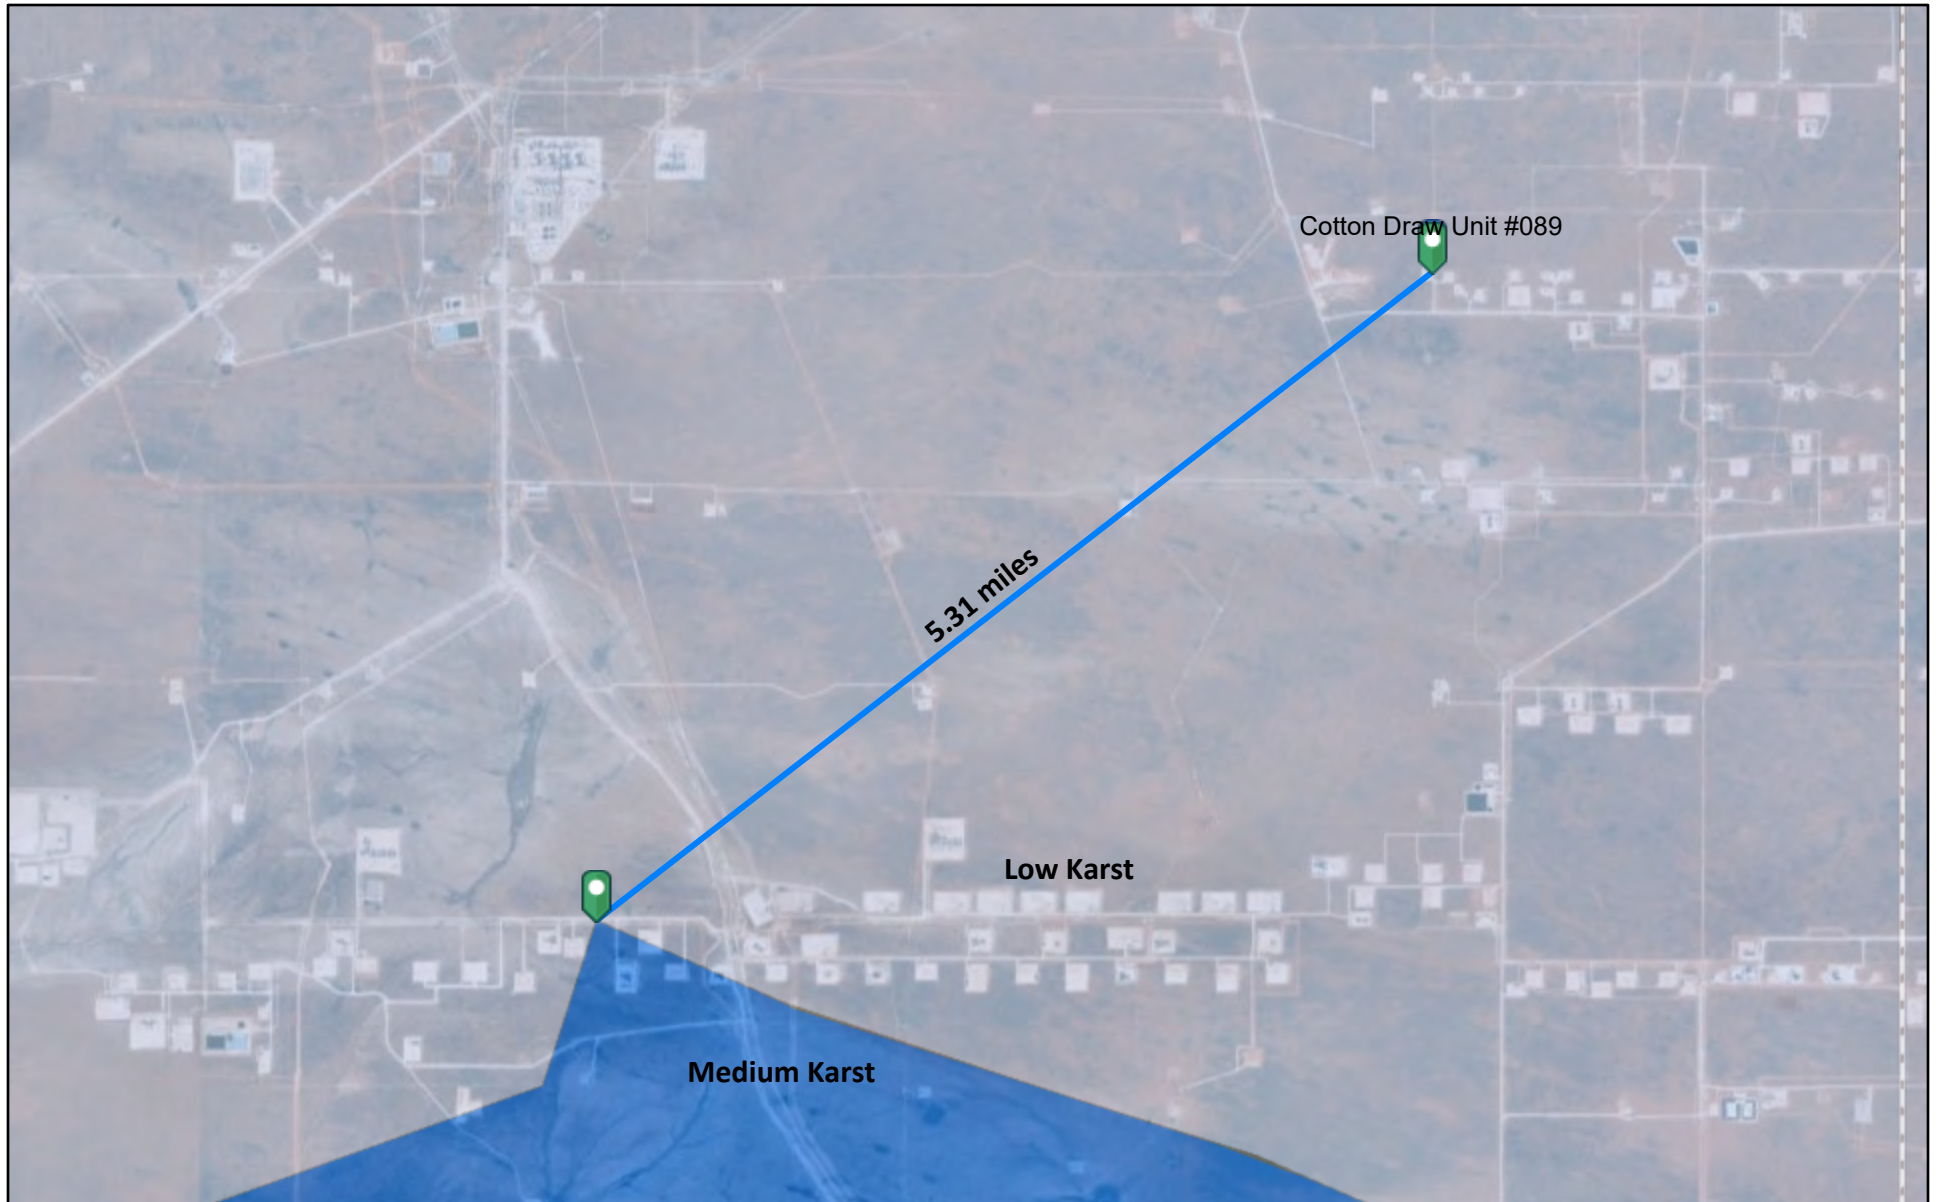
Cotton Draw Unit #089 - Karst Potential Map

Karst Potential

Low

Nearest Karst Zone

Medium

Distance

5.31 miles

Karst potential for the Site is identified as low, with the nearest area of medium karst potential located 5.31 miles to the southwest. The Site is in a FEMA flood hazard area identified as Zone X (undetermined hazard); the nearest identified FEMA flood hazard area, classified as Zone A, is 1.31 miles to the southwest.
