**Re: Remediation Work Plan
Corral Canyon 21 CVB
Incident Number nAPP2603745853
Eddy County, New Mexico**

Ensolum, LLC (Ensolum), on behalf of XTO Energy, Inc (XTO), has prepared this *Remediation Work Plan (Work Plan)* to document site assessment, delineation, liner inspection, and soil sampling activities following a release of crude oil at the Corral Canyon 21 CVB (Site). The purpose of the site assessment and delineation activities were to assess for the presence or absence of impacts to soil following the release of crude oil at the Site. The following *Work Plan* proposes to excavate impacted soil identified following the completion of soil sampling activities.

XTO Energy, Inc
Remediation Work Plan
Corral Canyon 21 CVB

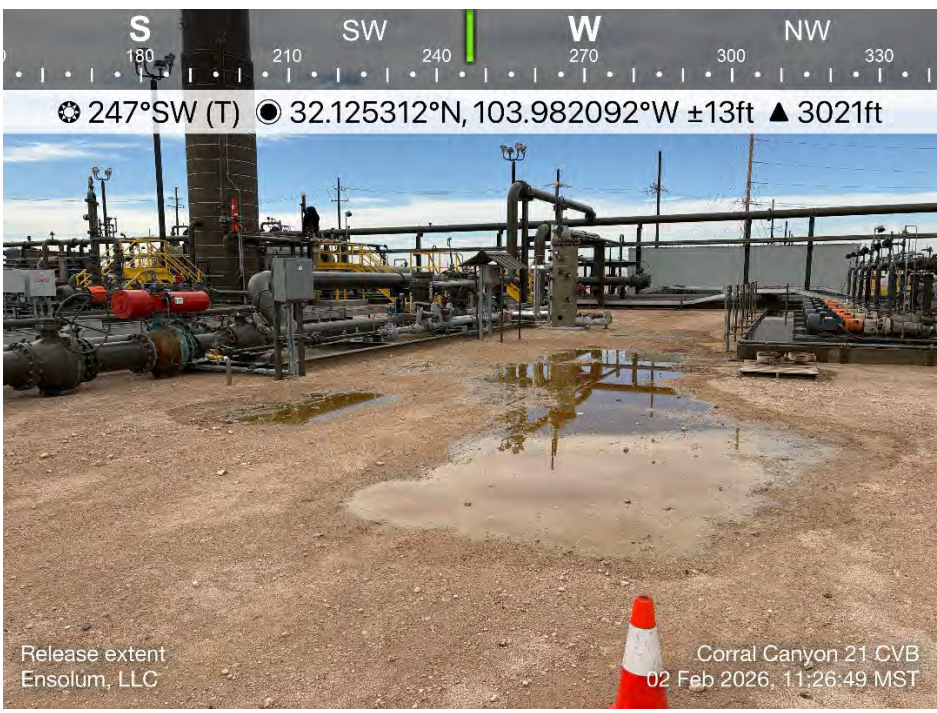
<p><u>Photograph</u> 1</p>	<p><u>Date</u> 02/02/2026</p>

<p>Release extent Ensolum, LLC</p> <p>Corral Canyon 21 CVB 02 Feb 2026, 11:26:49 MST</p>
<p><u>Description</u> Initial release on pad</p>		
<p><u>View</u> Southwest-West</p>		
<p><u>Photograph</u> 2</p>	<p><u>Date</u> 02/02/2026</p>

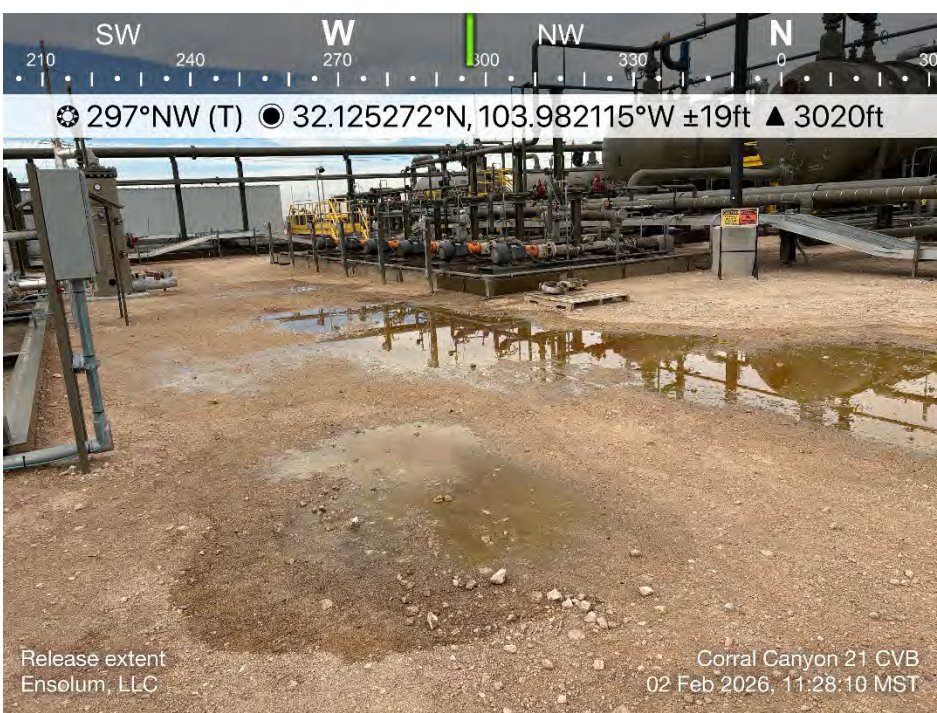
<p>Release extent Ensolum, LLC</p> <p>Corral Canyon 21 CVB 02 Feb 2026, 11:28:10 MST</p>
<p><u>Description</u> Initial release on pad</p>		
<p><u>View</u> Northwest</p>

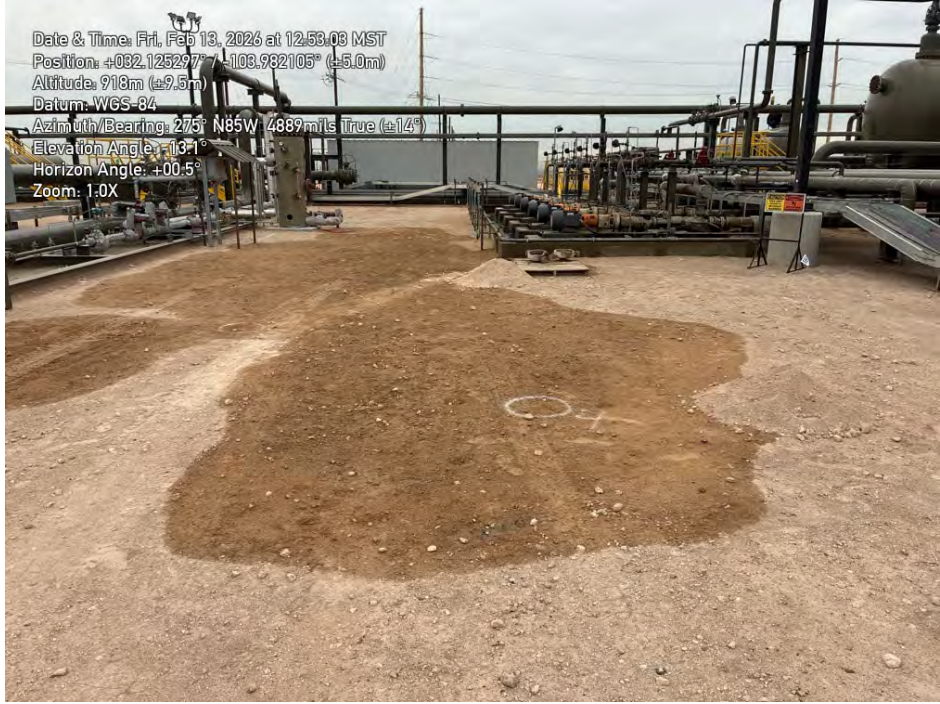
<p>Photograph 5</p>	<p>Date 02/13/2026</p>	<p>Date & Time: Fri, Feb 13, 2026 at 12:53:03 MST Position: +032.1252977° -103.982105° (±5.0m) Altitude: 918m (±9.5m) Datum: WGS-84 Azimuth/Bearing: 275° N85W 4889mils True (±14°) Elevation Angle: -13.1° Horizon Angle: +00.5° Zoom: 1.0X</p>

<p>Description Delineation activities, SS04/BH04</p>		
<p>View West</p>		
<p>Photograph 6</p>	<p>Date 04/13/2026</p>

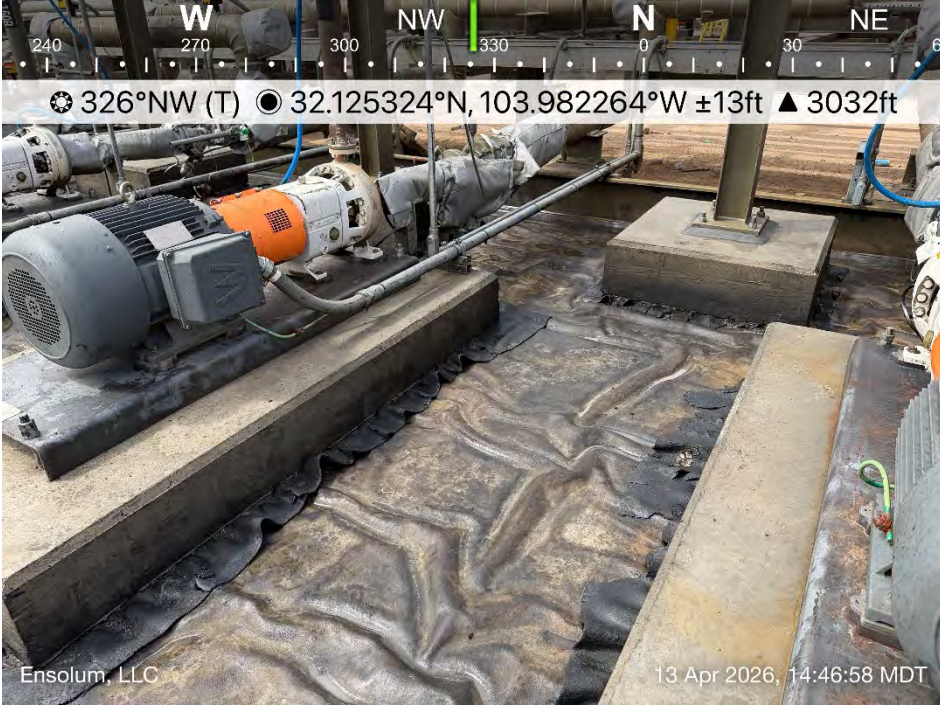
On April 13, 2026, Ensolum personnel conducted a liner integrity inspection immediately following power washing activities within the lined containment. Personnel inspected the floors and walls of the lined containment and no breaches or tears observed and it was determined that the liner was operating as designed.

<p>W 240 270 300 330 NW N 0 NE 60 326°NW (T) 32.125324°N, 103.982264°W ±13ft ▲ 3032ft Ensolum, LLC 13 Apr 2026, 14:46:58 MDT</p>
<p>Description Liner inspection activities</p>		
<p>View Northwest</p>

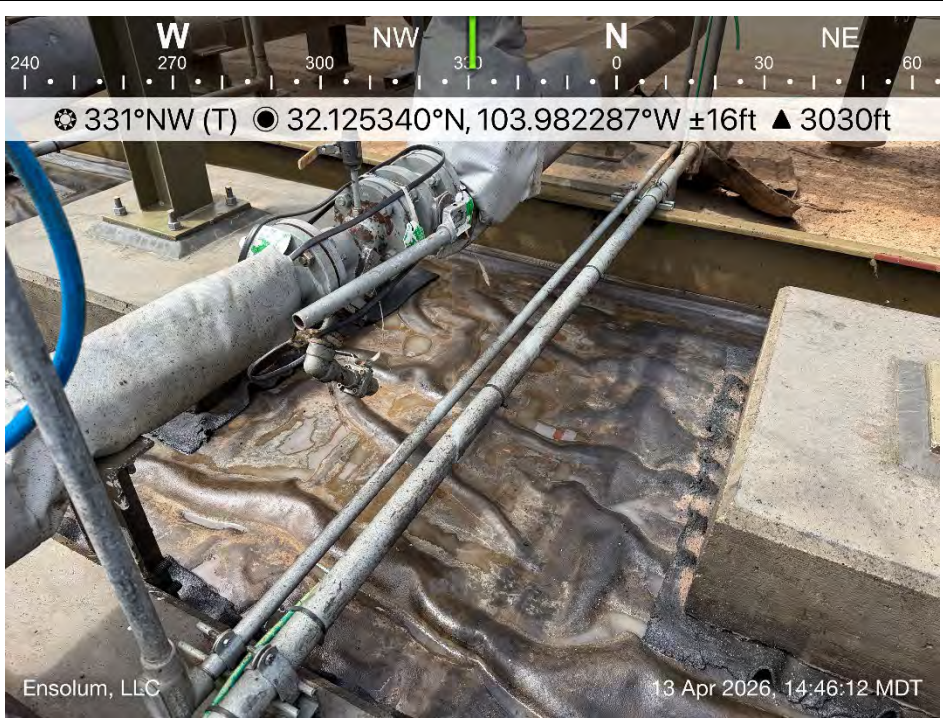
<p><u>Photograph</u> 7</p>	<p><u>Date</u> 04/13/2026</p>

<p><u>Description</u> Liner inspection activities</p>		
<p><u>View</u> Northwest</p>		
<p><u>Photograph</u> 8</p>	<p><u>Date</u> 04/13/2026</p>

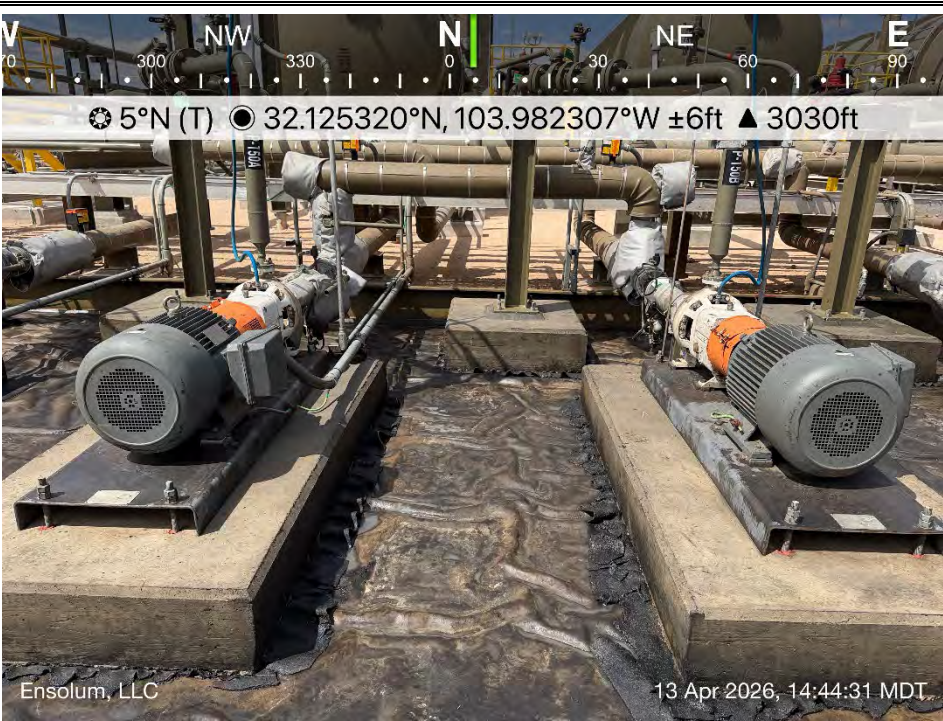
<p><u>Description</u> Liner inspection activities</p>		
<p><u>View</u> North</p>

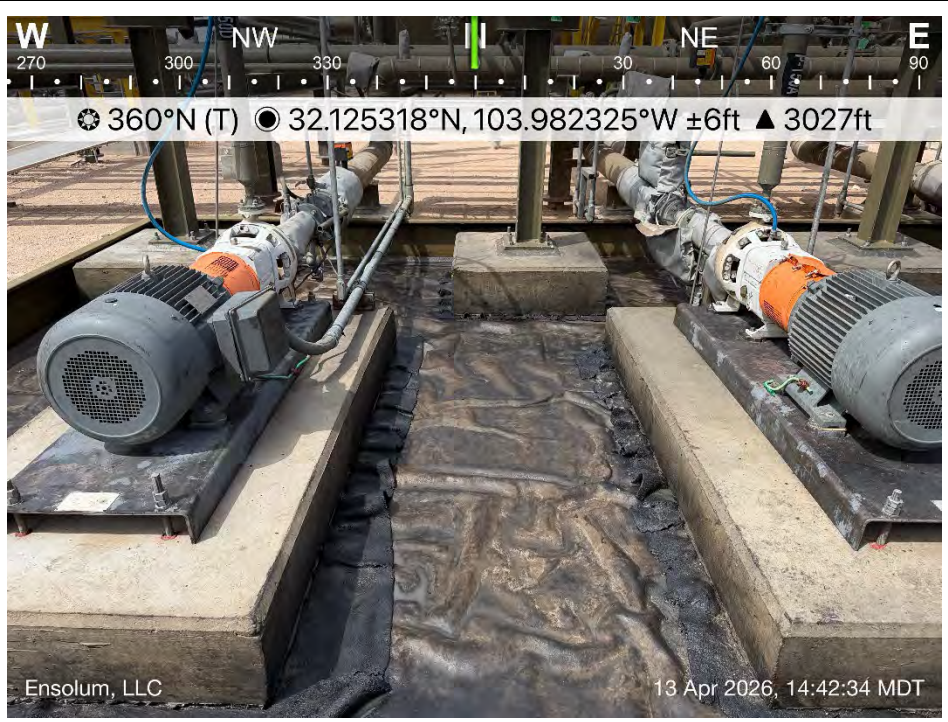
<p><u>Photograph</u> 15</p>	<p><u>Date</u> 04/13/2026</p>

<p><u>Description</u> Liner inspection activities</p>		
<p><u>View</u> North</p>		
<p><u>Photograph</u> 16</p>	<p><u>Date</u> 04/13/2026</p>

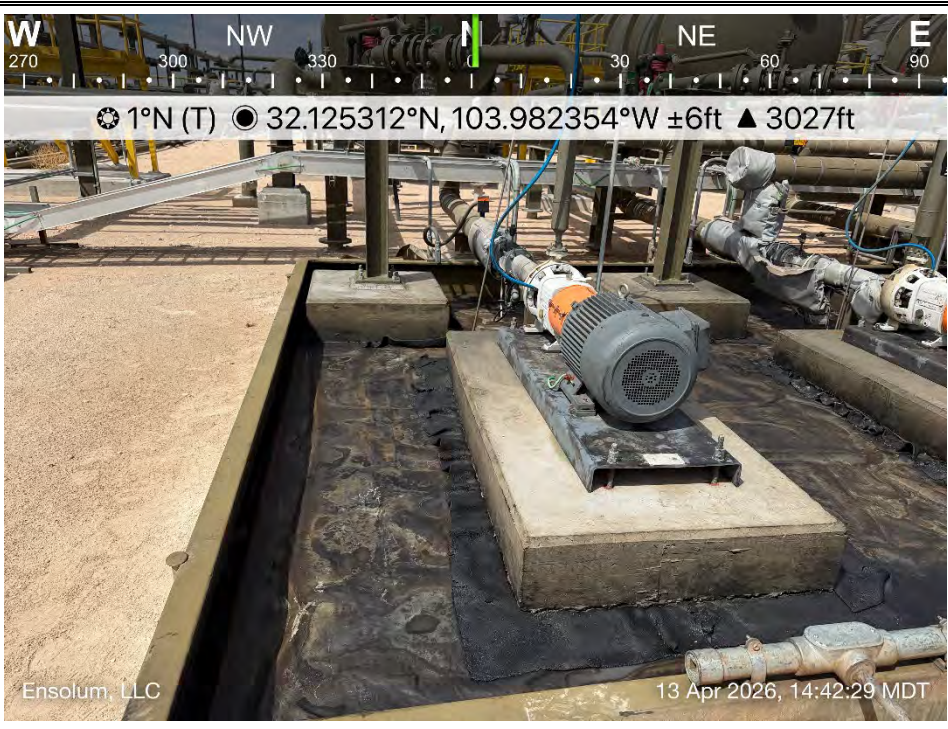
<p><u>Description</u> Liner inspection activities</p>		
<p><u>View</u> North</p>

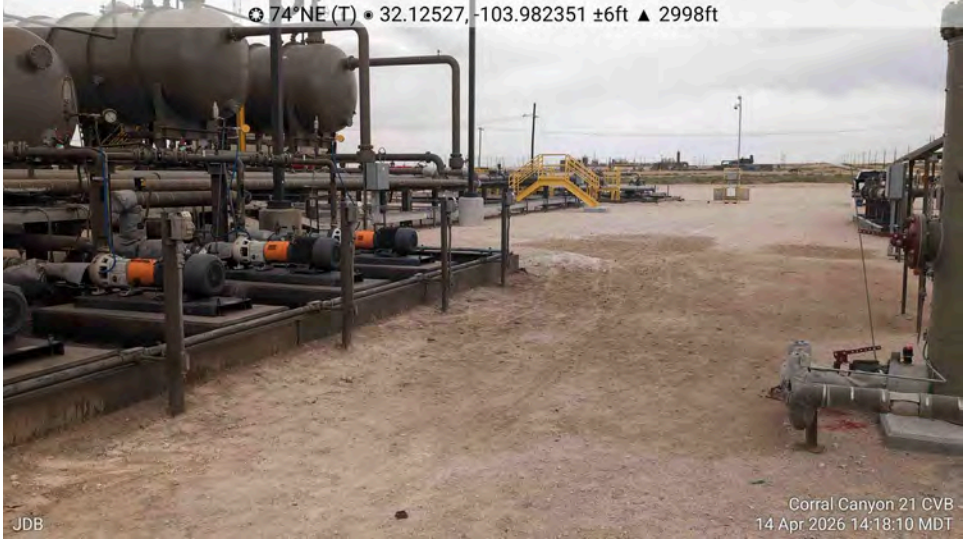
<p><u>Photograph</u> 19</p>	<p><u>Date</u> 04/14/2026</p>

<p><u>Description</u> Lateral delineation activities, near SS05</p>		
<p><u>View</u> Northeast</p>		
<p><u>Photograph</u> 20</p>	<p><u>Date</u> 04/14/2026</p>

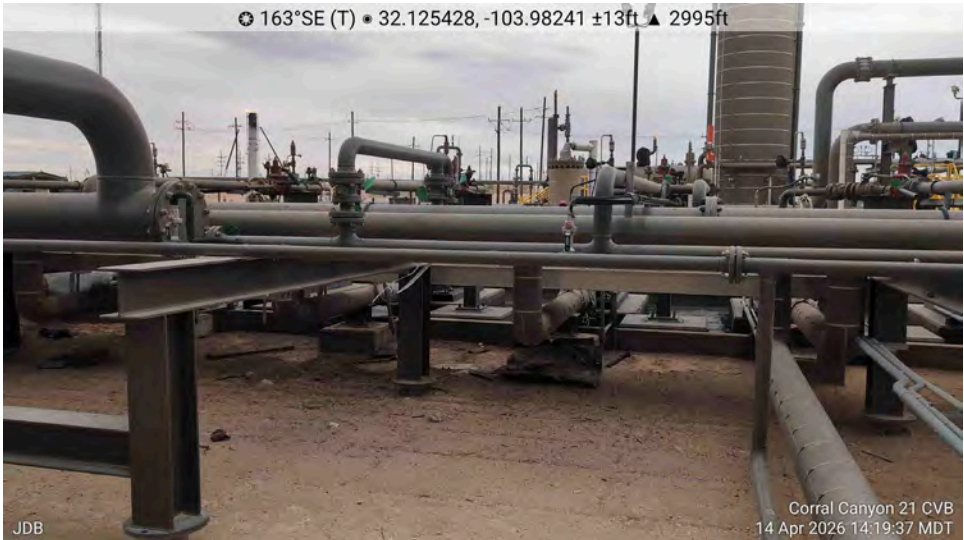
<p><u>Description</u> Lateral delineation activities, near SS07</p>		
<p><u>View</u> Southeast</p>
