Proposed Alternative Method Permit or Closure Plan Application

1.  
Operator: Harvest Four Corners OGRID # 373888  
Address: 1755 Arroyo Dr., Bloomfield, NM 87413  
Facility or well name: Wilmer Canyon 2  
API Number: 3004523459 OCD Permit Number: \_\_\_\_\_  
U/L or Qtr/Qtr C Section 25 Township 32N Range 8W County: San Juan  
Center of Proposed Design: Latitude 36.958071 Longitude -107.629684 NAD83  
Surface Owner: ☒ Federal ☐ State ☐ Private ☐ Tribal Trust or Indian Allotment

3.  
☒ **Below-grade tank:** Subsection I of 19.15.17.11 NMAC  
Volume: 45 bbl Type of fluid: Produced Water  
Tank Construction material: metal  
☐ Secondary containment with leak detection ☒ Visible sidewalls, liner, 6-inch lift and automatic overflow shut-off  
☐ Visible sidewalls and liner ☐ Visible sidewalls only ☐ Other \_\_\_\_\_  
Liner type: Thickness \_\_\_\_\_ mil ☐ HDPE ☐ PVC ☒ Other unspecified

**RE: Below Grade Tank Closure Report  
Wilmer Canyon #2  
API #3004523459  
San Juan County, New Mexico**

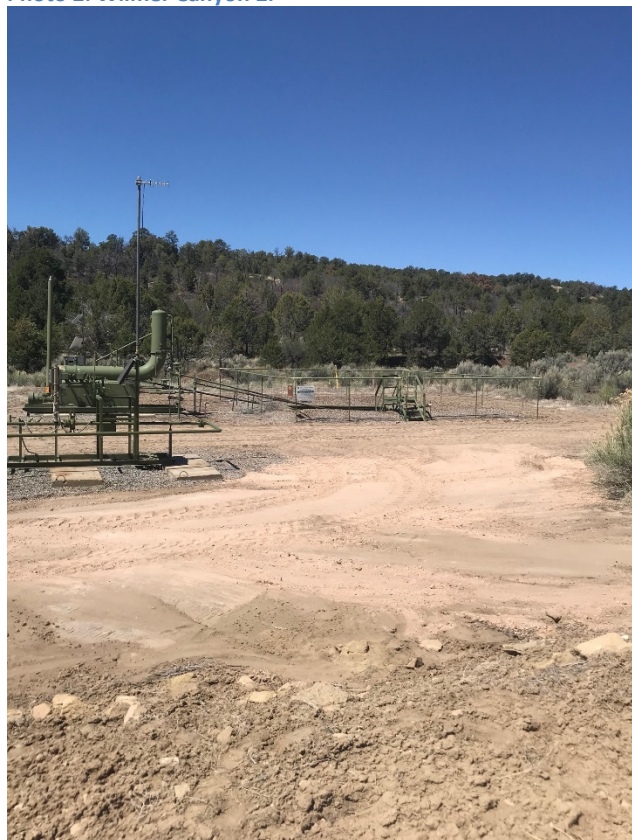
Photo 2: Wilmer Canyon 2.
