Pit, Below-Grade Tank, or
Proposed Alternative Method Permit or Closure Plan Application

**RE: Below Grade Tank Closure Report
Primo #1A
API #3004521827
San Juan County, New Mexico**

Animas Environmental Services, LLC (AES) is pleased to provide the final closure report for the 45-bbl below grade tank (BGT) under operational control of Harvest Four Corners (Harvest) at the Hilcorp Primo #1A (API #3004521827), located in San Juan County, New Mexico. Tank removal and closure sampling was completed by Harvest.

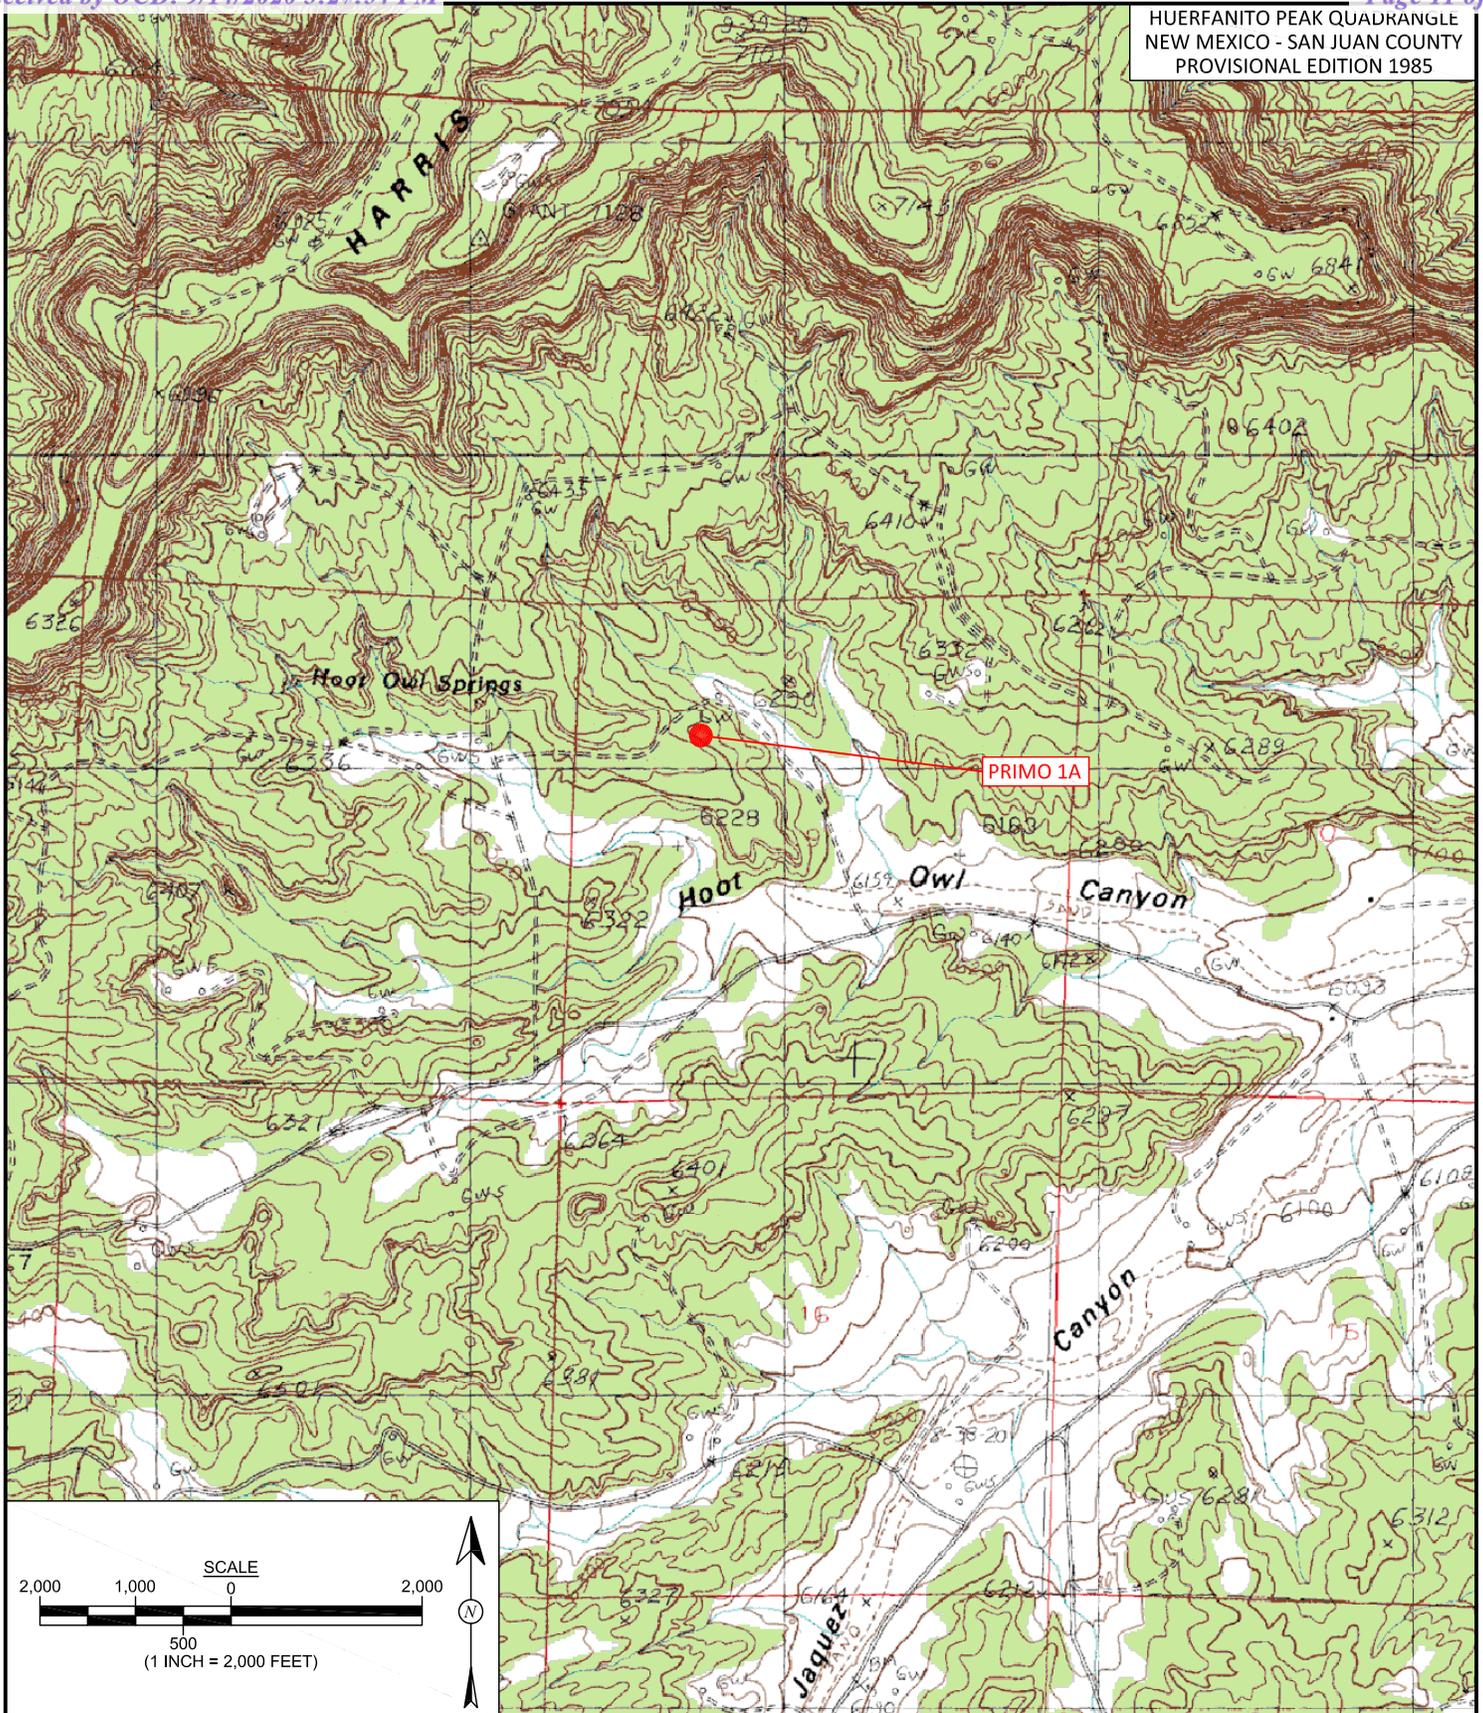
FIGURE 1

TOPOGRAPHIC SITE LOCATION MAP
HARVEST FOUR CORNERS, LLC
PRIMO 1A
API: 3004521827
NW¼ NW¼, SECTION 6, T31N, R10W
SAN JUAN COUNTY, NEW MEXICO
N36.93114, W107.92857

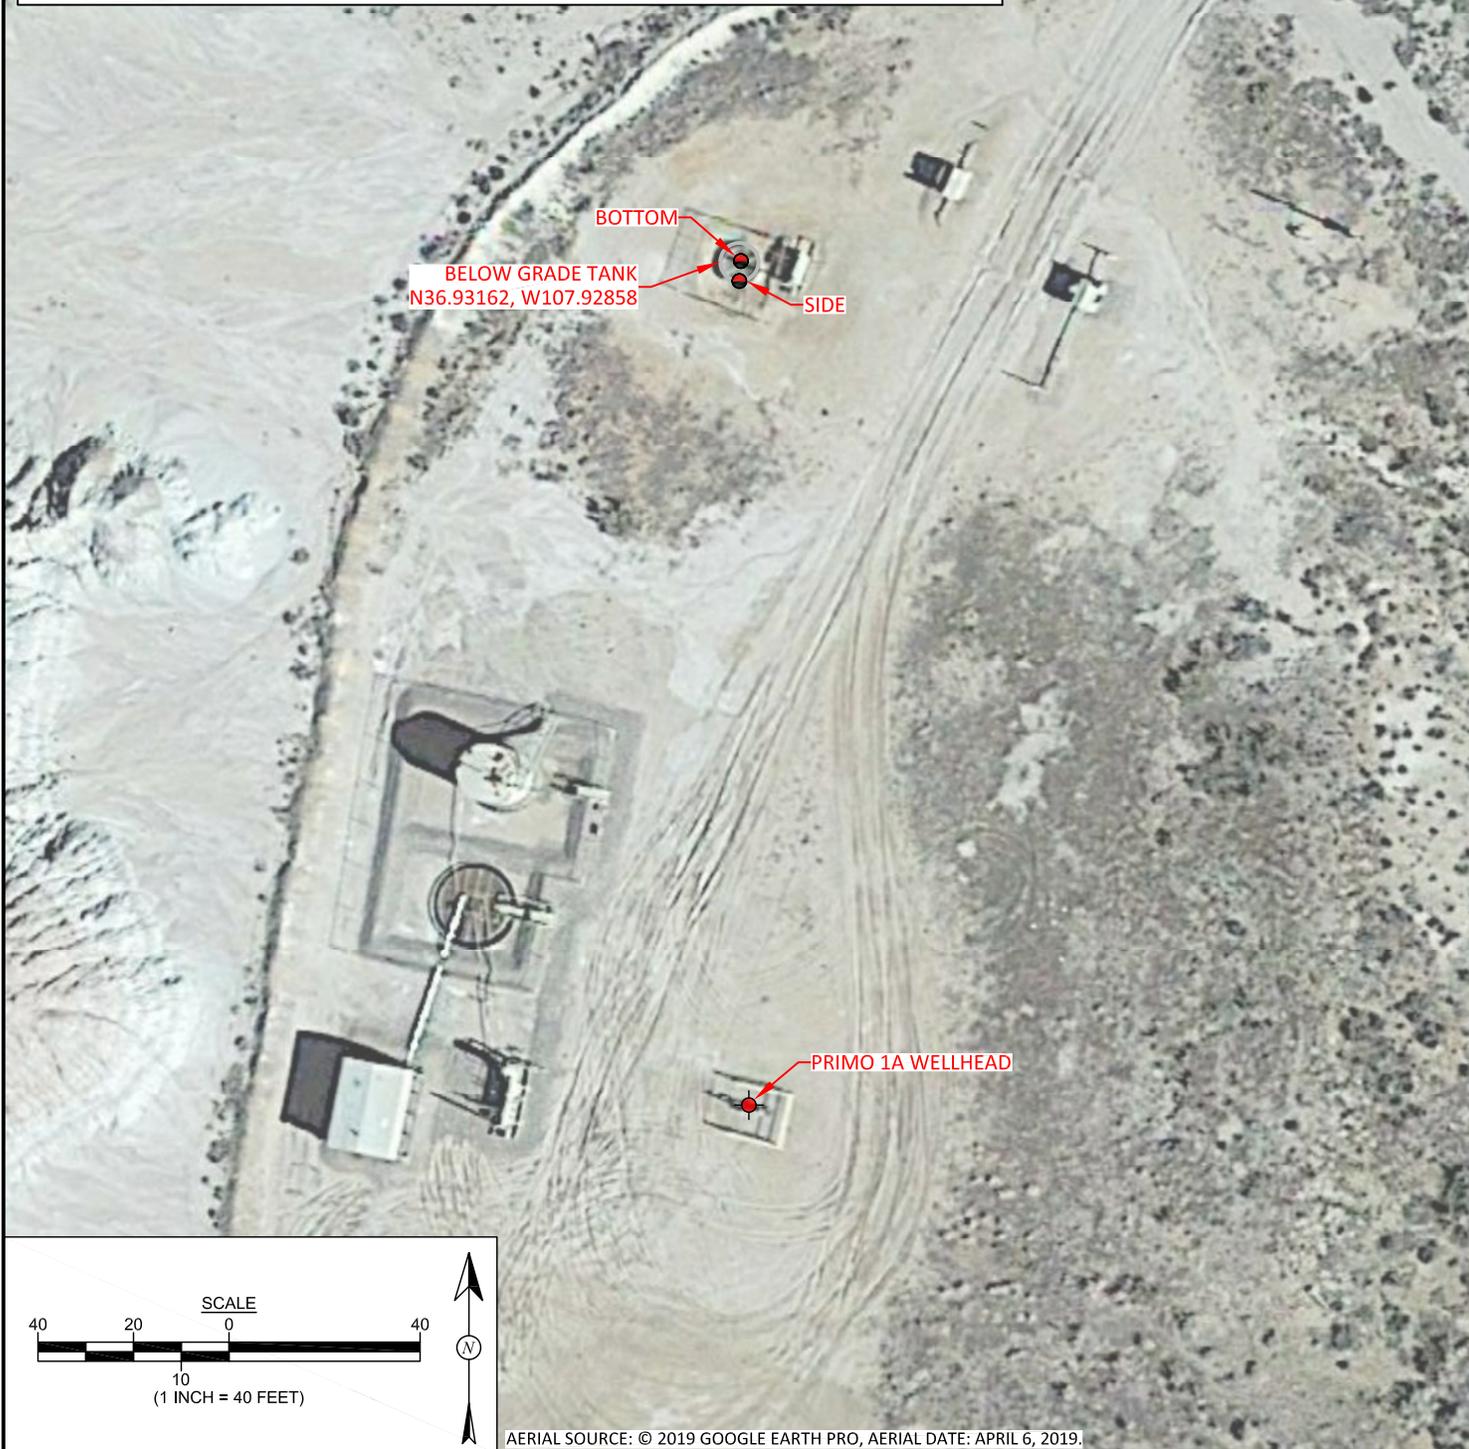
FIGURE 2

Laboratory Analytical Results								
Sample ID	Date	Depth (ft)	Benzene (mg/kg)	Total BTEX (mg/kg)	TPH-GRO (mg/kg)	TPH-DRO (mg/kg)	TPH-MRO (mg/kg)	Chlorides (mg/kg)
NMOCD ACTION LEVEL			10	50	1,000		---	10,000
					2,500			
SIDE	7/15/20	--	<0.023	<0.207	<4.6	<9.8	<49	<59
BOTTOM	7/15/20	--	<0.025	<0.222	<4.9	<10	<50	<60

SAMPLES WERE ANALYZED PER USEPA METHOD 8260B, 8015D AND 300.0.

AERIAL SITE MAP
BELOW GRADE TANK CLOSURE, JULY 2020
HARVEST FOUR CORNERS, LLC
PRIMO 1A
API: 3004521827
NW¼ NW¼, SECTION 6, T31N, R10W
SAN JUAN COUNTY, NEW MEXICO
N36.93114, W107.92857

Laboratory analytical results are summarized in Table 1 and presented on Figure 2. The laboratory analytical report is attached.

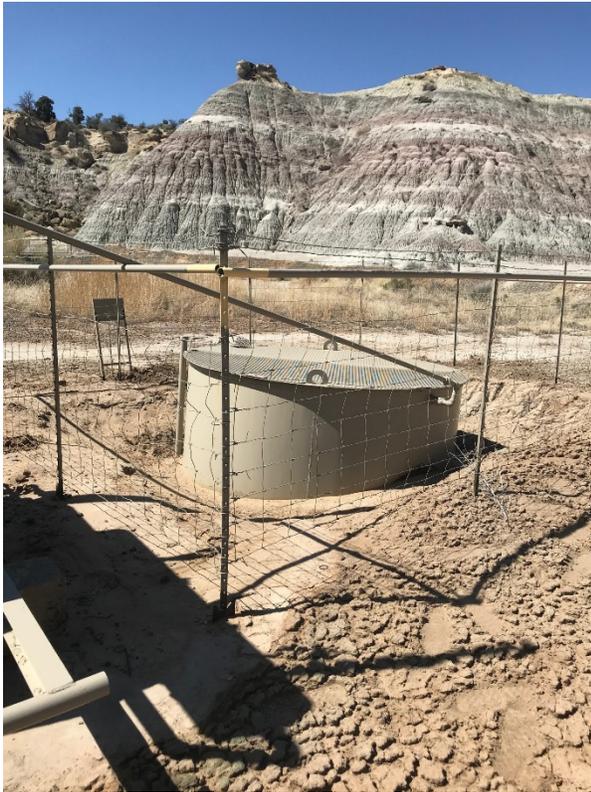
Photo 1: Primo #1A – Removed Harvest BGT.

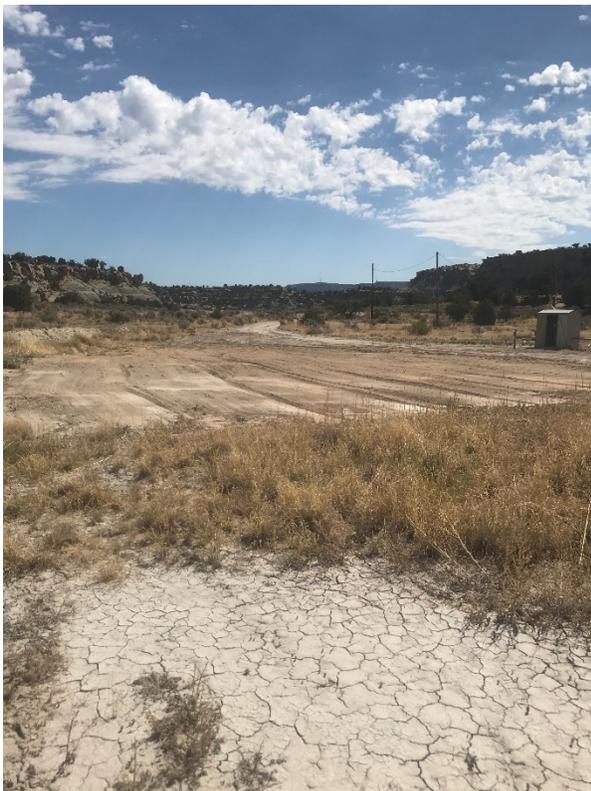
Photo 2: Primo #1A after BGT removal backfill.

Based on BGT laboratory analytical results for benzene, total BTEX, TPH, and chloride for the Harvest BGT removed from the location, the site was backfilled with clean soil. No further work is recommended at Primo #1A for the Harvest BGT Closure.
