Pit, Below-Grade Tank, or
Proposed Alternative Method Permit or Closure Plan Application

Hilcorp Energy Company
San Juan Basin
Below Grade Tank Closure Report

Lease Name: Huerfano Unit 255S

API No.: 30-045-34682

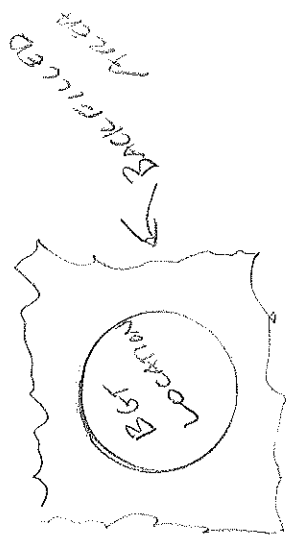
Huerfano Unit 2555
API 30-045-34682

→ PIC#1
PIC#2 3'x4'
PIC#3 3'x4'
→
PICS TAKEN
FROM
WH FACING
SOUTH EAST
