Pit, Below-Grade Tank, or
Proposed Alternative Method Permit or Closure Plan Application

1. Operator: Mustang Resources LLC OGRID #: 375495
Address: 1660 Lincoln Street, Suite 1450 Denver, CO 80264
Facility or well name: Flush #001
API Number: 30-045-30271 OCD Permit Number:
U/L or Qtr/Qtr F Section 02 Township 26N Range 13W County: San Juan
Center of Proposed Design: Latitude 36.519202 Longitude -108.190926 NAD83
Surface Owner: [] Federal [] State [] Private [x] Tribal Trust or Indian Allotment

**Flush #1
BGT
Closure Requirements**

Photograph Log
Flush #1 BGT
Mustang Resources, LLC

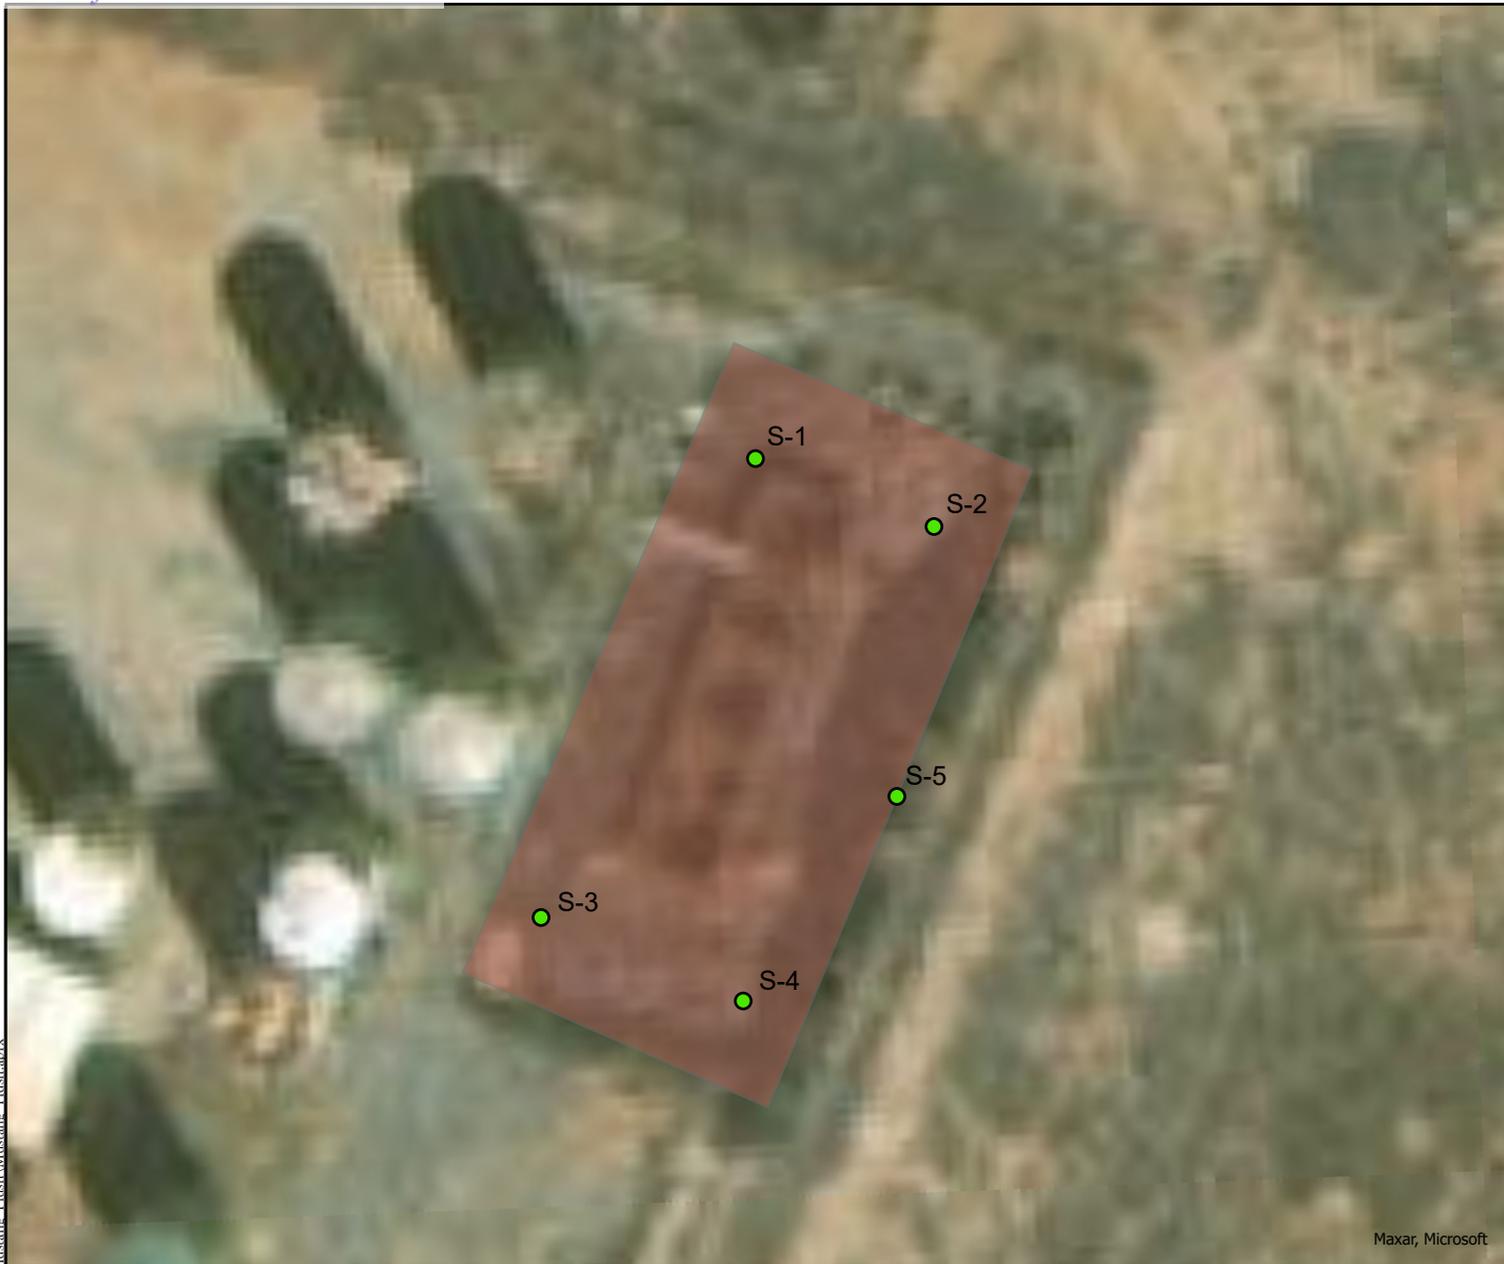
- Composite Sample Locations
- Pit Area

On July 12, 2022, following removal of the BGT, SMA personnel conducted a visual inspection for surface/subsurface indications of a release. No evidence of a release was observed. SMA personnel then collected five soil samples (S-1 through S-5) from 0.5 feet beneath the edges of the concrete slab at the base of the BGT excavation as illustrated on Figure 3.

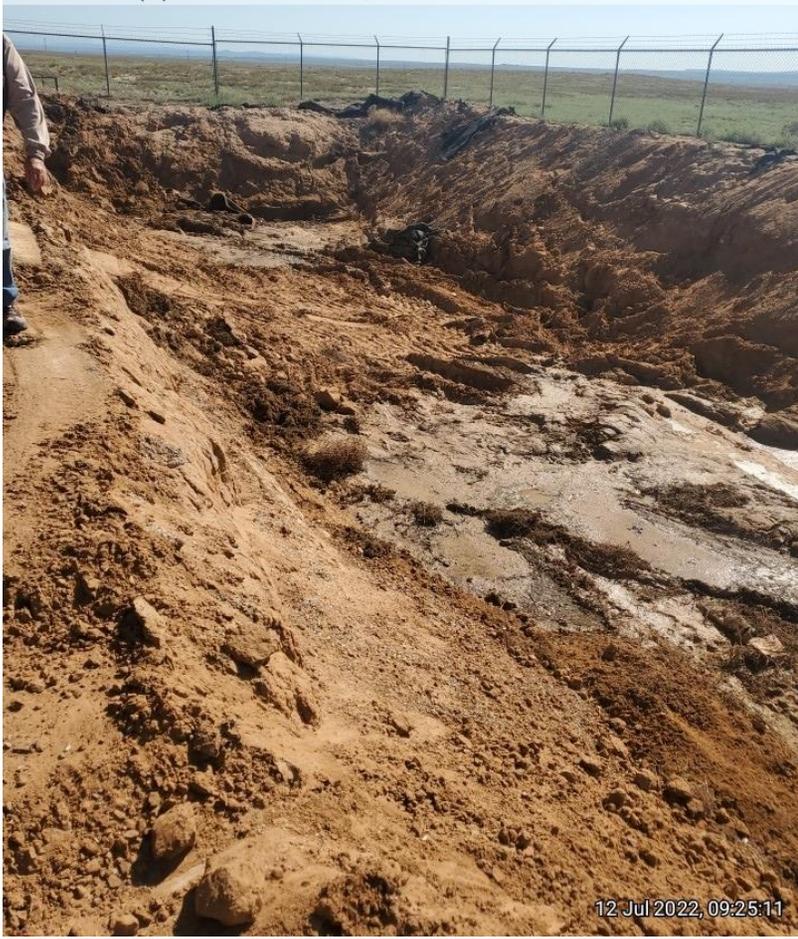
<p>Photograph #1</p>	<div style="text-align: center;"> <h3>South West Elevation</h3> <p>☉ 48°NE (T) • 36°31'8.8" N, 108°11'27.8" W ±3 m ▲ 1818 m</p>

</div>
<p>Client: Mustang Resources, LLC</p>	
<p>Site Name: Flush #1 BGT</p>	
<p>Date Photo Taken: July 12, 2022</p>	
<p>Site Location: N36.519202, W108.190926 F-Sec 02-T26N-R13W San Juan County, New Mexico</p>	
<p>Photo Taken by: Ashley Maxwell</p>	<p>Description: Facing northeast, view of the BGT excavation on July 12, 2022.</p>

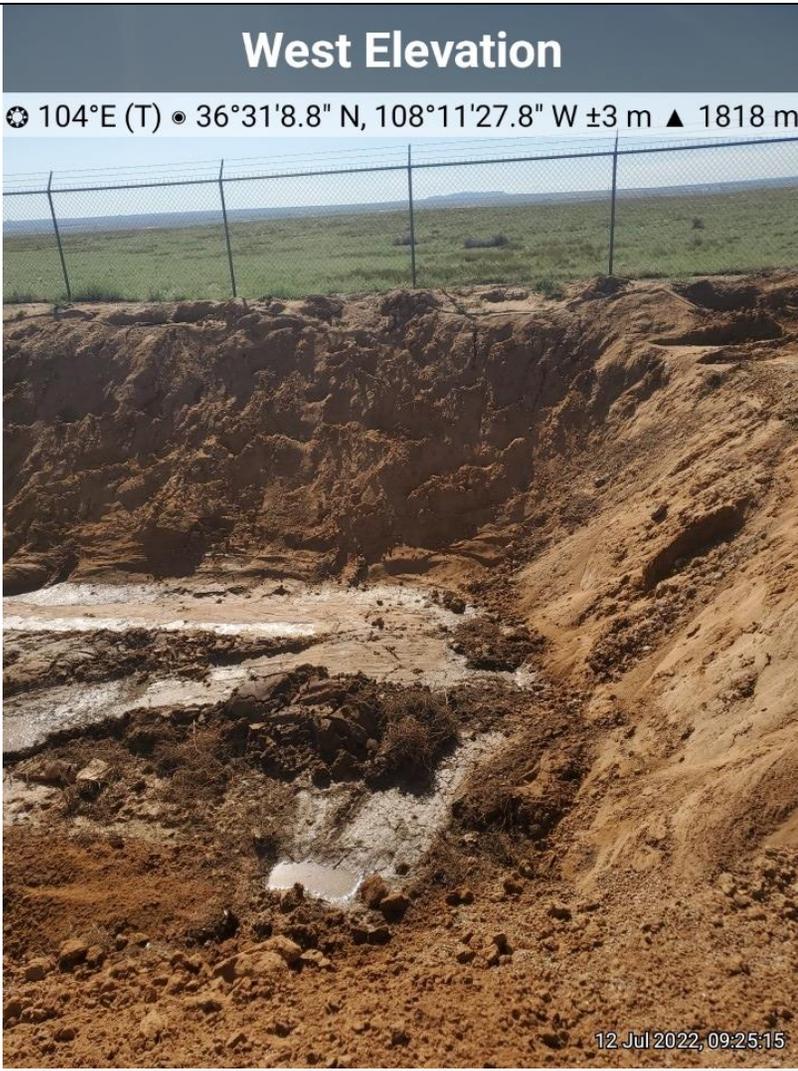
<p>Photograph #2</p>	<div style="text-align: center;"> <h3 style="background-color: #4a69bd; color: white; padding: 5px;">West Elevation</h3> <p style="font-size: small; color: #4a69bd;">📍 104°E (T) ● 36°31'8.8" N, 108°11'27.8" W ±3 m ▲ 1818 m</p>

<p style="text-align: right; font-size: x-small; color: #4a69bd;">12 Jul 2022, 09:25:15</p> </div>
<p>Client: Mustang Resources, LLC</p>	
<p>Site Name: Flush #1 BGT</p>	
<p>Date Photo Taken: July 12, 2022</p>	
<p>Site Location: N36.519202, W108.190926 F-Sec 02-T26N-R13W San Juan County, New Mexico</p>	
<p>Photo Taken by: Ashley Maxwell</p>	<p>Description: Facing east, view of the BGT excavation on July 12, 2022.</p>

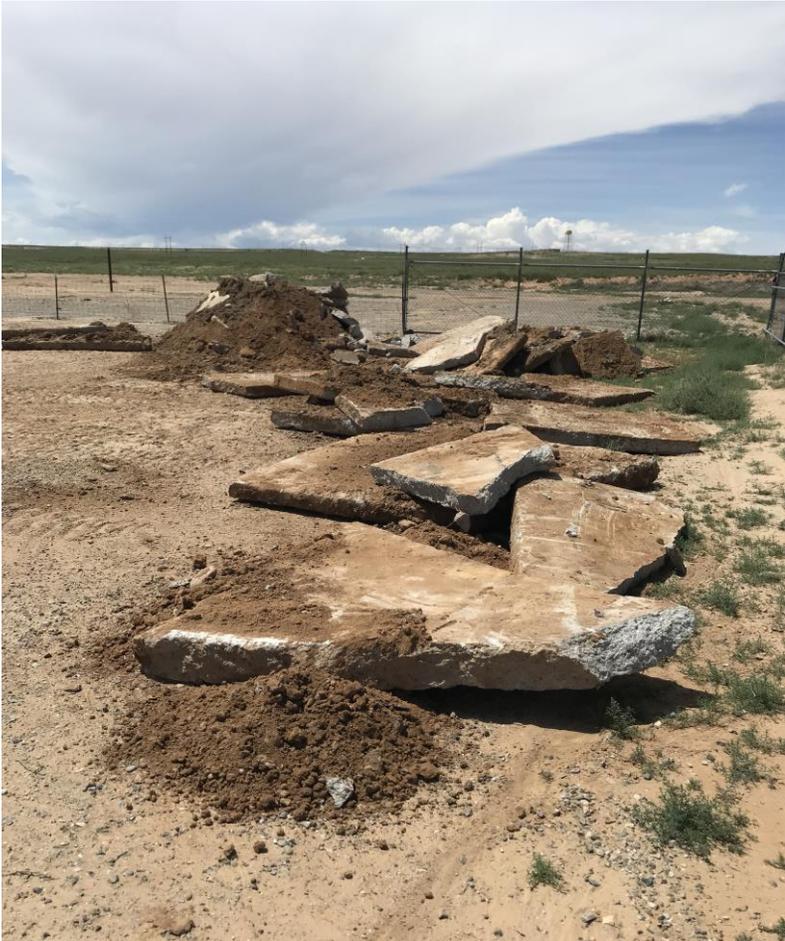
Photograph #3	
Client: Mustang Resources, LLC	
Site Name: Flush #1 BGT	
Date Photo Taken: August 4, 2022	
Site Location: N36.519202, W108.190926 F-Sec 02-T26N-R13W San Juan County, New Mexico

A photograph showing a large, rectangular concrete pad that has been broken into several pieces and is lying on a dirt and gravel surface. The concrete is light-colored with some darker spots. In the background, there is a fence line, a utility pole, and a cloudy sky. The ground is dry and sandy.
Photo Taken by: Don Johnson	Description: Concrete pad removed from base of BGT excavation on August 4, 2022.

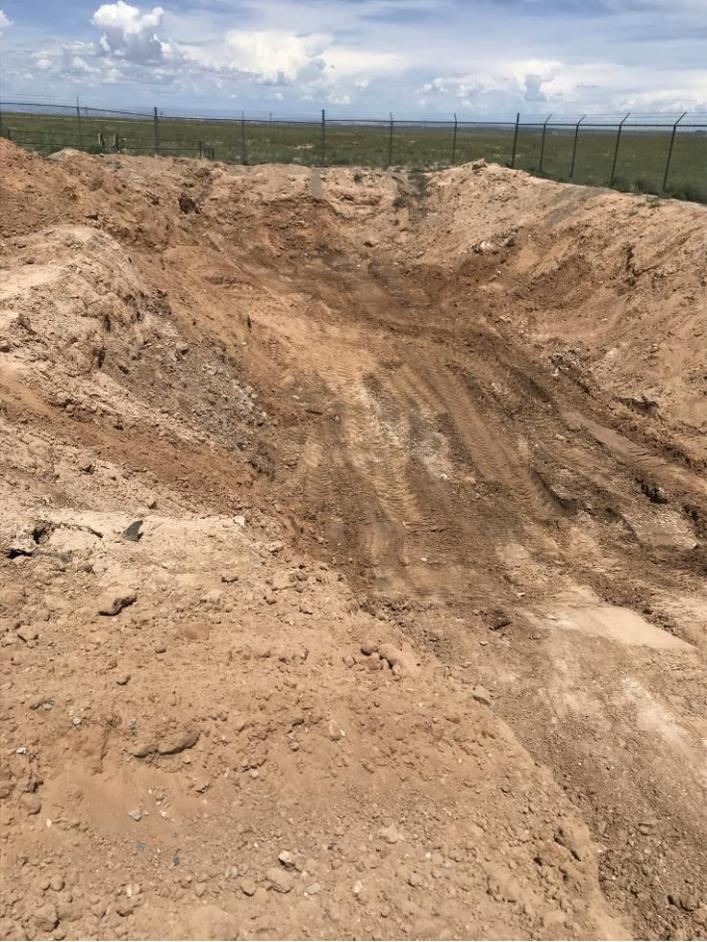
Photograph #4

A photograph showing a large, deep excavation site. The ground is reddish-brown soil, and there are visible tire tracks leading into the excavation. In the background, there is a chain-link fence and a clear blue sky with some clouds.
Client: Mustang Resources, LLC	
Site Name: Flush #1 BGT	
Date Photo Taken: August 4, 2022	
Site Location: N36.519202, W108.190926 F-Sec 02-T26N-R13W San Juan County, New Mexico	
Photo Taken by: Don Johnson	Description: Facing south, view of the BGT excavation with the concrete pad removed on August 4, 2022.

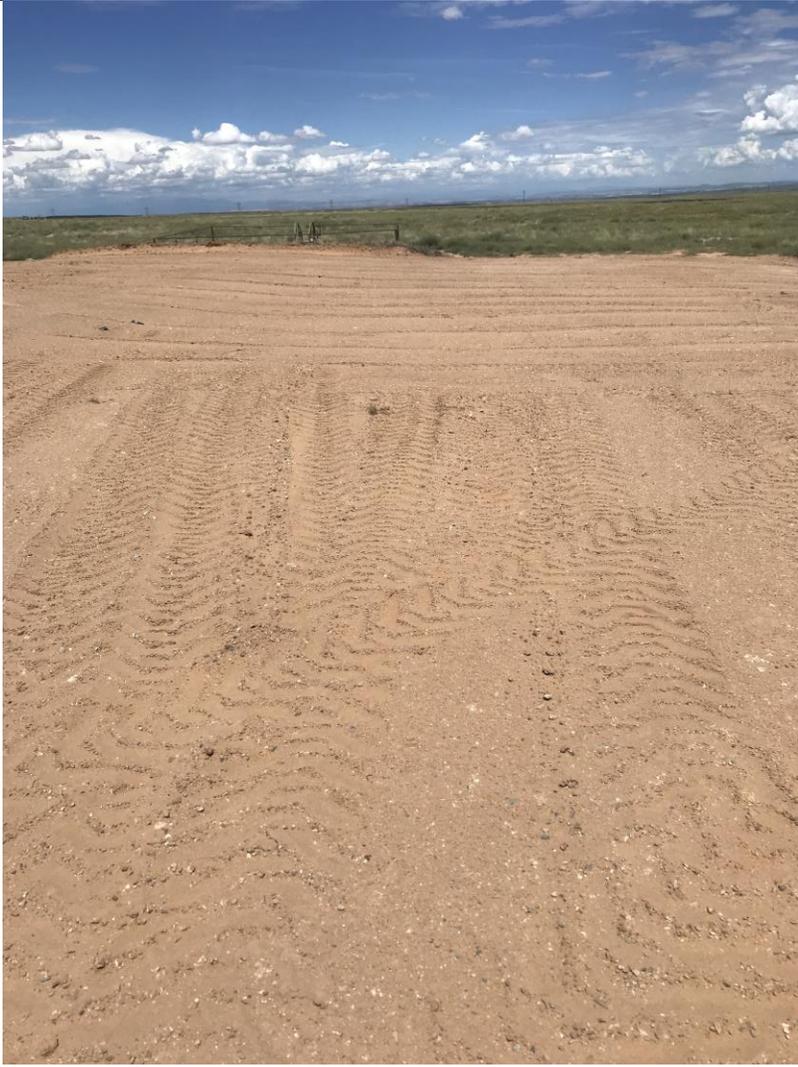
Photograph #5

Client: Mustang Resources, LLC	
Site Name: Flush #1 BGT	
Date Photo Taken: August 16, 2022	
Site Location: N36.519202, W108.190926 F-Sec 02-T26N-R13W San Juan County, New Mexico	
Photo Taken by: Don Johnson	Description: Facing north-northeast, view of the compacted and contoured excavation area on August 16, 2022.

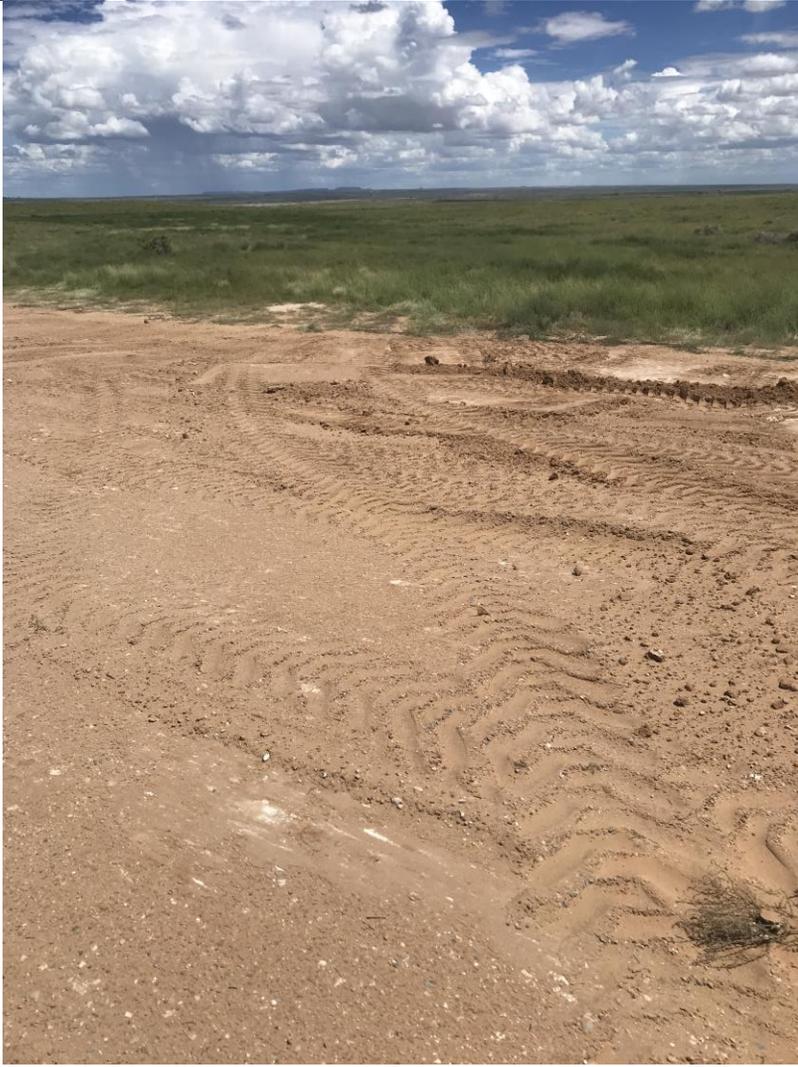
Photograph #6

Client: Mustang Resources, LLC	
Site Name: Flush #1 BGT	
Date Photo Taken: August 16, 2022	
Site Location: N36.519202, W108.190926 F-Sec 02-T26N-R13W San Juan County, New Mexico	
Photo Taken by: Don Johnson	Description: Facing east-northeast, view of the compacted and contoured excavation area on August 16, 2022.
