EME SWD #8

Closure

Reports

RE: Below Grade Tank (BGT) - Closure
EME G-8 East BGT (API 30-025-06017):
Unit G, Sec. 8, T20S, R37E
RICE Operating Company – Eunice Monument Eumont (EME) SWD System

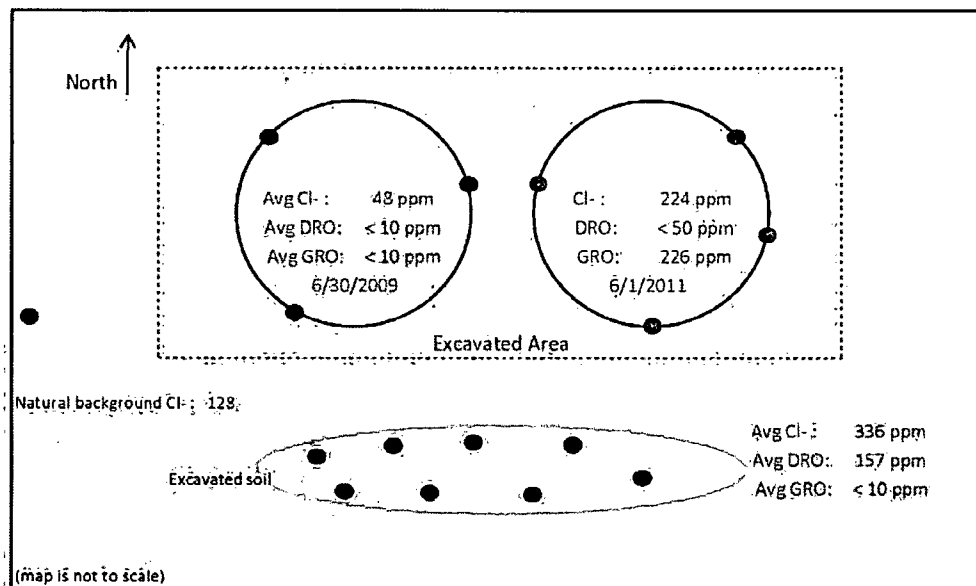
Figure 2 – Approximate soil sampling locations and laboratory results.

Based on the November 2nd, 2011, Finalization of Below Grade Tank Closure Plan, the east and west below grade tanks were removed from the site and were properly disposed of on September 27th, 2012. On October 25th, 2012, a composite sample was collected from the area beneath the former east tank. Laboratory analysis of the East 5 Pt. Comp resulted in a chloride concentration of 144 mg/kg, a GRO concentration of <10.0 mg/kg, a DRO concentration of 164 mg/kg, and BTEX concentrations below detectable limits. Based on the DRO concentration, the area located beneath the former below grade tank was scraped approximately 6 inches. The scraped soil was properly disposed of at the NMOCD approved facility Sundance (Permit # NM-01-0003). On November 13th, 2012, a second composite sample was collected from the east area, and laboratory analysis of that sample resulted in a chloride concentration of 96 mg/kg, a GRO concentration of <10.0 mg/kg, a DRO concentration of 21.2 mg/kg, and BTEX concentrations below detectable limits.

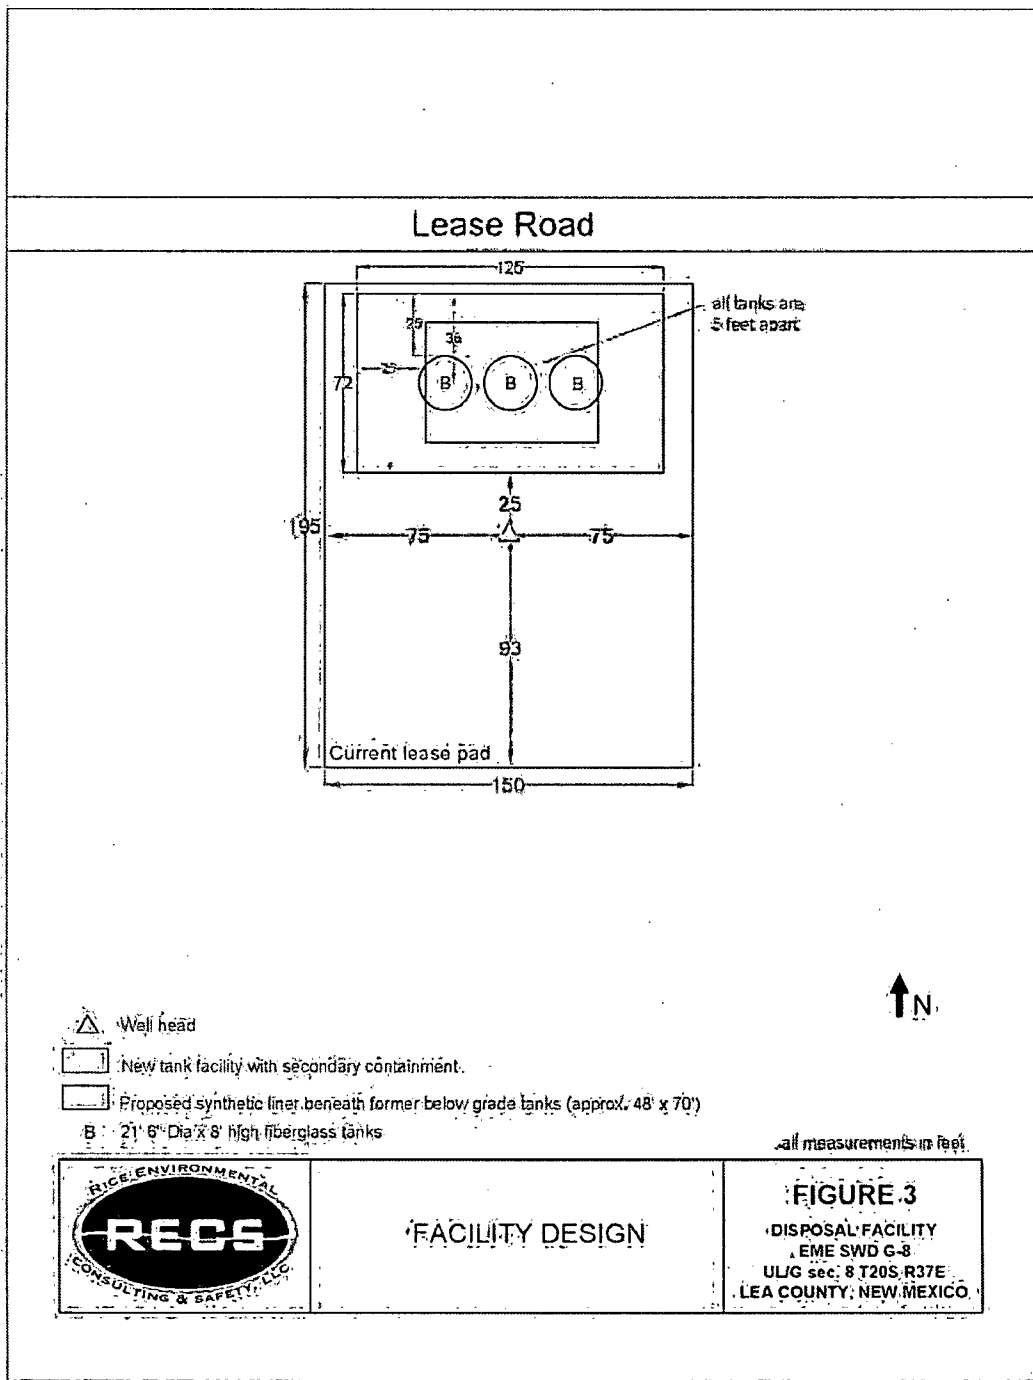
Figure 3 – Schematic diagram of proposed liner.

To further protect groundwater, a 76x67-ft, 20-mil reinforced liner was installed at approximately 5 ft below ground surface (bgs). The liner was then padded with 6 inches of imported top soil. Laboratory analysis of the imported topsoil resulted in a chloride concentration below detectable limit and a PID (field) reading of 0.0. The remaining excavation was backfilled with imported caliche and base coarse. Lab analysis of these resulted in a chloride concentration of below detectable limits and a PID (field) reading of 2.1 ppm for the caliche and concentration of 80 mg/kg chloride and a PID (field) reading of 0.0 ppm for the base coarse. Laboratory analyses, PID sheets, and photo documentation is attached.

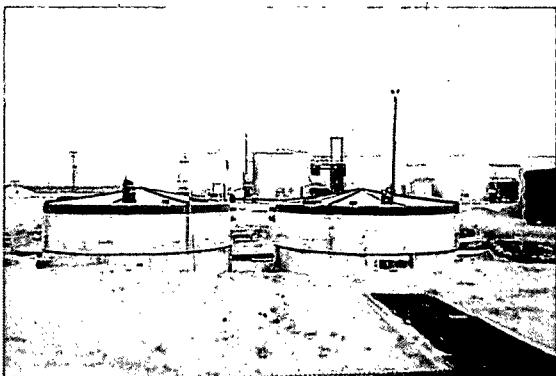
former below grade tanks, facing north
9/27/2012

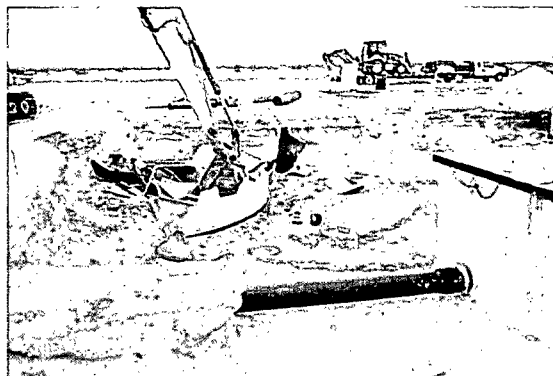
removing the below grade tanks, facing south
9/27/2012

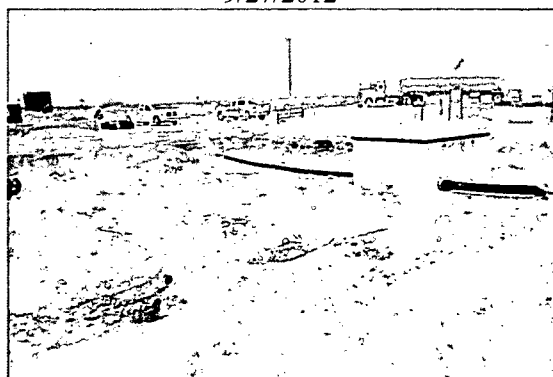
below grade tanks removed, facing northwest
9/27/2012

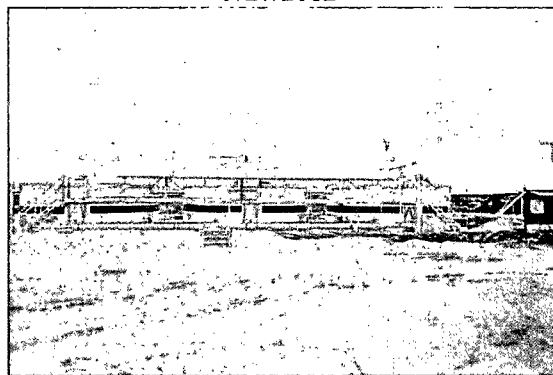
new G-8 facility, facing west
9/27/2012

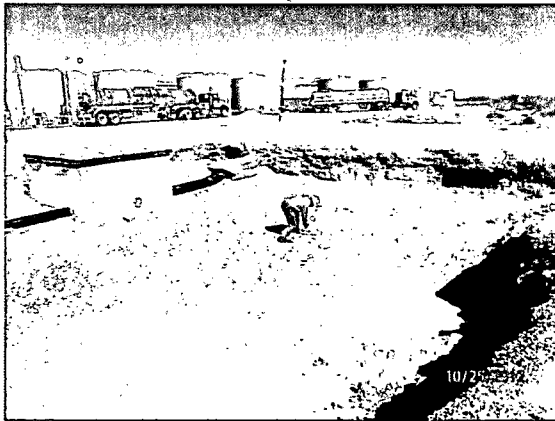
collecting soil samples, facing northeast
10/25/2012

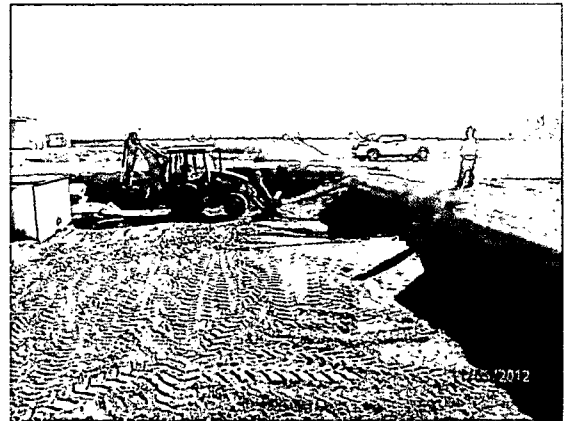
scraping soil from the area of the east tank,
facing east 11/5/2012

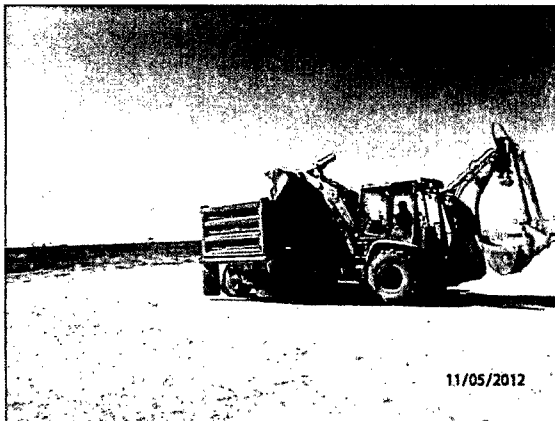
exporting scraped soil, facing south 11/5/2012

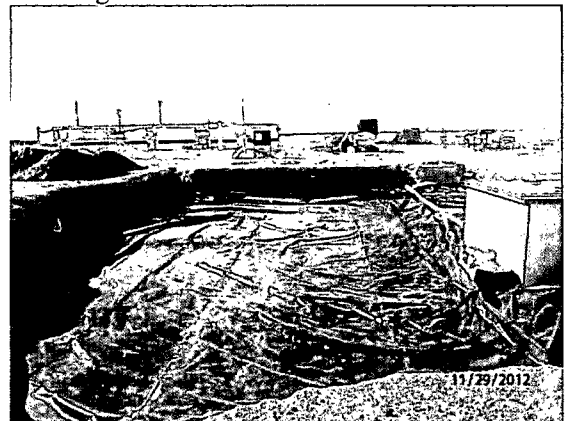
20-mil, reinforced liner installed at
approximately 5 ft bgs, facing west 11/29/2012

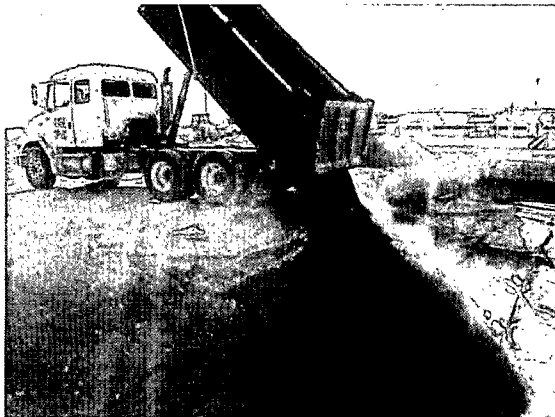
importing blow sand, facing north
11/29/2012

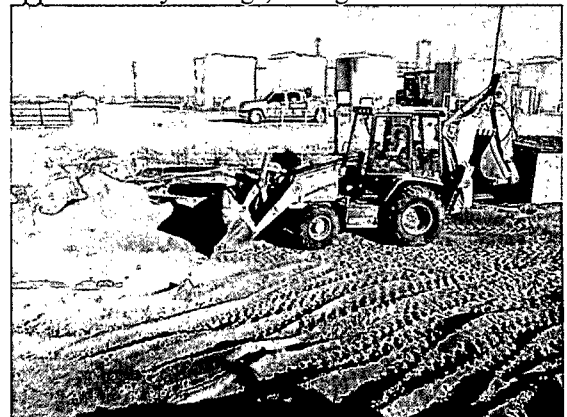
padding above the liner with blow sand,
facing north 11/30/2012

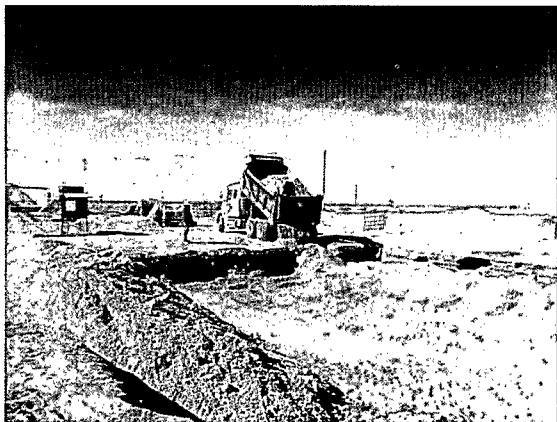
importing caliche, facing west
11/30/2012

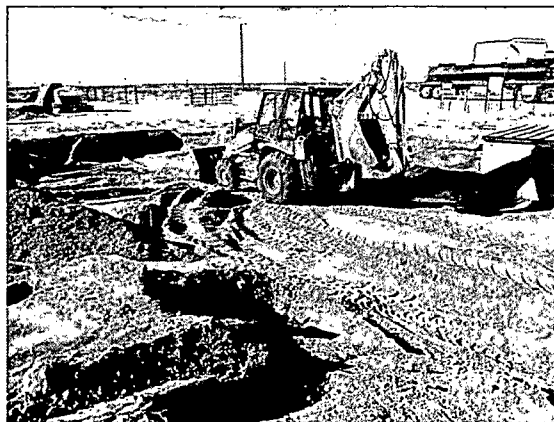
backfilling the site with caliche, facing
northwest 11/30/2012

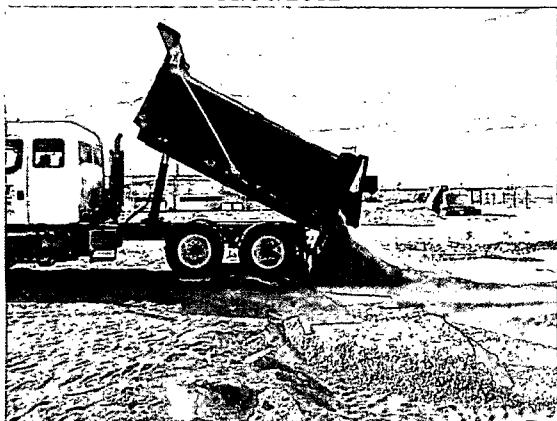
importing base coarse, facing west
12/3/2012

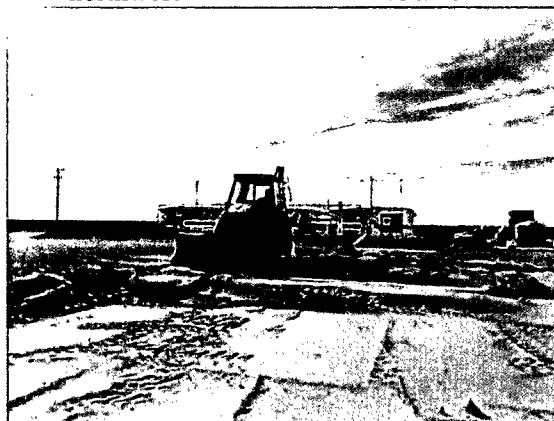
backfilling the site with base coarse, facing west
12/3/2012

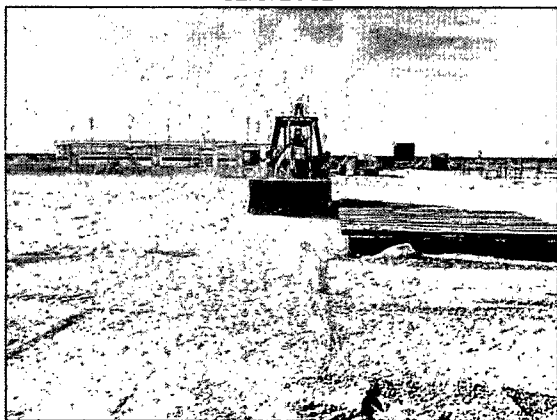
contouring the site, facing west
12/6/2012

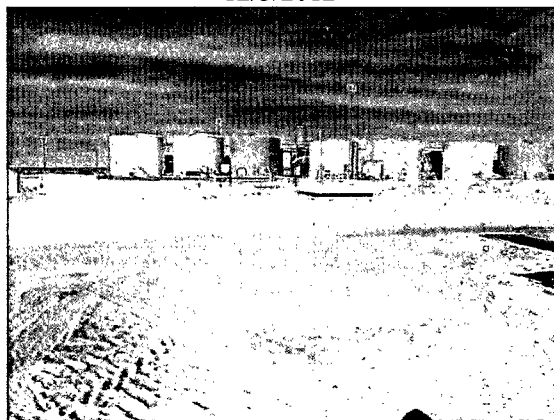
site complete, facing north
12/6/2012

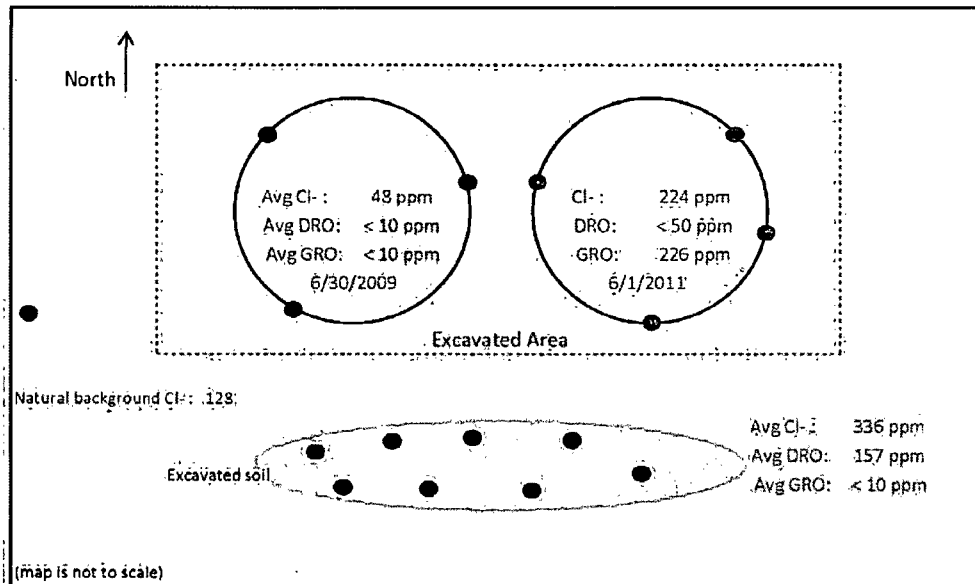
Figure 2 – Approximate soil sampling locations and laboratory results.

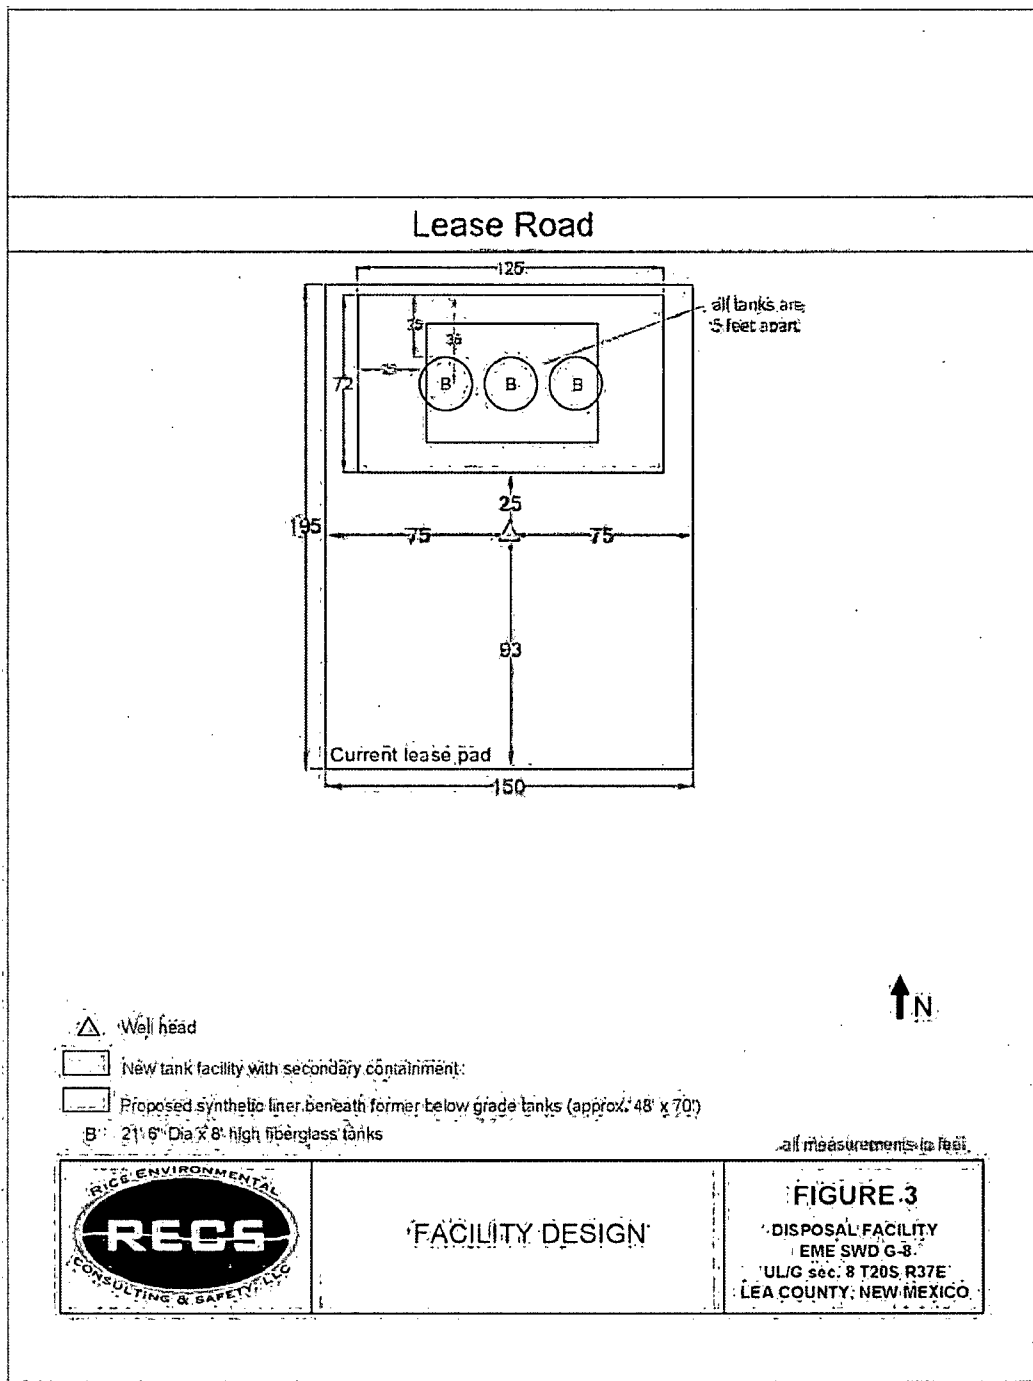
Figure 3 – Schematic diagram of proposed liner.

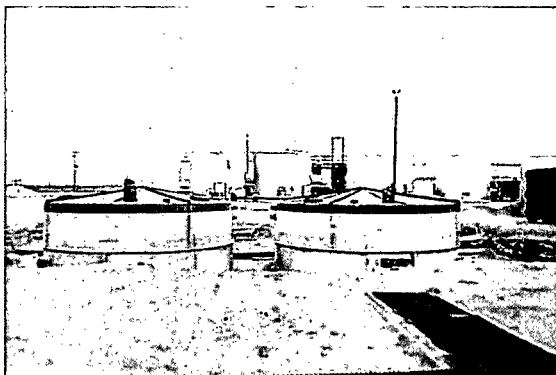
former below grade tanks, facing north
9/27/2012

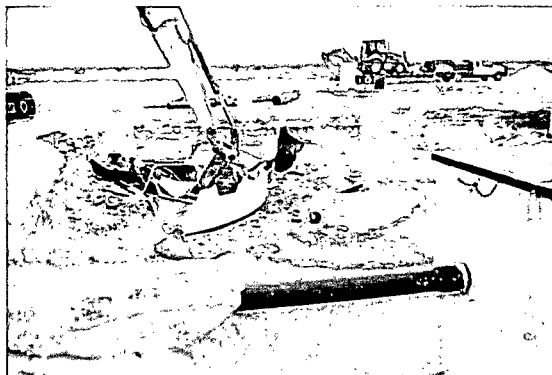
removing the below grade tanks, facing south
9/27/2012

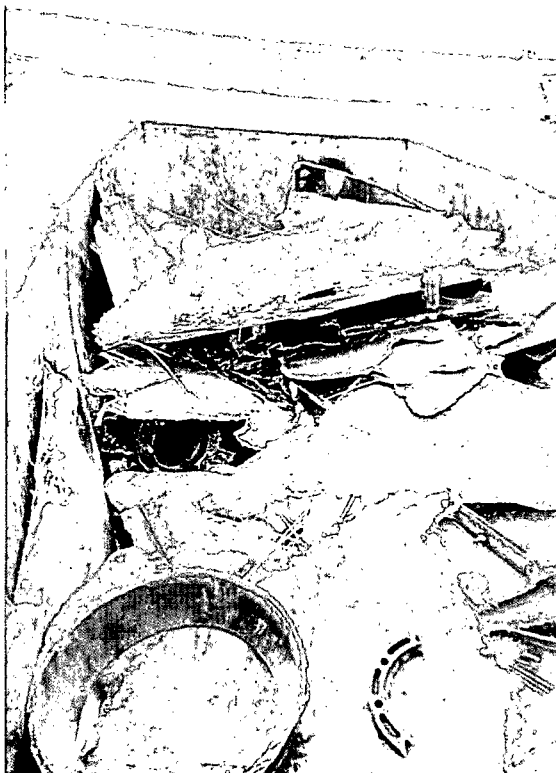
disposing of the below grade tanks
9/27/2012

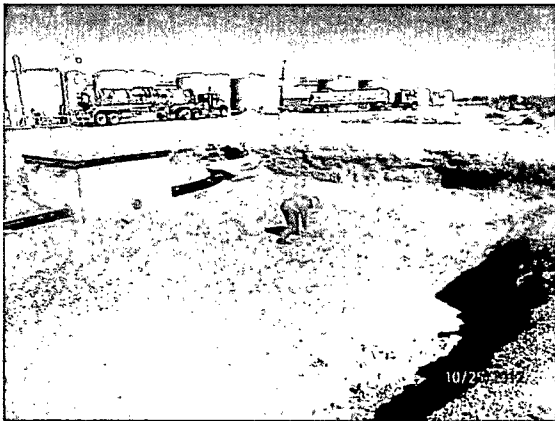
collecting soil samples, facing northeast
10/25/2012

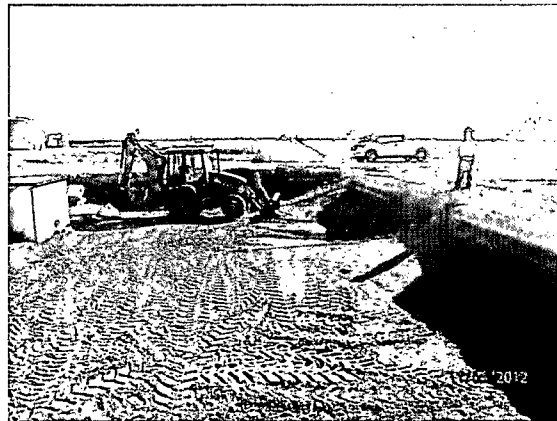
scraping soil from the area of the east tank,
facing east 11/5/2012

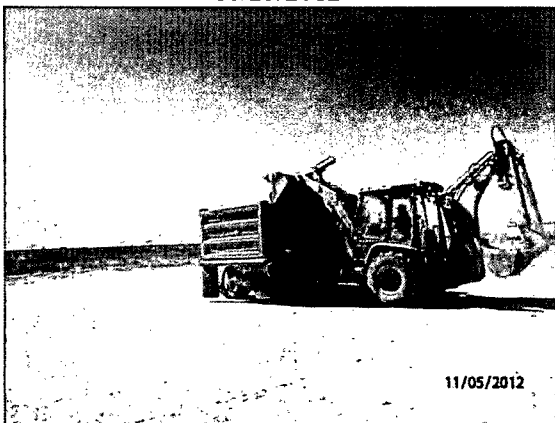
exporting scraped soil, facing south 11/5/2012

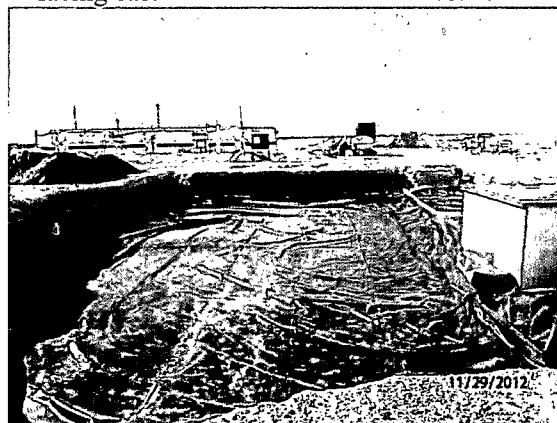
20-mil, reinforced liner installed at
approximately 5 ft bgs, facing west 11/29/2012

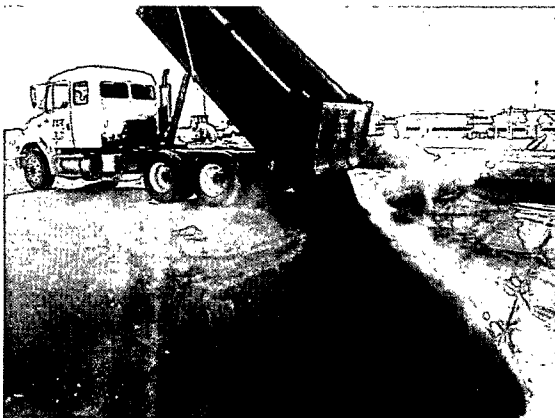
importing blow sand, facing north
11/29/2012

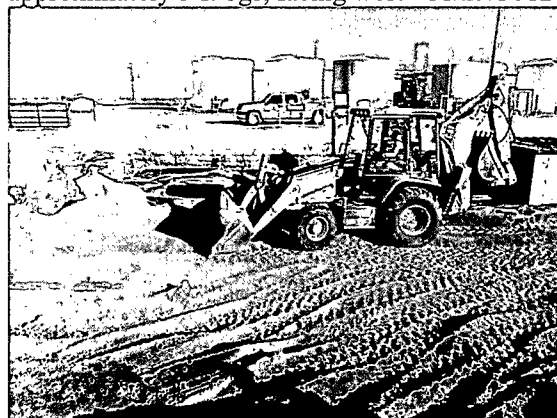
padding above the liner with blow sand,
facing north 11/30/2012

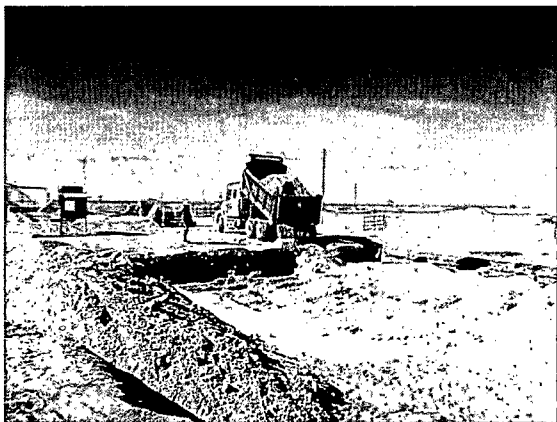
importing caliche, facing west
11/30/2012

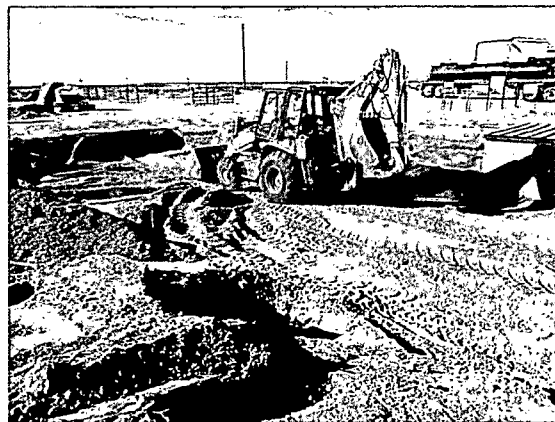
backfilling the site with caliche, facing
northwest 11/30/2012

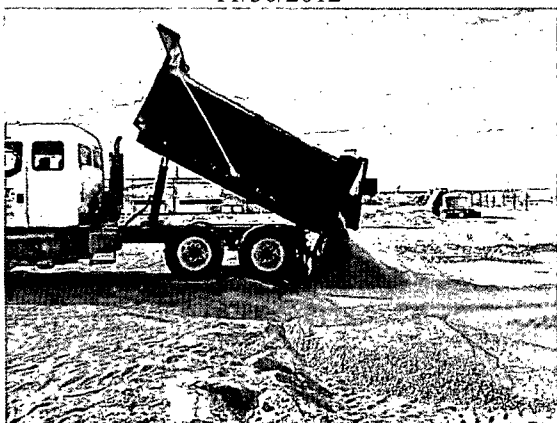
importing base coarse, facing west
12/3/2012

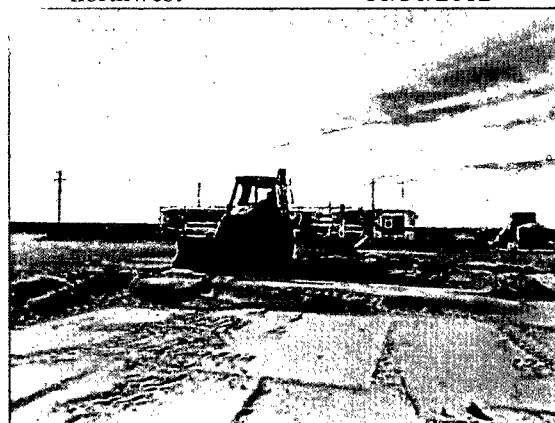
backfilling the site with base coarse, facing west
12/3/2012

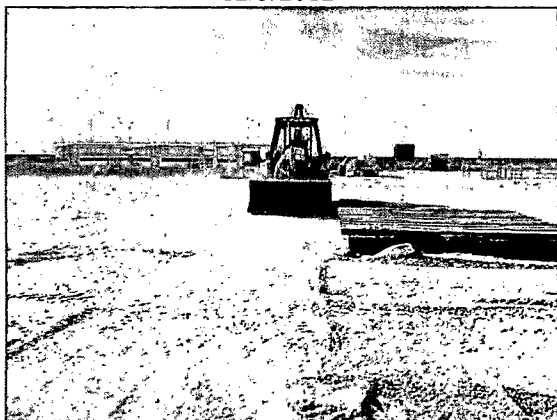
contouring the site, facing west
12/6/2012

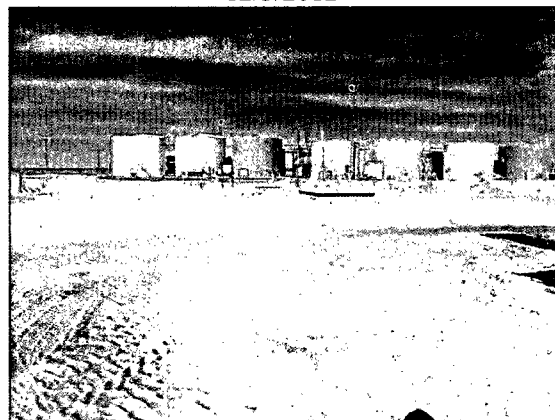
site complete, facing north
12/6/2012
