1R - 427-317

**RE: TERMINATION REQUEST
 Rice Operating Company – EME SWD System
 EME jct. K-8-2 (1R427-317): UL/K sec. 8 T20S R37E
 (formerly EME jct. N-8-2)**

**RICE OPERATING COMPANY
JUNCTION BOX DISCLOSURE REPORT**

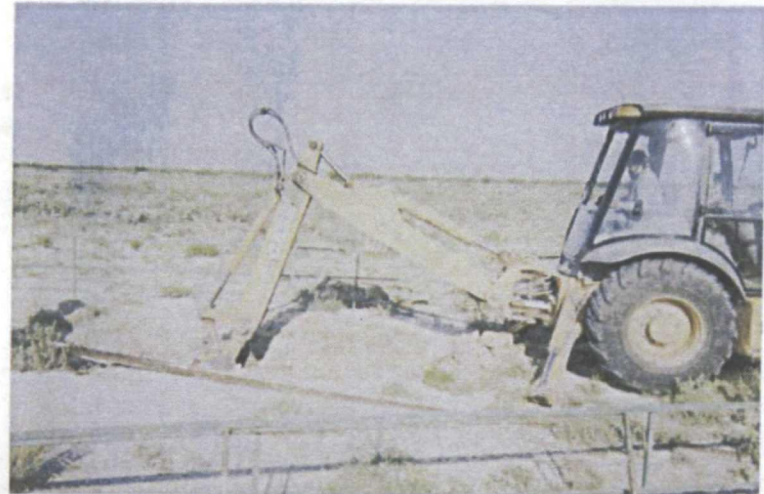
9/1/2009

excavating the former
junction box site, facing west

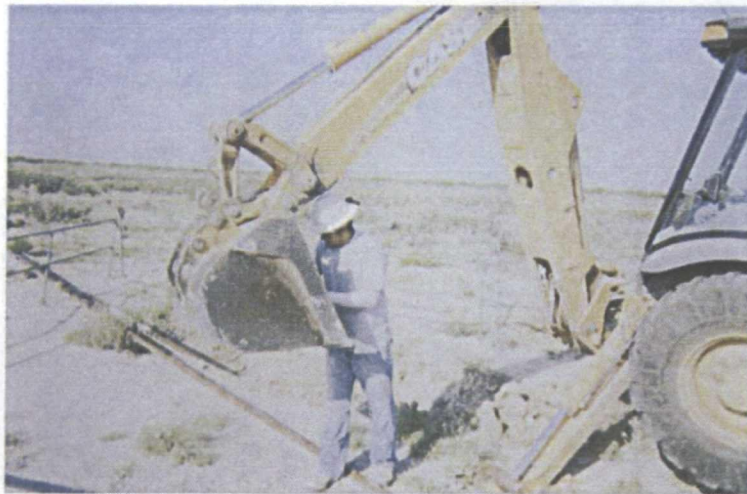
9/1/2009

collecting a soil sample, facing west

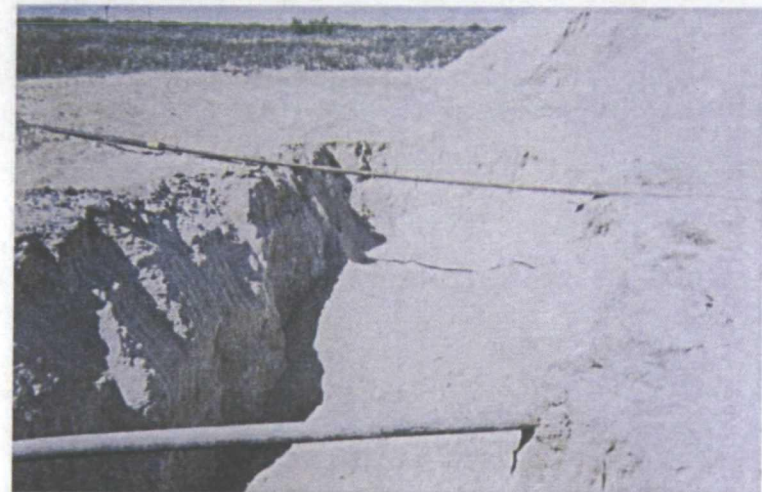
10/20/2009

backfilling the final excavation
up to 5 ft BGS, facing east

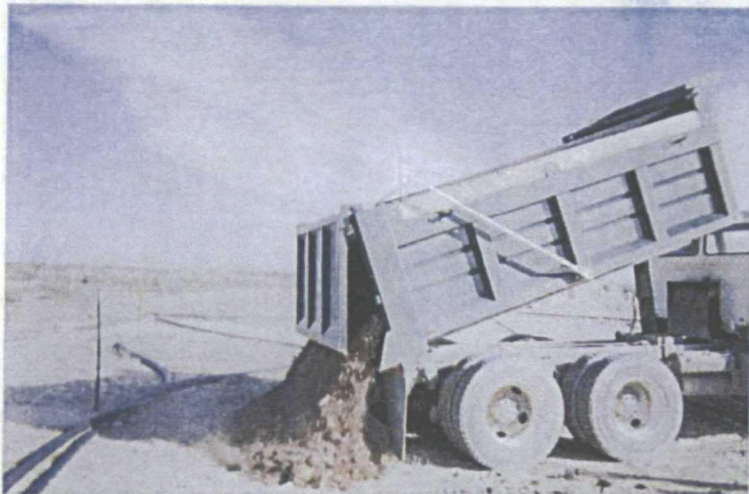
10/28/2009

unloading clay

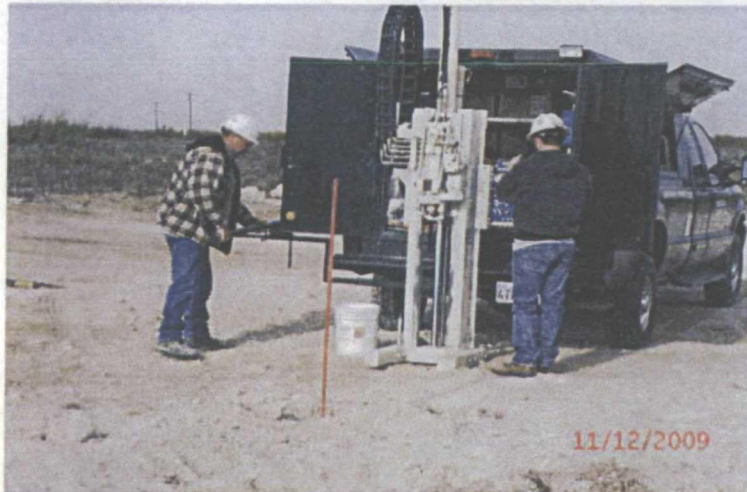
11/12/2009

drilling SB #1 at 15 ft east
of the former junction

The bottom composite laboratory reading suggested that ROC did not in fact encompass the chloride contamination vertically, a soil bore was advanced on November 12th, 2009, fifteen feet east of the source (the area of the highest chloride concentrations). The boring was advanced to 28 ft bgs and samples were taken every two feet. The samples were screened in the field for both chlorides and hydrocarbons. The 20 ft, 24 ft, and 28 ft samples were taken to a commercial laboratory to be analyzed. The 20 ft samples showed negligible GRO and DRO readings and a chloride reading of 1,650 mg/kg. The 24 ft sample showed a negligible GRO reading, a DRO reading of 10.7 mg/kg and a chloride reading of 1,280 mg/kg. The 28 ft sample showed a negligible GRO reading, a DRO reading of 55.5 mg/kg, and a chloride reading of 256 mg/kg. The entire bore hole was plugged with bentonite to the ground surface. NMOCD was notified of potential groundwater impact on February 25, 2010 and a junction box disclosure report (Appendix A) was submitted to NMOCD with all the 2009 junction box closures and disclosures.

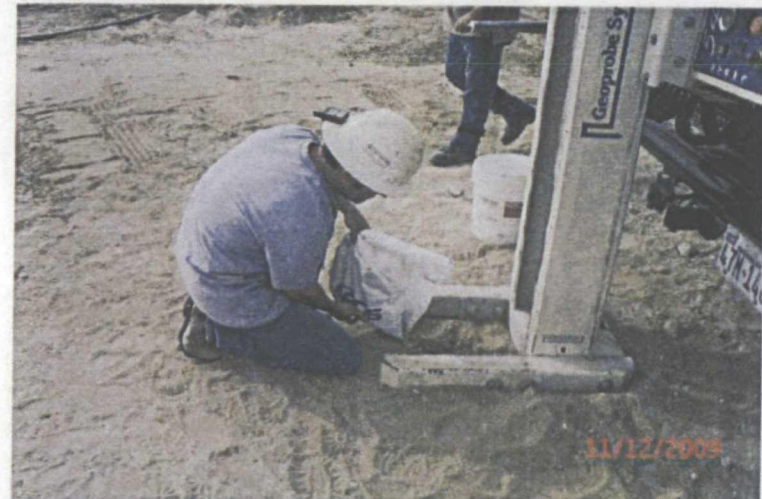
11/12/2009

plugging SB #1 with bentonite

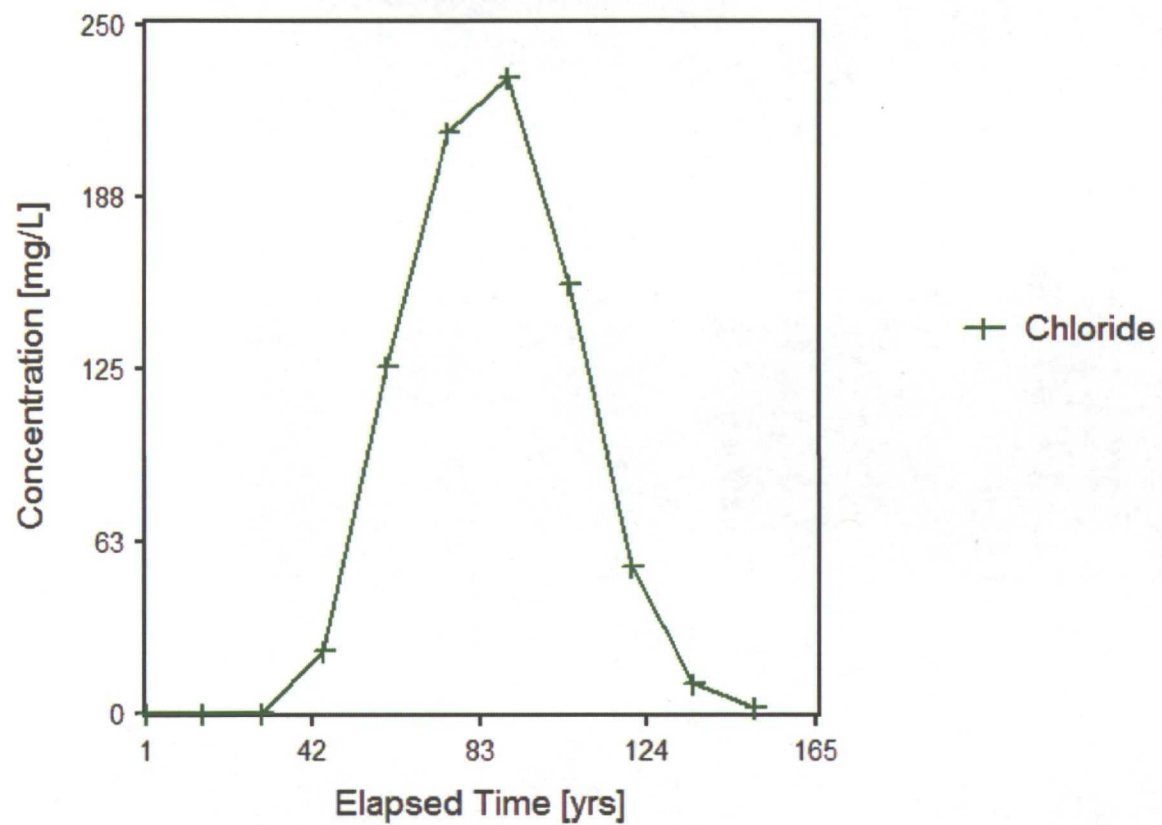
Chloride Concentration

To determine if residual chlorides pose a threat to groundwater quality, ROC personnel ran the U.S. Environmental Protection Agency Exposure Assessment Multimedia Model (MULTIMED Version 1.5, 2005) to determine the possible increase in concentration of chlorides contributed by soils in the vadose zone. Data inputs and model outputs are included in Attachment B. With the existing clay barrier, the model output concludes that the peak concentration of chlorides in groundwater contributed by the vadose zone soils would be approximately 230 mg/L in 90 years. Since the estimated increase in

chloride concentrations in groundwater from residual chloride migration is below the WQCC standard of 250 mg/L, no further action is warranted for this site.

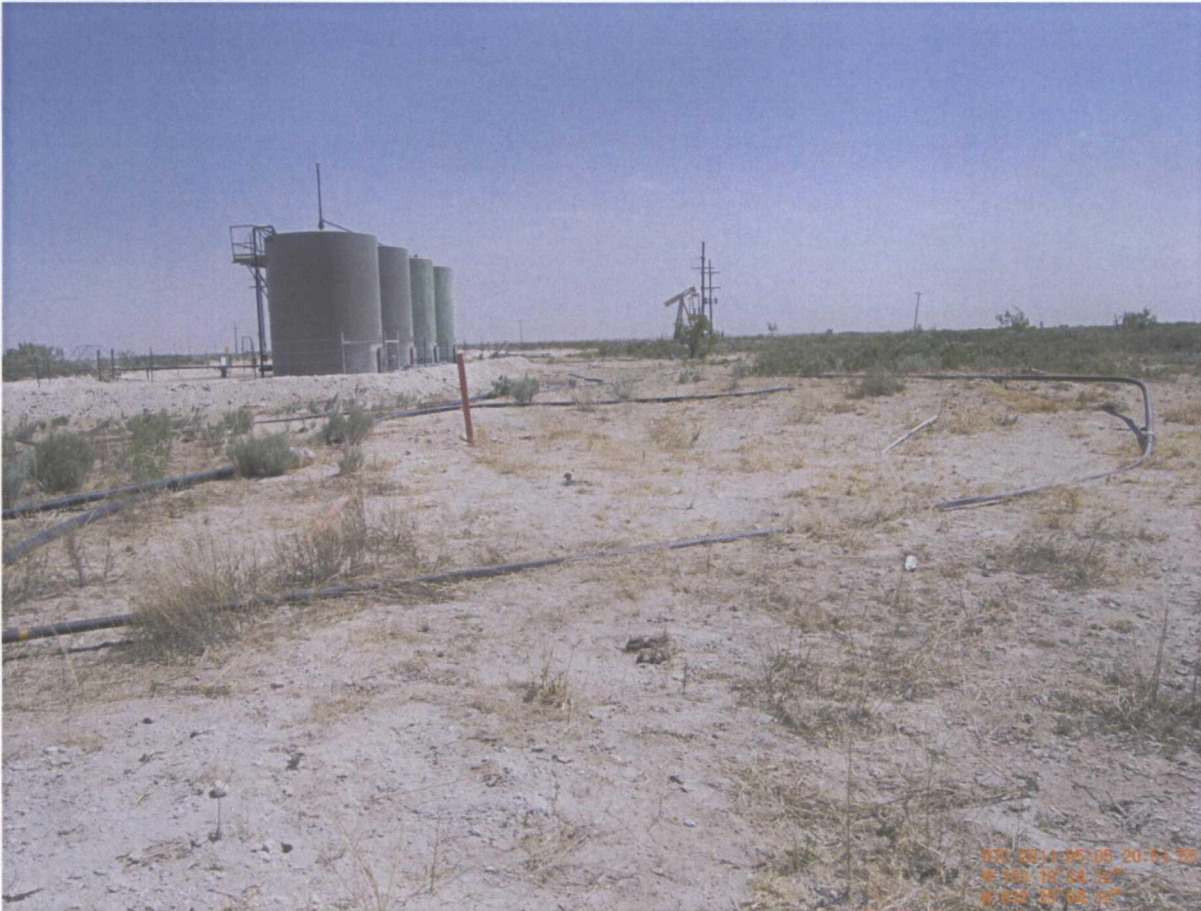
EME jct. K-8-2
Site photo

On December 18th, 2009, ROC personnel seeded the site with a blend of native vegetation (photo included in Appendix A: Junction Box Disclosure Report). This site is located in a high oilfield traffic area, next to an active tank battery with numerous flow lines (Appendix C). Given the location of the site, no further surface restoration is warranted.

May 5th, 2011
Facing south

Since the site poses no threat to groundwater based on the results of the Exposure Assessment Multimedia Model and since the site has returned to normal vegetative capacity, ROC requests that NMOCD grant TERMINATION to the EME jct. K-8-2 regulatory file.
