From:	Hansen, Edward J., EMNRD
Sent:	Thursday, August 15, 2013 3:59 PM
То:	Hack Conder (hconder@riceswd.com)
Cc:	Leking, Geoffrey R, EMNRD; Laura Pena (lpena@riceswd.com); Katie Jones
	<kjones@riceswd.com> (kjones@riceswd.com); Scott Curtis (scurtis@riceswd.com)</kjones@riceswd.com>
Subject:	Remediation Plan (1R427-104) Termination - ROC EME O-17-1 Site

RE: Termination Request EME O-17-1 (1R427-104): UL/O, Sec. 17, T20S, R37E RICE Operating Company – Eunice Monument Eumont (EME) SWD System

RICE OPERATING COMPANY JUNCTION BOX FINAL REPORT

EME O-17-1 (1R427-104) Unit Letter O, Section 17, T20S, R37E

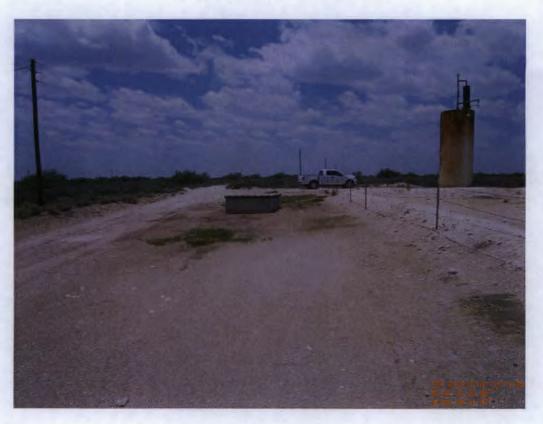
Facing west

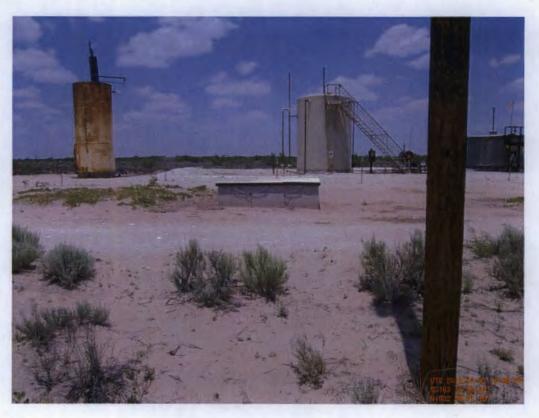
Facing north
