From: Hansen, Edward J., EMNRD
Sent: Monday, July 29, 2013 2:08 PM
To: Hack Conder (hconder@riceswd.com)
Cc: Leking, Geoffrey R, EMNRD; Laura Pena (lpena@riceswd.com); Katie Jones <kjones@riceswd.com> (kjones@riceswd.com); Scott Curtis (scurtis@riceswd.com)
Subject: Remediation Plan (1R427-139) Termination - ROC EME O-35 North Site

RE: Termination Request
EME O-35 North (1R427-139): UL/O, Sec. 35, T20S, R36E
RICE Operating Company – Eunice Monument Eumont SWD System

**EME O-35
North
(1R427-139)**

**RICE OPERATING COMPANY
JUNCTION BOX FINAL REPORT**

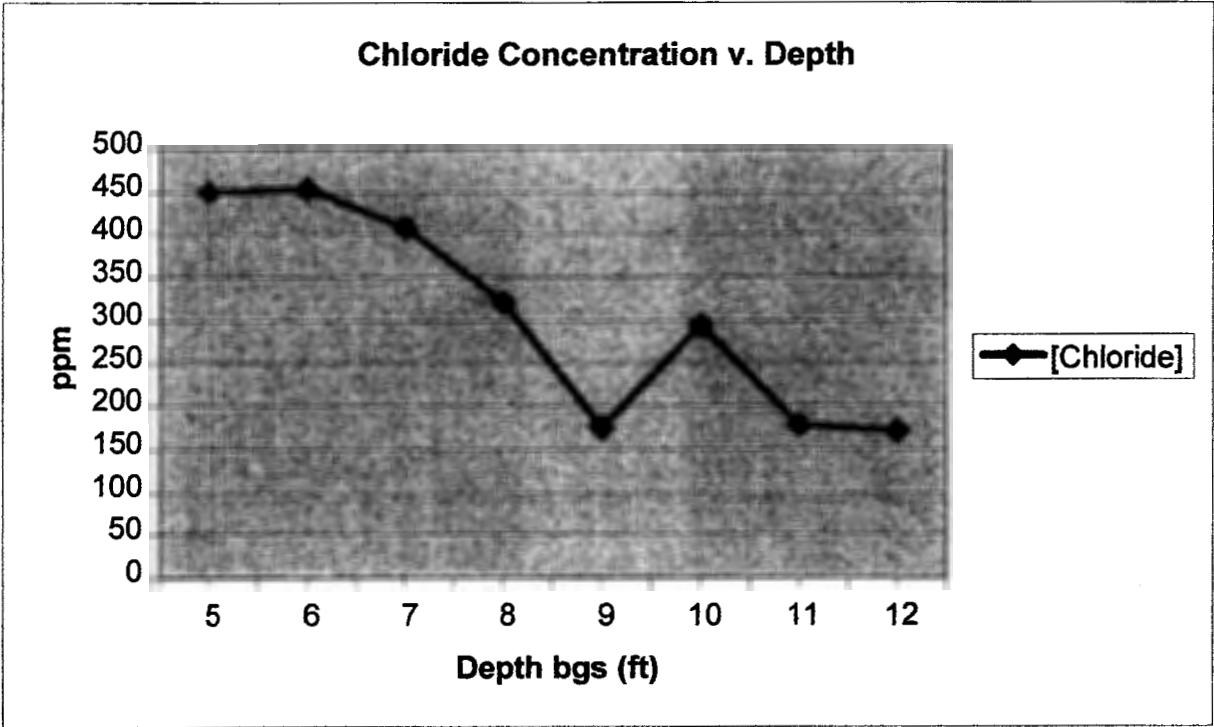
Vertical Delineation at Source

Depth bgs (ft)	[Cl ⁻] ppm
5	449
6	453
7	407
8	321
9	175
10	294
11	178
12	171

Groundwater = 122 ft

General Description of Remedial Action: This was the North box of 2 that were located inside an active production facility. Vertical delineation was conducted with a backhoe while chloride field tests were performed every foot. Chloride concentrations exhibited a conclusive decline in concentrations (see graph), indicative of non-saturated vadose conditions and not threatening to groundwater at 122 ft BGS. PID field screening results were minimal and lab analysis confirmed TPH concentrations well below NMOCD guidelines. The excavation trench was backfilled and contoured to the surrounding surface. A new watertight junction box has been built outside the battery approximately 200 ft Northeast of this box.

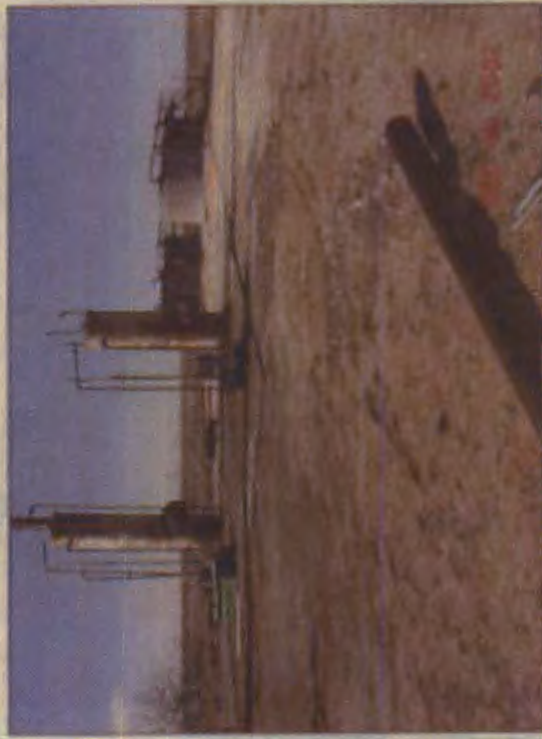
Boxes inside battery (looking SW); North box on right. 12/30/02

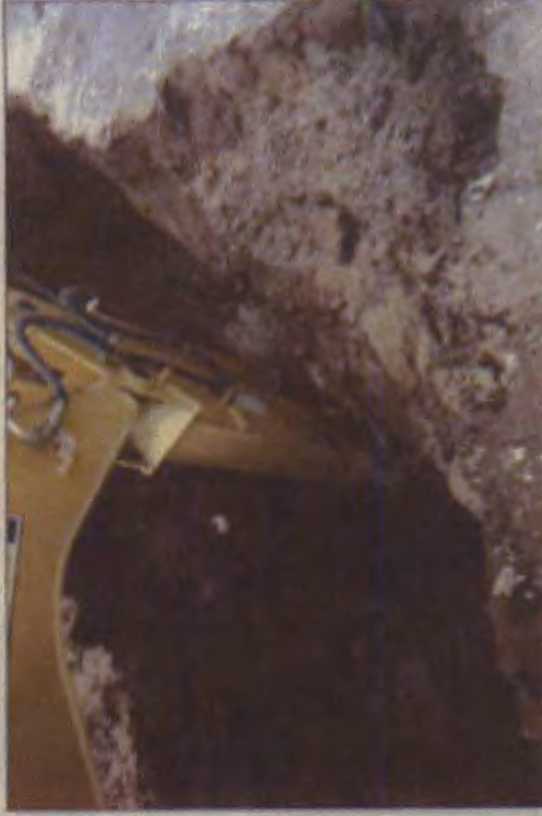
Vertical delineation with backhoe 3/22/04

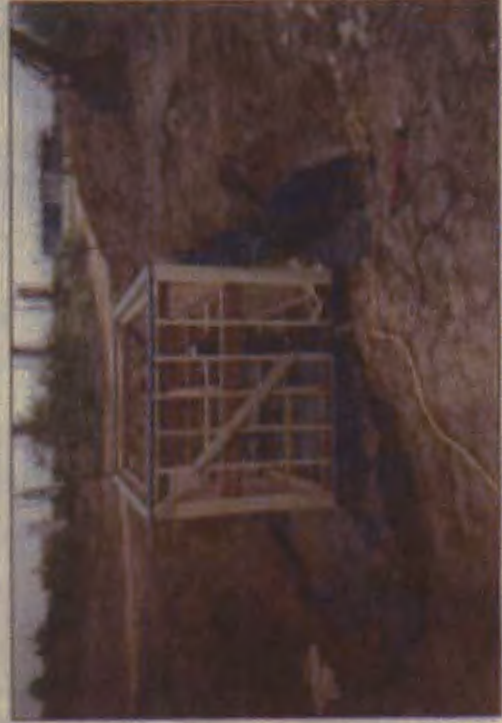
Construction of new junction box 200 ft. NE 9/26/03

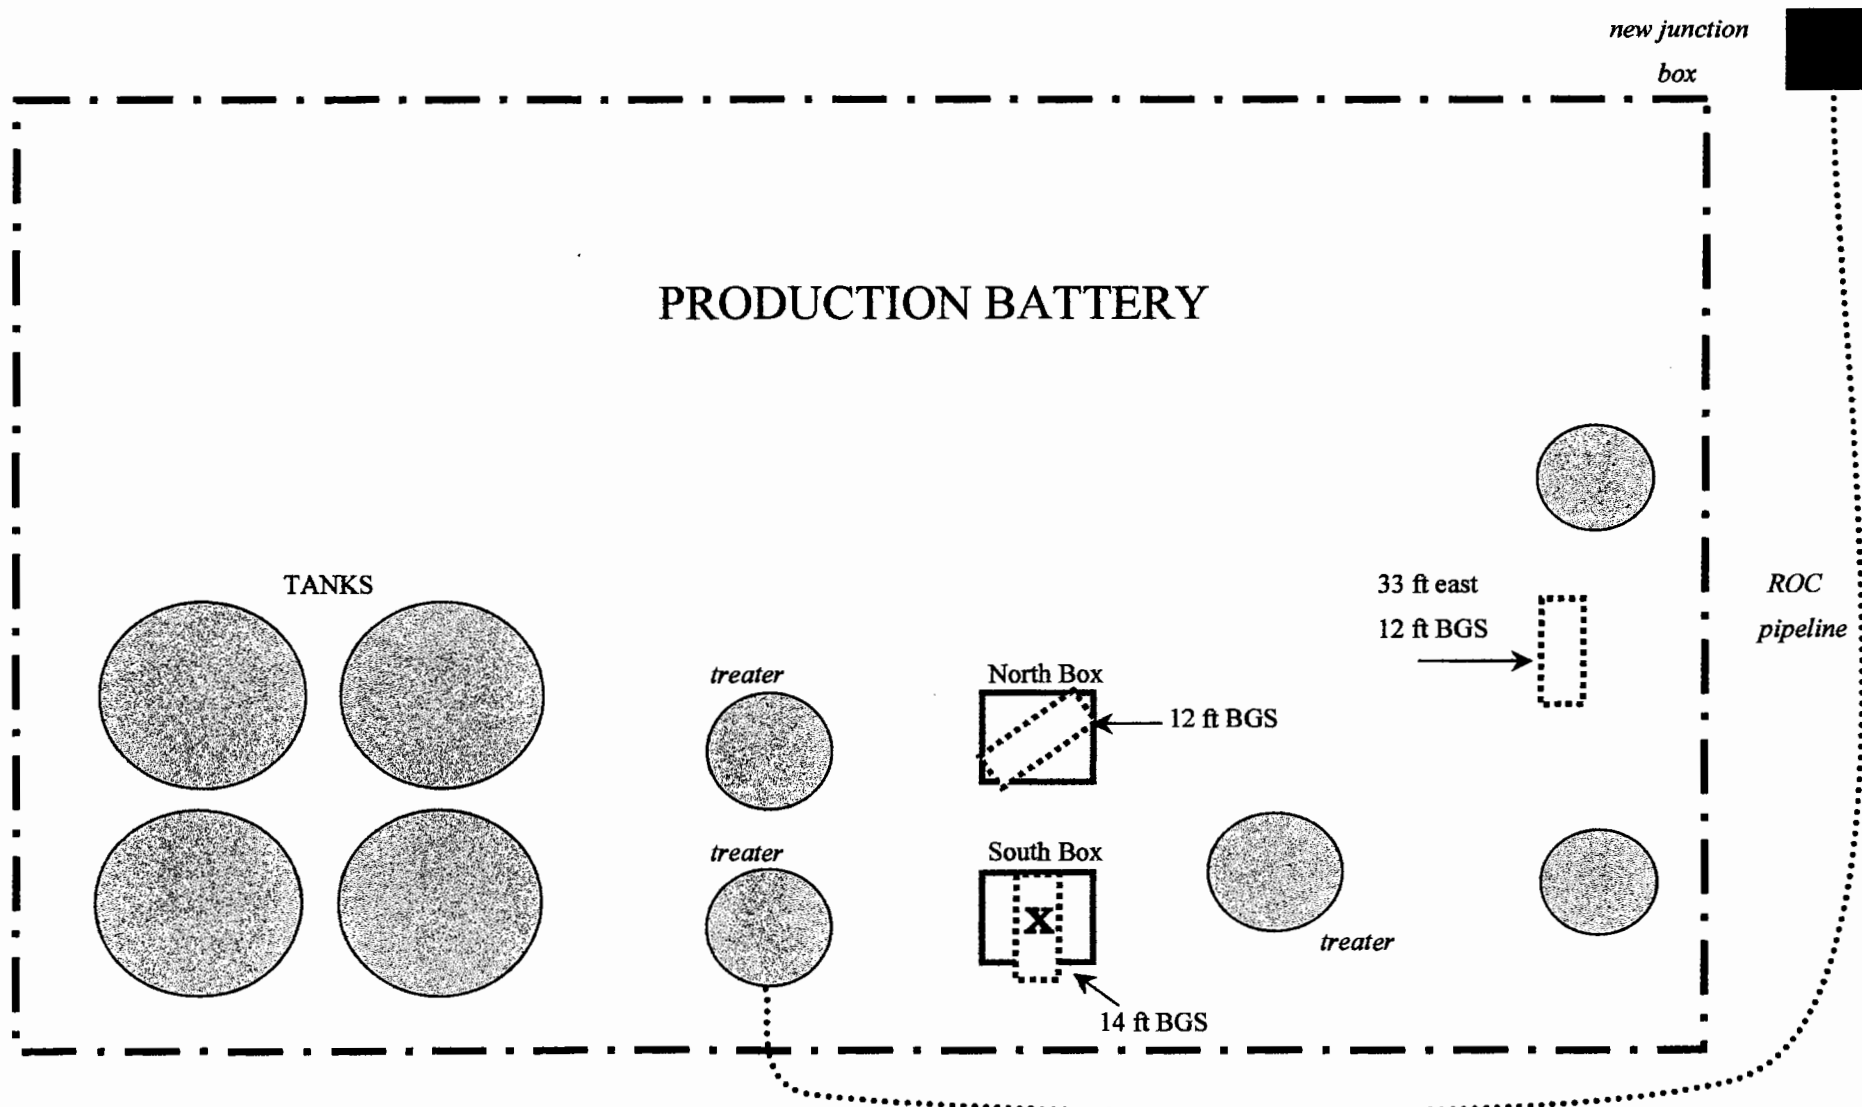
EME jct. O-35 North & South

= Excavation trench

X = Soil Bore Location
