**RE: Termination Request
for the Rice Operating Company's
EME O-24-1 Site
Unit Letter O, Section 24, T20S, R36E, NMPM, Lea County, New Mexico
Remediation Plan (1R427-145) Termination**

EME Jct. O-24-1 (1R427-145): UL/O, Sec. 24, T20S, R36E

**RICE OPERATING COMPANY
JUNCTION BOX FINAL REPORT**

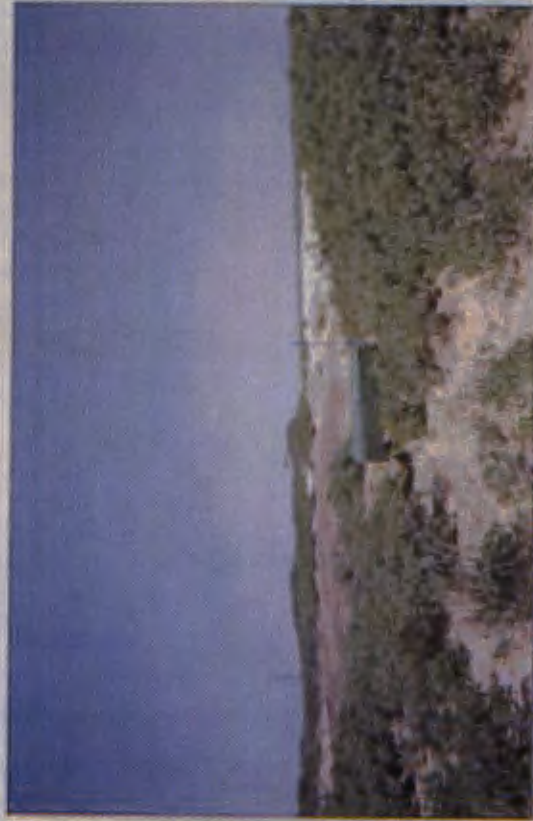
Undisturbed junction box

5/7/2004

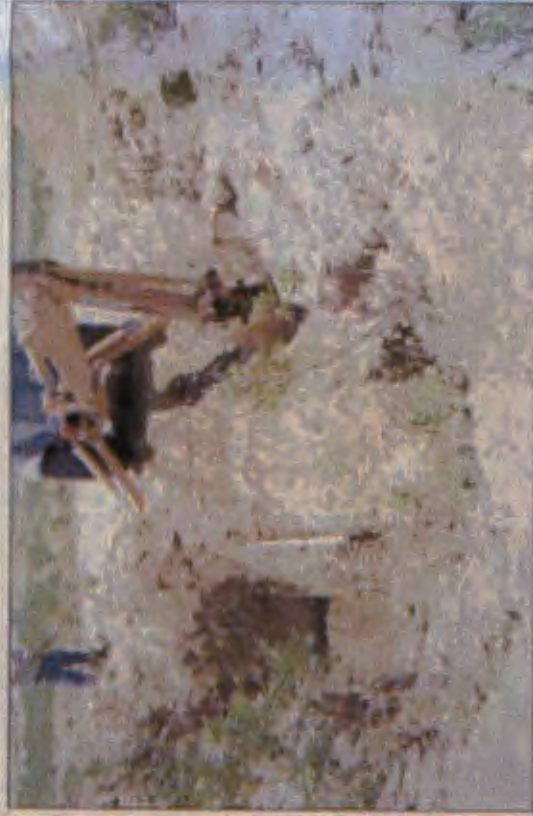
backhoe delineation

5/19/2004

General Description of Remedial Action: Delineation and excavation were performed at this junction box site with a backhoe as chloride field tests and PID field screenings were conducted at regular intervals. Vertical delineation at the box yielded an overall trend of chloride decline and low concentrations. A spike was observed at around 9 ft indicating a mass of historical chloride that has been flushed through the loose sand by recent rains (see graph). The graph indicates non-saturated vadose conditions that are not threatening to groundwater. All PID readings were 0.0 ppm and laboratory results confirmed TPH concentrations well below NMOCD guidelines. Soils from the 10 x 10 x 12-ft deep excavation were blended before they were backfilled into the hole. The surface has been contoured and will be seeded with a blend of native vegetation. This junction has been eliminated with a new pipeline re-plumbed straight through.

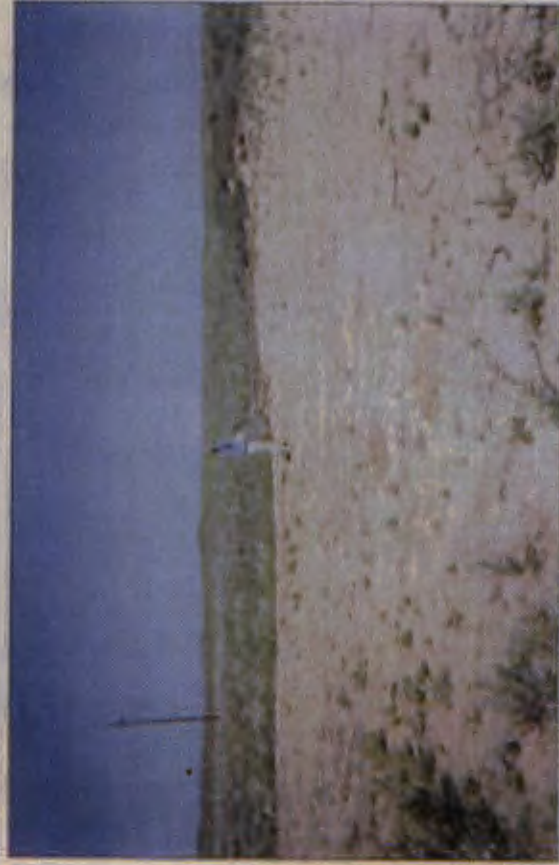
seeding disturbed surface

8/4/2004

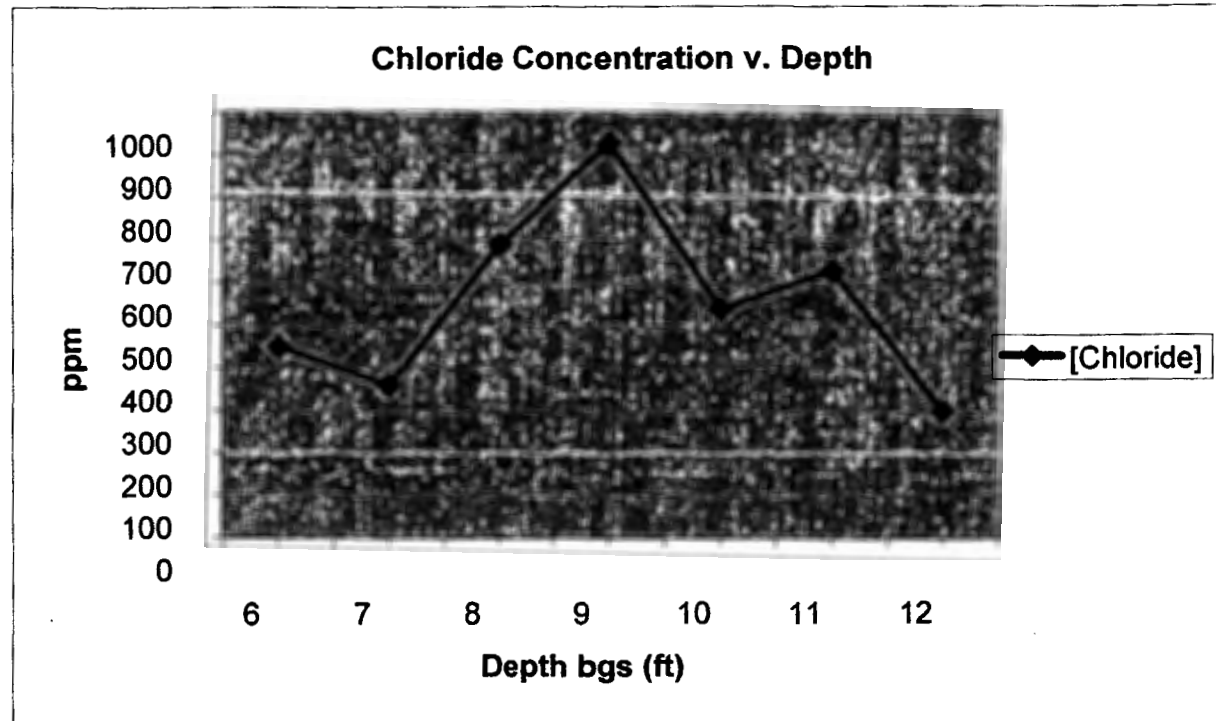
Vertical Delineation at Source

Depth bgs (ft)	Cl (ppm)
6	449
7	359
8	689
9	929
10	539
11	629
12	299

Groundwater = 36-117 ft

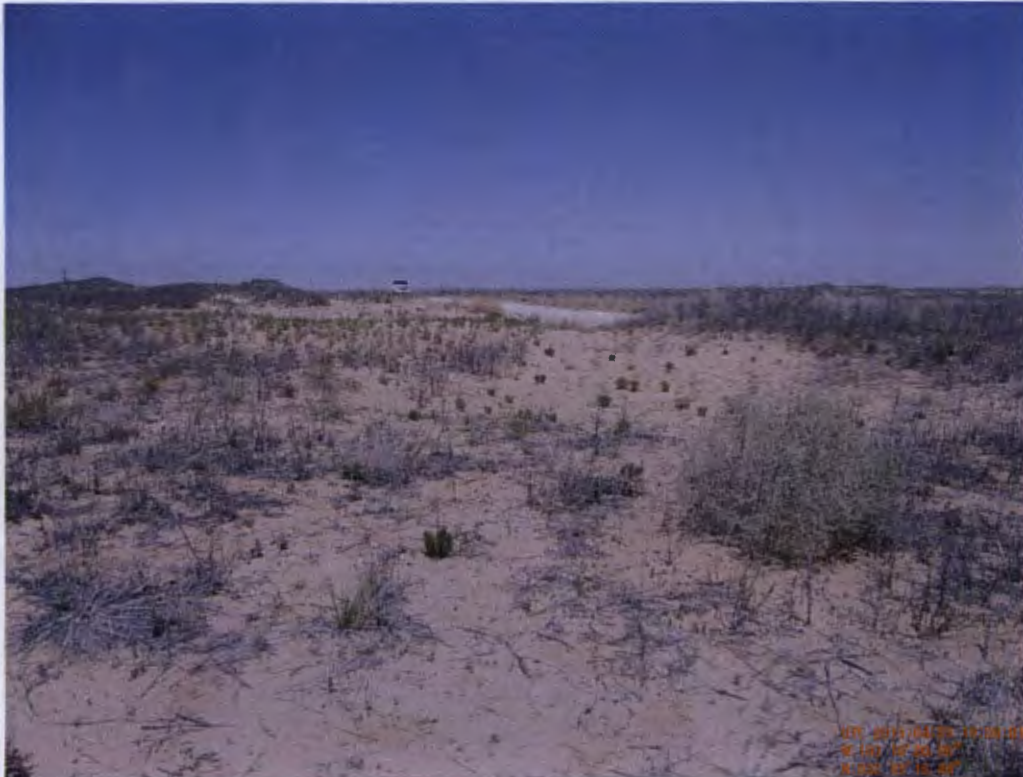
Facing north

4/23/2013

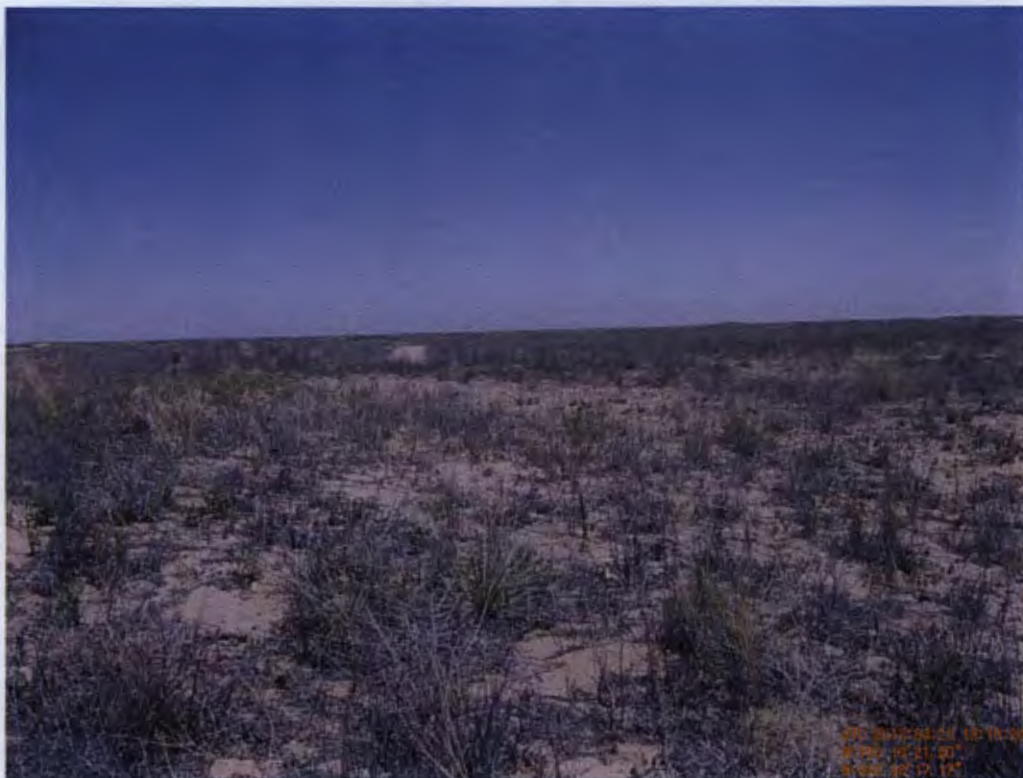
Facing east

4/23/2013
