**RE: CAP Report and Termination Request  
Rice Operating Company – BD SWD System  
BD Jct. P-30 west (1R426-127): UL/P sec. 30 T21S R37E  
BD P-30 EOL (1R426-218): UL/P sec. 30 T21S R37E**

## Corrective Action Plan Report

**BD Jct. P-30 west (1R426-127) and BD P-30 EOL (1R426-218)  
Unit Letter P, Section 30, T21S, R37E**

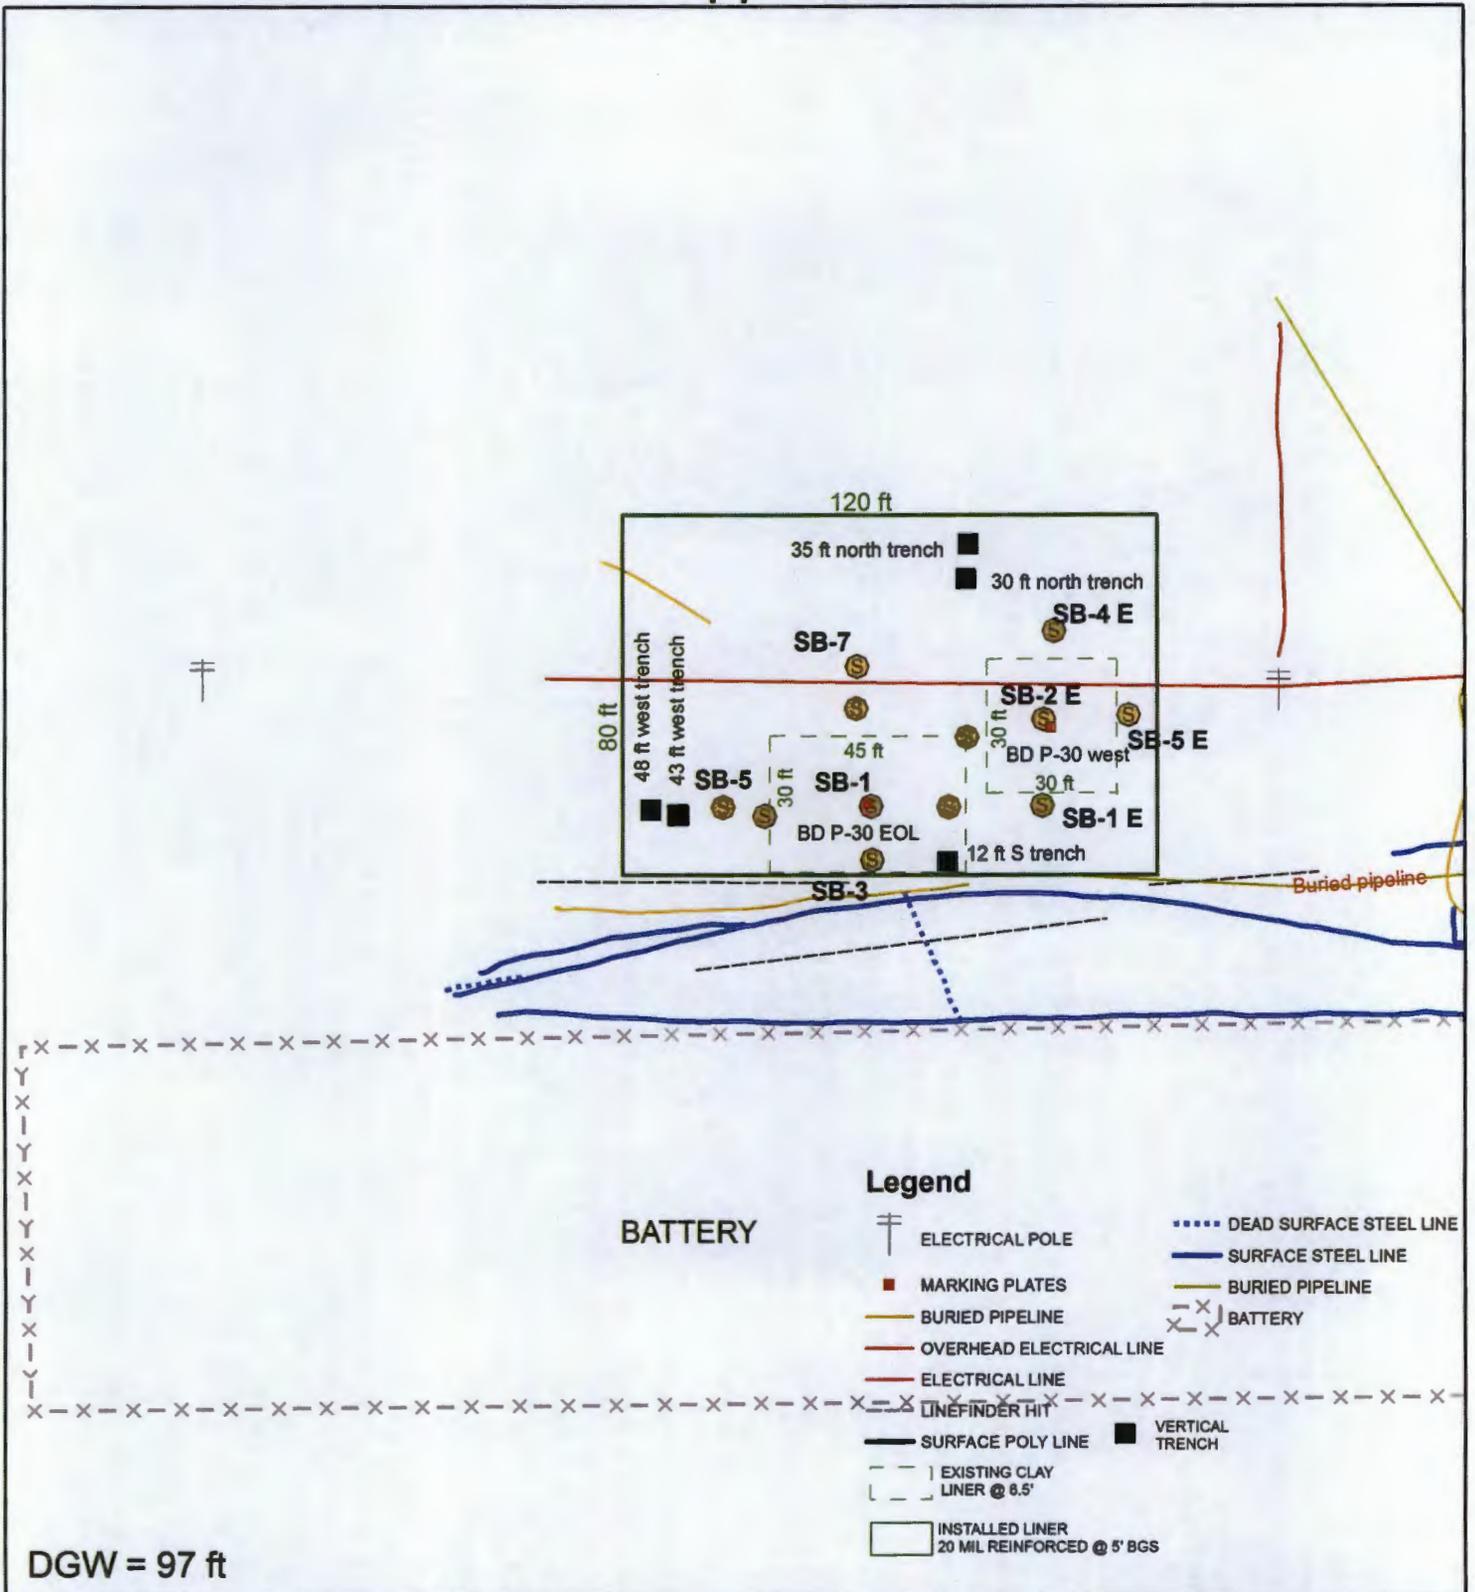
# NMOCD Approved Liner

On July 12<sup>th</sup>, 2013, RECS personnel were on site to begin the Corrective Action Plan work. The site was excavated to 80 ft x 120 ft to a depth of 5 ft bgs (Figure 3). A total of 2,300 yards of excavated soil was disposed of at a NMOCD approved facility. At the base of the excavation, a 20-mil reinforced poly liner was installed and properly seated at a depth of 5 ft bgs. Since the site contained primarily sandy/silty soils without appreciable rock, it was not necessary to pad either the top or bottom of the liner. Approximately 2,256 yards of soil was imported to the site to serve as backfill. A sample of this imported soil was field tested for hydrocarbons and returned a result of 1.7 ppm. The sample was then taken to a commercial laboratory and returned a chloride result of non-detect. The excavation was backfilled with the imported soil and contoured to the surrounding location.

To address the vadose zone, ROC proposed to excavate the site to the dimensions of 120 ft x 80 ft and properly seat a 20-mil reinforced poly liner at approximately 4-5 ft bgs. The liner would cover the existing clay layers installed at 6.5 ft bgs measuring 30 ft x 30 ft at the BD jct. P-30 west site and 30 ft x 45 ft at the BD P-30 EOL site. The soils placed above the liner would have a laboratory chloride reading no greater than 500 mg/kg and a field PID reading below 100 ppm. Excavated soils would be evaluated for use as backfill and any soils requiring disposal would be properly disposed of at a NMOCD approved facility. Upon completion of backfilling, the site would be seeded with a native vegetative mix and soil amendments will be added as needed. Vegetation above the liner would also provide a natural infiltration barrier for the site since plants capture water through their roots thereby reducing the volume of water moving through the vadose zone to groundwater.

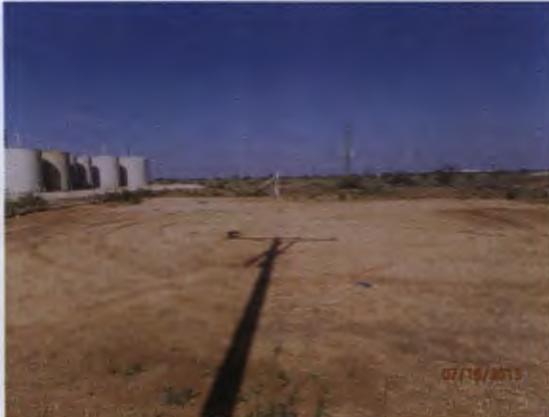
Site prior to excavation, facing west 7/16/2013

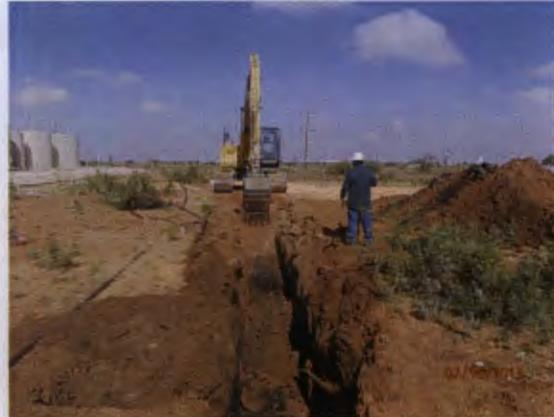
Excavating, facing west 7/16/2013

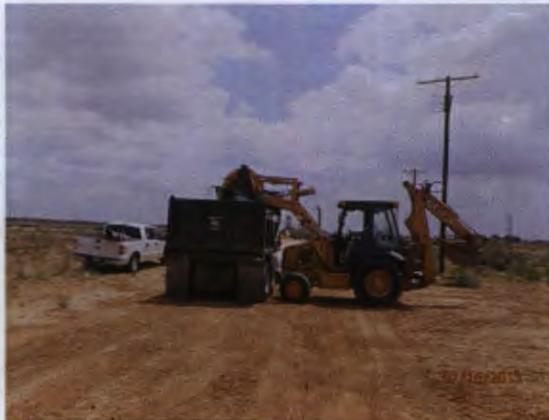
Exporting soil, facing east 7/16/2013

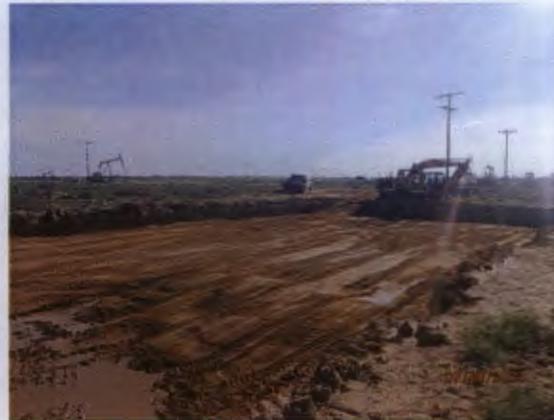
Excavation final, facing northeast 7/30/2013

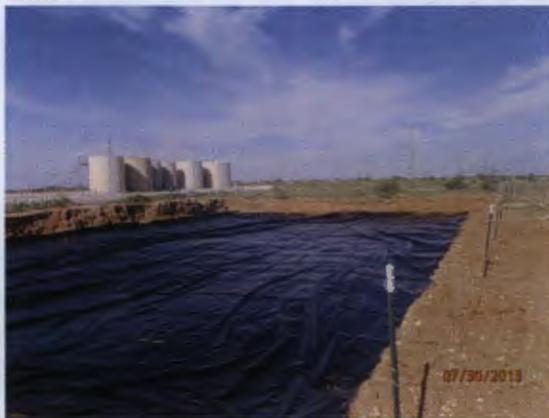
Liner complete, facing southwest 7/30/2013

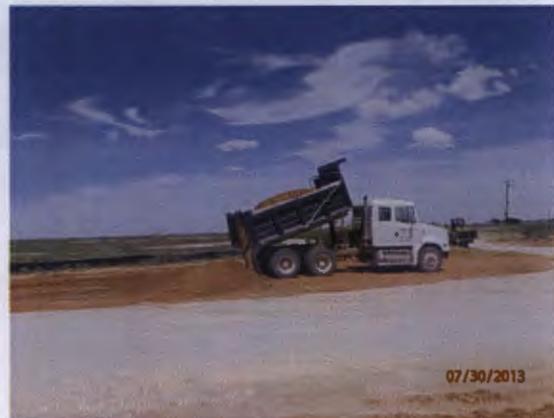
Importing, facing east 7/30/2013

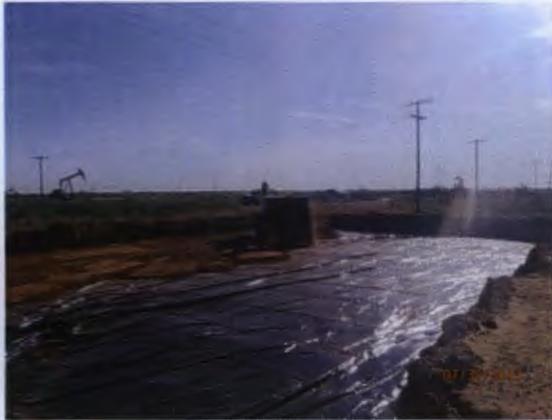
**Backfilling above the liner, facing northeast  
7/31/2013**

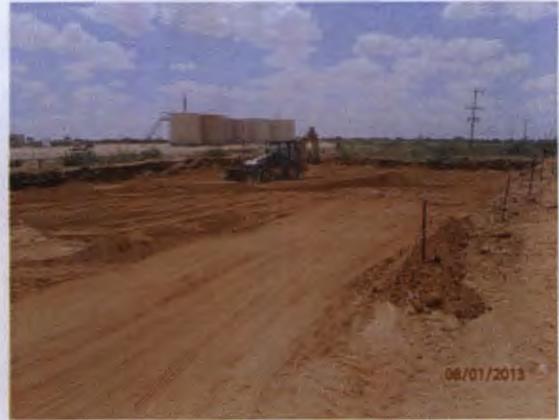
**Backfilling excavation, facing southwest  
8/1/2013**

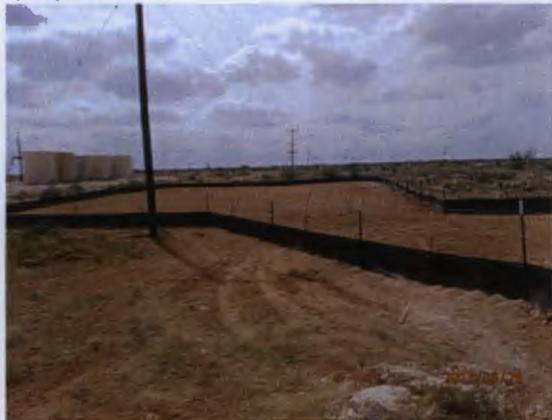
**Silt net fence complete, facing west 8/28/2013**

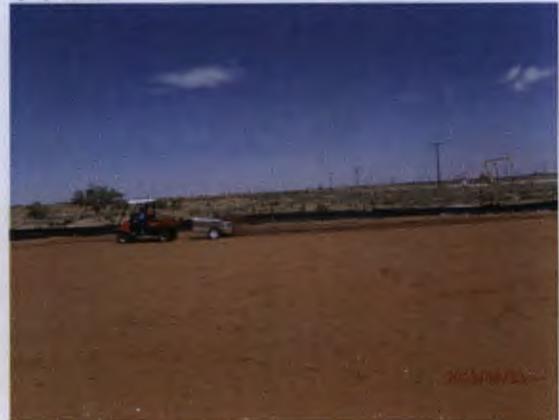
**Spreading amendments, facing north 8/30/2013**

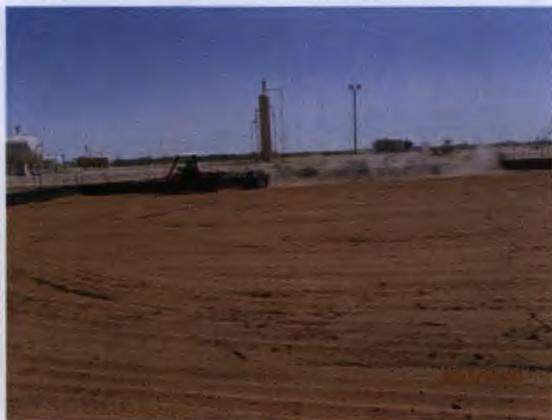
**Spreading seed, facing south 8/30/2013**

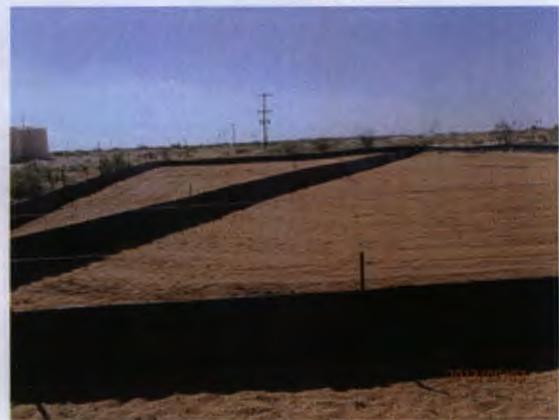
**Site complete with vegetation, facing west  
9/3/2013**
