RE: Termination Request EME Citation Devonian Vent G-20 (1R427-152): UL/G, Sec. 20, T21S, R36E RICE Operating Company – Eunice Monument Eumont (EME) SWD System

RICE OPERATING COMPANY JUNCTION BOX FINAL REPORT

> RE: Additional Information and Termination Request EME Citation Devonian Vent G-20 (1R427-152): UL/G, Sec. 20, T21S, R36E RICE Operating Company – Eunice Monument Eumont (EME) SWD System

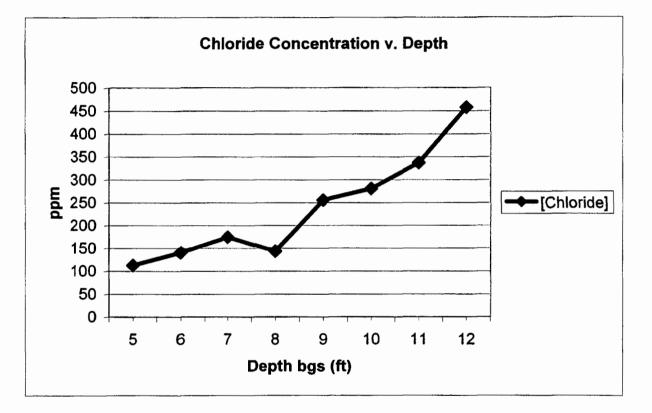
Vertical Delineation at Source

Depth bgs (ft)	[Cl ⁻] ppm
5	113
6	141
7	175
8	144
9	256
10	281
11	337
12	458

Groundwater = 174 ft

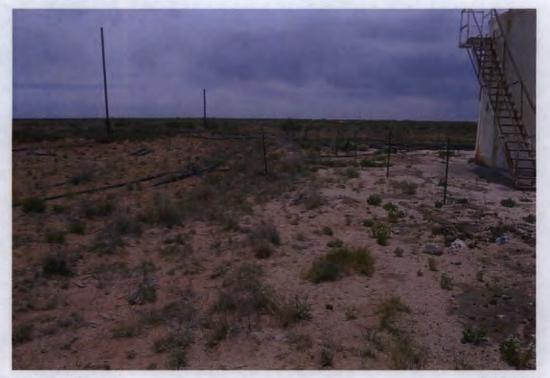
Facing Southwest

5/10/2013

Vegetation has rebounded at this site; vegetation will act as an evapo-transpiration barrier that will also inhibit the downward migration of chlorides and hydrocarbons. Plants capture water through their roots and so reduce the amount of water infiltrating below the root zone.

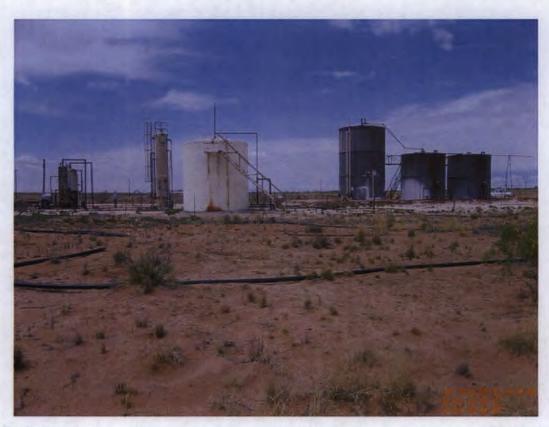
Facing west

5/10/2013

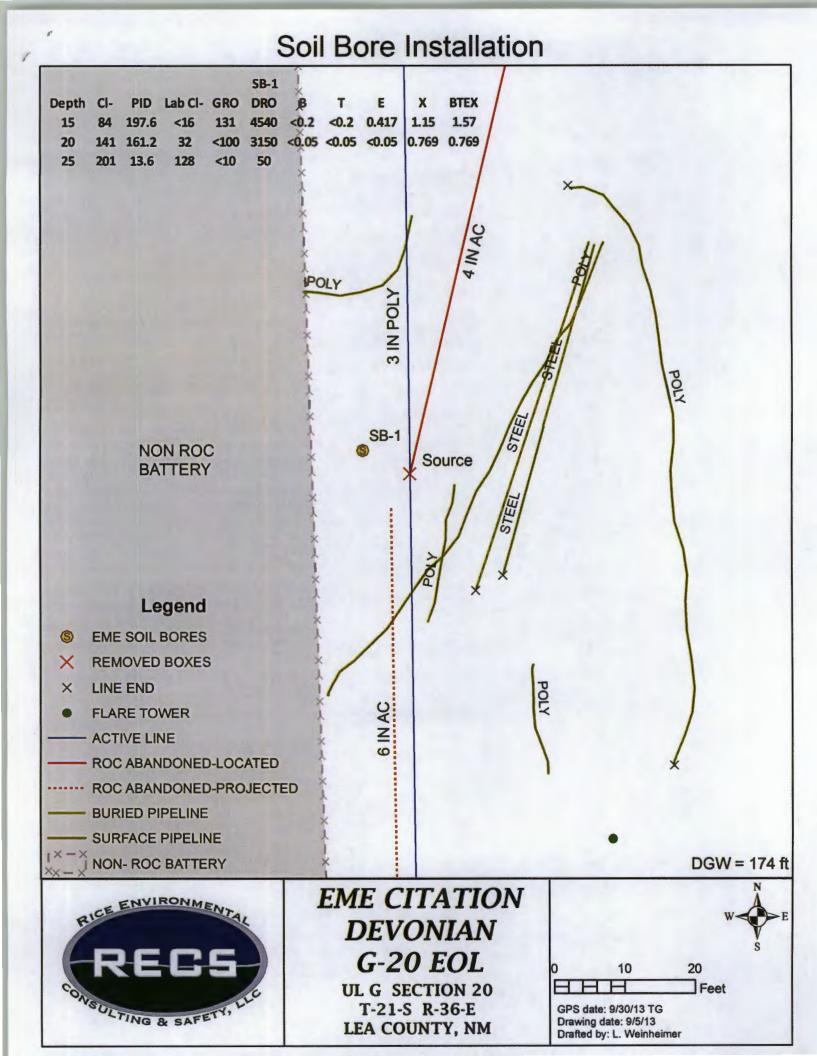
Soil Bore Installation Documentation

To further investigate the depth of chloride presence, a soil bore was initiated on August 22, 2013 at 7.5 ft northwest of the former junction box site. The boring was advanced to a depth of 25 ft below ground surface (bgs) with soil samples collected every 5 ft. Each sample was field titrated for chlorides and field screened using a PID for hydrocarbons, resulting in low concentrations. The 15 ft, 20 ft and 25 ft samples were sent to a commercial laboratory for analysis. The 15 ft samples resulted in a chloride concentration below detectable limits, a GRO concentration of 131 mg/kg and a DRO concentration of 4,540 mg/kg. The sample was also analyzed for BTEX, resulting in concentrations of 0.417 mg/kg for ethyl benzene, 1.57 mg/kg for total xylenes of 1.57 mg/kg and concentration of 32 mg/kg, a DRO concentration of 3,150 mg/kg and a GRO concentration below detectable limits. The sample was also analyzed for BTEX resulting in a total xylenes concentration of 0.769 mg/kg and concentrations of benzene, toluene and ethyl benzene below detectable limits. The 25 ft sample resulted in a chloride concentration of 50 mg/kg and a GRO concentration below detectable limits. The 25 ft sample resulted in a chloride concentration of 50 mg/kg and a GRO concentration below detectable limits. The 25 ft sample resulted in a chloride concentration of 50 mg/kg and a GRO concentration below detectable limits. The 25 ft sample resulted in a chloride concentration of 50 mg/kg and a GRO concentration below detectable limits. The 25 ft sample resulted in a chloride concentration of 50 mg/kg and a GRO concentration below detectable limits.
