1R-427-160

RE: Termination Request

EME Jct. B-31 (1R427-160): UL/B, Sec. 31, T21S, R36E

RICE Operating Company – Eunice Monument Eumont SWD System

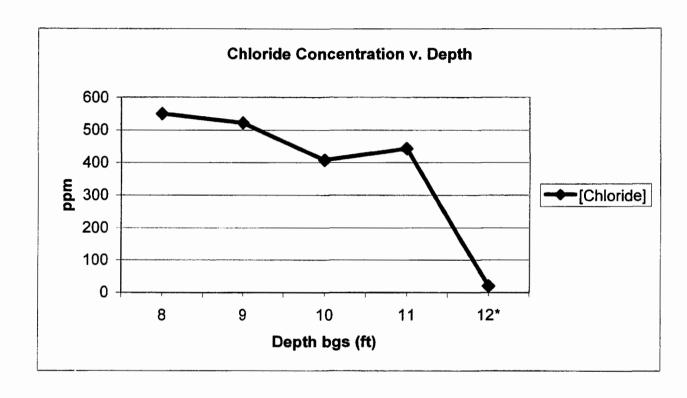
Vertical Delineation at Source

Depth bgs (ft)	[Cl] ppm
8	550
9	522
10	408
11	443
12*	20

* Lab test <20 ppm Cl

Groundwater = 231 ft

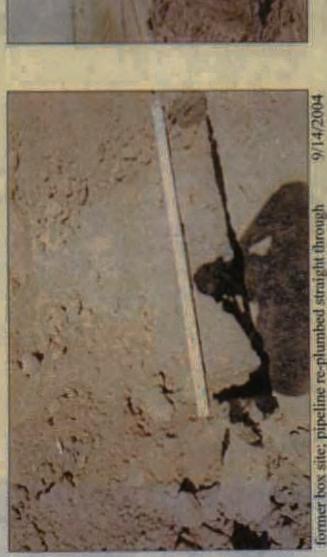
former box site; pipeline re-plumbed straight through

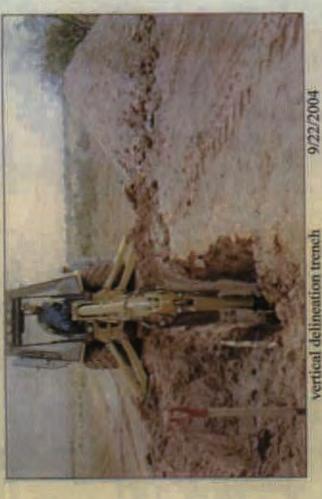
vertical delineation trench

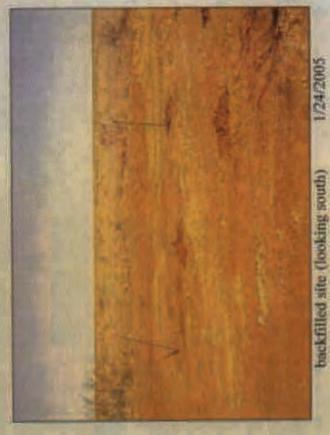
backfilled site (looking south)

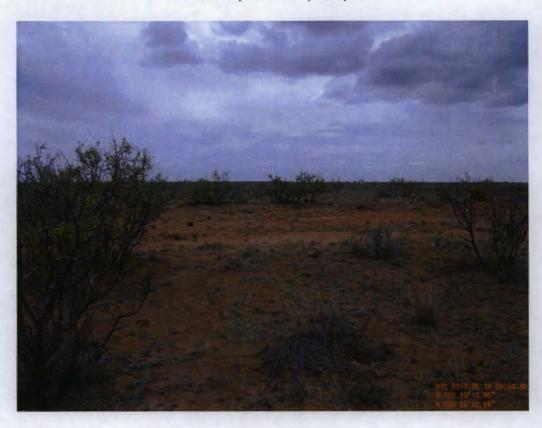
Facing south 5/10/2013

Vegetation around this site has rebounded; therefore, additional seeding is not necessary. Vegetation will act as an evapo-transpiration barrier that will also inhibit the downward migration of chlorides and hydrocarbons. Plants capture water through their roots and so

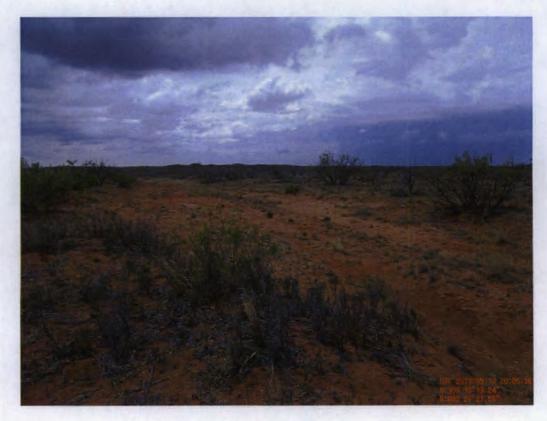
Facing west 5/10/2013
