WORKPLANS

Rice Environmental Consulting & Safety

**RE: Corrective Action Plan (CAP)
Rice Operating Company – Vacuum SWD System
Vacuum Jct. C-31 (1R425-84): UL/C sec. 31 T17S R35E**

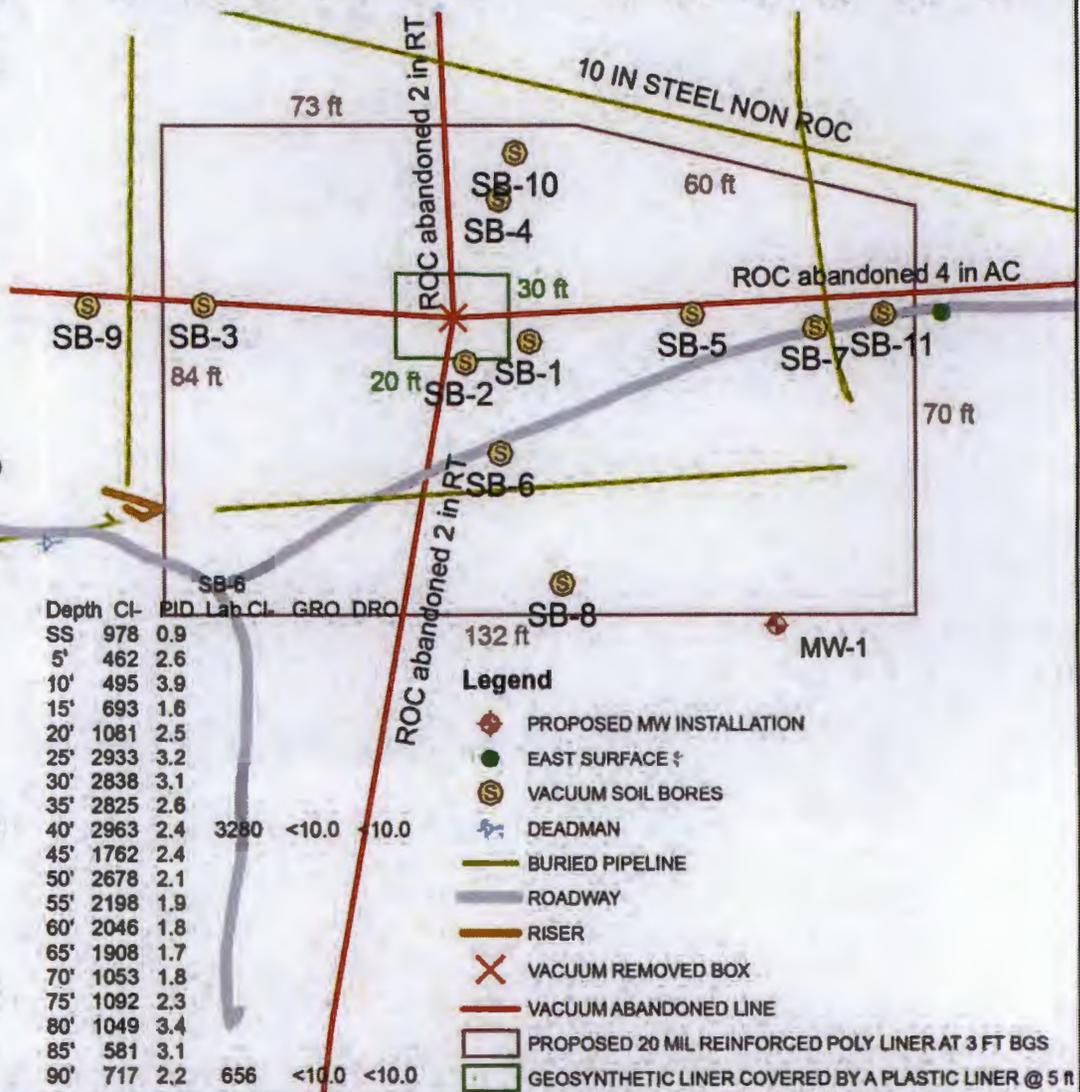
Figure 3

Soil Bore Installation

SB-1					
Depth	CI-	PID	Lab CI-	GRO	DRO
SS	1158	0.1			
5'	370	1.3			
10'	443	2.4			
15'	335	3.9			
20'	682	2.2			
25'	1425	1.2			
30'	2216	0.6	2210	<10.0	14.4
35'	1724	0.8			
40'	2026	0.8			
45'	1545	0.9			
50'	949	0.7			
55'	903	0.7			
60'	996	0.5			
65'	534	1.2			
70'	302	1.1			
75'	242	0.8	256	<10.0	<10.0

SB-2					
Depth	CI-	PID	Lab CI-	GRO	DRO
SS	771	0.7			
5'	600	1.2			
10'	677	10.3			
15'	173	5.7			
20'	1264	3.6			
25'	1096	3.1			
30'	2099	3.8			
35'	3385	3.7			
40'	3619	3.7	3960	<10.0	<10.0
45'	1841	2.2			
50'	1696	1.8			
55'	1788	2.5			
60'	1076	3.8			
65'	1296	3			
70'	591	2.8			
75'	1813	4.6			
80'	2014	3.6			
85'	1400	3.3			
90'	1693	3.4	1710	<10.0	<10.0

SB-3					
Depth	CI-	PID	Lab CI-	GRO	DRO
SS	641	0.7			
5'	508	1.2			
10'	1767	96.8			
15'	3905	22.1			
20'	2982	24.5			
25'	3179	4.5			
30'	3531	4.9			
35'	2476	3.1			
40'	4242	3.3	4000	<10	20.7
45'	3402	2.5			
50'	3722	2.7			
55'	3284	4.1			
60'	1544	2.5			
65'	2194	3			
70'	1431	1.5			
75'	753	1.9			
80'	841	2.3			
85'	707	3.3			
90'	892	4.2	928	<10	<10

SB-4					
Depth	CI-	PID	Lab CI-	GRO	DRO
SS	4425	1	5920	<10.0	45.9
5'	1092	1.4			
10'	3520	2.1	4880	<10.0	<10.0
15'	1926	2			
20'	743	2			
25'	2271	0.9			
30'	1545	1.7			
35'	997	1.8			
40'	826	1.8			
45'	1072	2.1			
50'	1481	2.6			
55'	1794	2.3			
60'	1749	2.7			
65'	1002	2.6			
70'	796	1.5			
75'	858	1.9			
80'	1097	2.3			
85'	701	2.1			
90'	1053	0.9	1150	<10.0	<10.0

SB-5					
Depth	CI-	PID	Lab CI-	GRO	DRO
SS	2621	0.8	4160	<10.0	11.3
5'	780	4.2			
10'	1609	16.5			
15'	1479	8.4			
20'	600	40			
25'	334	8.1			
30'	657	5.3			
35'	1424	4.5			
40'	2096	4			
45'	1995	2.9			
50'	2440	3	2600	<10.0	<10.0
55'	1676	3.4			
60'	1420	3.6			
65'	385	4.2			
70'	556	4.3			
75'	497	1.3			
80'	277	1.6			
85'	248	2	240	<10.0	<10.0

The site is located approximately 0.5 miles southeast of Buckeye, New Mexico in Unit Letter C, Section 31, T17S, R35E as shown on the Site Location Map and Geographical Location Map (Figure 1 and Figure 2). Soil bore installation at the site indicates that groundwater is likely to be encountered at 100 ft bgs.

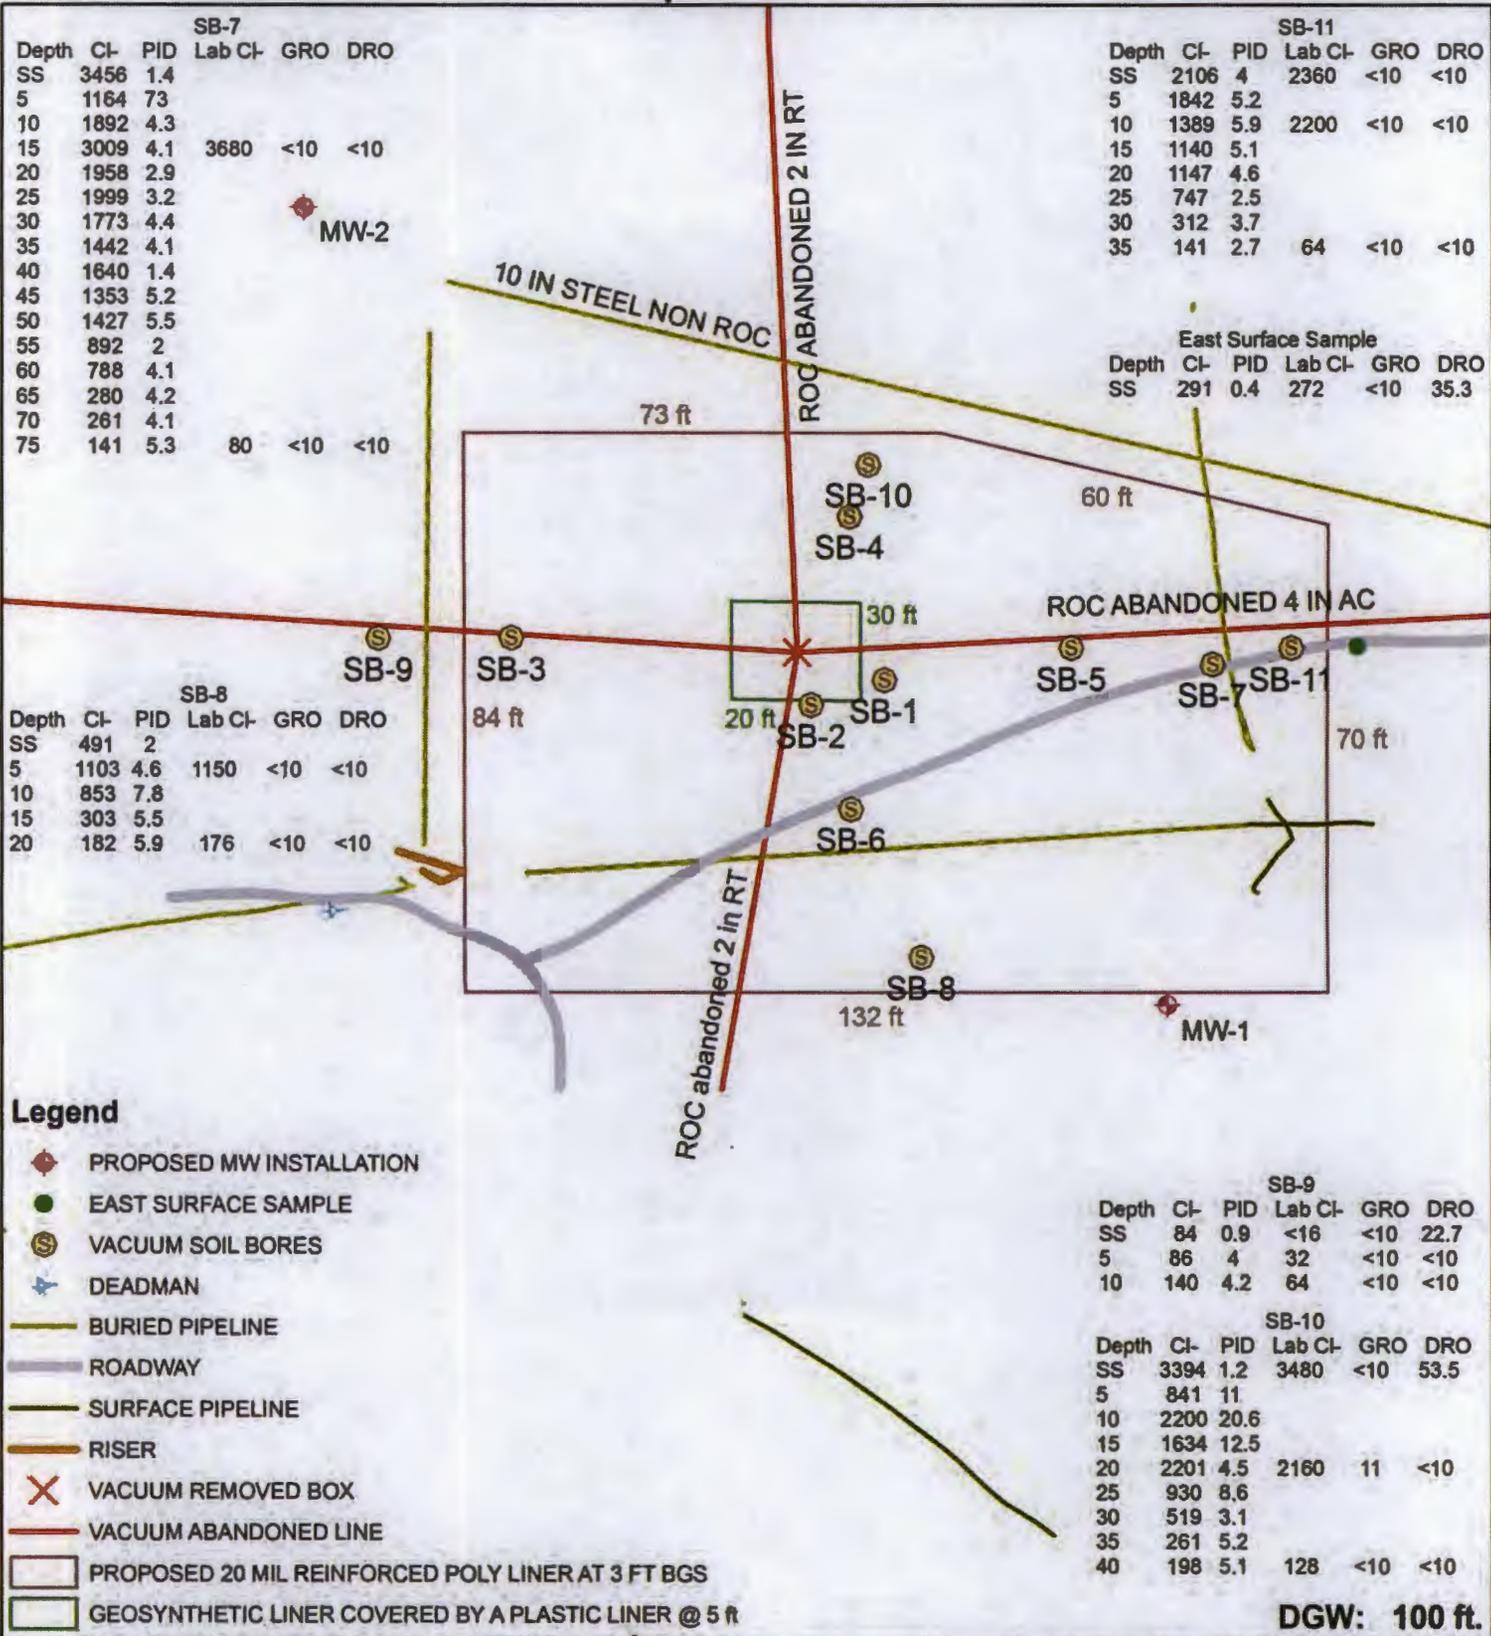
Soil Bore Installation, Proposed Liner and MW Installation

Additional soil bores were installed on September 24th, 2013 to further delineate the site (Figure 4). A total of five soil bores were drilled at the site and as they were advanced, soil samples were taken at regular intervals. The samples were field tested for chlorides and hydrocarbons and representative samples were taken to a commercial laboratory for analysis. SB-7 returned laboratory chloride results of 3,680 mg/kg at 15 ft bgs, which decreased to 80 mg/kg at 75 ft bgs. SB-8 returned laboratory chloride results of 1,150 mg/kg, which decreased to 176 mg/kg at 20 ft bgs. SB-9 returned laboratory chloride results of non-detect at the surface, 32 mg/kg at 5 ft bgs and 64 mg/kg at 10 ft bgs. SB-10 returned laboratory results of 3,480 mg/kg at the surface which decreased to 2,160 mg/kg at 20 ft bgs and 128 mg/kg at 40 ft bgs. SB-11 returned laboratory chloride results of 2,360 mg/kg at the surface, which decreased to 2,200 mg/kg at 10 ft bgs and 64 mg/kg

at 35 ft bgs. GRO and DRO results were non-detect in all the bores at all depths except for at SB-9 which returned a DRO result of 22.7 mg/kg at the surface and at SB-10 which returned a GRO result of 11 mg/kg at 20 ft bgs and a DRO result of 53.5 mg/kg at the surface (Appendix A).

A surface sample was taken 10 ft to the east of SB-11. The sample was field tested for chlorides and hydrocarbons and then taken to a commercial laboratory for confirmatory analysis. The surface sample returned a chloride result of 272 mg/kg, a GRO result of non-detect and a DRO result of 35.3 mg/kg (Appendix A).

RECS recommends that to inhibit the downward migration of contaminants at the site to groundwater, ROC install a 20-mil reinforced poly liner at 3 ft bgs measuring 84 ft to the west, 132 ft to the south and 70 ft to the east. The north edge of the liner will cover SB-10 by 5 ft. The northeast corner will also remain 5 ft away from a 10 inch, non-ROC steel line for safety reasons (Figure 4). The soils placed above the liner will have a laboratory chloride reading no greater than 500 mg/kg and a field PID reading below 100 ppm. Excavated soils will be evaluated for use as backfill and any soils requiring disposal will be properly disposed of at a NMOCD approved facility. Upon completion of backfilling, the site will be seeded with a native vegetative mix and soil amendments will be added as necessary. Vegetation above the liner will also provide a natural infiltration barrier for the site since plants capture water through their roots thereby reducing the volume of water moving through the vadose zone to groundwater.

In order to determine what affect the residual chlorides may have had on the groundwater quality below the site, RECS recommends that ROC install a near-source monitor well (MW-1) located just outside the liner (Figure 4). To determine if there is an up-gradient source of contaminants coming onto the site from the non-ROC adjacent historical facilities, MW-2 will be installed approximately 100 ft up-gradient of the site. The monitor wells will be installed after the liner installation is completed. The monitor wells will be sampled quarterly. Once groundwater quality has been determined, ROC will either submit a groundwater remedy to NMOCD to address groundwater quality at the site or submit a 'remediation termination' request for site closure.

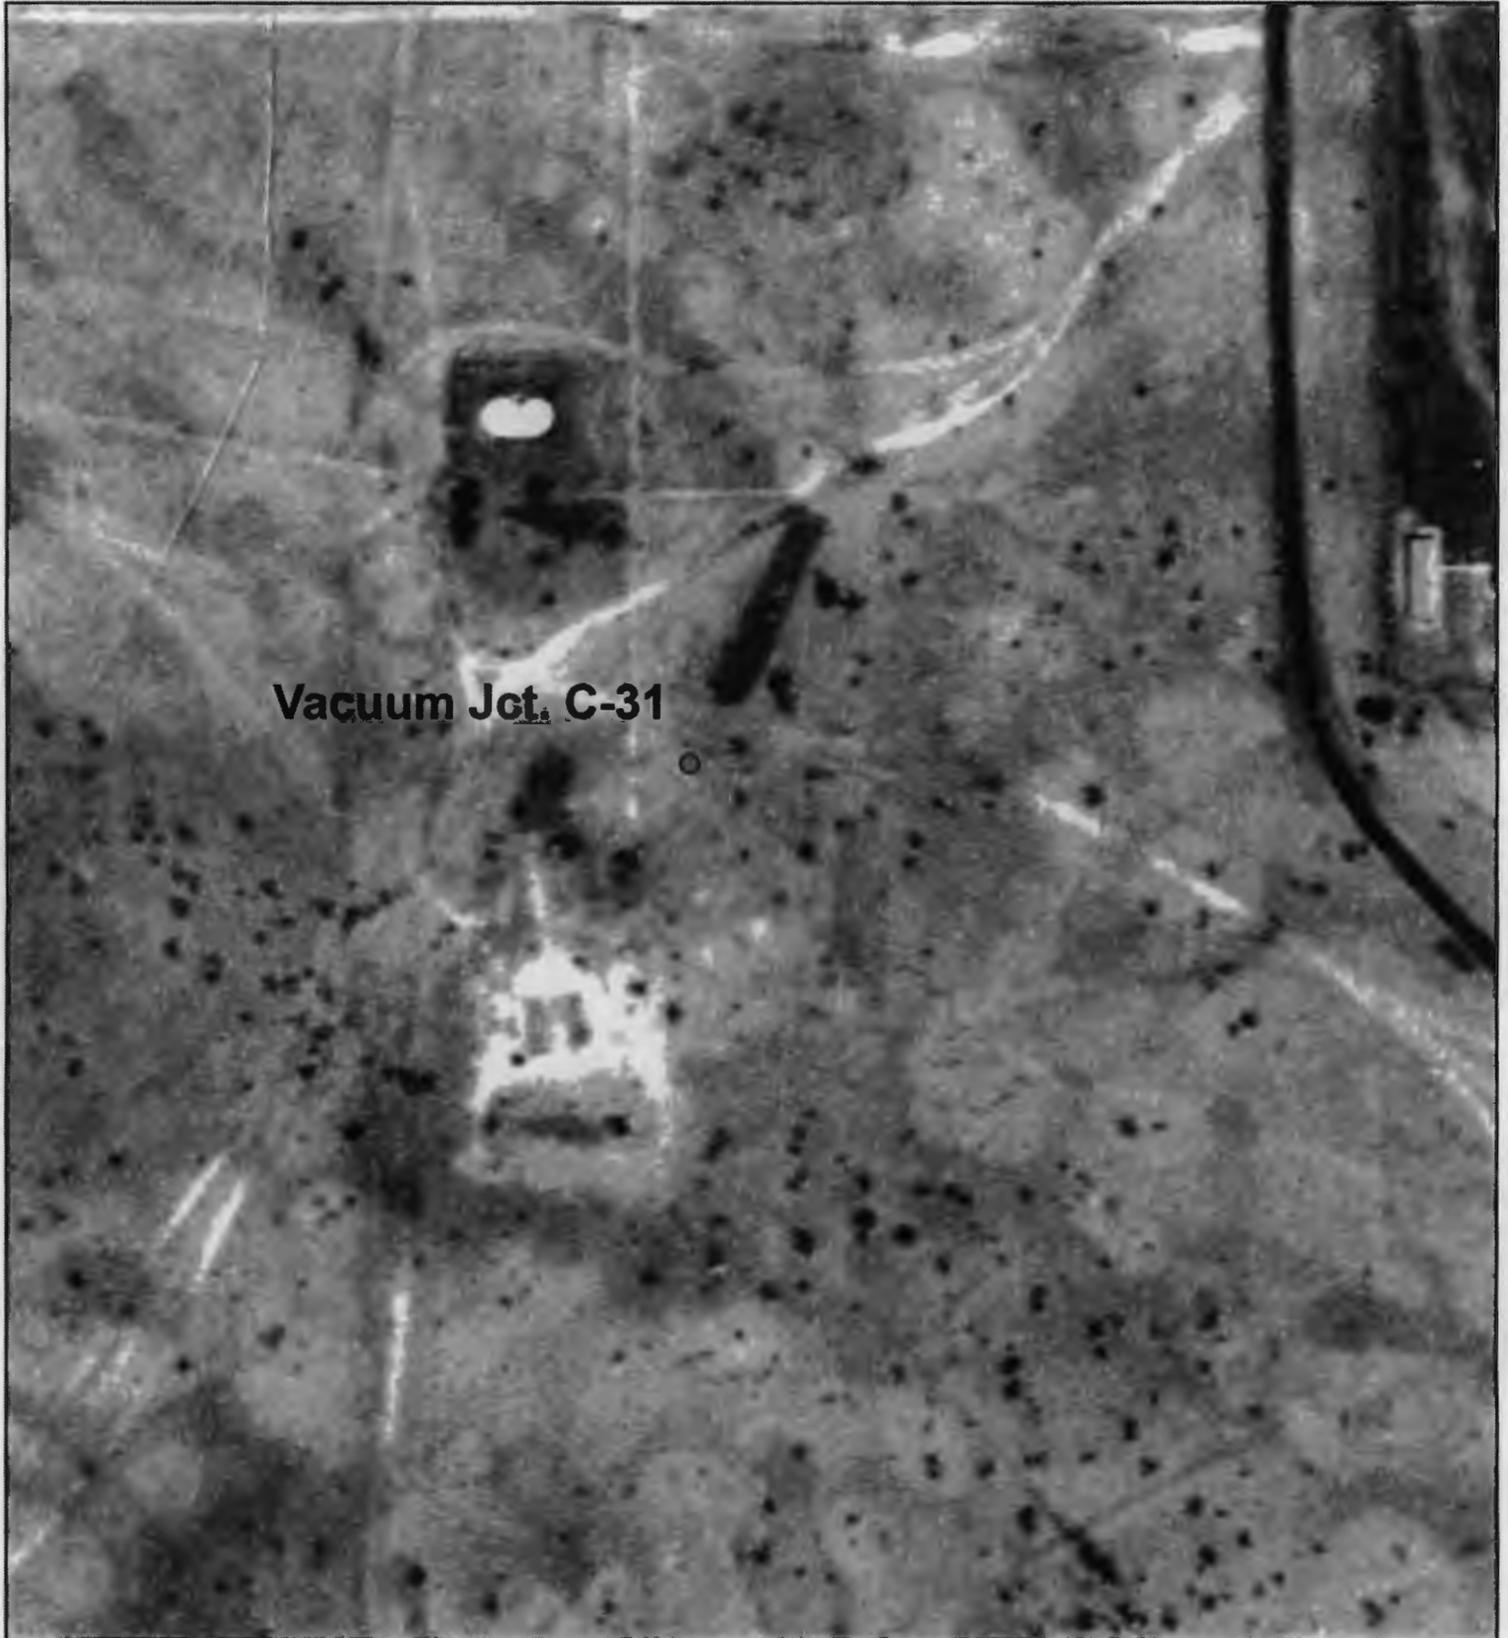
Historical aerial photos were assessed to determine areas of concern adjacent to the site. In the 1955 aerial photo, a facility is evident north of the site and a stain is evident south of the site. In the 2013 aerial photo, a facility is evident directly east of the site (Appendix B).
