Re: **CAP Report and Termination Request**
Rice Operating Company -- Hobbs O-29 EOL
UL O, Sec 29, T18S, R38E
OCD Case No. 1R428-51

This letter summarizes work completed by Rice Operating Company (ROC) at their Hobbs O-29 EOL former junction box site, as outlined in the Corrective Action Plan (CAP) and CAP Addendum of August 8th and 27th, respectively, and approved by NMOCD on September 3rd 2013.

Rice Operating Company – Hobbs O-29 EOL

Hobbs O-29 EOL (1R428-51)
Unit Letter O, Section 29, T18S, R38E

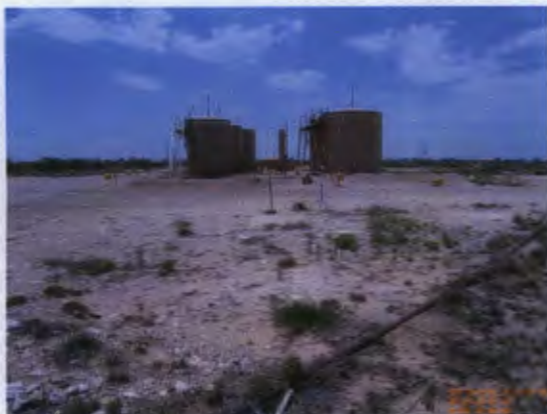
Site prior to excavation, facing west 6/25/2013

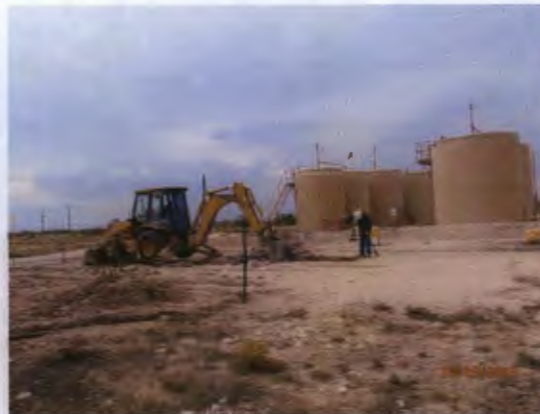
Excavating the west side of the site, facing southwest 10/15/2013

1. Once ROC began spotting lines, it was discovered that the buried pipeline running east to west through the site was abandoned. This allowed the installation of two liners, one on each side of the buried injection line. The east and west side of the site was excavated to a depth of 5 ft bgs.

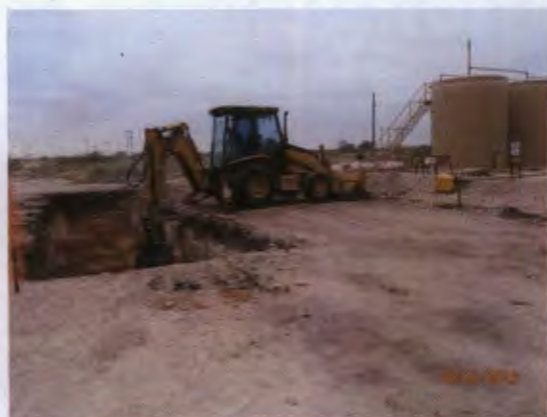
Padding the west excavation with blow sand, facing southwest 10/16/2013

2. ROC padded each excavation with 6 inches of blow sand, then installed and properly seated a 20-mil, reinforced poly liner in each of the excavations. The west liner measured approximately 13x53-ft and the east liner measured approximately 40x53-ft. The liners were then padded with approximately 1 foot of blow sand. Approximately 636 cu yds of soil material was hauled to and disposed at Sundance, a NMOCD approved oil field disposal facility.

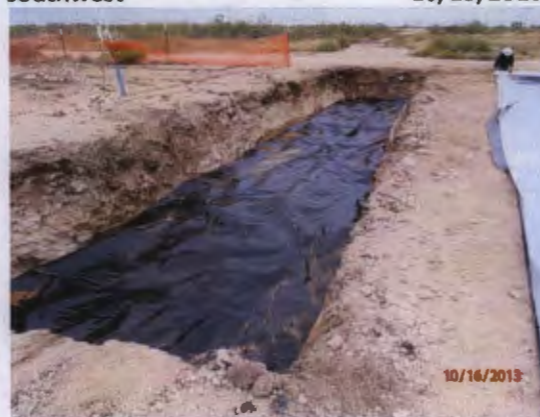
20-mil, reinforced liner installed, facing southeast 10/16/2013

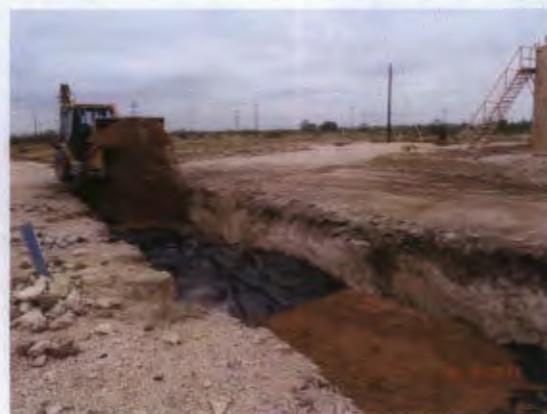
Padding the liner with blow sand, facing southwest 10/16/2013

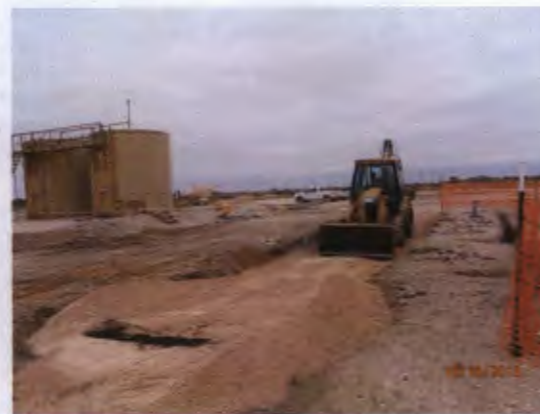
Backfilling with base coarse, facing northwest 10/16/2013

3. The west excavation was backfilled with base coarse to ground surface. A composite sample of the base coarse was analyzed by a commercial laboratory resulting in a chloride concentration of 112 mg/kg. The sample was also field analyzed for hydrocarbon, resulting in a PID reading of 32 ppm. The east excavation was backfilled with blow sand to ground surface. A composite sample of the imported blow sand was analyzed by a commercial laboratory resulting in a chloride concentration of <16 mg/kg. The sample was also field analyzed for hydrocarbon, resulting in a PID reading of 38 ppm. Approximately 546 cu yds of clean material was imported to the site.

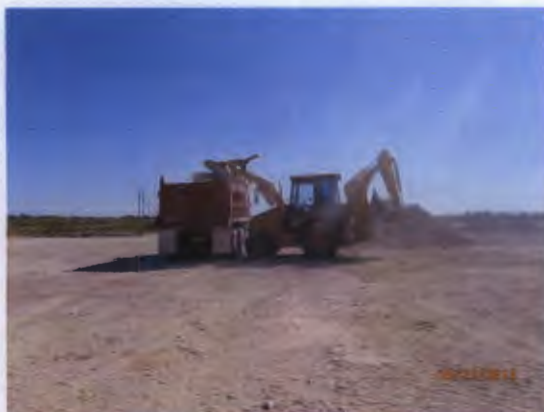
Exporting excavated soil,
facing east

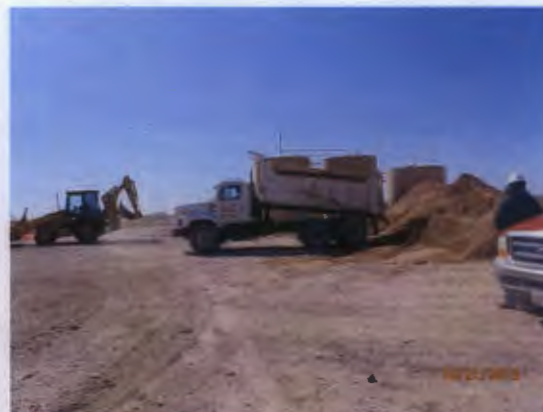
Importing blow sand,
facing south

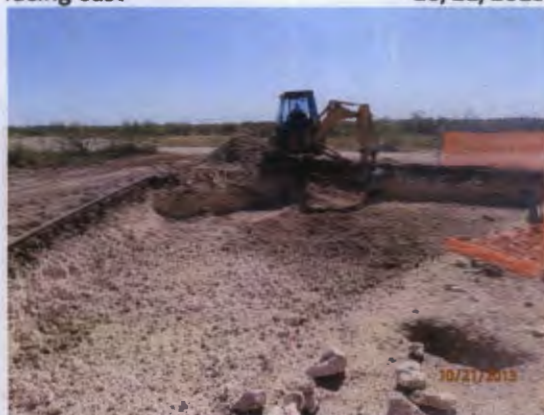
Excavating the east side of the site, facing
southeast

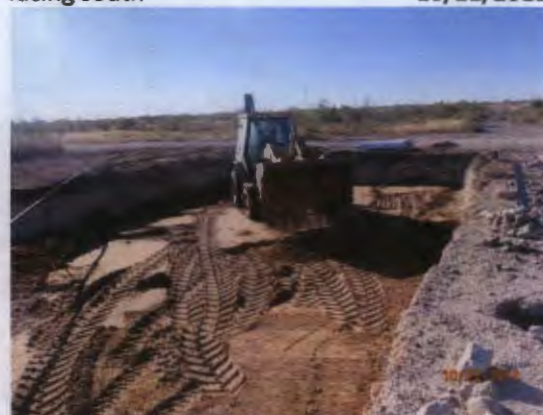
Padding the excavation with blow sand,
facing southeast

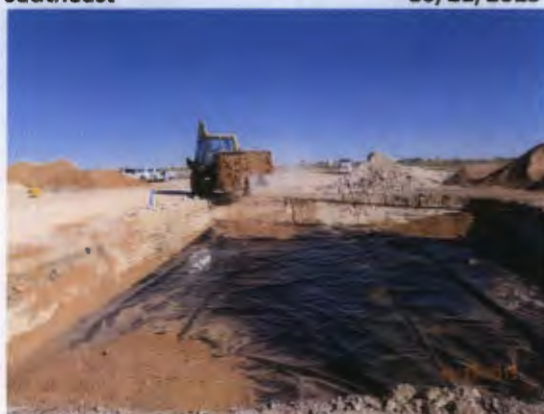
Padding the 20-mil, reinforced liner with blow
sand, facing north

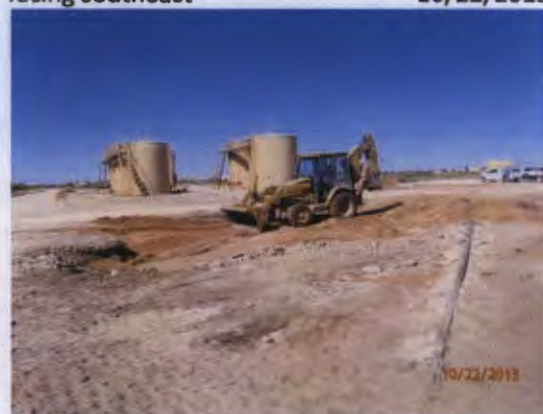
Backfilling the excavation,
facing northwest

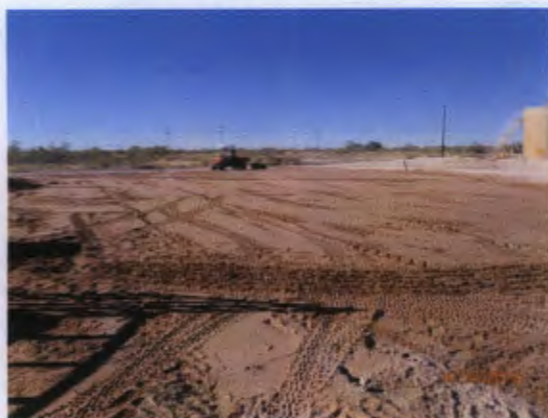
Discing the backfilled site,
facing southwest

4. ROC restored the surface to natural grade and added amendments and seed with a blend of native vegetation mix.

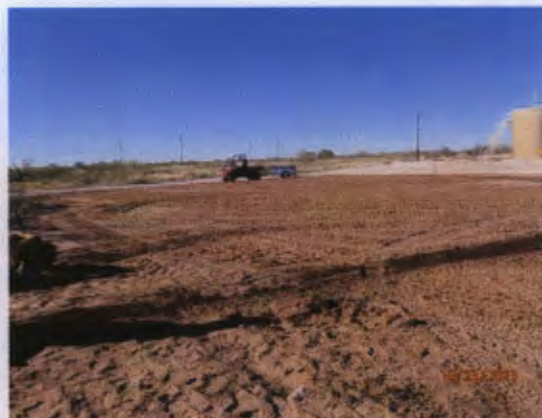
Adding amendments to the soil,
facing southwest

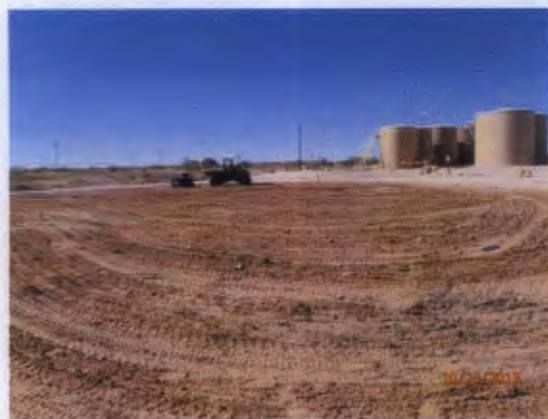
Seeding the site, facing southwest

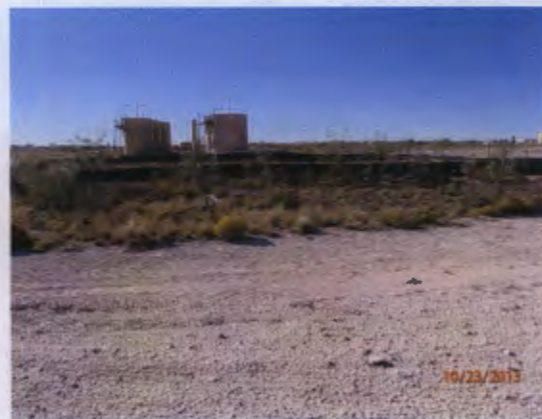
Site complete, facing west
