HIP - __125__

**GENERAL
CORRESPONDENCE**

**RE: Enterprise Products Operating LLC
Submittal of Notice of Intent to Discharge Hydrostatic Test Water
Western Expansion Pipeline III, Segment 5
Guadalupe, Lincoln and De Baca Counties, New Mexico**

**Subject: Submittal of a Notice of Intent to Perform Hydrostatic Test
 WEP III – Segment 5
 Guadalupe, Lincoln, and De Baca Counties, New Mexico**

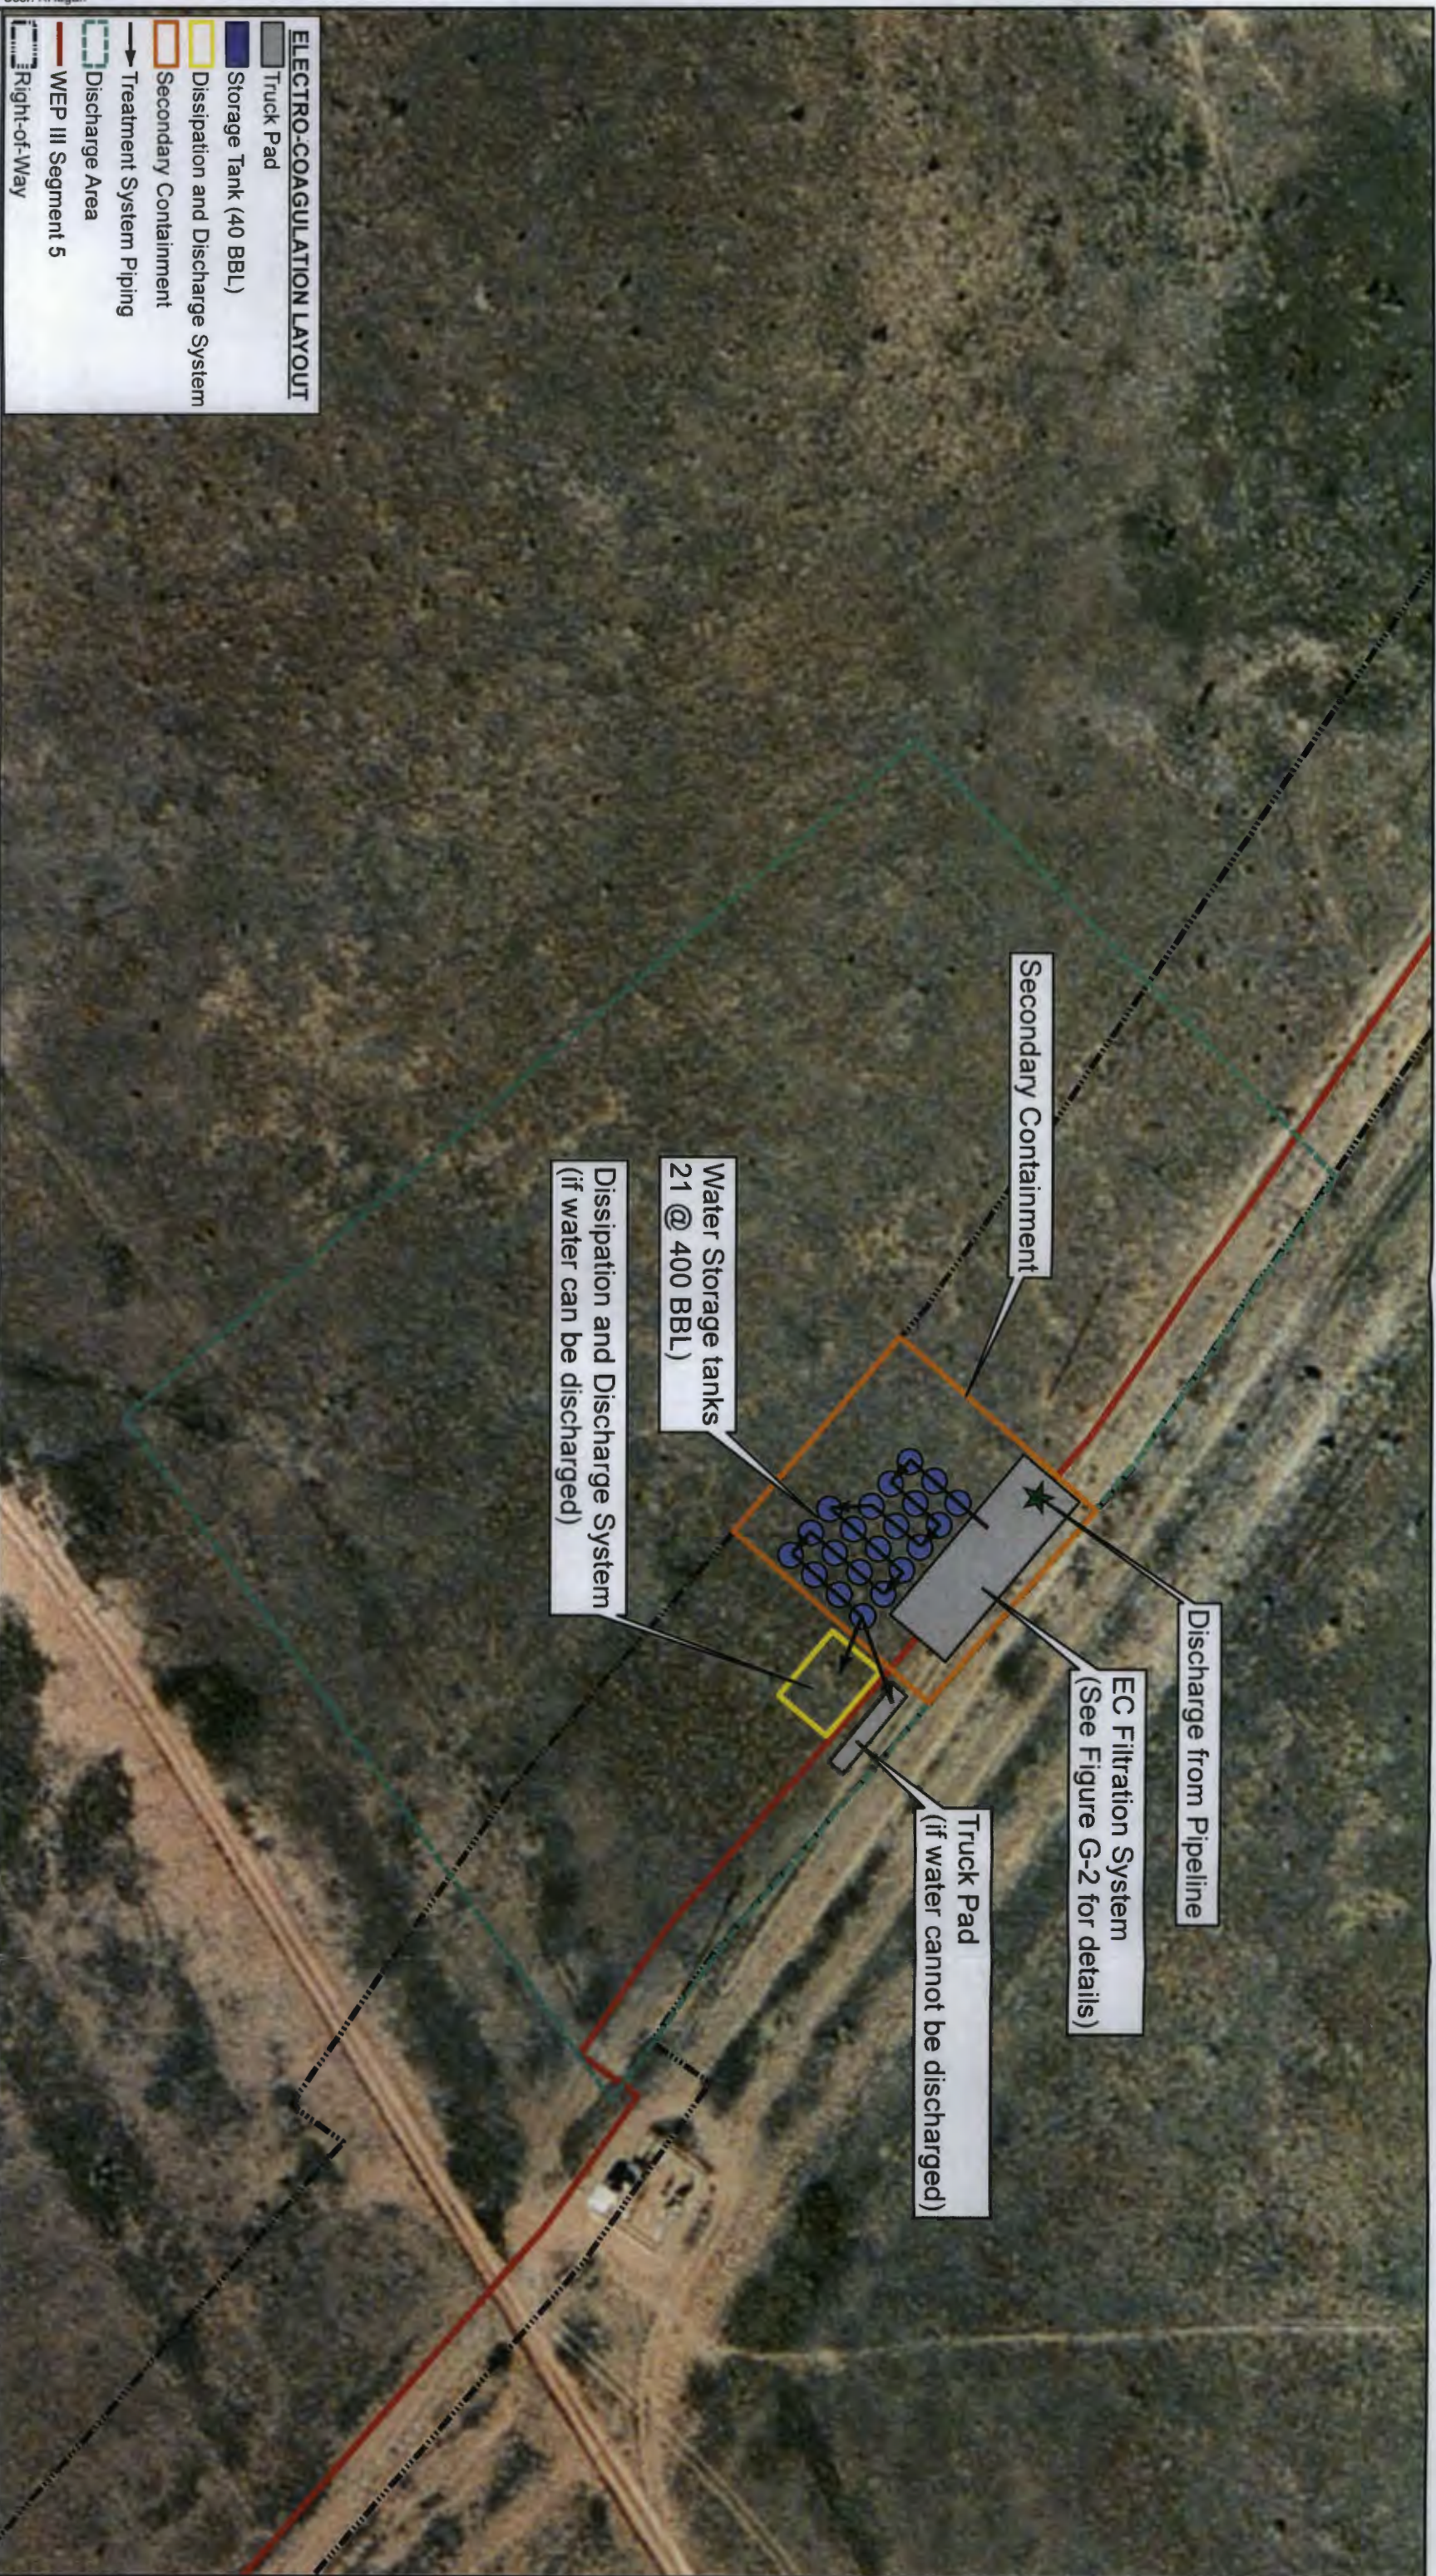
If hydrostatic test water analytical results exceed the water quality standards of NMAC 20.6.2.3103, the test water will be treated using an electro-coagulation cleaning process and a separate filtering system. This process is described in Appendix G.
