BD G-29 EOL
2013

**RICE OPERATING COMPANY
JUNCTION BOX DISCLOSURE* REPORT**

General Description of Remedial Action: This junction box and line were eliminated during the pipeline replacement/upgrade program. After the former junction box was removed, an investigation was conducted using a backhoe to collect soil samples at regular intervals producing a 20x20x12 ft deep excavation. Chloride field tests performed on each sample resulted in concentrations that did not relent with depth. Organic vapors were measured using a PID, which yielded low concentrations. The excavated soil was blended on site, and representative composite samples of the excavation bottom, excavation walls, and the blended backfill were sent to a commercial laboratory for analysis of chloride and TPH. A total of 256 yards of excavated soil was transported to a NMOCD approved facility.

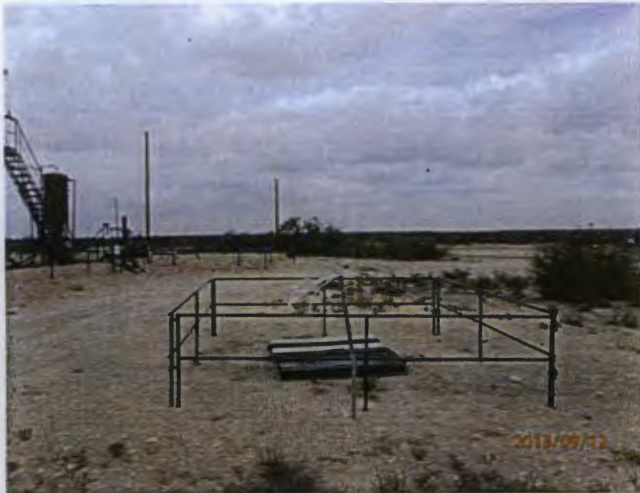
Site prior, facing north

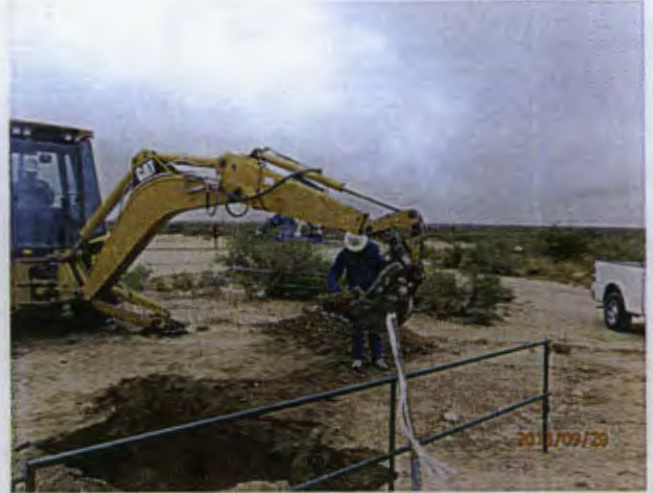
Collecting sample, facing northeast

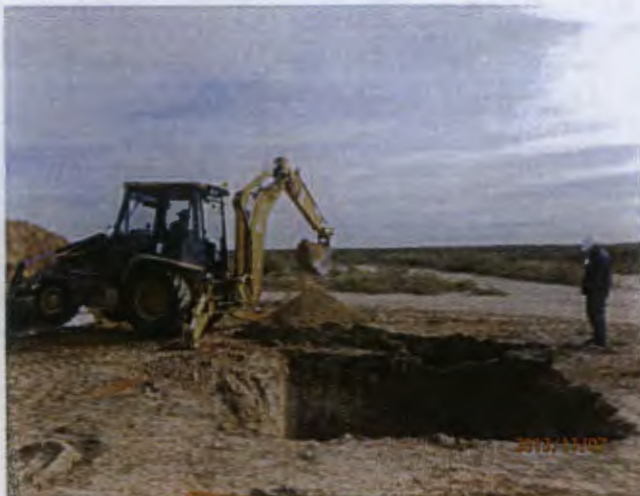
Digging vertical, facing east

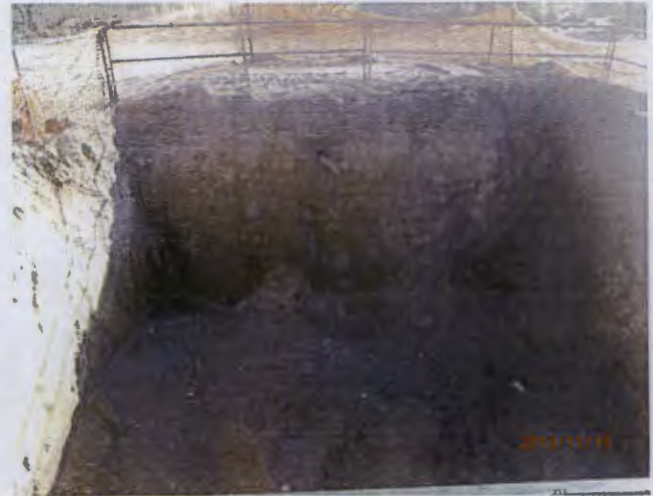
Installed 6" sand pad at base of excavation, facing south

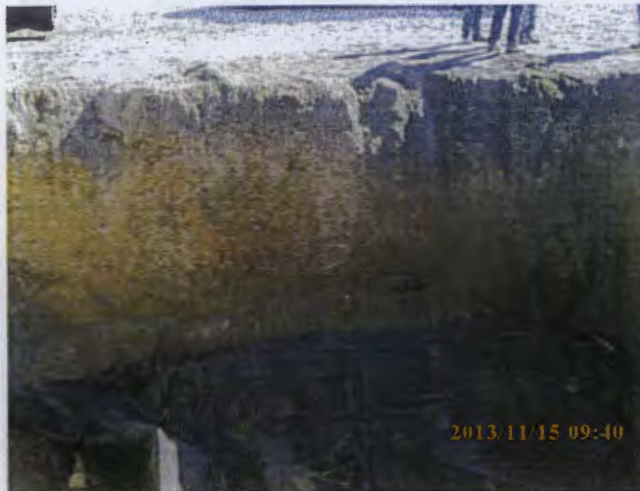
Installed 20'x20', 20-mil poly liner at 11.5', facing east

On 11/15/13, a 20-mil reinforced poly liner was installed at approximately 11.5', in between a 6" pad below and above the liner. The excavation was backfilled to 5 ft bgs with blended backfill. On 11/26/2013, a second 20 mil-reinforced plastic liner was installed at 4.5 ft bgs, in between a 6" pad below and above the liner. The remainder of the excavation was backfilled with clean, imported soil to ground surface and contoured to the surrounding area. On 1/7/14, the site was seeded with a blend of native vegetation and is expected to return to a productive capacity at a normal rate. NMOCD was notified of potential groundwater impact on 2/13/14.

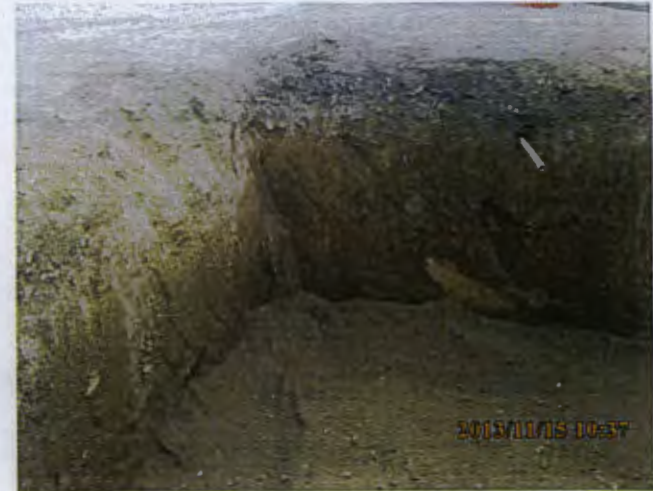
Installed 6" pad above liner, facing northeast

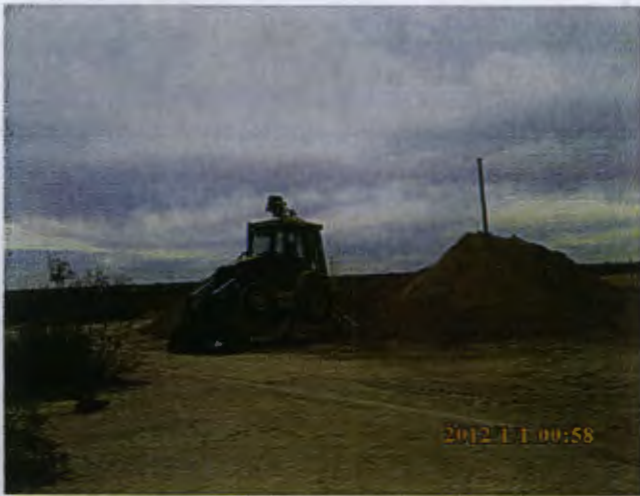
Blending spoil pile, facing southwest

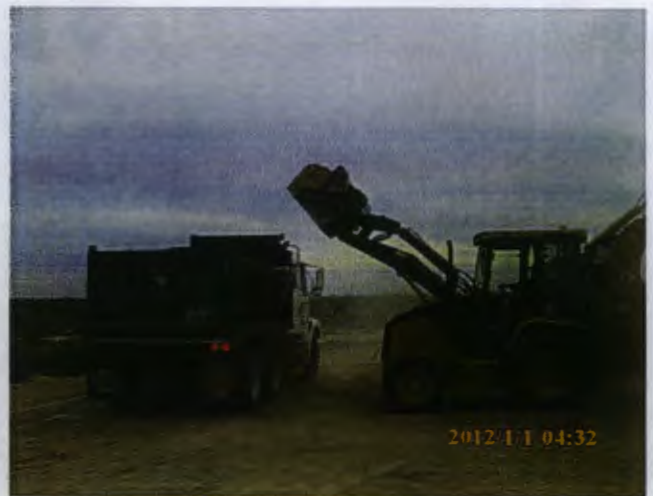
Exporting spoil pile, facing south

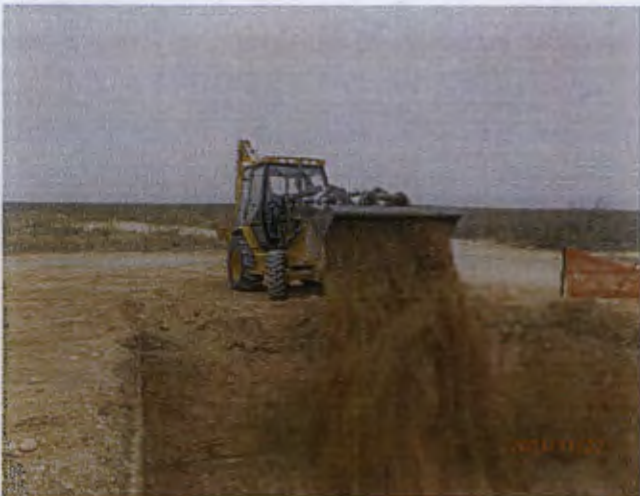
Backfilling excavation, facing southeast

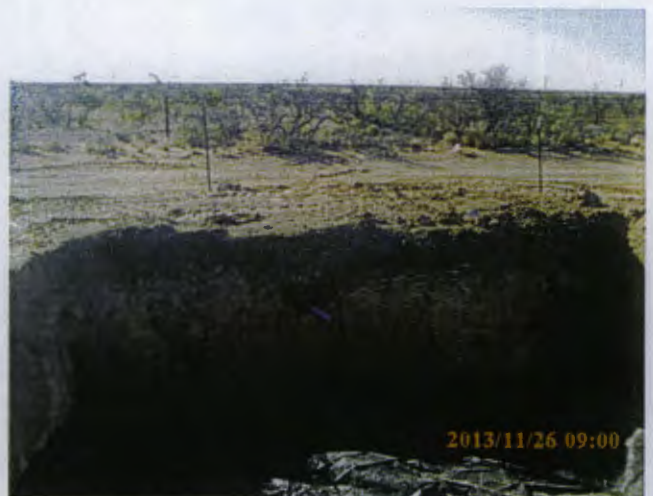
Installed 20'x20', 20-mil poly liner at 4.5 ft bgs, facing southwest

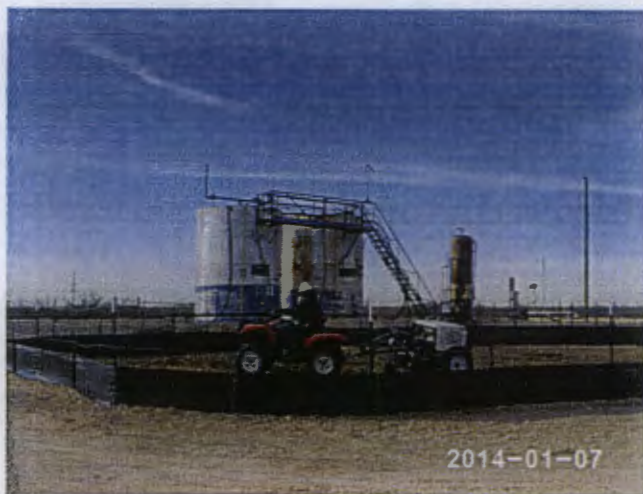
Seeding site, facing north

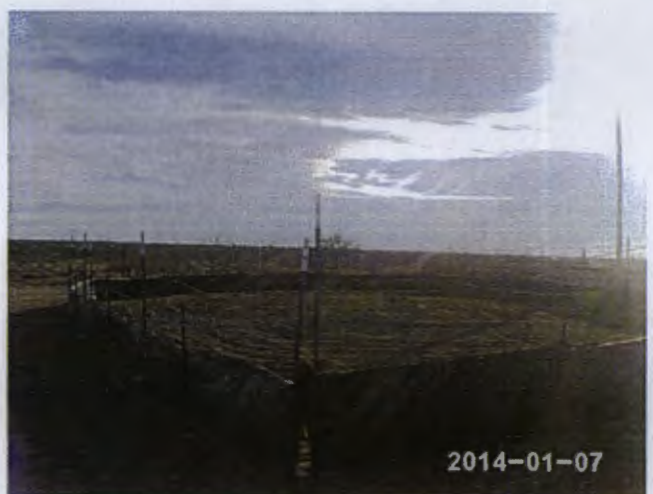
Site completed, facing east
