4.
10-2-44
EME Jct. D-20

RE: Termination Request
EME Jct. D-20: UL/D, Sec. 20, T19S, R37E
RICE Operating Company – Eunice Monument Eumont SWD System

**RICE OPERATING COMPANY
JUNCTION BOX FINAL REPORT**

SWD SYSTEM	JUNCTION	UNIT	SECTION	TOWNSHIP	RANGE	COUNTY	BOX DIMENSIONS - FEET		
Eunice Monument Eumont (EME)	Jct. D-20	D	20	19S	37E	Lea	Length	Width	Depth
							Eliminated

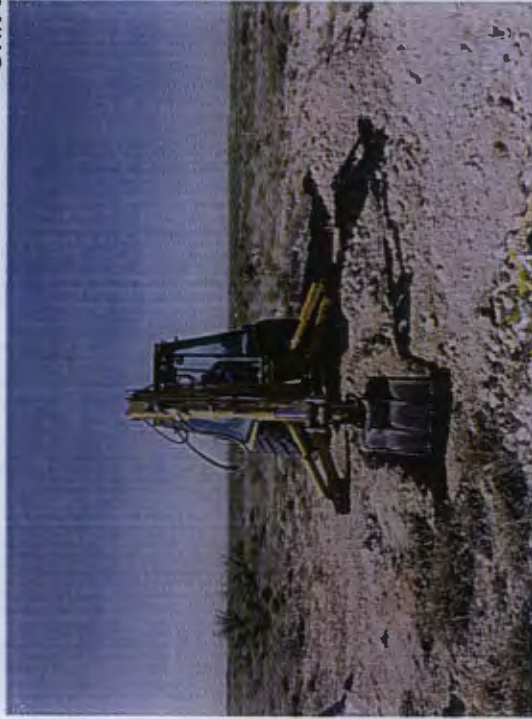
Digging initial, facing south

6/3/2013

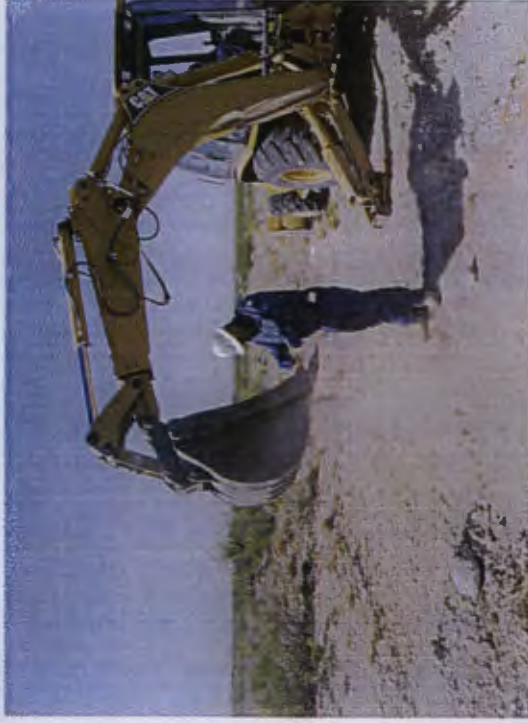
Collecting sample, facing south

6/3/2013

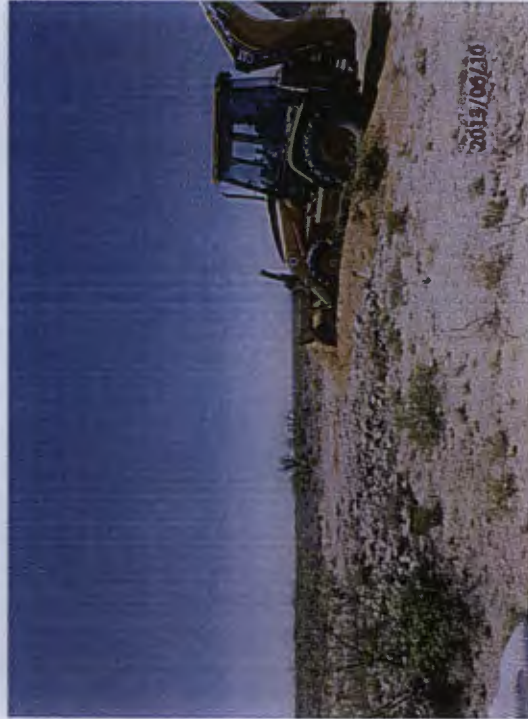
Backfilling site, facing south

6/10/2013

General Description of Remedial Action: This junction was eliminated during the pipeline replacement/upgrade program. After the former junction box was removed, an investigation was conducted using a backhoe to collect soil samples at regular intervals, creating a 3X7X7-ft. deep excavation. Chloride field tests performed on each sample yielded concentrations similar to that of the background sample. Organic vapors

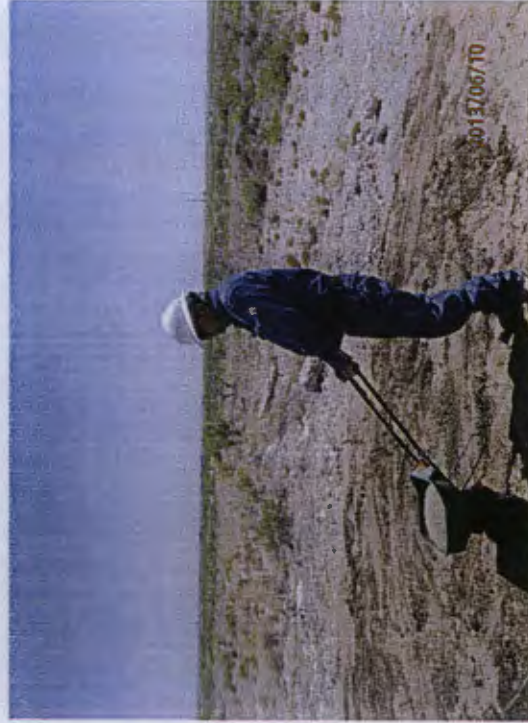
Seeding site, facing south

6/10/2013

Custom Seed Mix	<input checked="" type="checkbox"/>	Prescribed Mix	Seed Mix Name:	2.5 LBS BLUE GRAMA AND 2.5LBS SIDE OATS	Date:	6/10/2013
Broadcast	MECHANICAL			Method:	USE THE PUSH SEEDER TO EVENLY SPREAD SEED	
Soil conditions during seed:	Dry	<input checked="" type="checkbox"/>	Damp	Wet		
Observations:	RAKED SEED AND AMMENDMENTS INTO SOIL THOROUGHLY
