RE: Jacquez Gas Com F#1 Report Documents

**RE: Soil and Groundwater Sampling Results for Jacquez Gas
Com F#1 Release, San Juan County, New Mexico**

EXCAVATION DETAIL, OCTOBER 2011

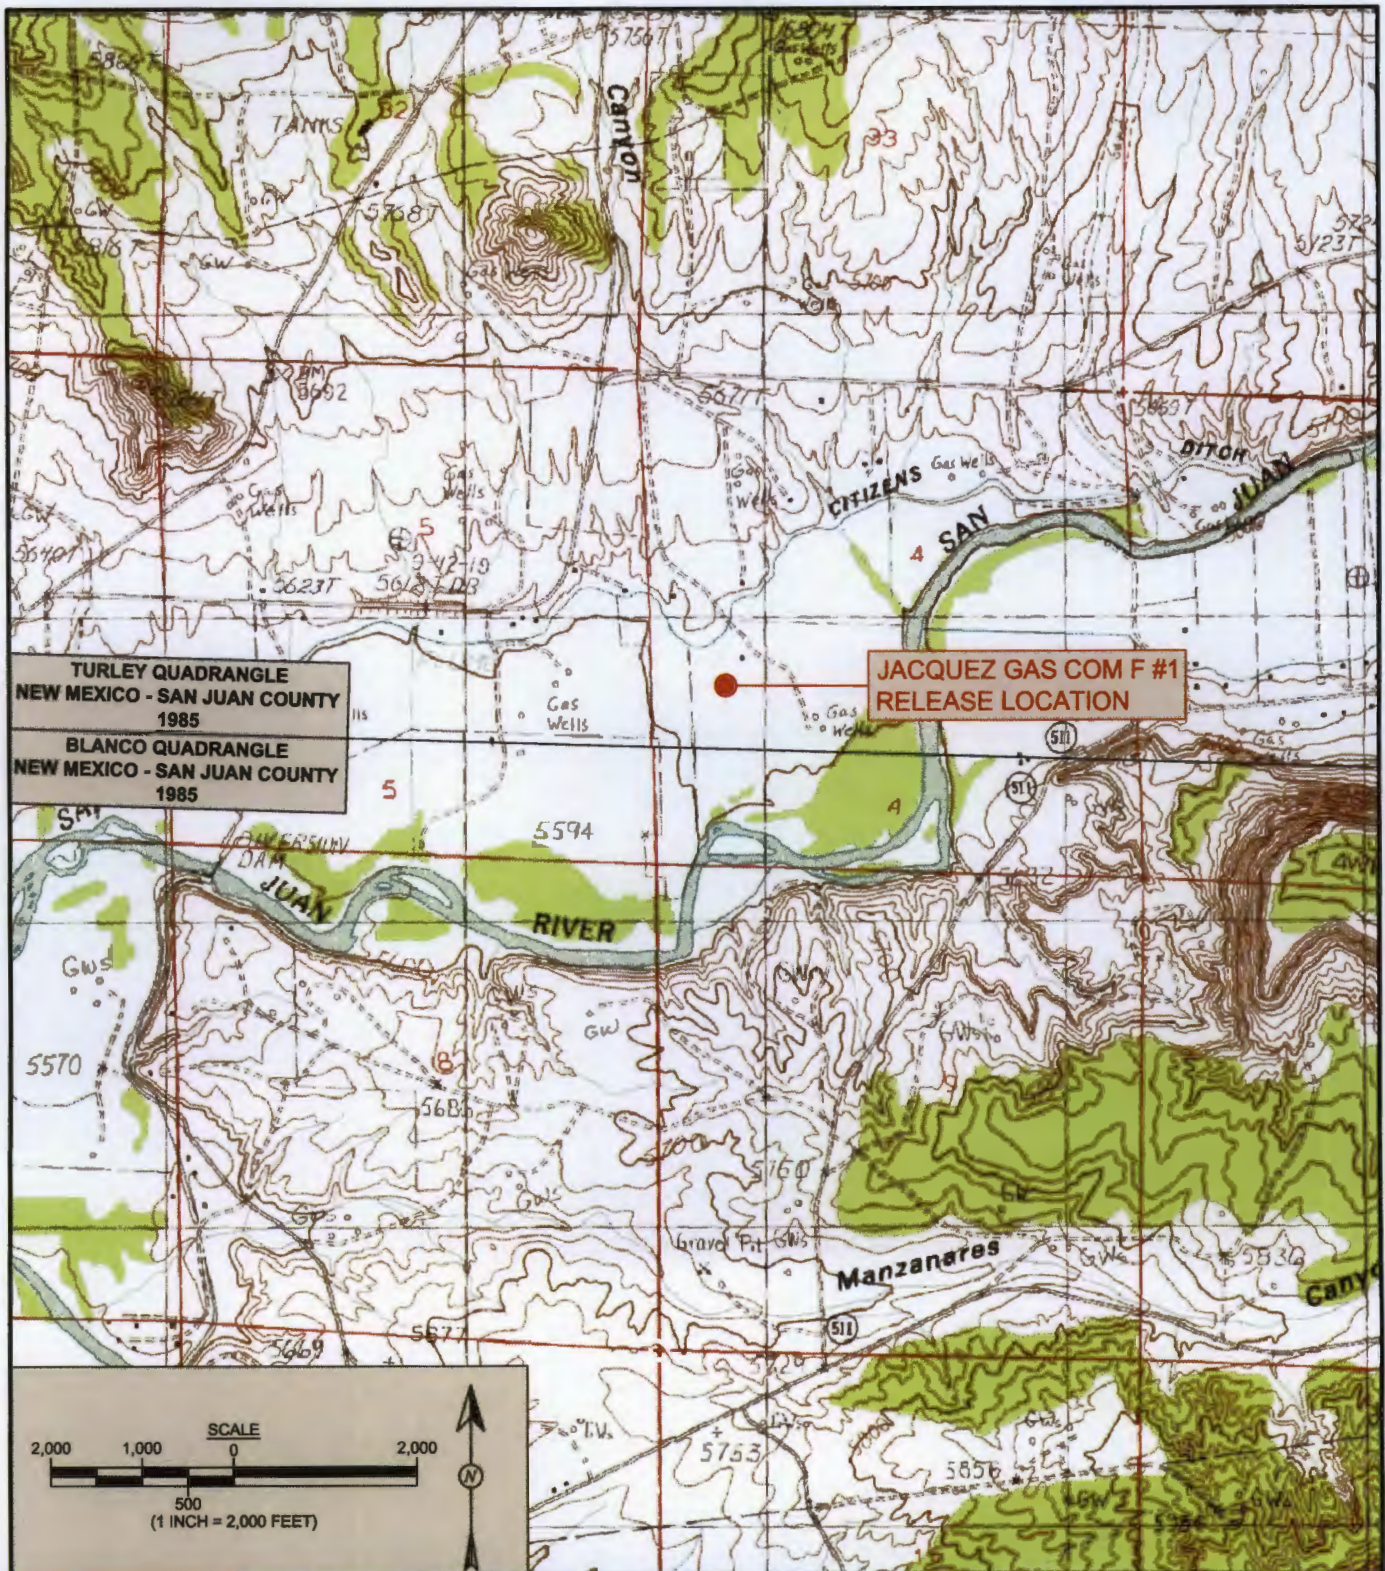
FIGURE 1

TOPOGRAPHIC SITE LOCATION MAP

ENTERPRISE PRODUCTS COMPANY
JACQUEZ GAS COM F #1
PIPELINE RELEASE LOCATION
SAN JUAN COUNTY, NEW MEXICO
NW ¼, SW ¼, SEC. 4, T29N, R9W
N36°45.105', W107°47.454'

The release, located on private property, occurred along the Enterprise Jacquez Gas Com F#1 pipeline within the NW¼, SW¼, Section 4, T29N, R9W, San Juan County, New Mexico. Latitude and longitude of the release were recorded as N36° 45.105' and W107° 47.454'. The approximate site elevation is 5,610 feet above mean sea level. A topographic site location map is included as Figure 1, and an aerial map showing the release location is included as Figure 2.

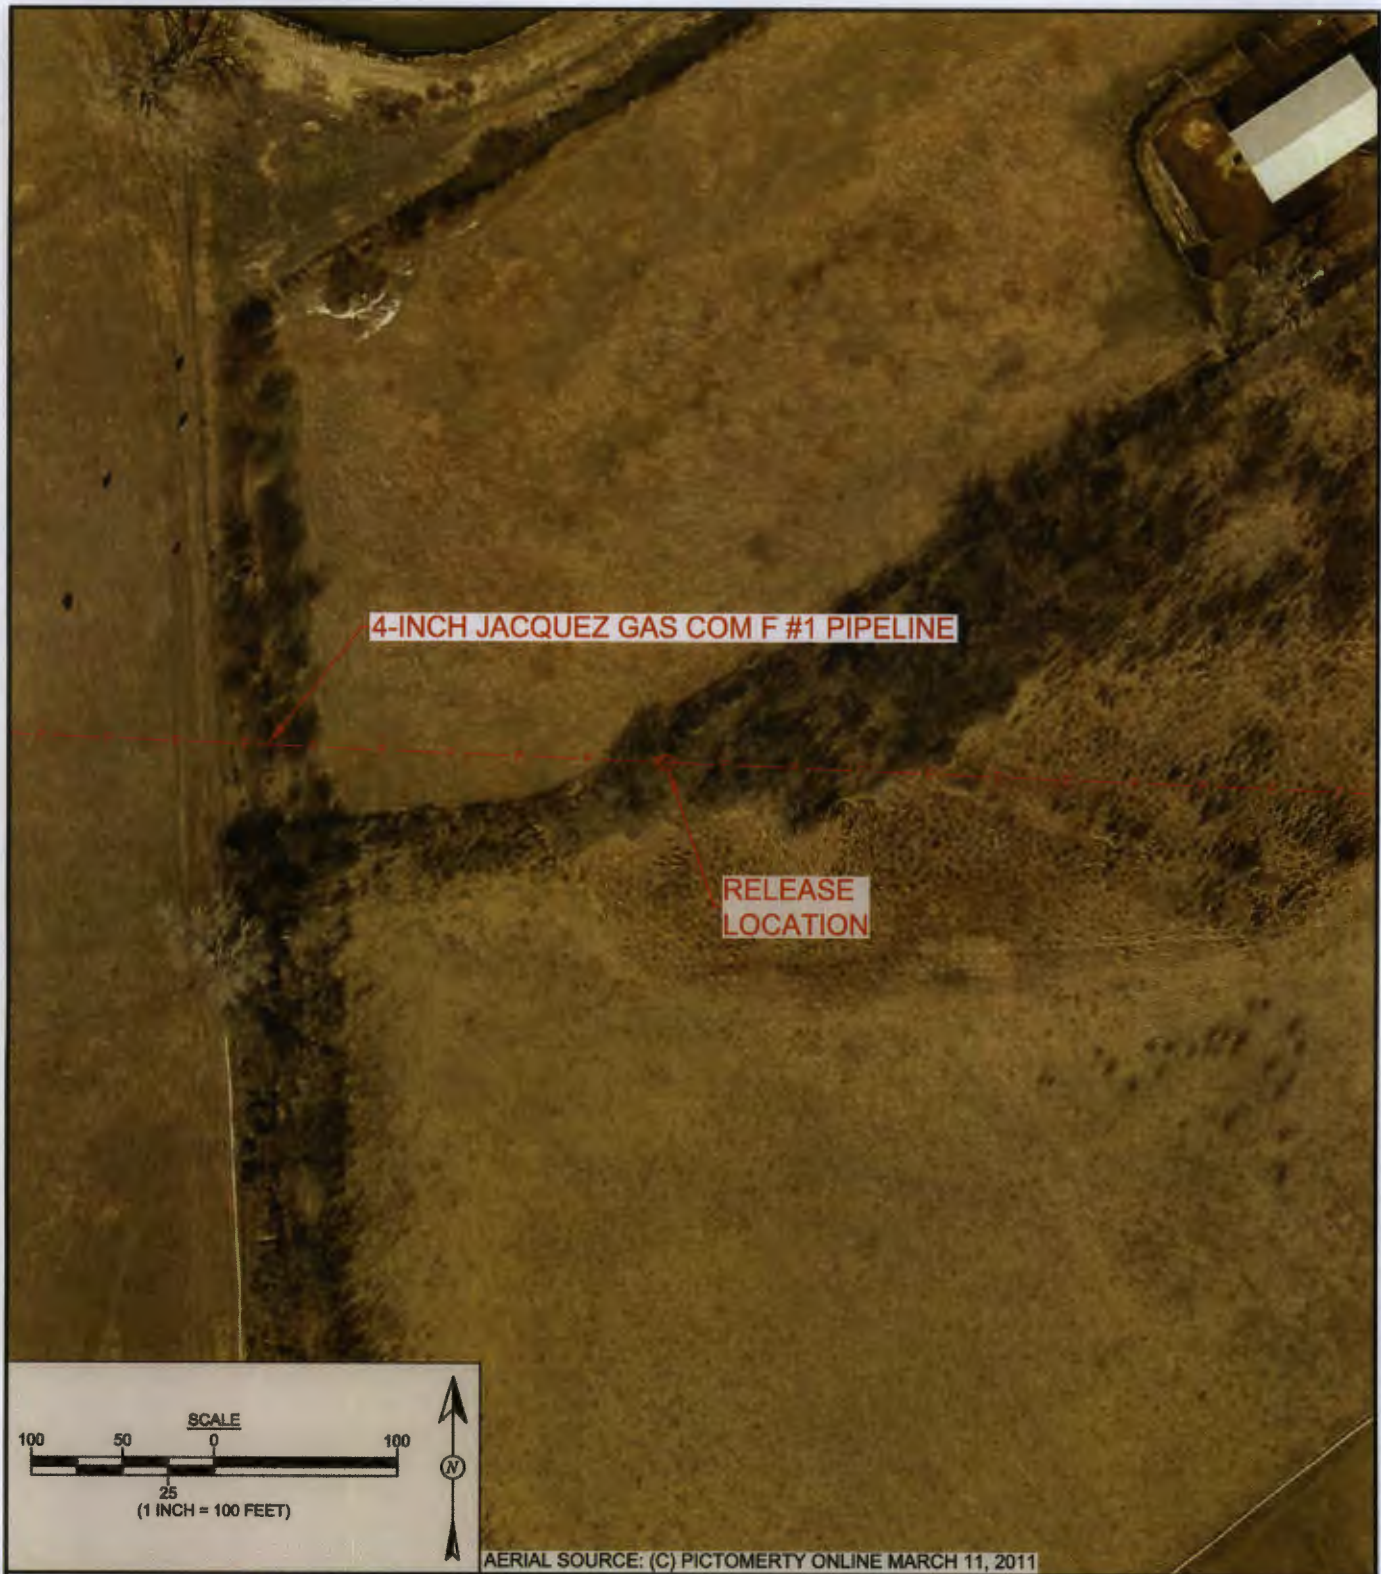
FIGURE 2

AERIAL SITE MAP

ENTERPRISE PRODUCTS COMPANY
JACQUEZ GAS COM F #1
PIPELINE RELEASE LOCATION
SAN JUAN COUNTY, NEW MEXICO
NW ¼, SW ¼, SEC. 4, T29N, R9W
N36°45.105', W107°47.454'

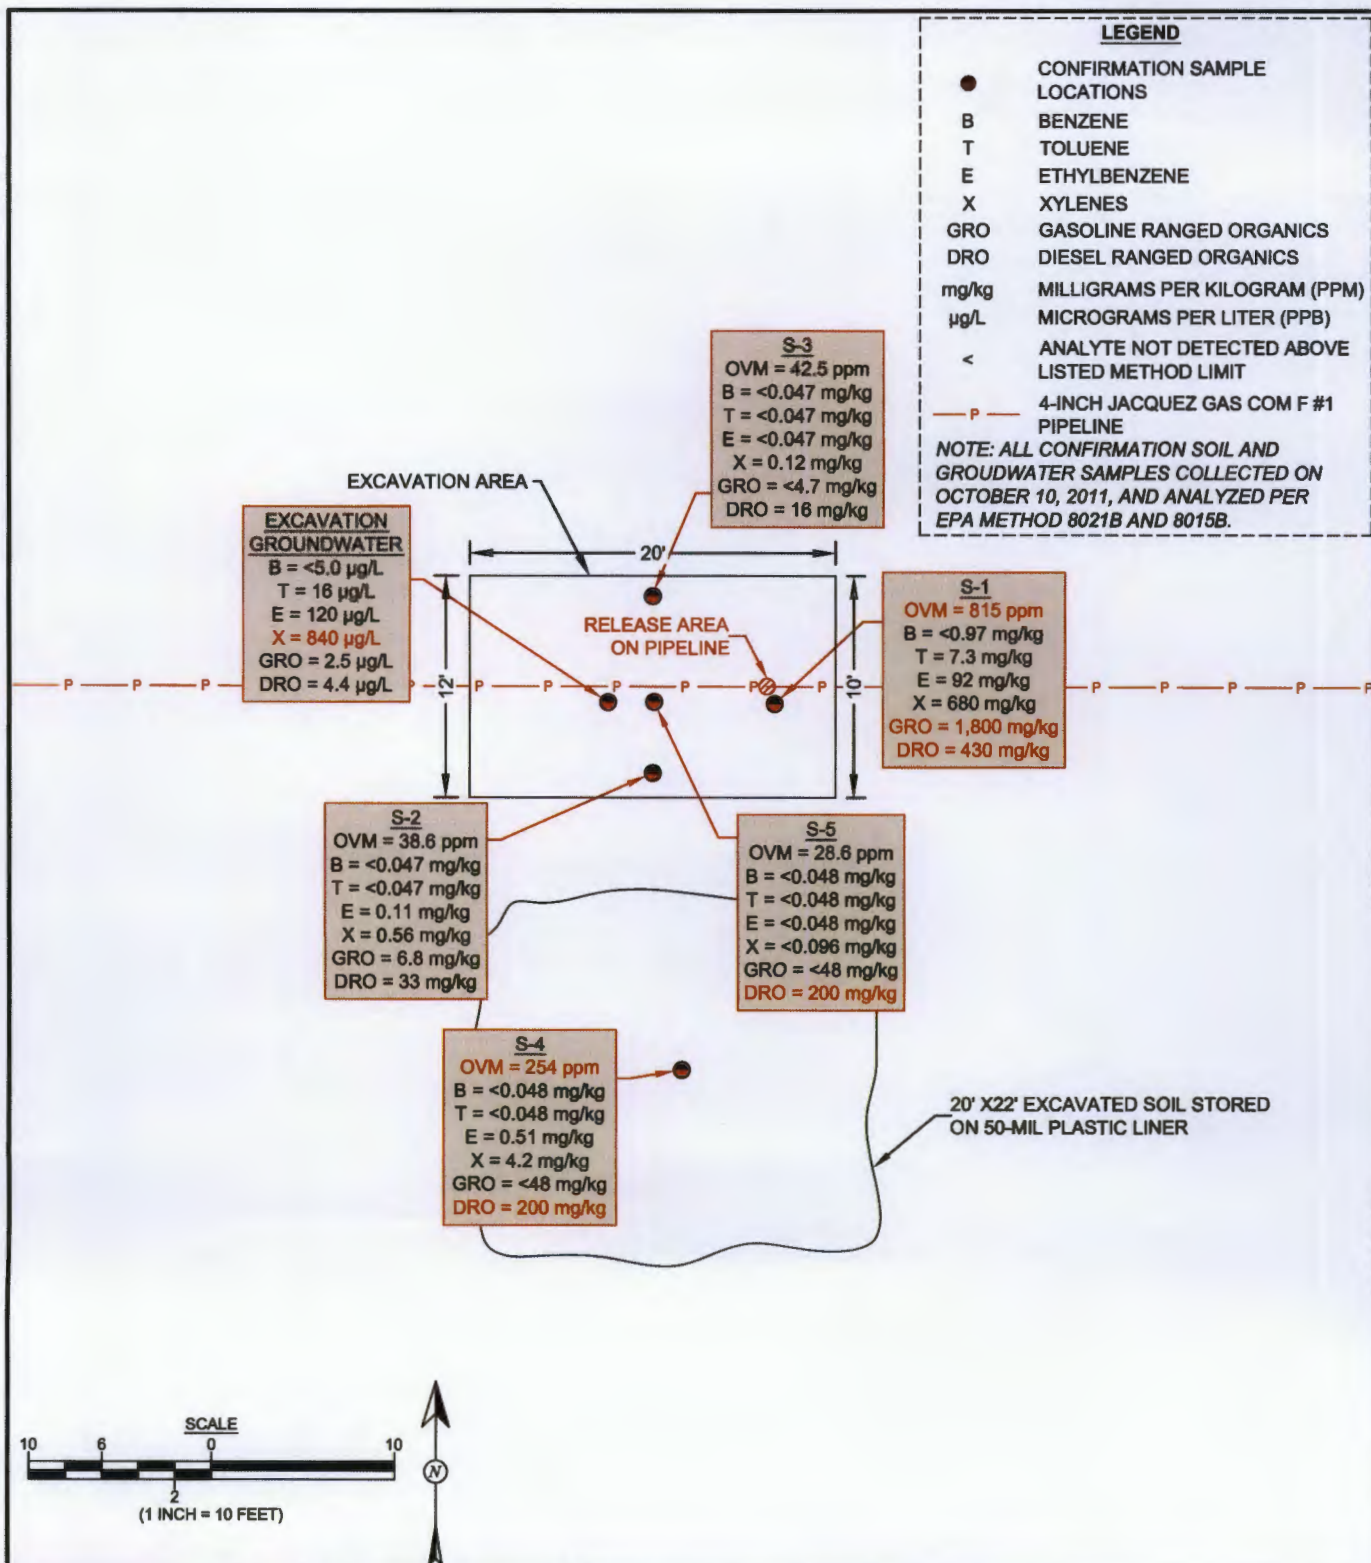
FIGURE 3

On October 10, 2011, AES personnel conducted field screening and collected a total of four grab soil samples from locations within the Jacquez Gas Com F#1 release excavation. Three samples (S-1 through S-3) were collected along the north, south, and east excavation walls at a depth of approximately 4 feet bgs, and one sample (S-5) was collected from the excavation base near the release location. A composite sample of stockpiled spoil material was also collected. Soil sample locations are included on Figure 3.

Upon completion of the initial excavation and line repair work, OVM readings were taken prior to the collection of laboratory samples. Based on the field screening results, the obvious hydrocarbon odors and staining, and the presence of shallow groundwater within the contamination zone, AES suggested that determining the extent of the release in both soil and groundwater would require additional investigation at a later date. OVM measurement locations and results are presented in Table 1 and in Figure 3.

Laboratory analytical results are included in Figure 3, and laboratory analytical reports are attached.

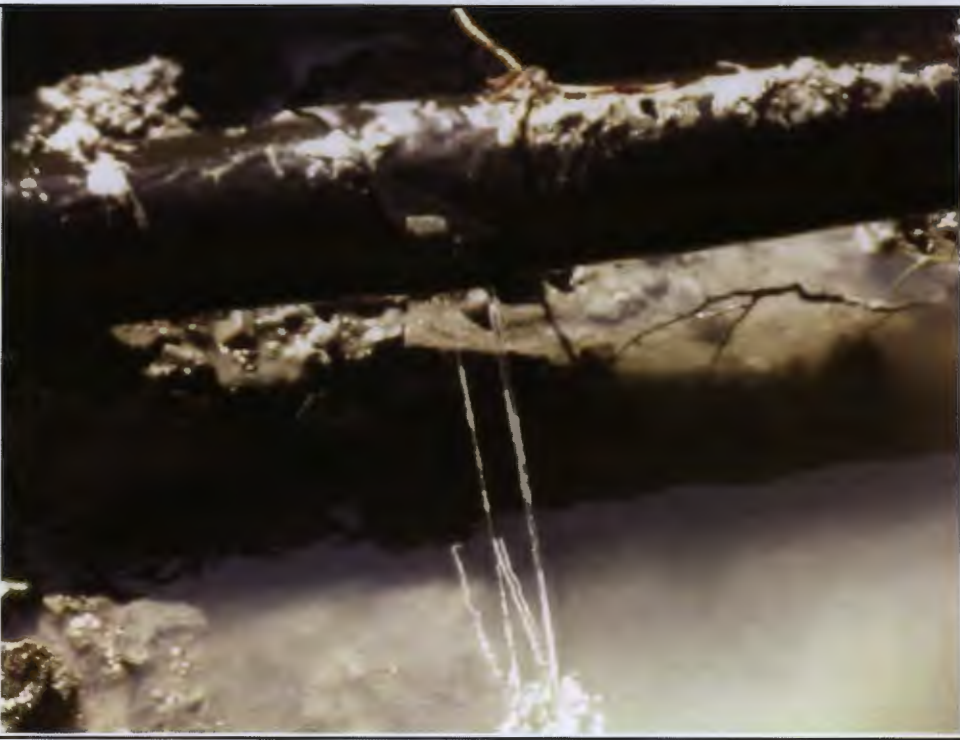
Photo #4

Client: Enterprise Products Company	
Project: Jacquez Gas Com F #1 Pipeline Release	
Taken by: Ross Kennemer	
October 10, 2011	
AES Project No: 110809	Description: Groundwater draining from pipeline.

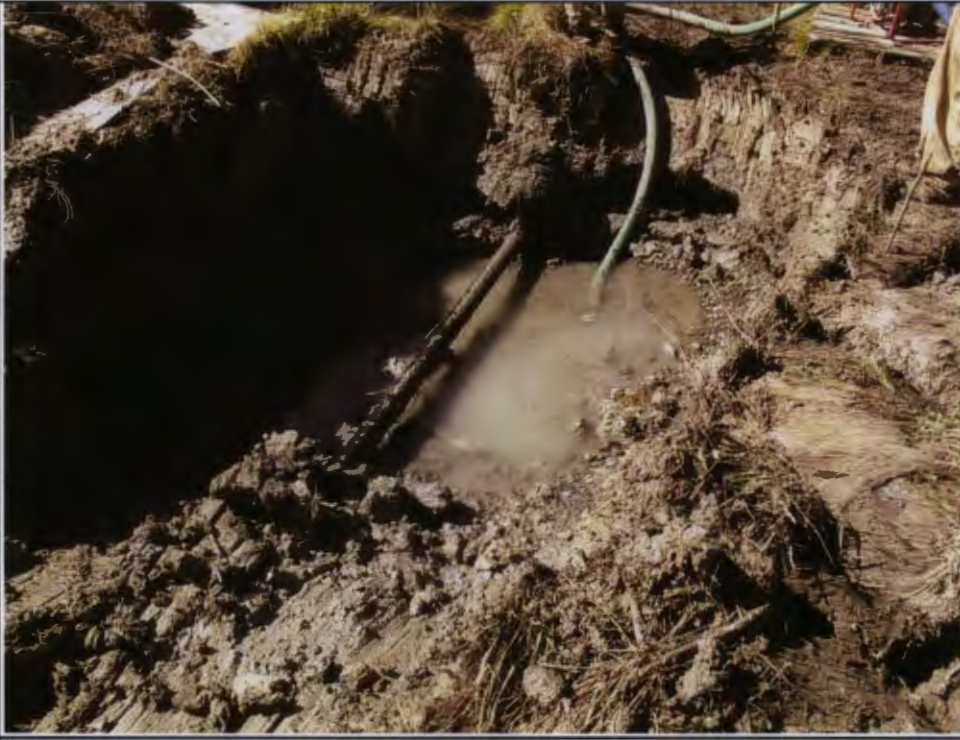
Photo #5

Client: Enterprise Products Company	
Project: Jacquez Gas Com F #1 Pipeline Release	
Taken by: Ross Kennemer	
October 10, 2011	
AES Project No: 110801	Description: Completed excavation and dewatering.

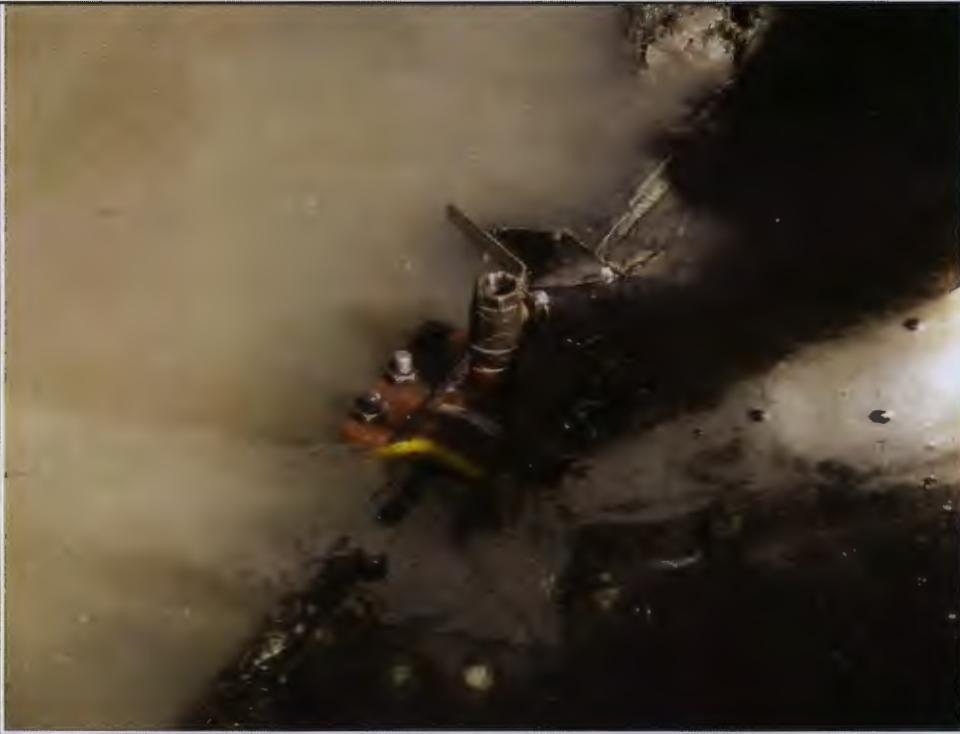
Photo #6

Aaron Dailey of Enterprise contacted AES on July 28, 2011, and an initial site visit was scheduled. On July 30, 2011, Ross Kennemer of AES and Aaron Dailey inspected the release location, and Enterprise postponed further work by AES pending scheduling of the line repair. On September 26, 2011, AES mobilized to the site, but the job was cancelled due to scheduling issues with the landowner. On October 10, 2011, Ross Kennemer of AES met with Enterprise representatives Mike Lee and Chris Lynn at the release location. Representatives from Enterprise, AES, Industrial Mechanical, Inc. (IMI; water pumping and transport), and Southwest Field Services (excavation contractor) were present on-site during the initial site activities. The cause of the release was attributed to a line leak due to a quarter-inch corrosion hole located on the underside of the line.

Client: Enterprise Products Company	
Project: Jacquez Gas Com F #1 Pipeline Release	
Taken by: Ross Kennemer	
October 10, 2011	
AES Project No: 110801	Description: Temporary clamp prior to replacing corroded section of pipeline.
