**3R - 448**

**Q2 GWMR**

**09 / 23 / 2013**

**Re: Periodic Progress Report 2<sup>nd</sup> Qtr 2013**  
**Benson-Montin-Greer**  
**Highway 537 Truck Receiving Station 2009 Release**  
**Rio Arriba County, New Mexico**

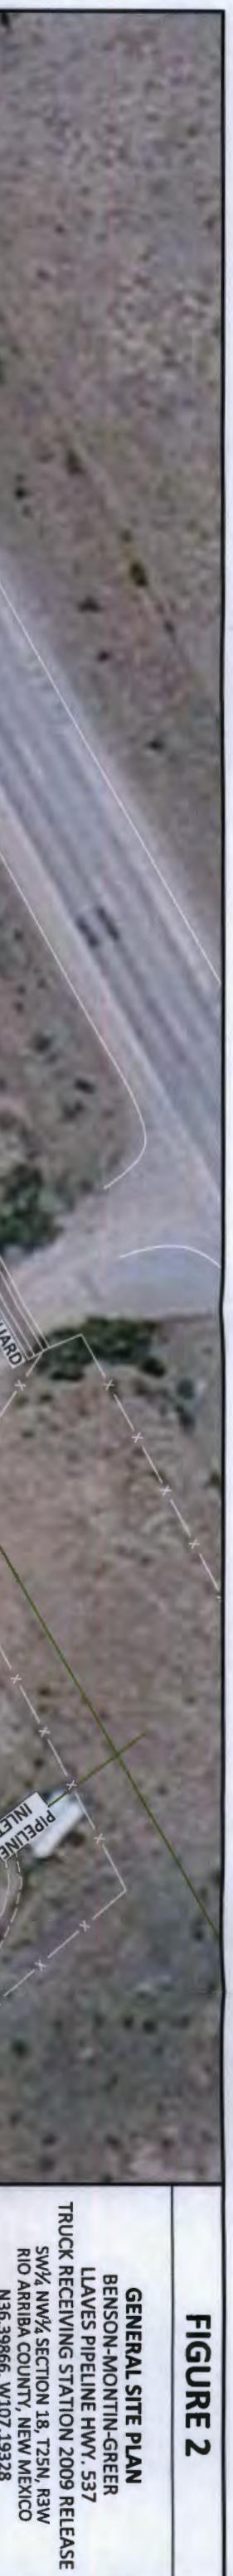
**FIGURE 2**

The truck receiving station is located along the south side of NM State Highway 537 and is adjacent to the Los Ojitos Arroyo, which eventually drains to Largo Canyon. The facility is described legally as being located within the SW $\frac{1}{4}$  NW $\frac{1}{4}$  Section 18, T25N, R3W in Rio Arriba County, New Mexico. Latitude and longitude were recorded as being N36.39866 and W107.19328, respectively. A topographic site location map, based on an excerpt from the United States Geological Survey (USGS) 7.5-minute Schmitz Ranch, Rio Arriba County, New Mexico topographic quadrangle (USGS 1963), is included as Figure 1. An aerial map with a site plan, including existing monitor wells, is presented as Figure 2.

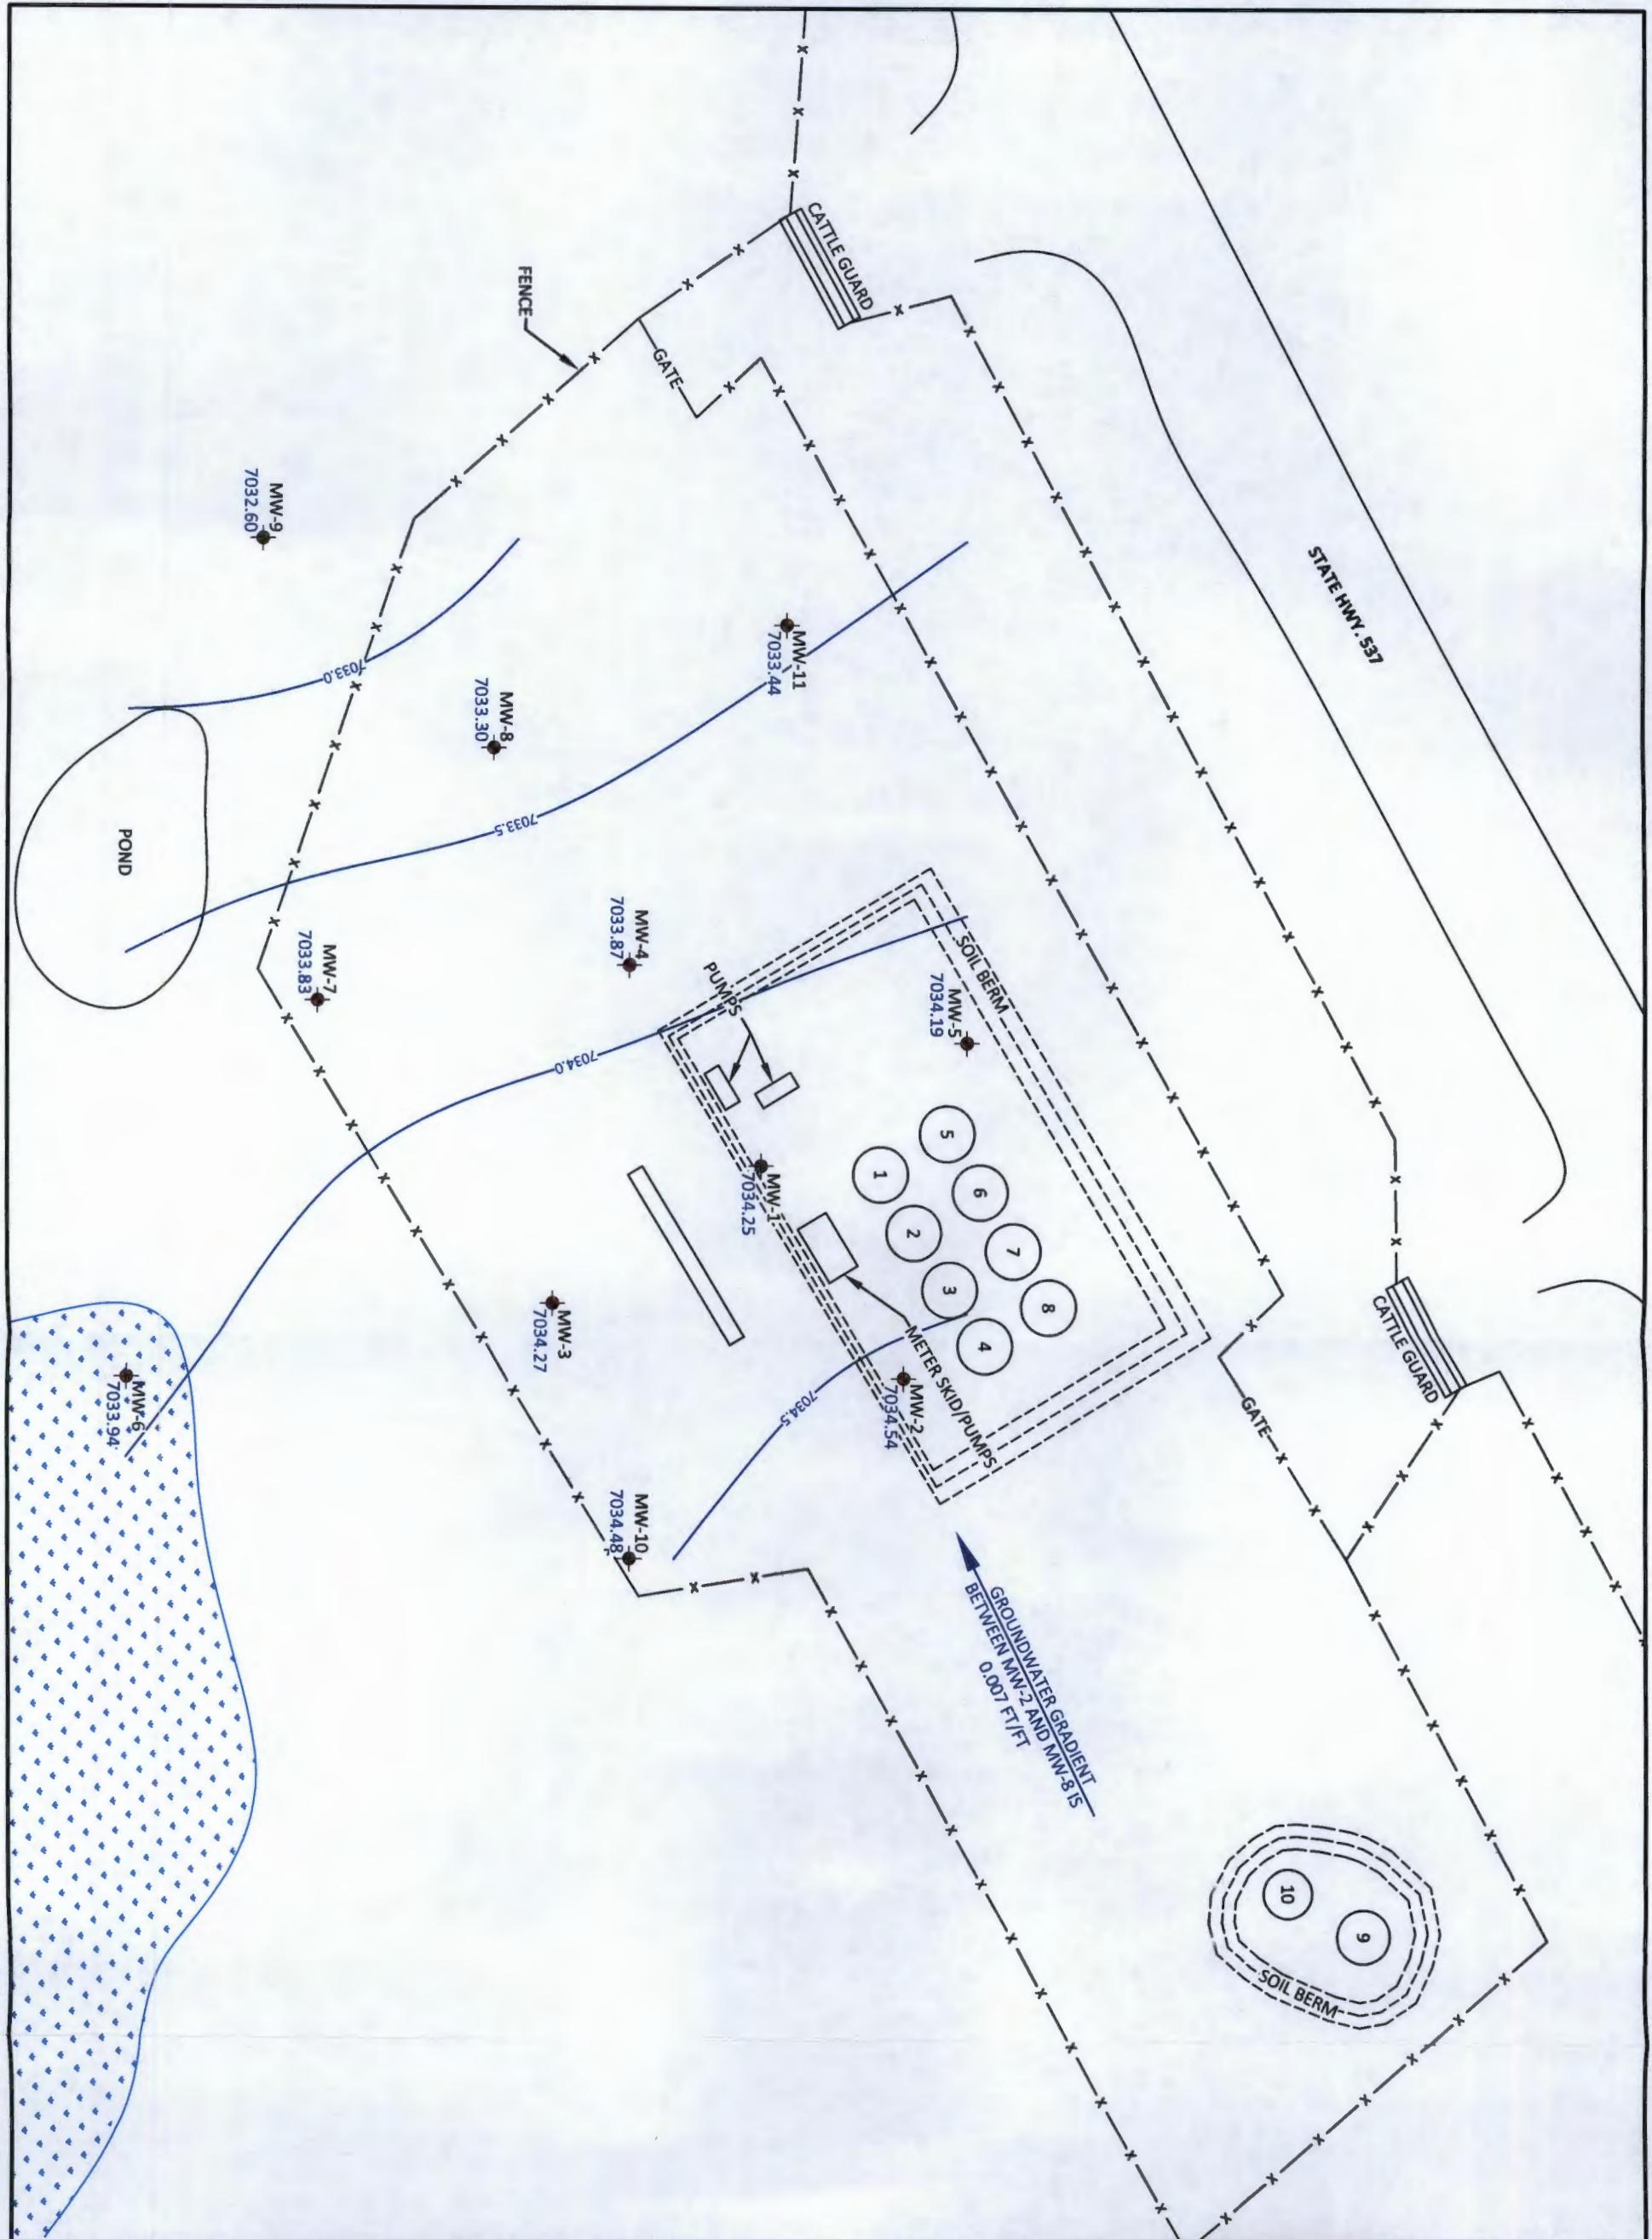
**FIGURE 3**

During the June 2013 sampling event, groundwater measurements were recorded for MW-1 through MW-11. Average groundwater elevations decreased across the site by an average of 0.55 feet since the March 2013 sampling event. Groundwater gradient was calculated between MW-2 and MW-8, with a magnitude of 0.007 ft/ft to the southwest. Groundwater elevations ranged from 15.60 feet below top of casing (TOC) in MW-6 to 30.66 feet below TOC in MW-11. Groundwater elevation data and contours are presented in Figure 3.

AES conducted groundwater monitoring and sampling at the BMG Highway 537 Truck Receiving Station on June 27 and July 1, 2013. Groundwater elevations were found to have decreased in all wells by approximately 0.55 feet since March 2013. Groundwater gradient was calculated to be approximately 0.007 ft/ft in a southwestern direction, which is consistent with historic site data.

GROUNDWATER ELEVATION  
CONTOURS, JUNE AND JULY 2013  
BENSON-MONTIN-GREER  
LLAVES PIPELINE HWY. 537  
TRUCK RECEIVING STATION 2009 RELEASE  
SW $\frac{1}{4}$ , NW $\frac{1}{4}$ , SECTION 18, T25N, R3W  
RIO ARRIBA COUNTY, NEW MEXICO  
N36.39866, W107.19328

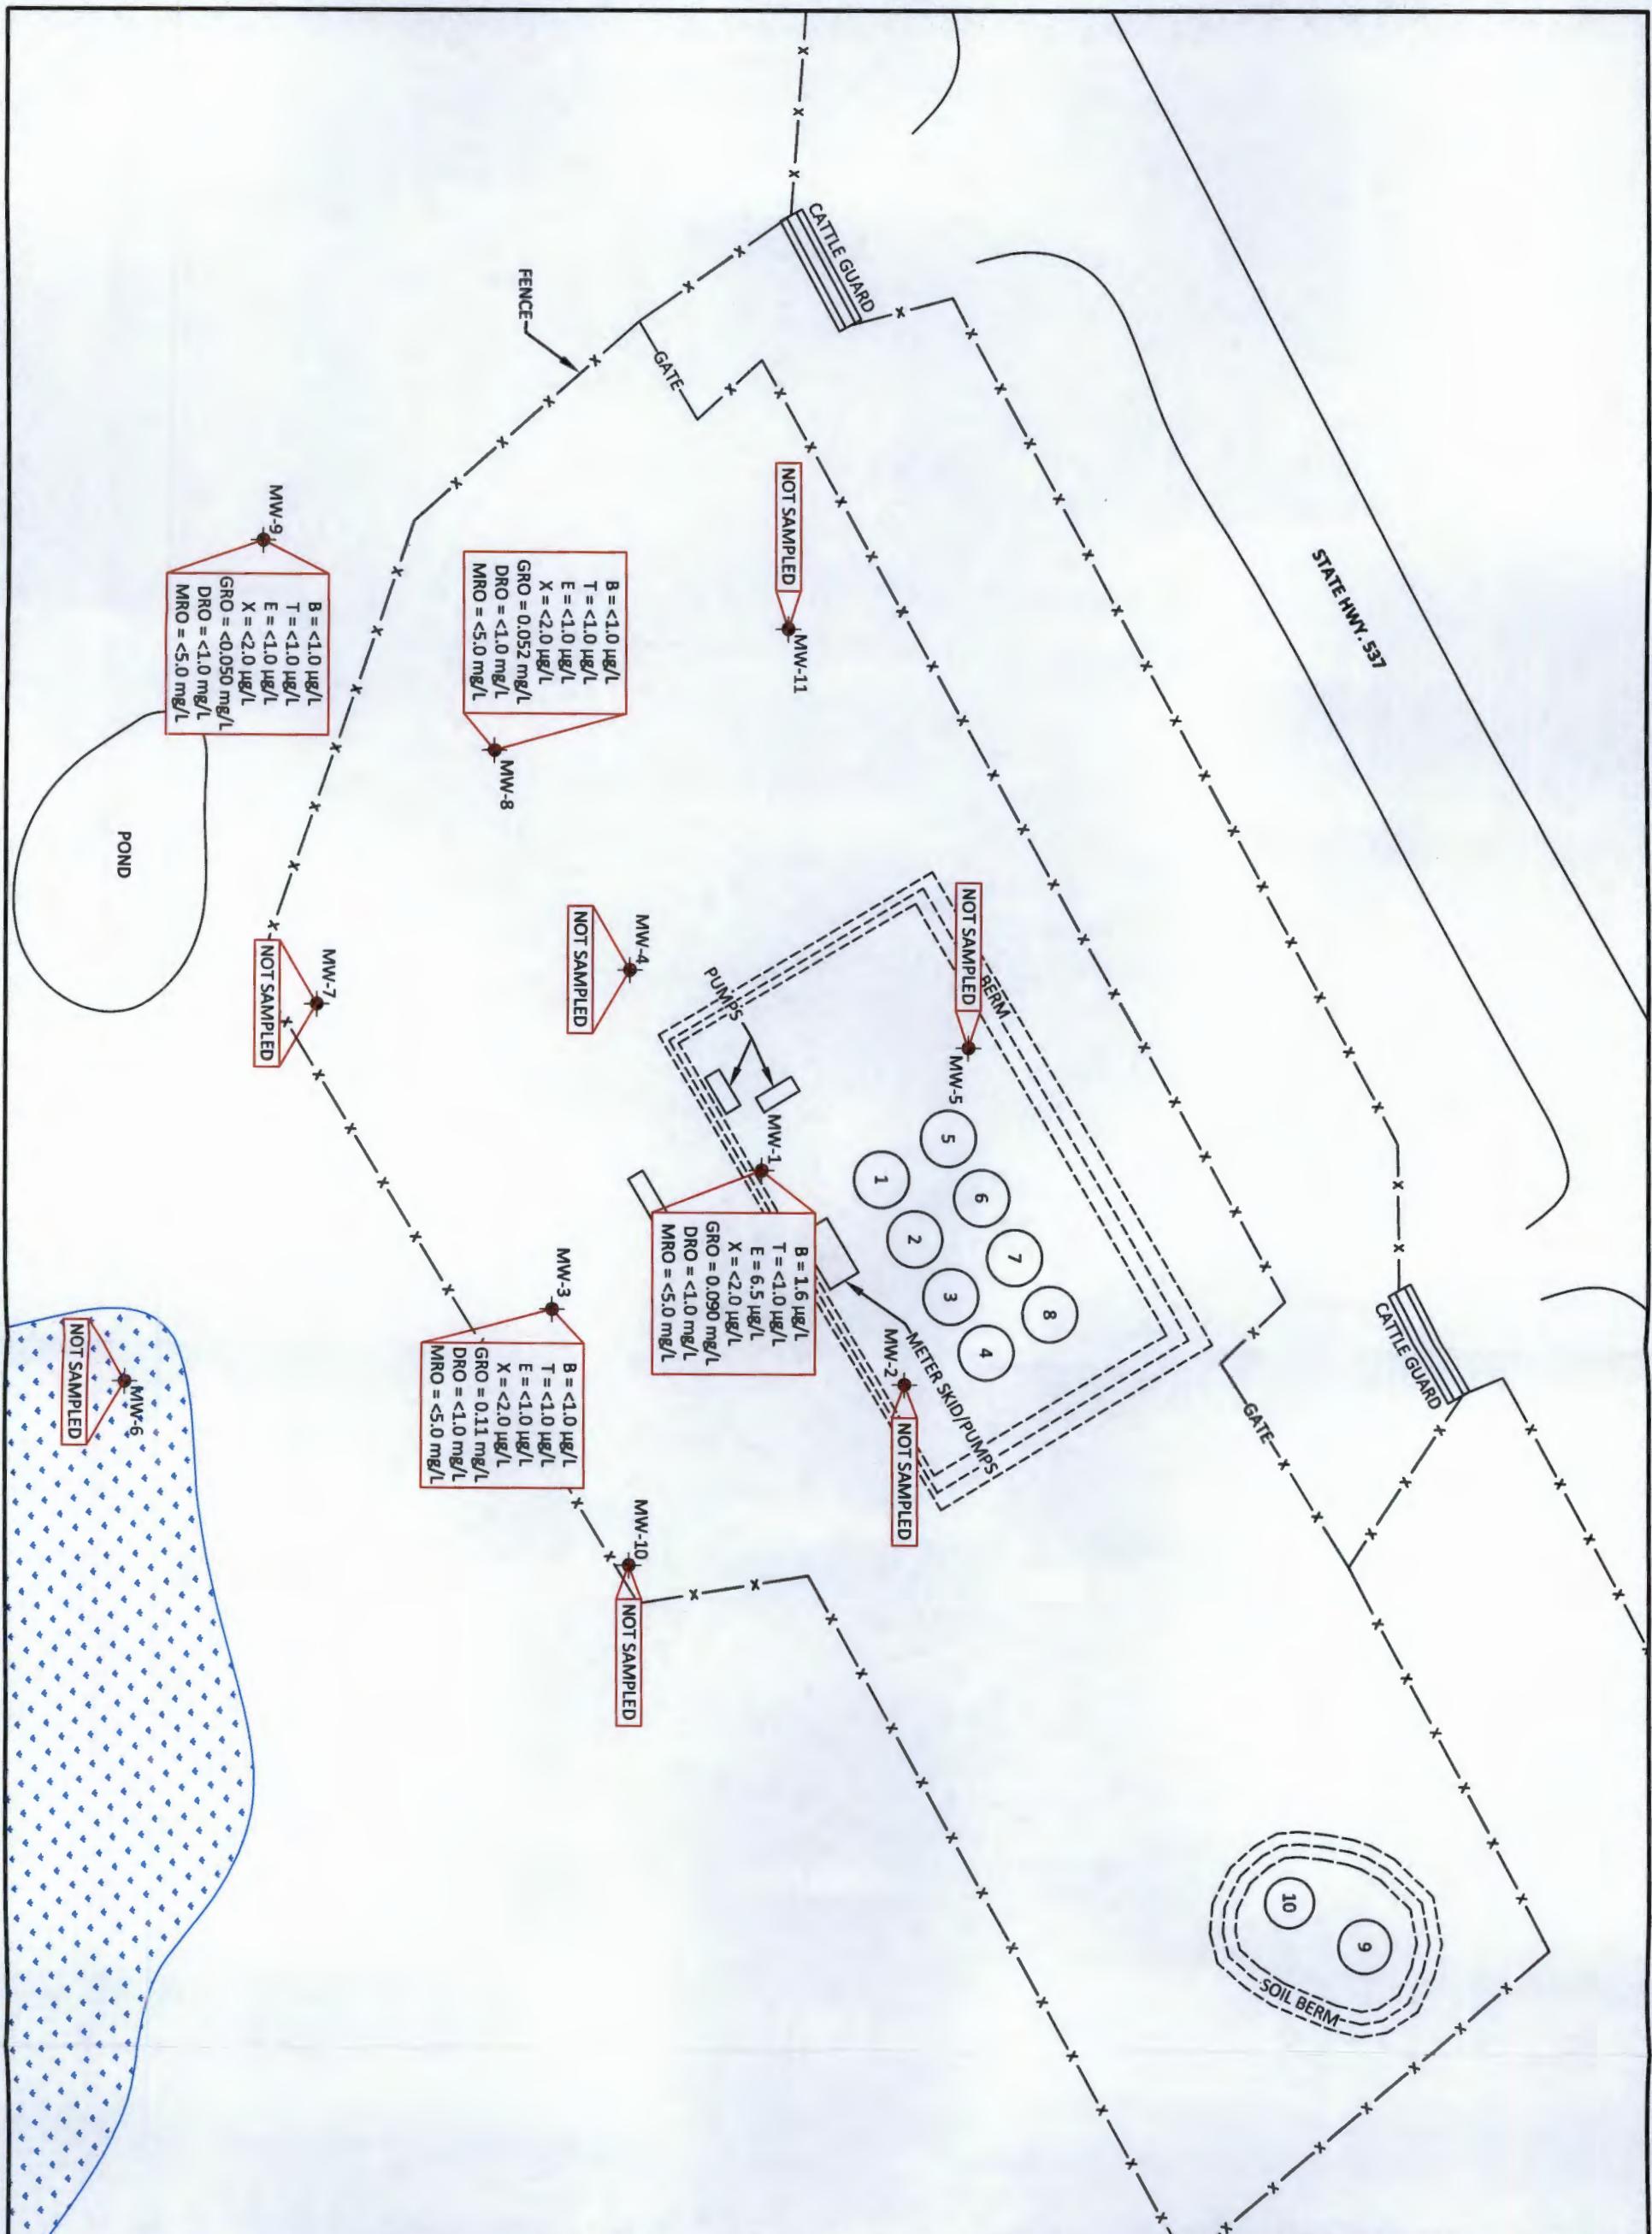
**FIGURE 4**

Dissolved phase benzene, toluene, ethylbenzene, and xylene concentrations were below applicable New Mexico Water Quality Control Commission (WQCC) standards in each of the wells sampled. TPH concentrations as GRO above laboratory detection limits were reported in MW-1 (0.09 mg/L), MW-3 (0.11 mg/L), and MW-8 (0.052 mg/L), and TPH concentrations (as DRO and MRO) were reported below the laboratory detection limits in all wells sampled. Tabulated laboratory analytical results are included in Table 2. Contaminant concentrations are included in Figure 4, and Graphs 1 through 4 present groundwater elevations and dissolved phase benzene concentrations for MW-1, MW-3, MW-8, and MW-9, respectively. Laboratory analytical reports for June and July 2013 are included in the Appendix.

The dissolved phase benzene concentration in MW-1 was reported below the WQCC standard of 10 µg/L for the third consecutive quarter. Benzene concentrations have remained below the WQCC standard for the fourth consecutive quarter in MW-3, the eighth consecutive quarter in MW-8, and the fifth consecutive quarter in MW-9. Dissolved phase toluene, ethylbenzene, and xylenes have remained below the applicable WQCC standards in each of the wells. GRO concentrations above the laboratory detection limit were reported in MW-1 (0.09 mg/L), MW-3 (0.11 mg/L), and MW-8 (0.052 mg/L). DRO and MRO concentrations were reported below the laboratory detection limits in each of the wells sampled during the June 2013 sampling event.

GROUNDWATER CONTAMINANT CONCENTRATIONS, JUNE 2013  
 BENSON-MONTIN-GREER  
 LLAVES PIPELINE HWY. 537  
 TRUCK RECEIVING STATION 2009 RELEASE  
 SW $\frac{1}{4}$ , NW $\frac{1}{4}$ , SECTION 18, T25N, R3W  
 RIO ARRIBA COUNTY, NEW MEXICO  
 N36.39866, W107.19328

Based on laboratory analytical results, AES recommends continuing groundwater monitoring and sampling of monitor wells MW-1, MW-3, and MW-9 on a quarterly basis. AES further recommends continued groundwater monitoring and sampling of MW-8 on an annual basis since it has remained below WQCC standards for BTEX for eight consecutive quarters.

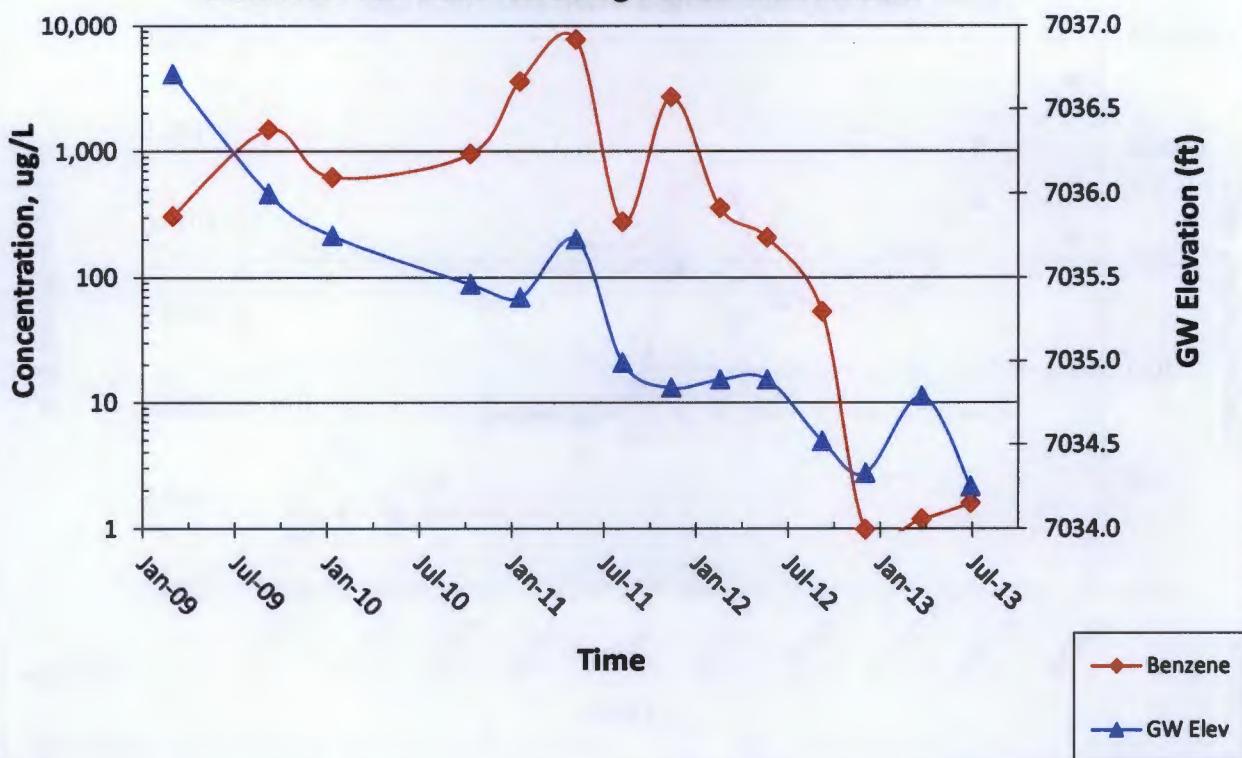
**Graph 1. MW-1 Benzene Concentrations Over Time  
BMG HWY 537 Truck Receiving Station 2009 Release**

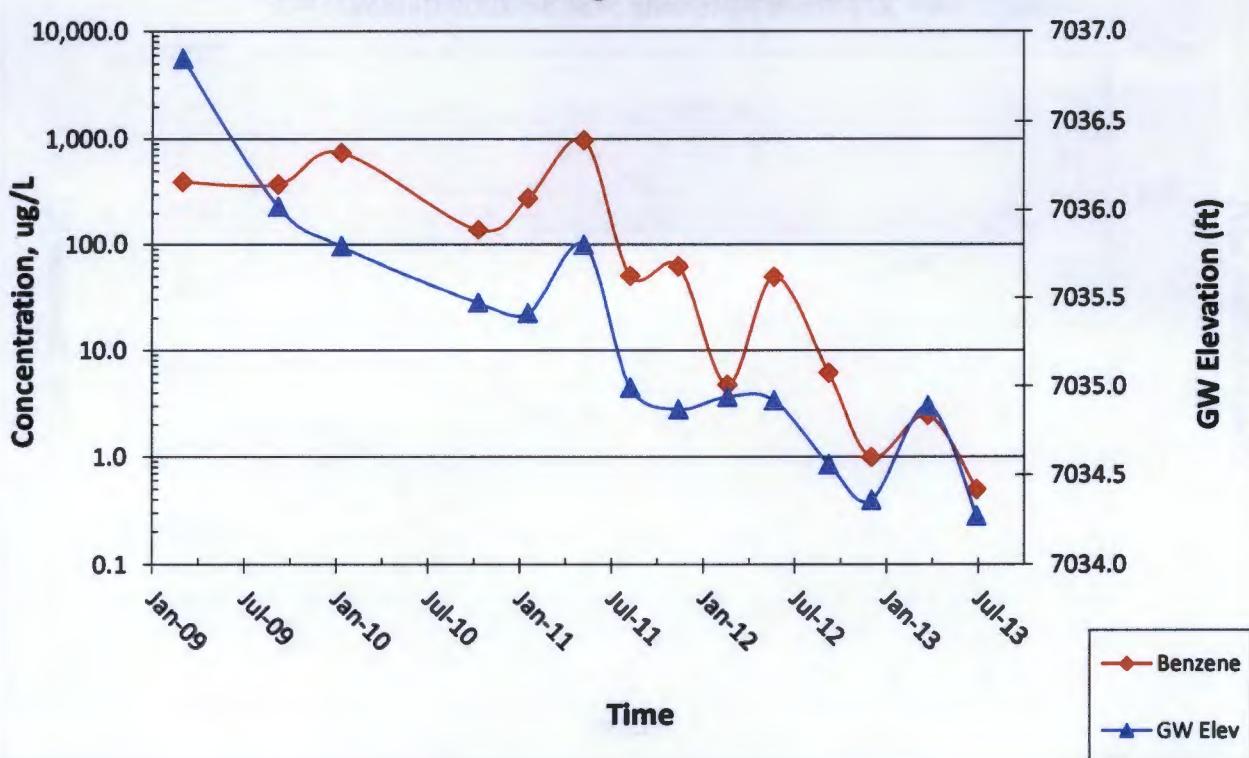
**Graph 2. MW-3 Benzene Concentrations Over Time  
BMG HWY 537 Receiving Station 2009 Release**

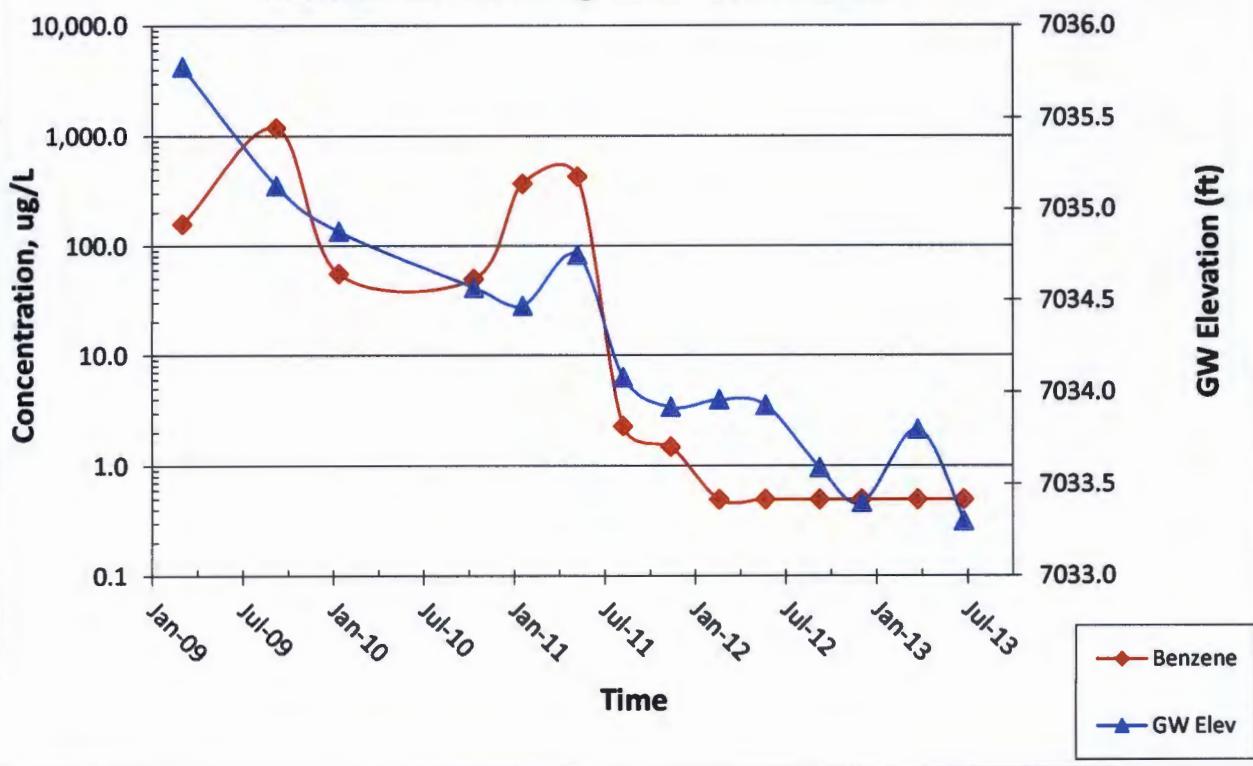
**Graph 3. MW-8 Benzene Concentrations Over Time  
BMG HWY 537 Receiving Station 2009 Release**

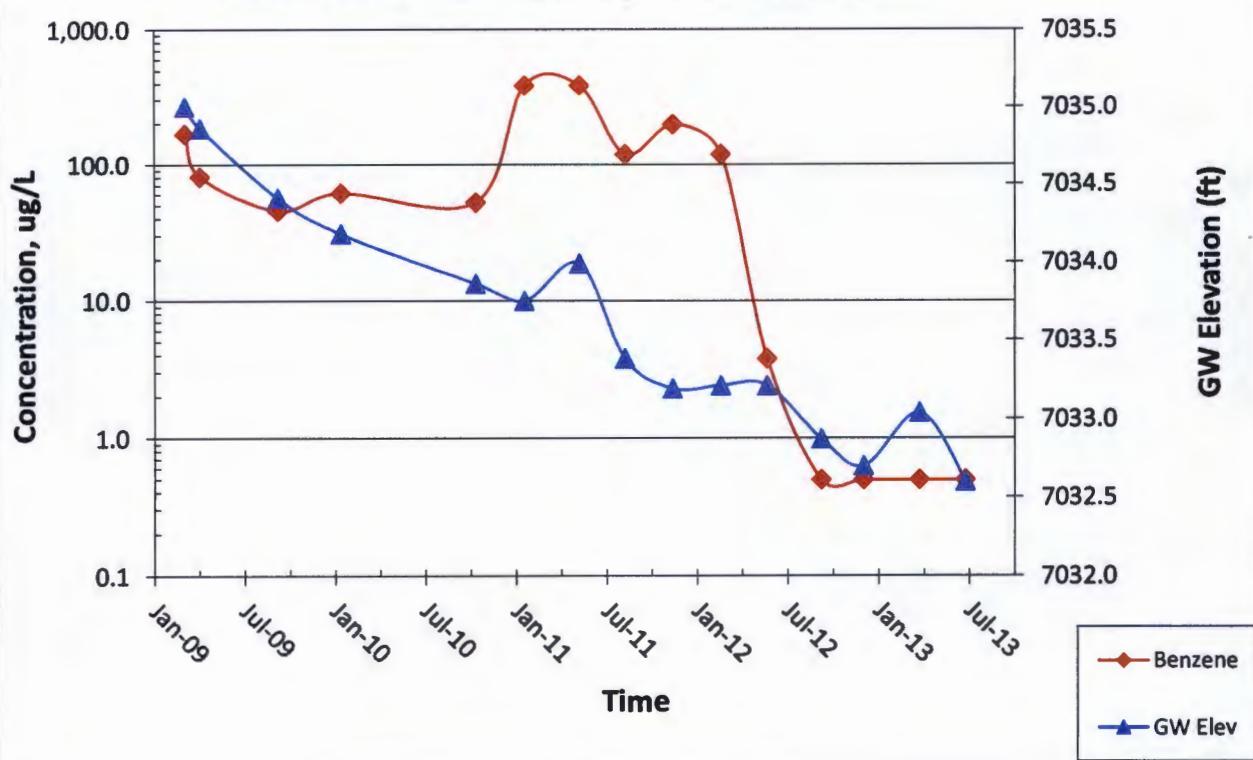
**Graph 4. MW-9 Benzene Concentrations Over Time  
BMG HWY 537 Truck Receiving Station 2009 Release**
