# **FINAL C-141 AND SPILL REMEDIATION REPORT**

**AUGUST 2011**

**Release Notification and Corrective Action**

Name of Company	Burgundy Oil & Gas of NM, Inc.	Contact	Ben Taylor
Address	401 W. Texas, Suite 1003, Midland, TX 79701	Telephone No.	(432) 684-4033
Facility Name	Eunice Monument Unit Tank Battery	Facility Type	Central Oil & Gas Battery

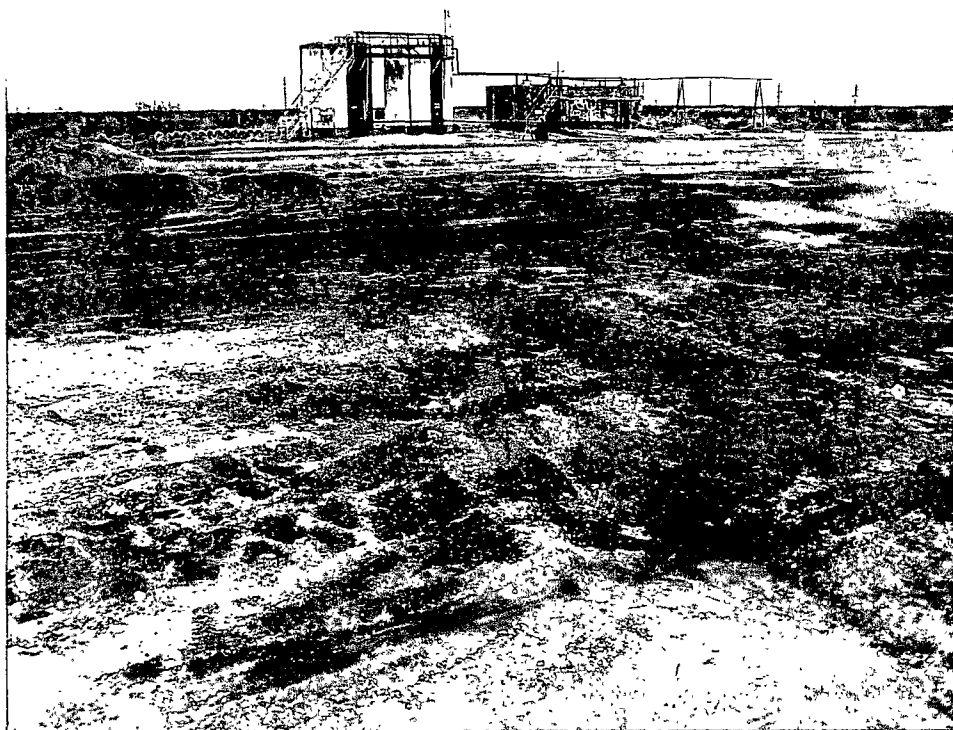
**View to south of spill 8/6/10**

Pad around tanks were stained with oil. Soil was excavated in an approximate 250' x 100' x 3' (deep) area until laboratory results of samples reported TPH concentrations below 100 mg/kg and chloride concentrations below 250 mg/kg. Impacted soil was blended on-site with clean soil and fertilizer until TPH concentrations were reported below 100 mg/kg, and the excavation was backfilled with blended soil. A site drawing with sample locations is attached, along with laboratory documentation and a table summarizing the sample results. The tank battery areas were lined with 20 mil plastic and new firewalls were constructed with the additional blended soil.

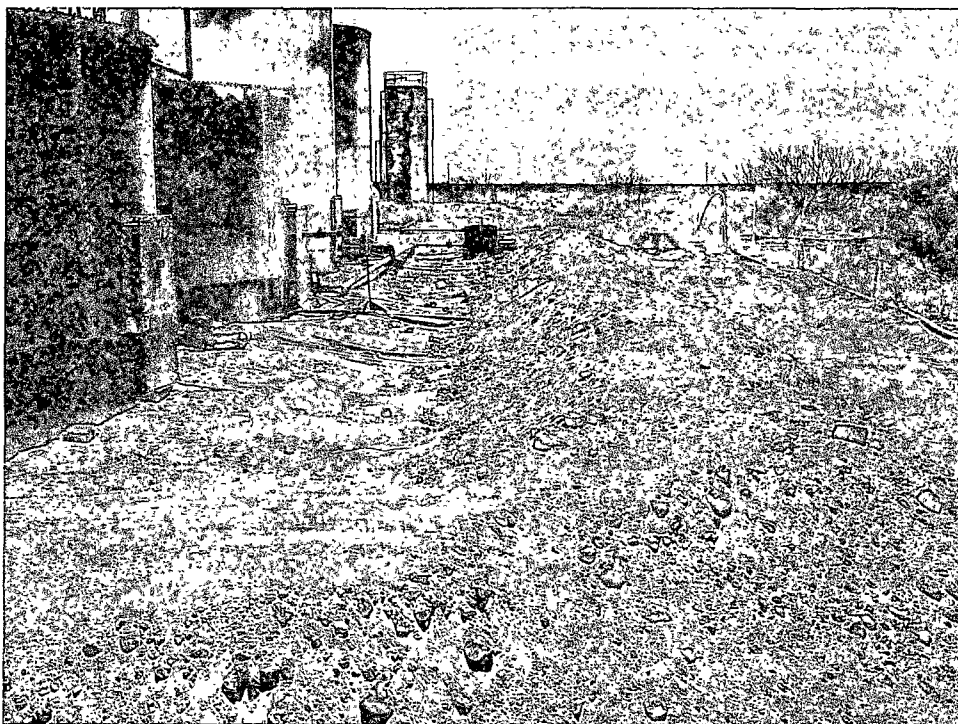
**View to east of completed remediation**
