RE: ICP REPORT
Rice Operating Company – BD SWD System
BD G-23 EOL (1R426-281): UL/G sec. 23 T22S R37E
(formerly BD B-23 EOL)

Geographical Location Map

BD G-23 EOL

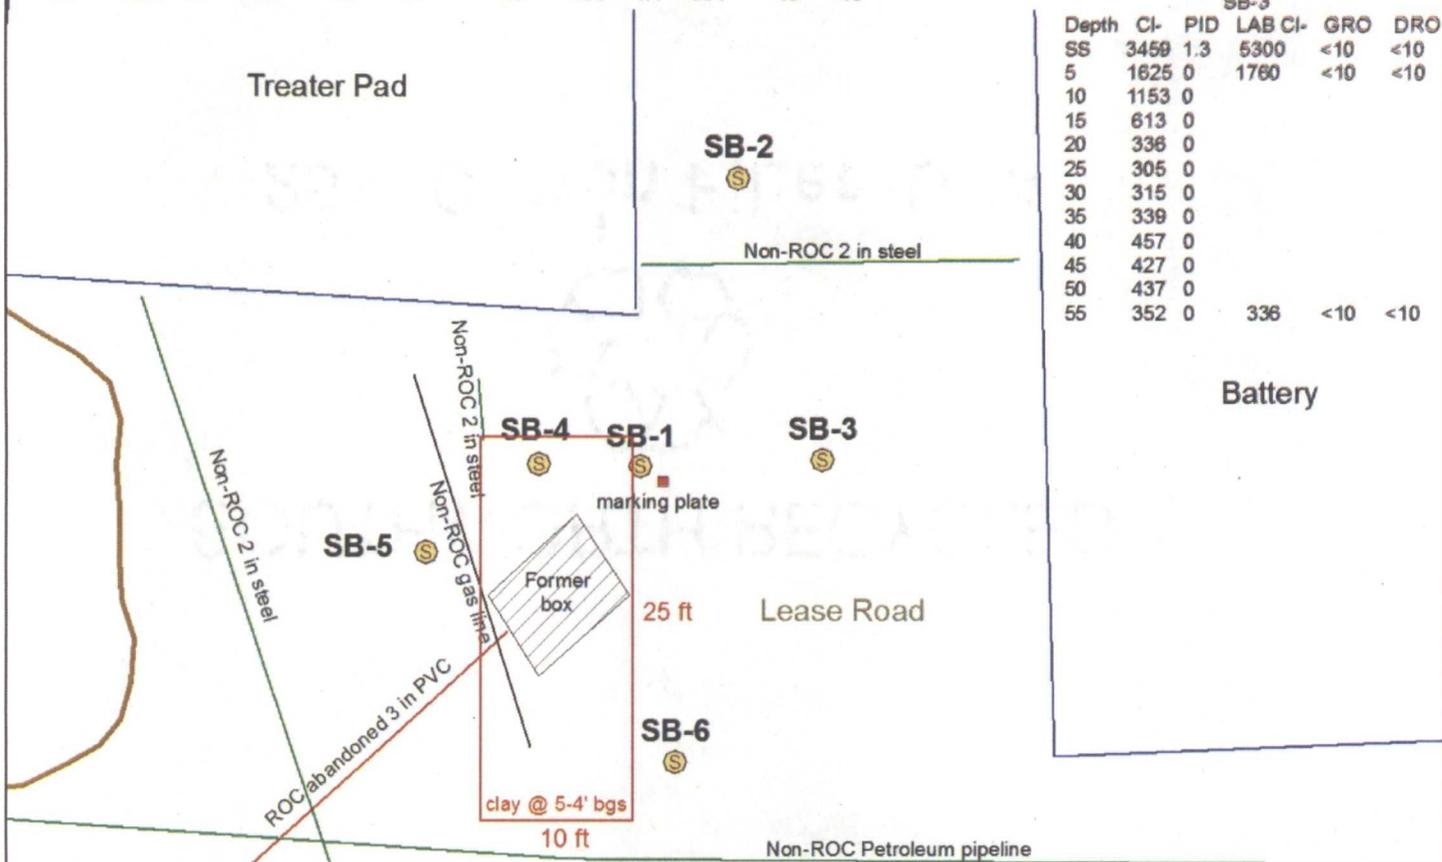
Soil bore installation

SB-1					
Depth	CI-	PID	LAB CI-	GRO	DRO
15	6687	23.7	8200	<10	<10
20	2839	9.3			
25	2181	3.6			
30	1749	1.7			
35	2294	0			
40	1055	0			
45	752	0			
50	570	0			
55	289	4.4	160	<10	<10

SB-2									
Depth	CI-	PID	LAB CI-	GRO	DRO	B	T	E	X
SS	201	0							
5	201	0							
10	323	0							
15	918	0							
20	1132	0.7	1420	<10	<10				
25	424	12							
30	193	213	112	<10	26.9	0.113	0.132	0.119	0.499
35	168	24.9							
40	183	1.4	304	<10	<10

SB-3					
Depth	CI-	PID	LAB CI-	GRO	DRO
SS	3459	1.3	5300	<10	<10
5	1625	0	1760	<10	<10
10	1153	0			
15	613	0			
20	336	0			
25	305	0			
30	315	0			
35	339	0			
40	457	0			
45	427	0			
50	437	0			
55	352	0	336	<10	<10

SB-4					
Depth	CI-	PID	LAB CI-	GRO	DRO
SS	168	2.7			
5	450	3.1			
10	3574	4.4			
15	8488	1.1	12800	<10	<10
20	2850	1			
25	5998	1			
30	2812	1			
35	4232	1.1			
40	3429	1.1			
45	2455	1			
50	1268	0.2			
55	2613	0	4000	<10	<10

SB-5					
Depth	CI-	PID	LAB CI-	GRO	DRO
SS	141	0.1			
5	773	0.8			
10	2468	0.9			
15	7881	0.8			
20	8823	0.9	10200	<10	<10
25	2136	1			
30	1378	0.3			
35	842	0.2			
40	625	0.8			
45	368	0.1			
50	210	0.1	544	<10	<10

SB-6					
Depth	CI-	PID	LAB CI-	GRO	DRO
SS	167	0			
5	295	0			
10	1800	0			
15	1919	0	2560	<10	<10
20	446	0			
25	252	0			
30	205	0	192	<10	<10

The marking plat is 10 ft northeast of the former junction box site

DGW: 59 ft

Attached is the soil data from the G-23 EOL , this site is enclosed in all four direction by either pipelines or facilities. We are evaluating options for further delineation.
