RE: ICP Report and Termination Request

Rice Operating Company – EME SWD System

EME N-17 EOL (1R427-286): UL/N sec. 17 T19S R37E

Geographical Site Map

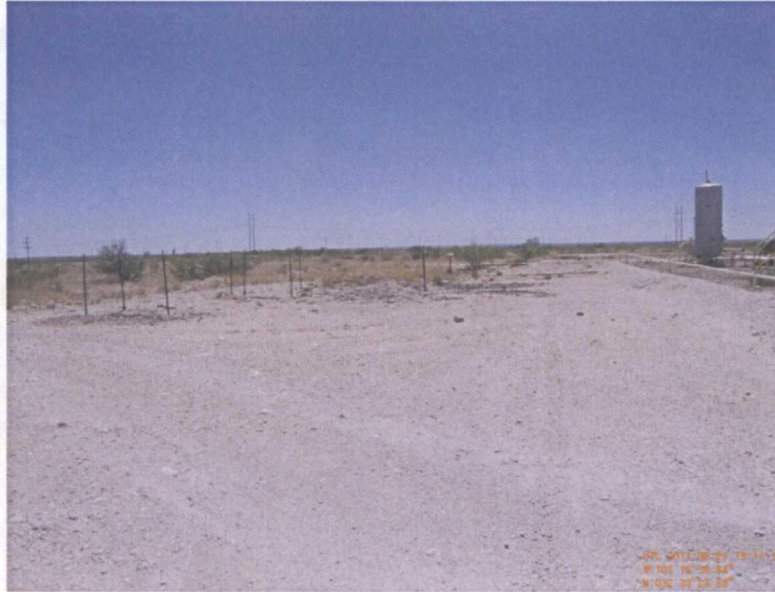
Figure 3

Site photo, facing south

8/23/11

The highest chloride concentrations observed during the initial investigation of the junction box were found in the source vertical. A lateral decline was observed from that source vertical to the 15 ft north and the 10 ft east, west, and south verticals. That soil was remediated and returned to the excavation with a chloride concentration of 179 mg/kg. Based on the fact that the soil bore advanced through the source of the former junction box site shows chloride laboratory numbers below 250 mg/kg and hydrocarbon laboratory numbers as non-detect, the site will in no way contribute to the degradation of groundwater beneath the site. The site is located near an active battery and on a caliche lease road surrounding the battery; therefore, re-vegetation of the site is unnecessary (Figure 3). Because the site will in no way contribute to the degradation of groundwater beneath the site and given that re-vegetation efforts are not necessary, ROC submits this site for termination of the regulatory file.

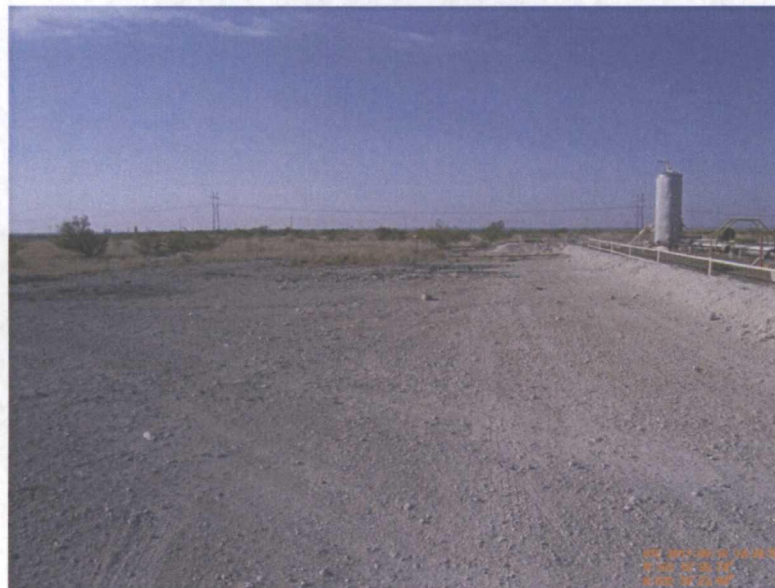
Site photo, facing south

9/12/11
