RE: Initial CAP Report – Liner Installation
NMOCD Case #: 1R425-66
Vacuum L-26 Vent Site, T17S, R35E, Section 26 (L)

R.T. Hicks Consultants, Ltd. is submitting this Initial CAP Report that describes the activities associated with the liner installation, on behalf of Rice Operating Company (ROC) for the above-referenced site. Information from the investigations conducted to date was presented in the Initial Characterization Plan (ICP) and Corrective Action Plan (CAP), submitted to your office on September 14, 2010. That report included recommendations to: (1) install a monitoring well 50 feet down gradient from the site to evaluate possible ground water impact due to historic, intermittent releases from the former junction box; and (2) surface restoration, including the removal of large rocks and seeding the area to encourage re-vegetation. On April 1, 2011 an addendum to the CAP was submitted to your office. It indicated that a single monitoring well had been installed and sampled; based on the initial results further delineation was proposed. In addition, ROC proposed the installation of a 4,032 ft² 20-mil reinforced polyethylene liner to further protect the ground water. The CAP

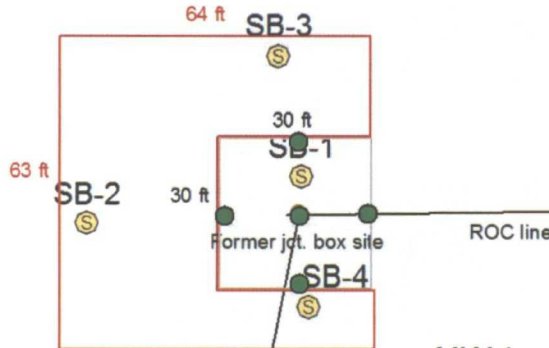
Vacuum L-26 vent

Proposed liner

- Backhoe delineation trenches
- Geo-synthetic liner

To further protect groundwater from potential chloride migration, ROC proposes to excavate soil with a 64x63-ft area to a depth of approximately 5 to 4-ft below ground surface (bgs) and properly seat a 20 mil, reinforced polyethylene liner in the base of the excavation. Backfill soils will not exceed a chloride concentration of 500 mg/kg and a PID (field) ready of 100 ppm. Excavated soil will be evaluated for use as backfill and any soil requiring disposal will be properly disposed of at a NMOCD approved facility. The site will then be seeded with native seed mixes and soil amendments will be added as necessary to encourage re-vegetation. As plants capture water through their roots, they reduce the volume of water infiltrating below the root zone and create a natural "infiltration barrier" that will remain in place after the buried synthetic liner degrades. Both the synthetic liner and vegetation help protect ground water as the decreased flux of water through the subsurface slows the transportation rate of residual chloride in the subsurface, allowing dilution and dispersion to decrease possible adverse impact to ground water.

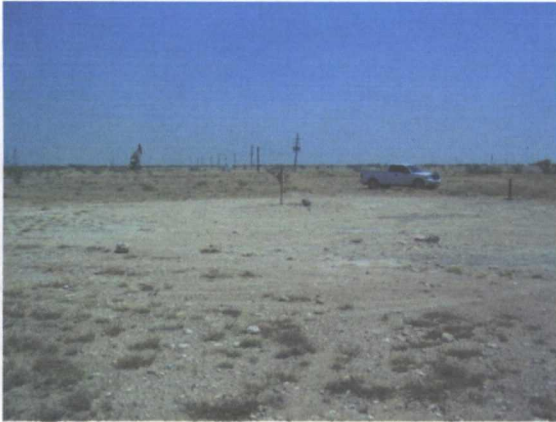
Site prior to excavation, facing east 4/16/2011

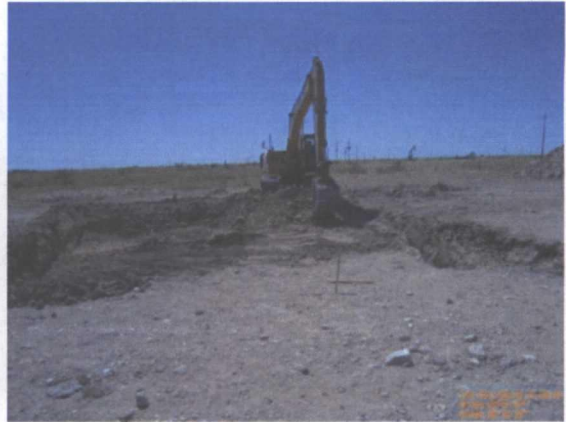
Excavating the site, facing west 5/23/2011

Beginning on May 23, 2011 a 64-foot by 63-foot area was excavated to a depth of five feet below the surface (bgs), covering the existing 30-foot by 30-foot geosynthetic liner that was installed in December 2008. Upon completion, the bottom of the excavation was padded with 6-inches of clean blow sand and a 20-mil reinforced polyethylene liner was installed at 4.5 feet bgs. A 6-inch pad of clean blow sand was placed above to protect the integrity of the seal. Pond bottom soil was used to backfill the excavation and blow sand was used to contour the site to the surrounding area. On July 15, 2011, 20 bags of "RestoreNance" was tilled into the surface soil. The area was then reseeded with 32 lbs of Black Grama seed.

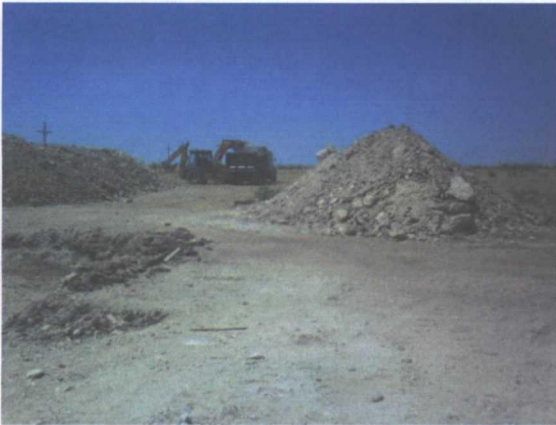
Exporting excavated soil, facing northwest
5/25/2011

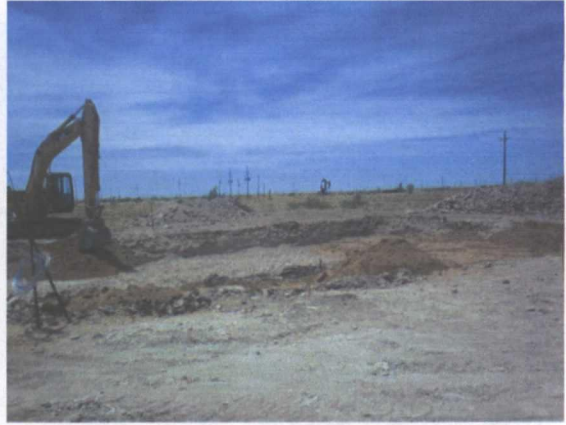
Padding the base of the excavation with 6" of
blow sand, facing west 5/27/2011

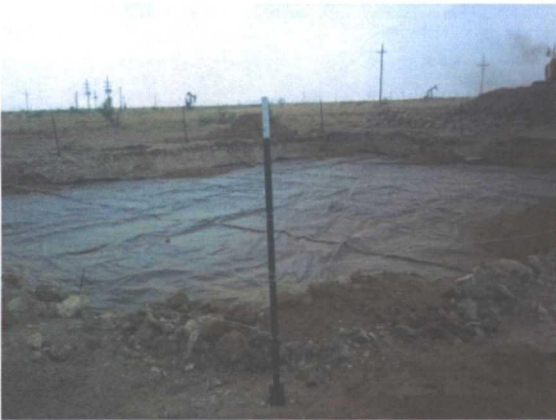
64x63 ft, 20-mil reinforced liner installed at 4.5
ft bgs, facing west 5/31/2011

- The site was excavated and backfilled to grade from May 23 to June 7, 2011. A total of 740 yd³ of soil was transported to Sundance Disposal and 804 yd³ of soil was imported.
- The liner was installed at 4.5-feet below existing grade on May 31, 2011
- Seeding of the area occurred on July 15, 2011
- Imported soil met the concentration requirements of the CAP Addendum
 - Imported Pond Bottom Soil: Cl⁻ 48.0 mg/kg and PID 4.2 ppm

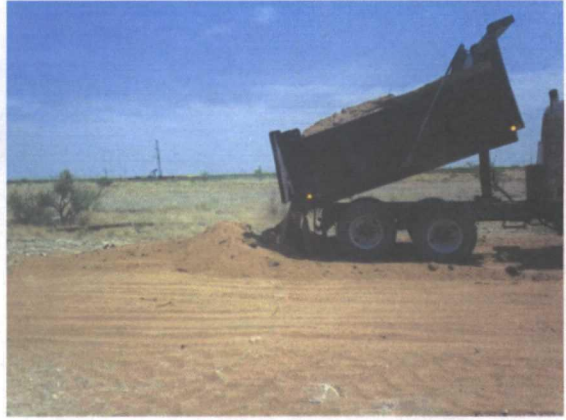
Importing blow sand, facing northeast 6/1/2011

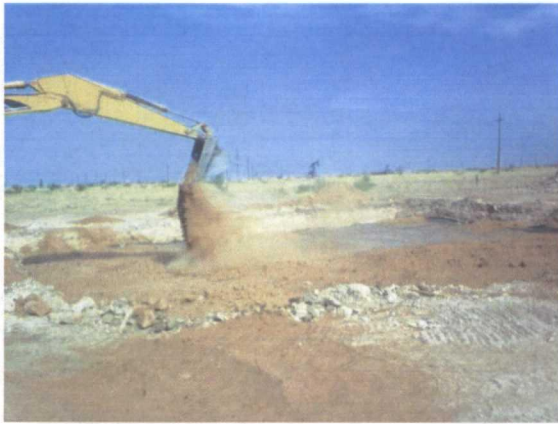
Padding above the liner with 6" of blow sand,
facing northwest 6/1/2011

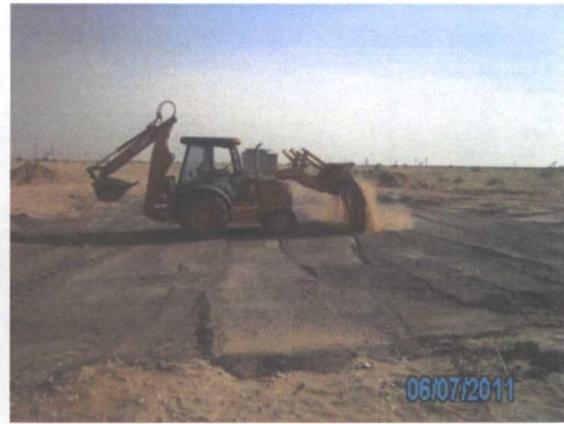
Contouring the backfilled site with imported
soil, facing north 6/7/2011

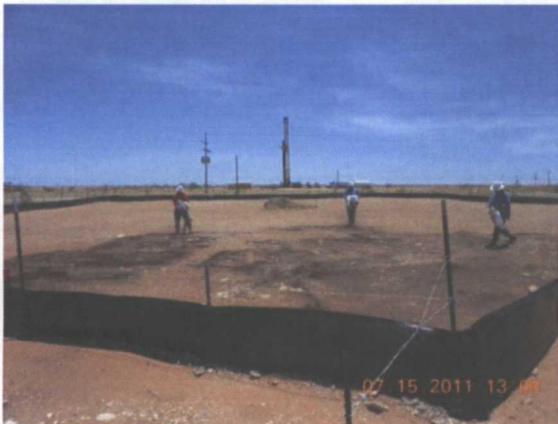
Spreading RestoreNhance on the backfilled site,
facing southeast 7/15/2011

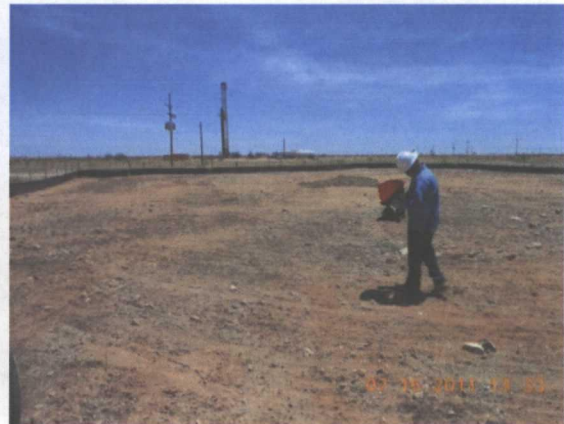
Seeding the backfilled site, facing southwest
7/15/2011

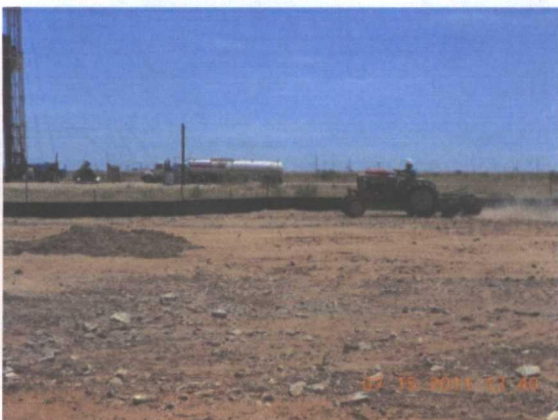
Tilling in seed and RestoreNhance, facing
southwest 7/15/2011

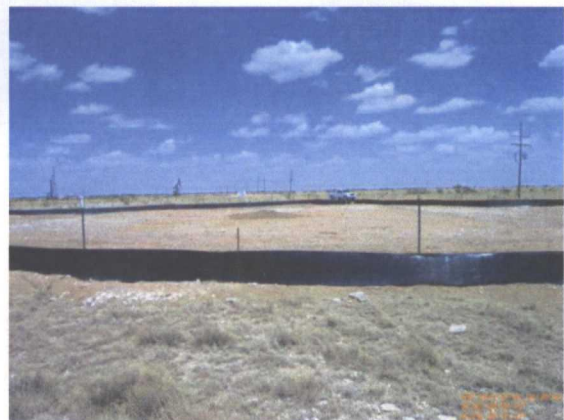
Site Completed 7/28/2011
